**ANALYSIS OF BANK EROSION ON THE
ILLINOIS RIVER IN NORTHEAST
OKLAHOMA**

**Submitted to the Faculty of the
Graduate College of the
Oklahoma State University
in partial fulfillment of
the requirements for
the Degree of
DOCTOR OF PHILOSOPHY
December, 1997**

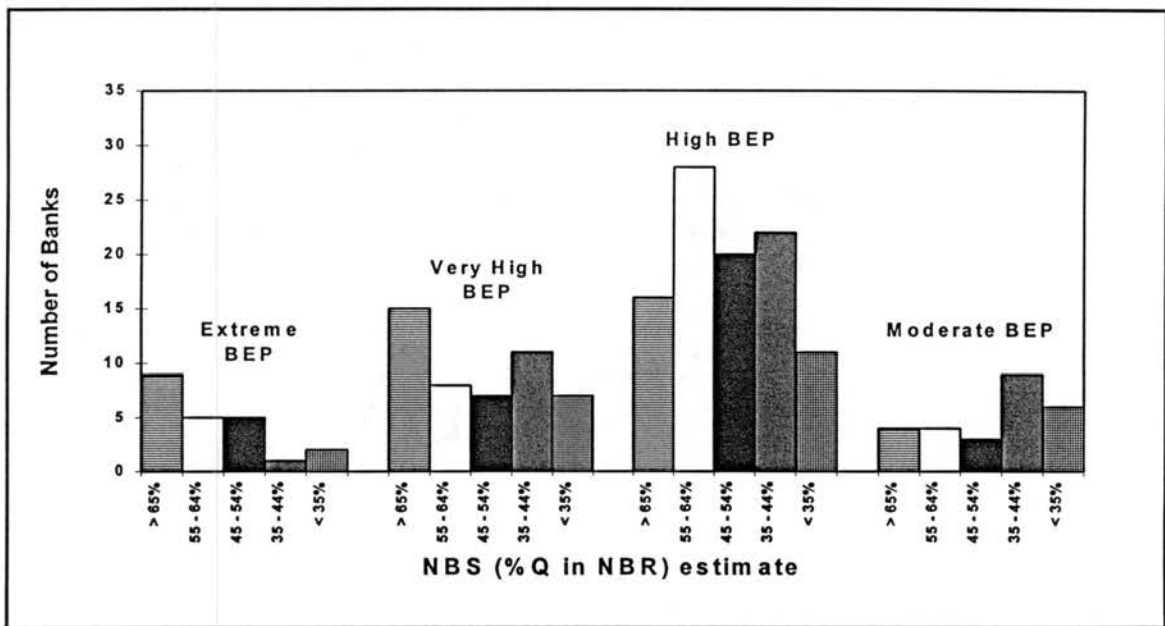
Figure 4: Groupings Based on Bank Erosion Potential and Near Bank Stress Estimates

Similar banks were grouped according to bank erosion potential and near bank stress estimates (figure 4). At least one bank from each group, a total of 36 sites, were selected for detailed study. The sites selected for detailed study were: 010, 015, 040a, 040b, 040c, 041a, 041b, 050a, 050b, 060a, 060b, 061, 060c, 065a, 065b, 069a, 069b, 072a, 072b, 084a, 088a1, 088a2, 088b, 093a, 093b, 094, 096, 105, 106a, 106b, 108, 120, 128a, 128b1, 128b2, and 143. Photographs of each of these sites appear in Appendix A.

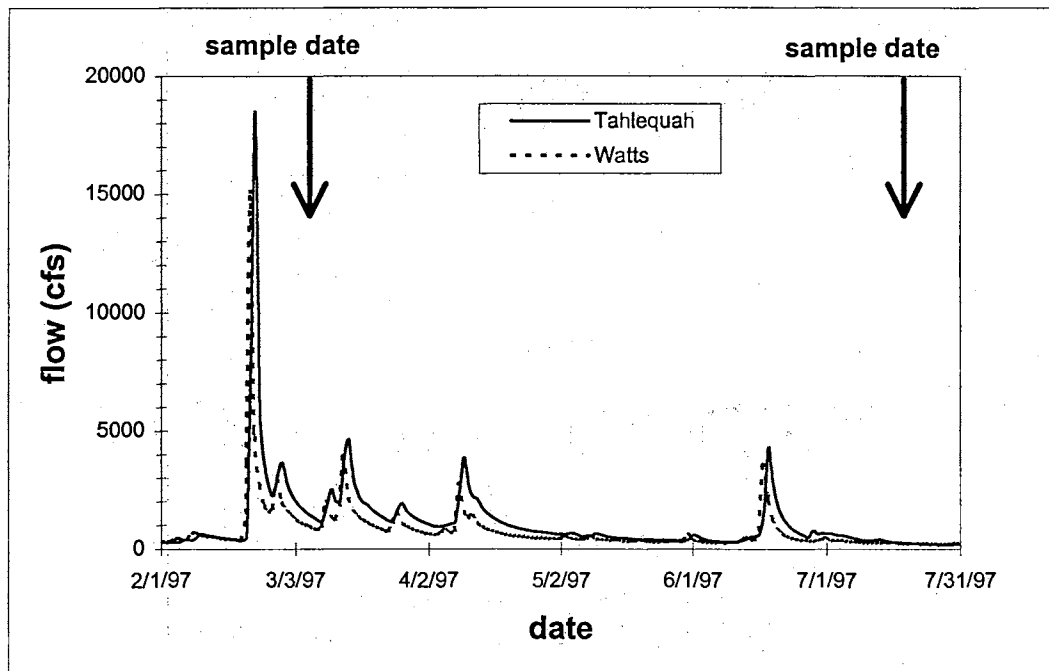
Figure 5b: Mean Daily Flows for the Illinois River Gage Stations at Watts and Tahlequah (provisional data for February 1, 1997 to July 31, 1997)

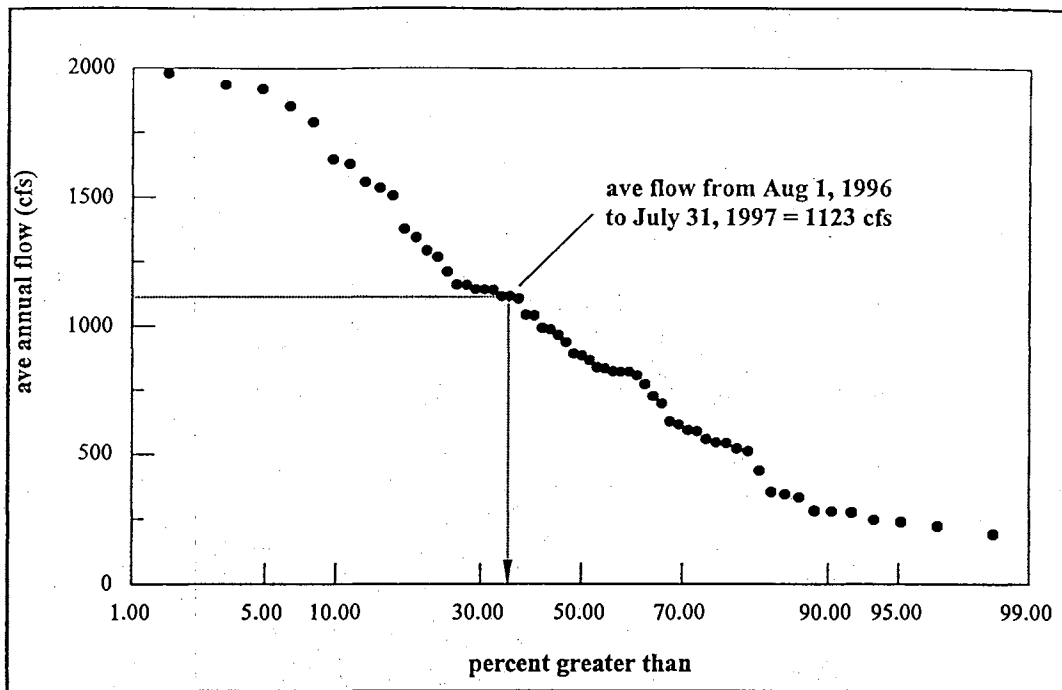
Figure 6a: Average Annual Flows for the Tahlequah Gage Station

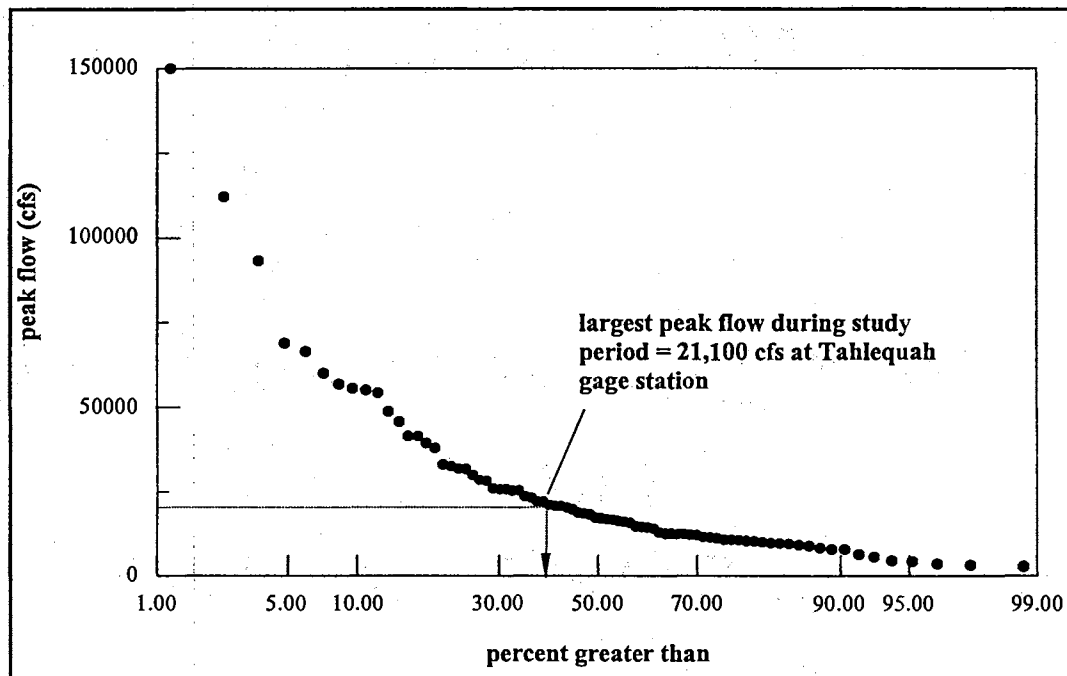
Figure 6b: Peak Flows for the Tahlequah Gage Station

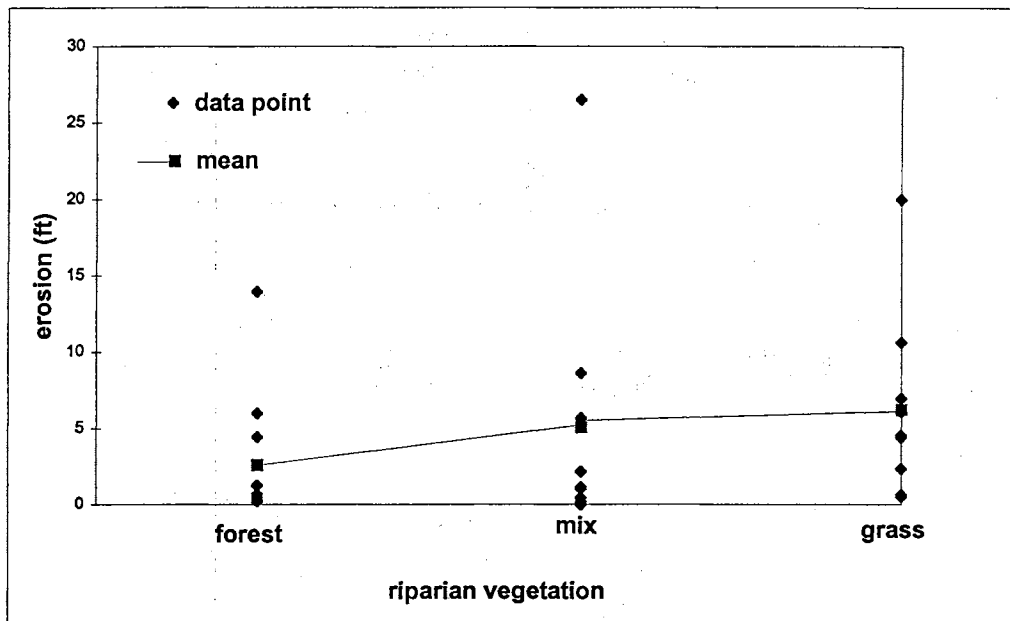
Figure 7: Short-term Erosion Versus Riparian Vegetation
(line drawn through means to show trend)

vegetation type		
	forest	mix	grass
mean (ft)	2.55	5.08	6.24
standard deviation	4.26	8.55	6.07
n	11	9	9
calculated t values		df	
t (forest-mix) =	0.86	18	
t (forest-grass) =	1.60	16	
t (mix-grass) =	0.33	18

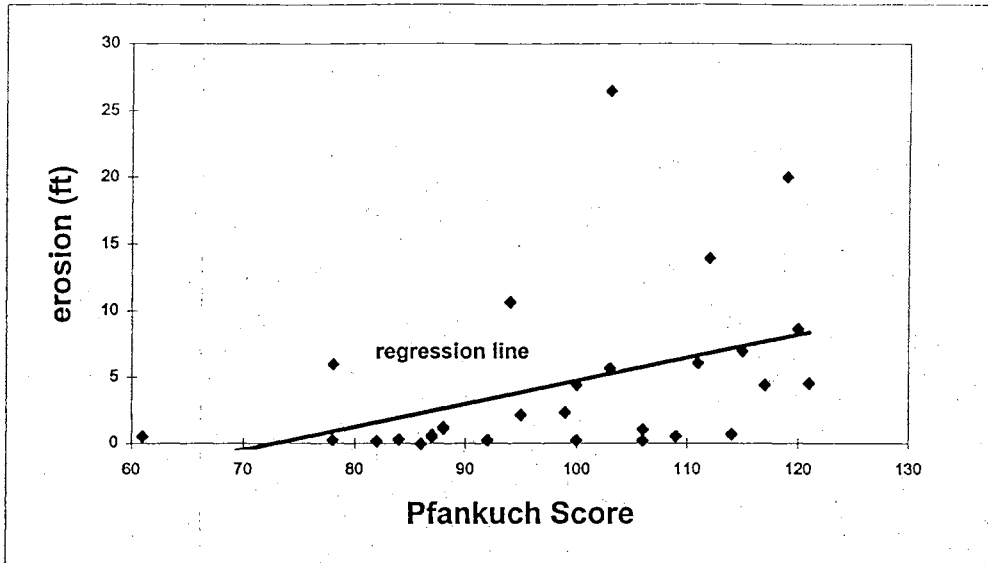
Figure 8: Bank Erosion Versus Pfankuch Channel Stability Score
(data in this figure appear in tables 6 and 11)

ANOVA					
	<i>df</i>	<i>SS</i>	<i>MS</i>	<i>F</i>	<i>Significance F</i>
Regression	1	190.89	190.89	5.48	0.03
Residual	27	940.90	34.85		
Total	28	1131.78

<i>Coefficients</i>	<i>Standard Error</i>	<i>t Stat</i>	<i>P-value</i>	<i>Lower 95%</i>	<i>Upper 95%</i>
Intercept	-12.66	7.41	-1.71	0.10	-27.86	2.53
Slope	0.17	0.07	2.34	0.03	0.02	0.33

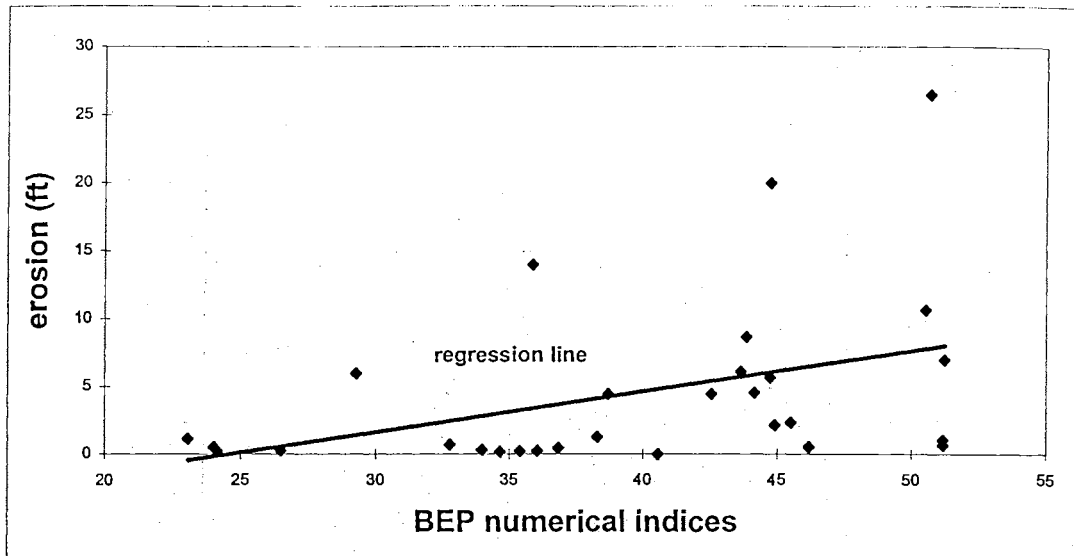
Figure 10: Bank Erosion Versus Bank Erosion Potential Numerical Indices
(data in this figure appear in tables 4 and 11)

<i>ANOVA</i>					
	<i>df</i>	<i>SS</i>	<i>MS</i>	<i>F</i>	<i>Significance F</i>
Regression	1	185.06	185.06	5.28	0.03
Residual	27	946.91	35.07		
Total	28	1131.96

<i>Coefficients</i>	<i>Standard Error</i>	<i>t Stat</i>	<i>P-value</i>	<i>Lower 95%</i>	<i>Upper 95%</i>
Intercept	-7.36	5.27	-1.40	0.17	-18.18	3.45
Slope	0.30	0.13	2.30	0.03	0.03	0.57

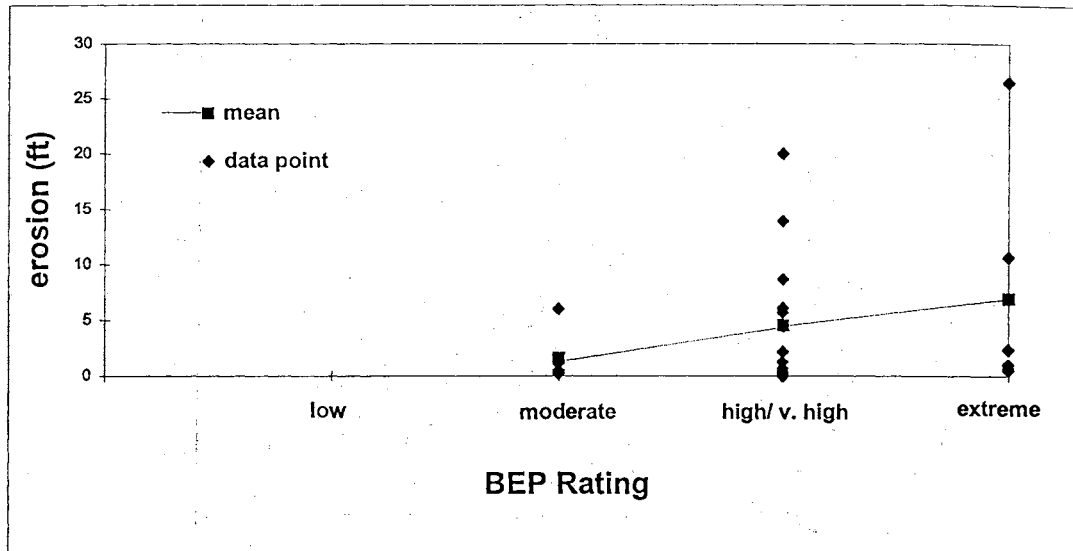
Figure 11: Bank Erosion Versus Bank Erosion Potential Ratings
(line drawn through means to show trend)

rating	erosion (ft)		
	average	median	variance
extreme	6.95	2.34	88.8
high/v. high	4.30	2.15	30.7
moderate	1.62	0.50	6.1
low	na	na	na

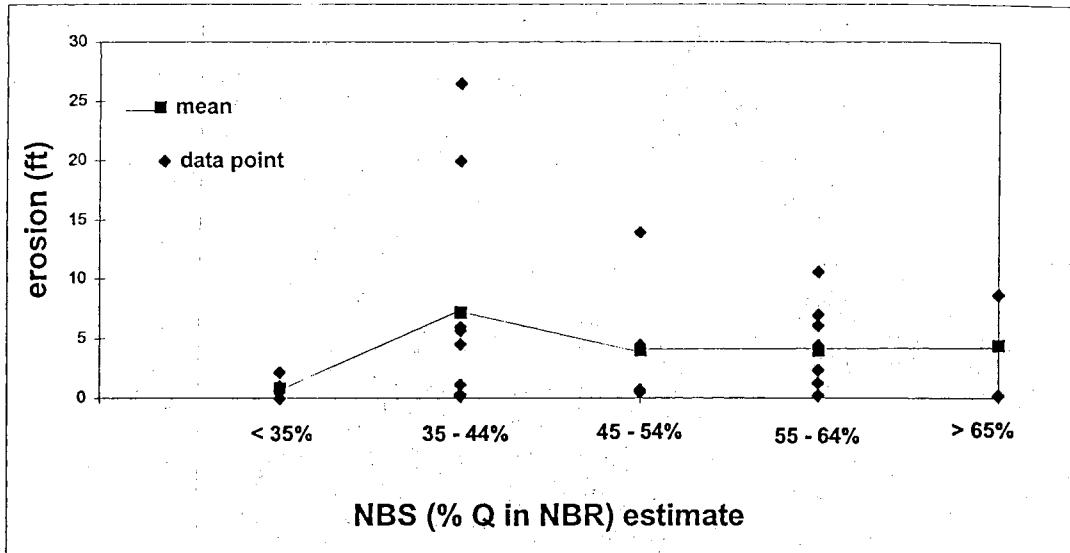
Figure 13: Bank Erosion Versus Grouped Near Bank Stress Estimates
(line drawn through means to show trend)

estimate	erosion (ft)		
	average	median	variance
> 65%	4.44	4.44	35.4
55 - 64%	4.01	3.39	13.8
45 - 54%	4.02	0.68	33.6
35 - 44%	7.17	4.55	41.2
< 35%	0.85	0.64	0.7

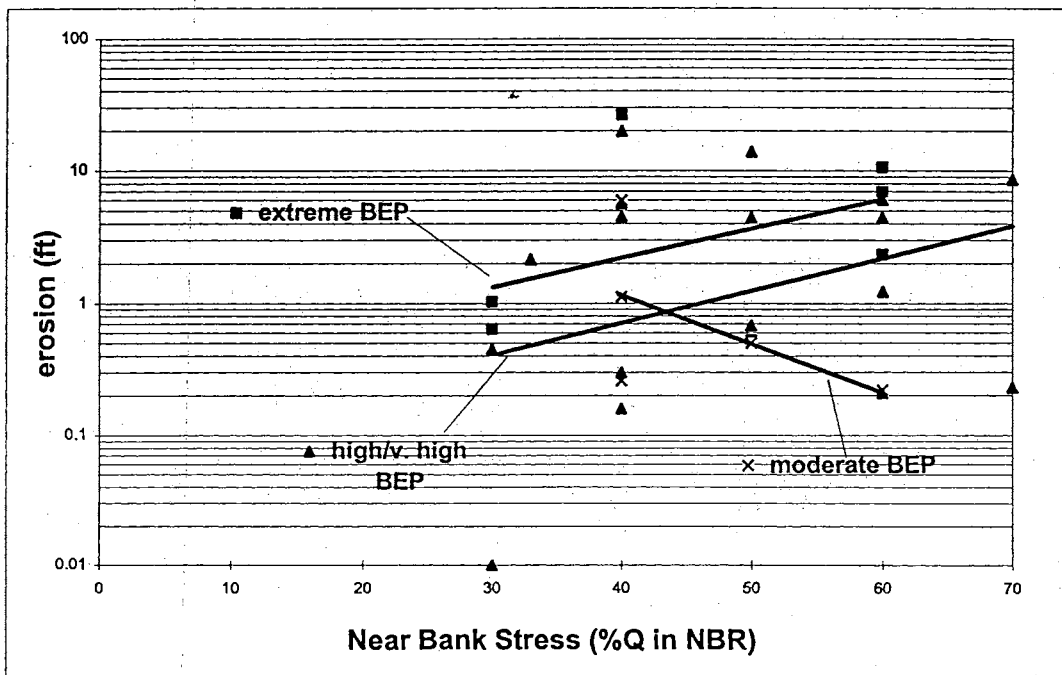
Figure 14b: Relationship Between Bank Erosion Potential and Near Bank Stress Estimates Versus Measured Erosion

categories, the relationship between NBS and erosion rate shows little variance. In the Colorado fluvial sites study, in an analysis of variance with the BEP and NBS ratings as independent variables and the log of erosion as the dependent variable, the r^2 value was 0.93 (Rosgen 1996b). In the Yellowstone National Park study, the coefficient of determination was 0.87 (Rosgen 1996b). Also in Rosgen's studies, the bank erosion rate increased, over the range of NBS ratings, as BEP increased; and the bank erosion rate increased as NBS increased within a BEP category.
