Flume tests on fluvial erosion mechanisms in till-bed channels

L. Pike¹, S. Gaskin¹, P. Ashmore²

Abstract

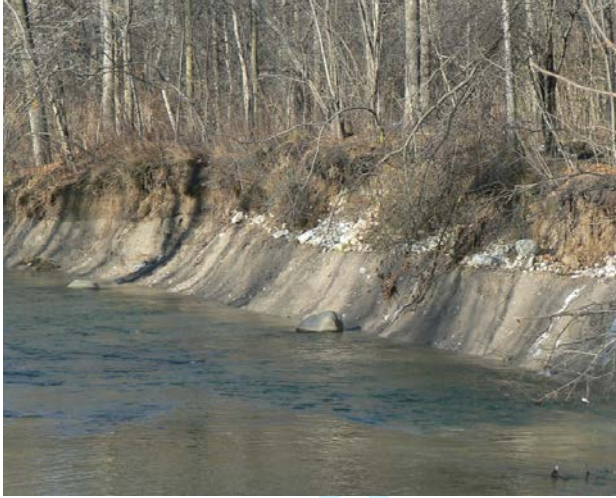
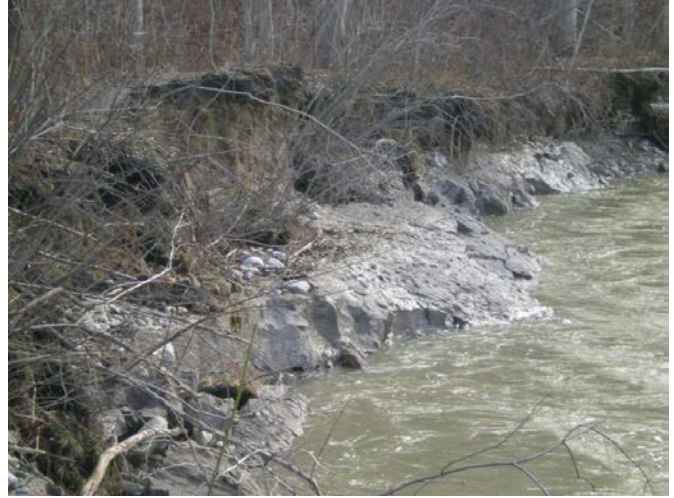
Figure 2 a) Medway Creek bank showing till in lower bank with overlying sand and gravel
b) Till at base of bank extending across the bed below the water

Medway River has a catchment area of approximately 200 km². Water Survey of Canada
has operated a gauging station near the sampling site since 1947 at which the mean
annual discharge is 2.8 m³/s, and maximum daily and instantaneous discharges are 117
and 146 m³/s respectively. Annual maximum daily mean discharge with 2.3 and 5 year
recurrence intervals are approximately 60 and 80 m³/s. Till is exposed in the bed and
banks along the sampled reach and in places is covered by a layer of alluvial gravel-
cobble up to 0.3 m thick (Hrytsak, 2012) (Figure 2).

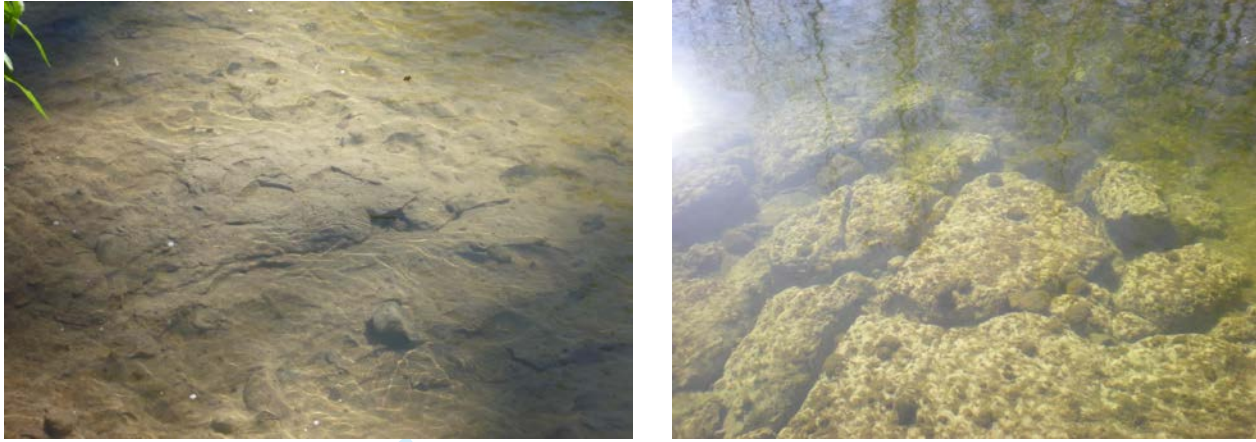
Figure 4 a) Till exposed in the channel bed with indications of erosion by fluvial scour and block separation
b) Close up view of mass erosion of till on channel bed

26 The un-weathered till was very dense and hard both on the bed (under water) and
27
28 exposed in the bank toe. It could not be penetrated with a shovel by hand and the specific
29
30 gravity of the samples was later calculated to be an average of 2.36. There is strong field
31
32 evidence of both mass erosion (block separation and detachment) and hydraulic surface
33
34 erosion of the till. Observations indicated that the till has natural planes of weakness and
35
36 defined fractures. In some cases, these fractures were similarly oriented and fracture
37
38 planes were observed (Figure 3) in the bed and banks. The apparent structure of the
39
40 material and the abundance of blocks of till on the bed where erosion had taken place was
41
42 evidence of mass erosion. Mass erosion was also observed as block separation under
43
44 the water (Figure 4) and mass failure of till blocks from the banks also occurs. The

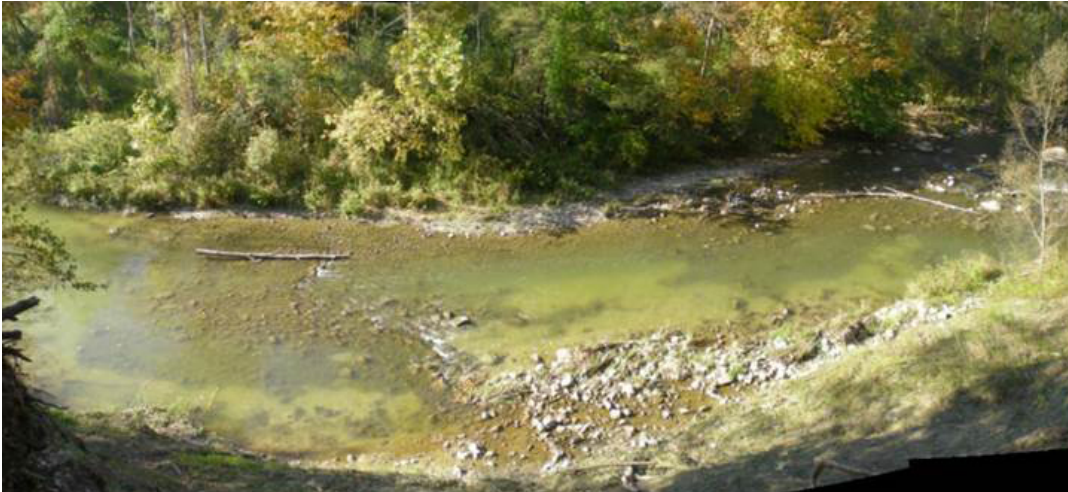
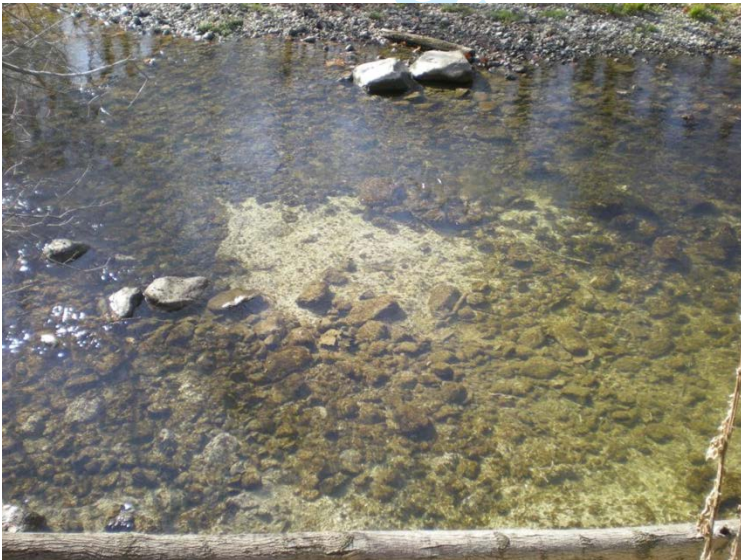
41
42
43
44 Figure 5 a) Overview of channel showing exposed till (light patches) and thin gravel cover
45 layer (Photo by Tatiana Hyrtsak)
46 b) Close up view of till patch exposed beneath gravel cover
47
48
49
50
51
52
53
54
55
56
57
58
59
60

10
11 Larger gravel and cobbles could be seen embedded in the till and pockets were visible
12 where embedded particles had been removed. The till is therefore a principle source of
13 the gravel-cobble cover on the bed, in addition to the thin gravel layers in the eroding
14 banks. Loose gravel mantles some areas of the bank toe and a discontinuous gravel-
15 cobble alluvium with occasional boulders covers the river bed (Figure 5). Previous
16 sampling in the reach (Hrytsak, 2012) showed that 50-70% of the bed area has some
17 cover. In some areas the cover is only one grain thick, but thicker (and finer-grained) bar
18 deposits also occur. Averaged over the reach, gravel cover thickness is 0.3 m (Hrytsak,
19 2012).
20
21
22
23
24
25
26
27
28
29
30
31
32
33

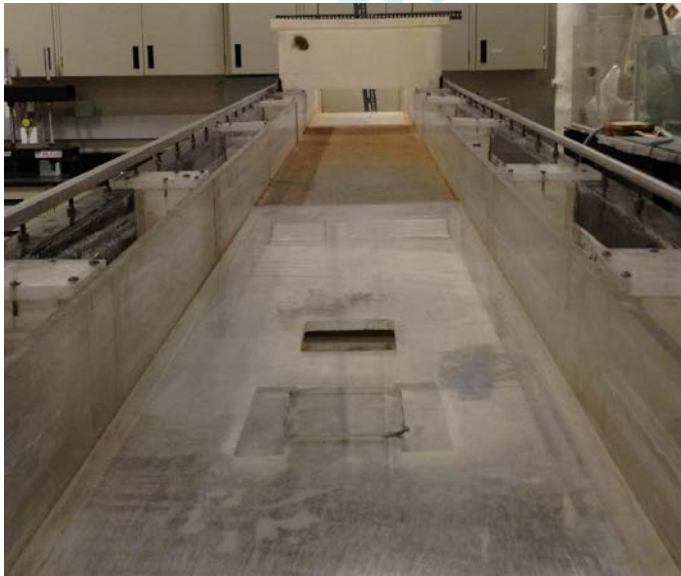
Figure 6 a) Plan view of flume and sample location
b) Photo of flume photo showing block placement

35
36
37 Erodibility tests in a hydraulic flume allowed observation of erosion mechanisms in a set-
38 up as close as possible to that in the field with the samples subjected to tangential
39 stresses equivalent to those at the bed of the channel. A 4 m x 0.4 m x 0.15 m
40 recirculating hydraulic flume was used to test the samples (Figure 6).
41
42
43
44
45
46
47

Each sample was placed in the flume such that the top surface of the sample was flush with the channel floor. This was achieved by placing the sample on a height-adjustable platform beneath the flume's plexiglass false floor in a 10 cm x 10 cm hole located at a distance of 2.5 m from the upstream end of the channel (Figure 6). The platform was adjusted throughout testing to maintain the erosion surface of the sample level with the flume floor at all times – the frequency of adjustment depended on the erosion rate ranging from seldom to every few minutes.

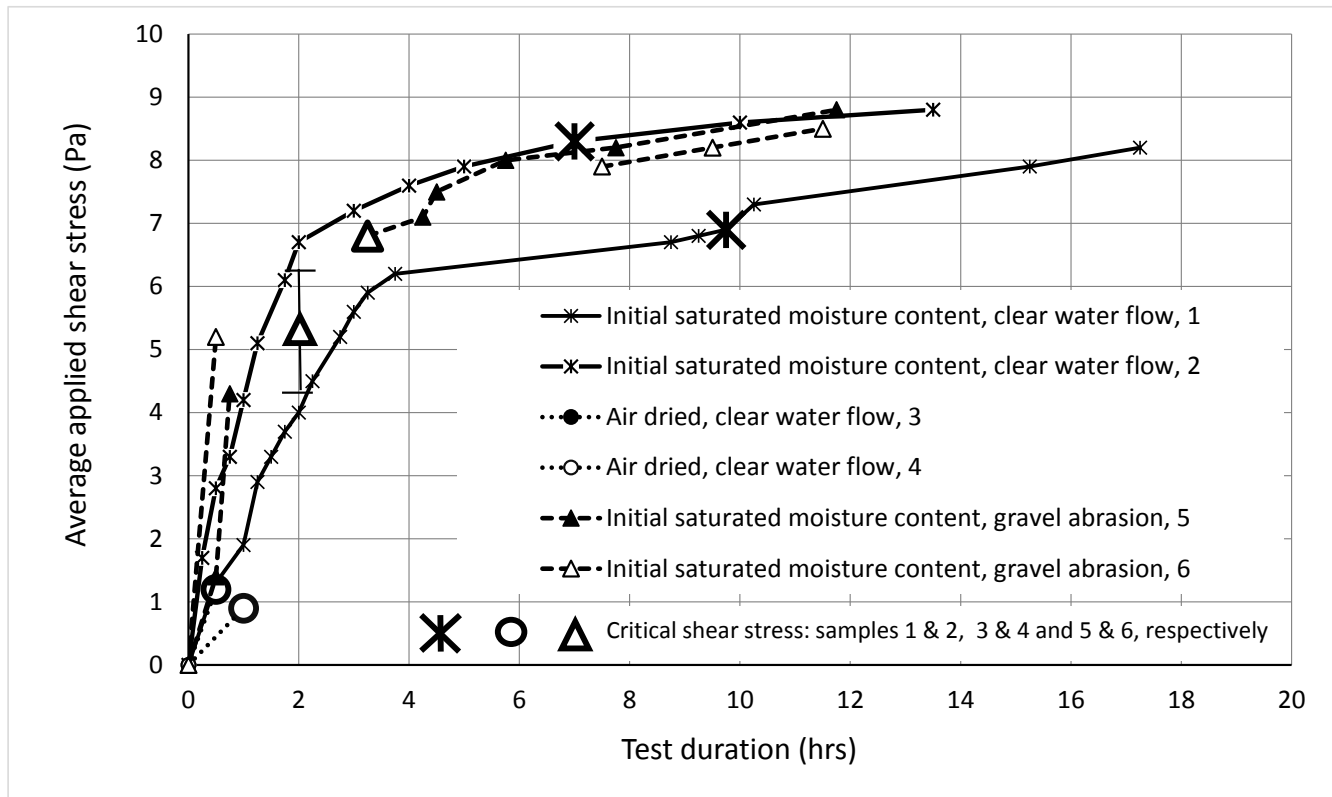
Figure 7. Flume erosion test results of the applied shear stress versus time (—, ···, ---) and the critical shear stress (*, ○, △) for each sample type: initial saturated moisture content, air dried and initial saturated moisture content with gravel abrasion.

25
26
27 The critical shear stress values for the six samples obtained from the hydraulic flume
28
29 studies are summarized in **Figure 7**. Critical shear stress ranged from 0.9 – 8.3 Pa. (Table
30
31 2). Critical shear stress was almost an order of magnitude lower for the two air-dried
32
33 samples (3 and 4) compared to the samples at the initial saturated moisture content, and
34
35 the presence of loose gravel moving over the till reduced critical shear stress slightly
36
37 compared to the absence of gravel. The plot of applied stress over time for samples 5 and
38
39 6 reflects the fact that at times the samples were completely covered by gravel and it was
40
41 assumed that stress on the till surface was effectively zero under those conditions.
42
43
44
45
46
47

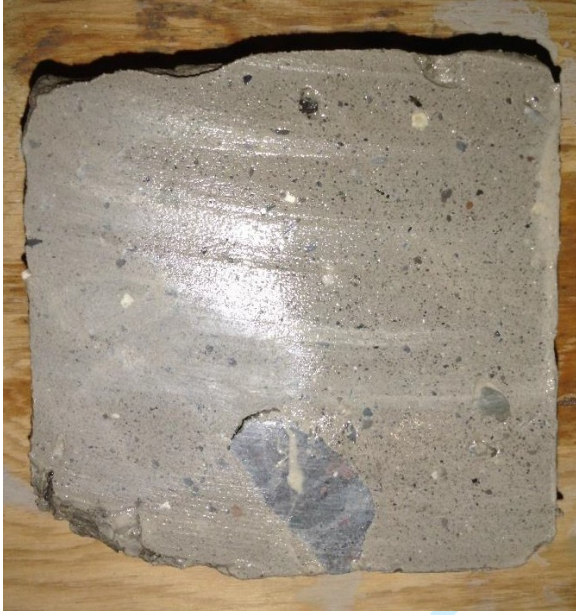
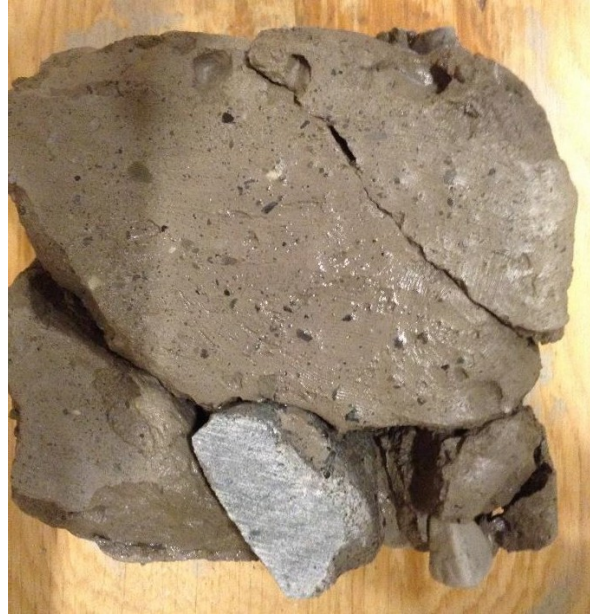
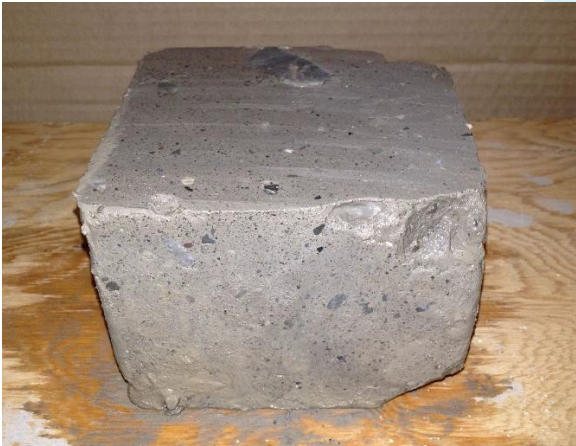
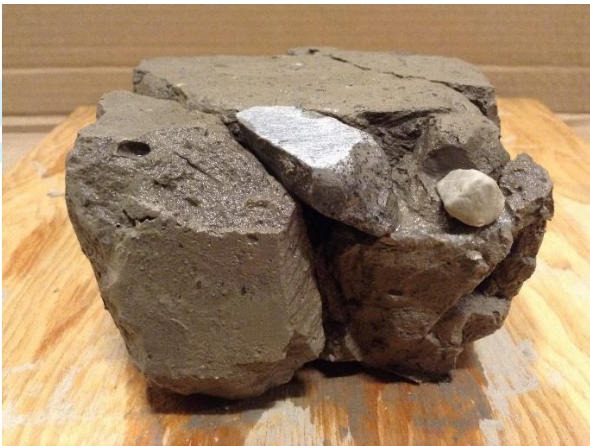
Figure 8 Sample 2, initial saturated moisture content clear water flow, a) before and b) after erosion test top view, and c) before and d) after erosion test side view.

49
50 Samples 1 and 2 showed similar erosion behaviour (**Fig 8**). Sample 1 eroded by a mass
51
52 erosion process in which spontaneous fracturing delineated small blocks of till, which
53
54 eventually detached from the sample. The first sign of weakening of the till sample was a
55
56 crack developing down the middle of the sample at an applied shear stress of 6.7 Pa,
57
58 appearing to split the entire sample in half. With a further increase in the applied shear
59
60

1
2
3 the initial water content sample) due to the microfissures resulting in a higher surface area
4 and allowing for increased absorption of water. These observations show that wetting and
5
6
7
8 drying has a substantial effect on the erosional resistance, as seen in a comparison of
9
10 Figures 8 and 9.

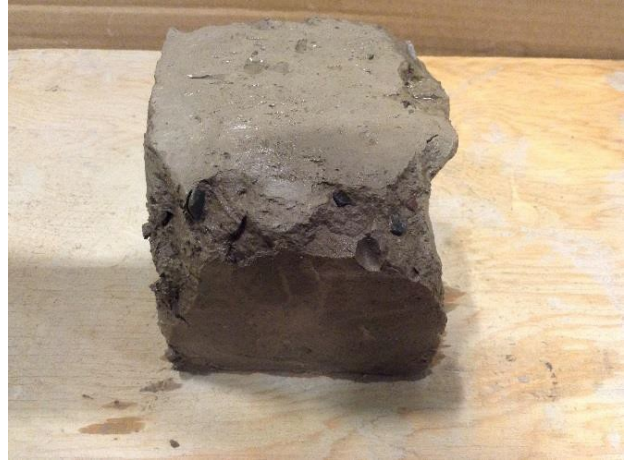
Figure 10 Samples 6, initial saturated moisture content gravel abrasion, a) before and b) after erosion test

1
2
3 Sample 6 showed similar effects, including erosion of the till while it was covered with
4 gravel (Fig 10), which occurred at shear stresses below 7.9 Pa. At higher stresses the
5 rolling gravel caused the sample to erode more quickly by first cracking, the cracks
6 delineating blocks, and finally separation and detachment of the blocks in a mass erosion
7 process. Blocks detaching from the sample caused irregularities in the surface of the
8 sample that was subsequently smoothed by the gravel particles. The shear stress versus
9 time trajectory for samples 5 and 6 has gaps as shear stress values on the till surface
10 were unknown due to the presence of the gravel. The gravel increased the flow depth,
11 channeled the flow and/or protected the till from exposure to the shear stress. Static
12 gravel cover may aid erosion by increasing turbulence, and mobile particles affect both
13 mass erosion as block separation and detachment of the material and surface erosion by
