Cyclic Testing of Reinforced Earthbag Walls

SENIOR DESIGN PROJECT REPORT

Department of Civil Engineering
Santa Clara University, Spring 2018

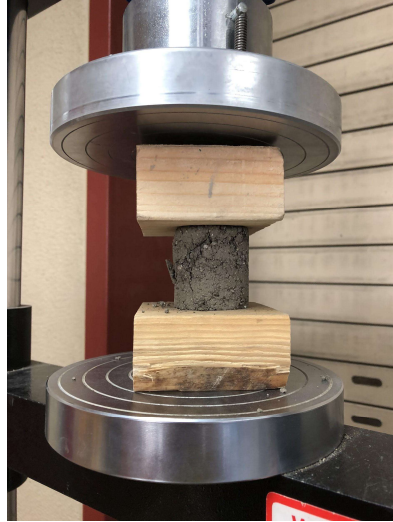
Figure 2: Setup of soil compression tests.

Compression experiments on the soil used for the project were performed in the SCU Structures Lab. **Figure 2**, below, shows the testing setup used to determine an f'_c value; this value is used to represent the compressive strength of a soil. The numerical results of these tests can be found in **Table 1**, where the f'_c value was found to be 320 psi. The test results shown in **Table 1** were from soil with similar compaction to the earth bags the team made for the completed walls.

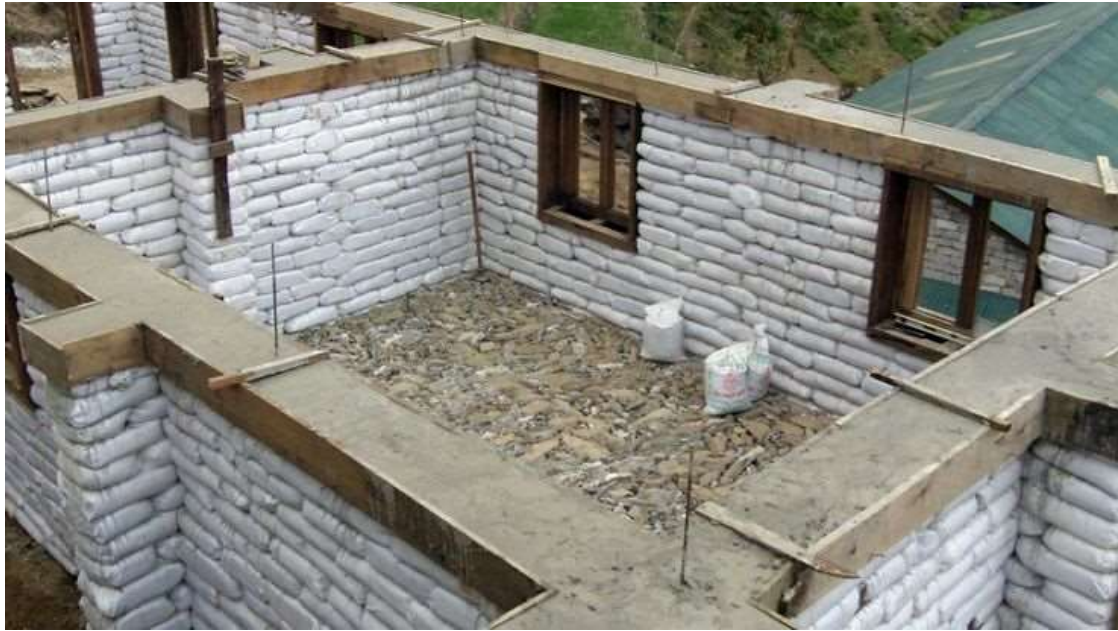
Figure 3: Earthbag home built with concrete bond beam.

The bond beam, which caps the top of the wall and provides a connection to the testing rig, was formed exclusively from wood, which simplified the design to resist the lateral force placed upon the bond beam. Considerations of the functionality of the beam and determining the best way to facilitate the desired connection to the wall, required several design iterations. The use of a concrete bond beam was ruled out early in the project as the weight of the beam would pose a safety hazard. This hazard is due to the fact that these concrete beams, when used on a full scale home project, are poured onto buttressed walls (Hart, 2015). An image of concrete bond construction in the field can be found in **Figure 3**, below.

While this method is feasible for the construction of a house, the team was concerned with constructability of a concrete bond beam. The most notable constructability issue the team had with the concrete beam design was designing the formwork for use while the concrete was poured and cured for 28 days. When the design scopes of both the concrete and timber bond beams were assessed, the timber bond beam was ultimately chosen. From the outset of the design process, the project team along with their advisors determined a singular pinned connection to the wall would best simulate the loading pattern of an earthquake. This pin connection was paired with the use of two steel T-plates that prevented any out of plane movement of the wall during testing. This was done to minimize the amount of torsional deformation that could occur in the wall. While earthquakes do cause torsion to occur in a building. This work focused on the direct shear forces that would be imparted on the wall during in-plane loading.

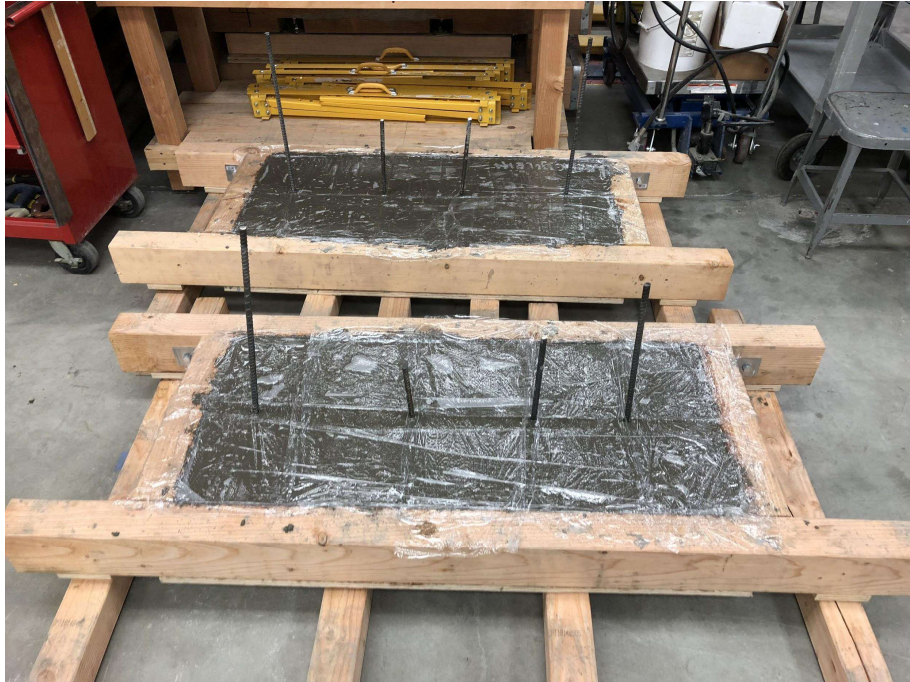
Figure 4: Finished concrete in completed bases.

The wall's base design was based off the work that a past SCU senior design group had done with straw bale walls (Ackerson, 2017), with additional concrete to help carry the heavier earthbag walls. The base design consisted of a 5.5" thick reinforced concrete beam with embedded rebar anchors that would pierce the first three courses of earthbags placed. This beam was formed using four by six (4 x 6) timber members which were left in place to provide additional strength during testing. **Figure 4**, below, provides an image of the completed bases. The design of the base allowed the use of six by twelve (6 x 12) timber members that were placed across the ends of the base to prevent overturning during testing. These beams were secured to the strong floor with the use of threaded rod, nuts and washers. **Figure 5** illustrates how these larger timber members were laid across the base to prevent overturning during testing.

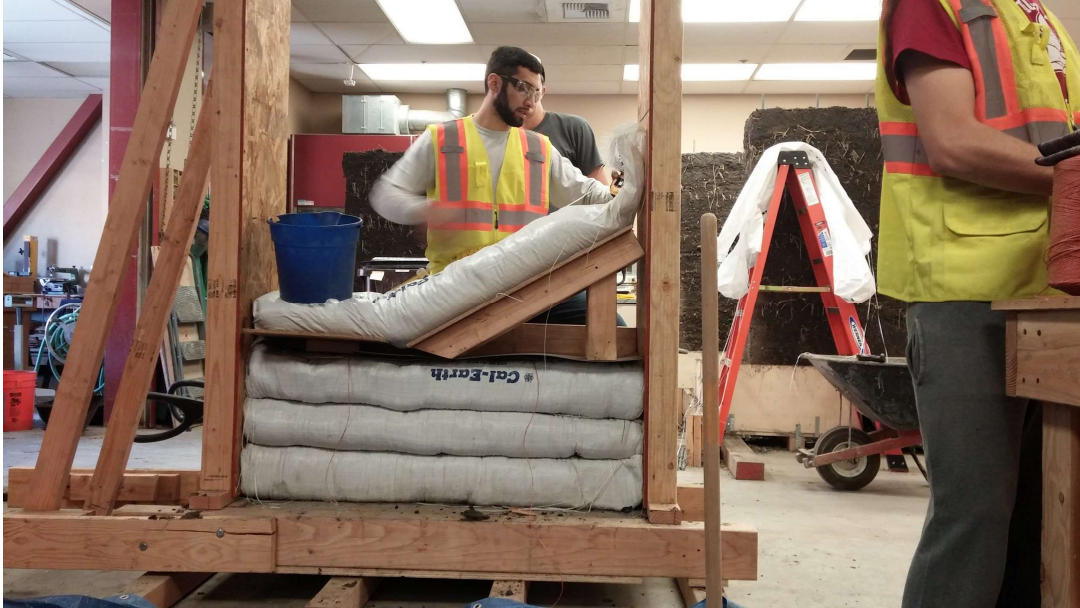
Figure 6: Construction practice used to build both wall specimens.

The timber members used in the base allowed for the attachment of vertical and horizontal forms which aided in the construction of plumb and compacted earthbag walls. While compacting bags in place, sheet metal was used to prevent the barbed wire from tearing the bag material. **Figure 6**, below, showcases what these construction practices looked like. Construction of the walls started inside of the SCU Civil Engineering Structures Lab but was moved outside to due to space constraints. After construction, the walls were relocated inside the SCU Structures Lab to dry until testing, which was scheduled for the first week of April 2018.

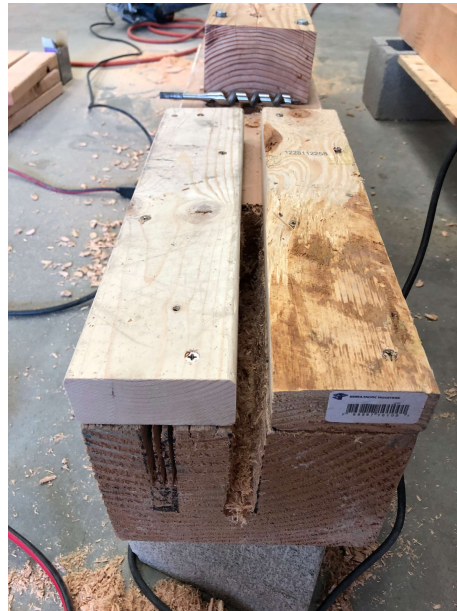
Figure 8: Guide channel at ends of bond beam.

Figure 8 demonstrates the finalized channel design that was cut into the bond beam.

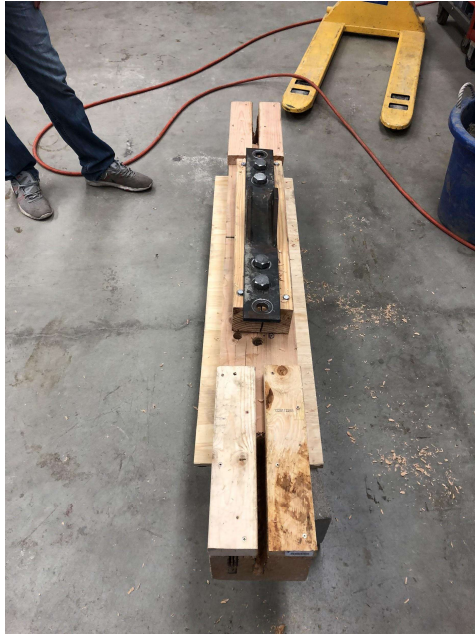
Figure 9: Bond beam from top side with plate-pin connection.

Figure 9 displays the completed bond beam used during the first test. This was the final design that was used for both wall tests.

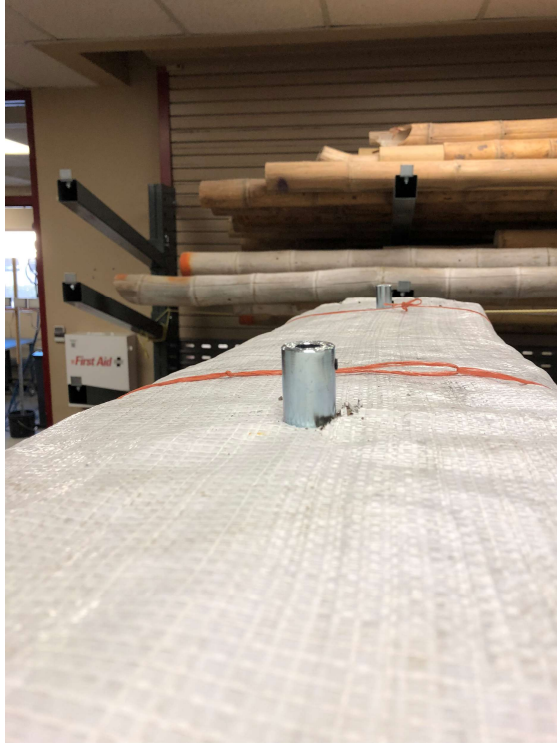
Figure 10: Rebar coupler to threaded rod connection.

The team used a coupler system to connect the rebar inside the wall to a piece of threaded rod. This threaded rod then had a washer and nut connection to prevent the bond beam from uplifting and twisting; **Figure 10** below displays this connection. Appendix A, page A-21 contains an image of the installation of the nut and washer used to connection the bond beam to the top course of the wall. After collecting and synthesizing results from the first test, the bond beam was redesigned for the second wall to better transfer forces from the testing machine to the wall. These changes included expanding the guide channels and attempting to better secure the rebar couplers. **Figure 11** shows the coupler inside the bond beam, and this was the final design the team decided on.

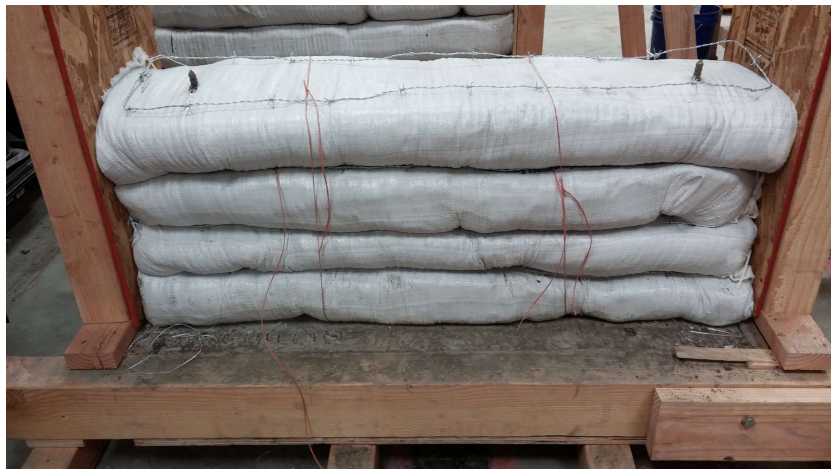
Figure 12: Standard barbed wire configuration between layers.

The reinforcement of the wall consisted of using barbed wire between each course of bags and the use of rebar driven into the courses at three foot height intervals. Nine foot strands of barbed wire were used between each course of bag in order to facilitate the friction force that would occur between courses trying to slide past each other. **Figure 12**, below, shows the layout of barbed wire that was used for both walls. The friction factor between the barbed wire and polypropylene bags was found to be 0.67 (University of Bath). This means that for every one pound (1 lb) of normal force applied at the interaction between bags, 0.67 lbs of shear resistance were generated. Two 4.5' lengths of #4 rebar were driven vertically into each end of the wall at 3' foot high intervals with the use of a fence post driver. This installation method resulted in a lap of approximately 18" between this rebar. **Figures 12 and 13**, below, shows the process used for both walls.

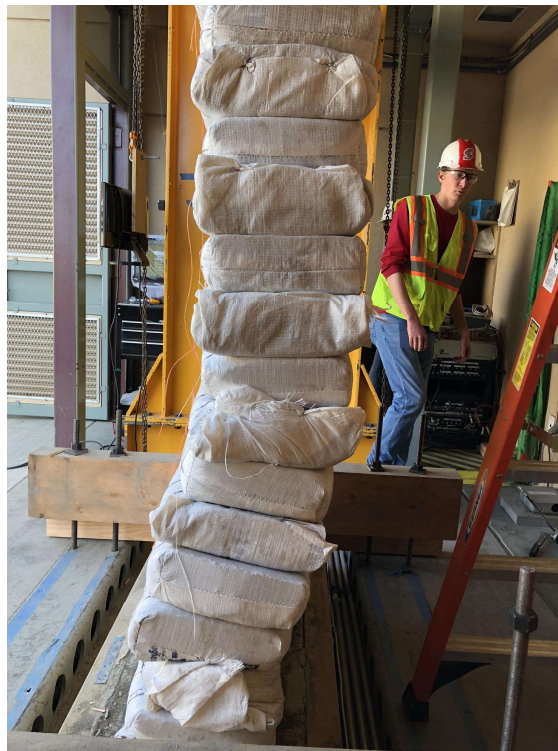
Figure 19: Out of plane buckling of Wall 1.

The failure mode observed for both test specimens was buckling in the north edge of the wall. This buckling was due to the force couple created by the in-plane shear forces upon the wall. While buckling is typically a relatively inflexible failure mode, these specimens were able to withstand severe buckling while remaining standing after removal of the top pin. This is a positive, as flexible failures are typically preferred for withstanding seismic loading. The out of plane deflection of the walls is shown in **Figure 19**, below.

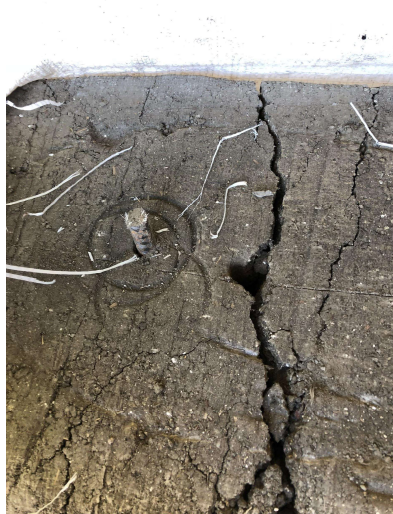
Figure 21: State of soil around rebar lap splice, Wall 1.

The soil around the rebar splice from the first wall test can be found in **Figure 21**.

One of the key components the group considered was the effects of the rebar splice on the nearby soil. The cracks that are observed in **Figure 21** were found at both lap splices on Wall 1. The team believed these cracks developed from the rebar moving out of plane during testing. This out of plane movement, the team believes, was caused by the rebar being loaded by the bond beam at the top of the wall. The rebar was connected to the bond beam via the aforementioned coupler system, this is what allowed the rebar to be loaded in such a way that allowed for the out of plane movement observed in Wall 1. This back and forth movement created the same cracks observed in **Figure 21** two to three courses above the rebar splice. This was due to the out of plane movement of the rebar occurring throughout the length of the stick of rebar. The bottommost piece of rebar did not experience the same out of plane movement. The marks left by the post driver, which was used to drive the rebar down the length of the wall, can also be seen in **Figure 21**. It is not known to the team exactly what effect the impacts from the post driver had on the strength of the course. The team did try to mitigate damage to the course during the placement of the rebar. This took the form of slowly driving the rebar as the fence post driver approached the earthbag course as well as avoiding any alteration of the courses once the walls started the drying process.

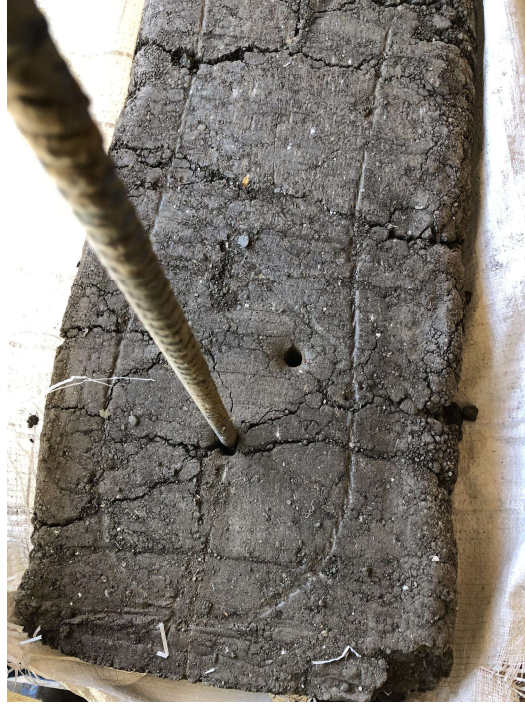
Figure 22: State of soil around rebar lap splice, Wall 2.

Figure 22, below, shows the soil around the rebar lap splice for Wall 2.

Wall 2 did not develop the same level of cracks that were observed at Wall 1's lap splice, but there was still some movement as can be seen by the small cracks originating from the rebar lap splice. Wall 2's rebar did not experience the same level of buckling as was seen in Wall 1. The team believes this was because Wall 1 failed due to the force couple that occurred at the rebar lap splices. The compression component of the force couple created in the wall caused this buckling deflection in the wall that was discussed previously. This same force couple was not seen in Wall 2, as can be seen by the lack of cracked soil around the lap splice in **Figure 22**. The variations in the installation of the rebar, along with the variations in how the soil dried in the bags, created the conditions that allowed for the creation of the force couple observed in Wall 1 and not in Wall 2. Without the force generated within the wall by the force couple, the rebar within the

walls would not have sufficient enough force to create the movement required to generate the level of cracking observed in Wall 1.

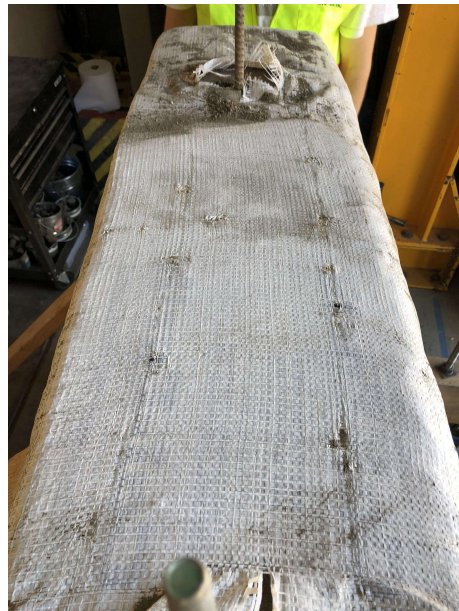
Figure 23: Marks left by barbed wire placed, Wall 1.

During deconstruction, the team also took note of the state of the barbed wire that was placed between each course. The team found that on average, 15 barbs out of the 20 were deformed due to the movement that occurred between the courses located at the rebar lap splices. The average in this case refers to the level of deformation listed above being constant for most layers in both Wall 1 and 2. A special case for the barbed wire deformation were the four courses located at the rebar lap splices for both walls. Although most of the barbs were found to be deformed at these lap splices, the barbs themselves did not cause a significant amount of damage to the polypropylene bags. This observation can be seen on **Figure 23**.

These same sized holes were found throughout Wall 1, as well as on Wall 2. The team does believe the barbed wire played a significant role in preventing bag slippage, however, the team was expecting to see more substantial holes in the polypropylene bags by the barbed wire. The deformation observed in the barbs of the barbed wire showed how much the barbed wire prevented the shifting of the bags in both walls during testing. Additional images of the bag slippage that was observed for both walls can be found in Appendix A, pages A-17 through A-20. The barbs of the barbed wire located at the bottom four courses of both walls were found to be less deformed than the barbs located at other points in the walls. The team believed this was due to the shear forces failing to fully transfer from the top of the wall to the base. Most of the shear forces were found to have focused around the rebar lap splices, which accounted for the lack of transfer of forces to the base.

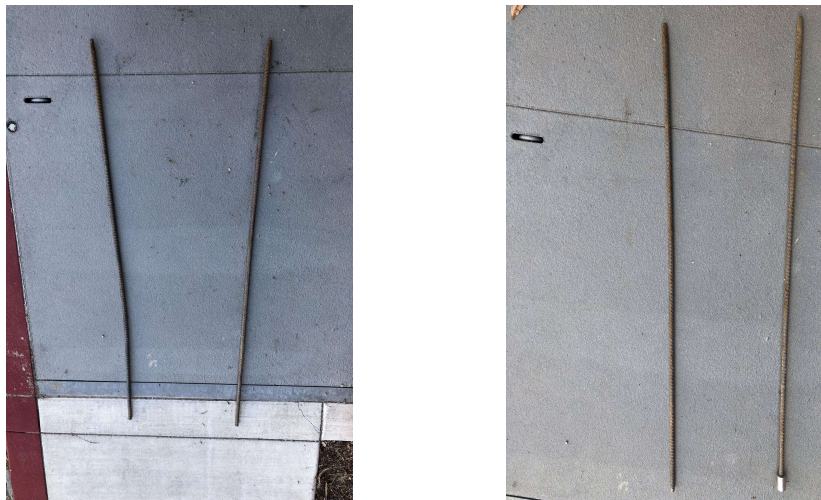
Figure 24 (L) and 25 (R): Rebar used in Wall 1.

The rebar used in Wall 1 can be found in **Figure 24** and **25**.

The rebar in Wall 1 was bent due to the testing protocol the wall was subjected to. This can be clearly seen in **Figure 24** as this rebar was heavily subjected to the load being transferred from the bond beam down into the rebar. **Figure 25** shows the rebar slightly bent, but this could be attributed to the lack of force couple that developed in this rebar lap splice. The team believes this was the case due to the aforementioned force couple that was developed in the wall, this led to the buckling failure that was observed. Wall 2's rebar can be seen in **Figure 26** and **27**, below.

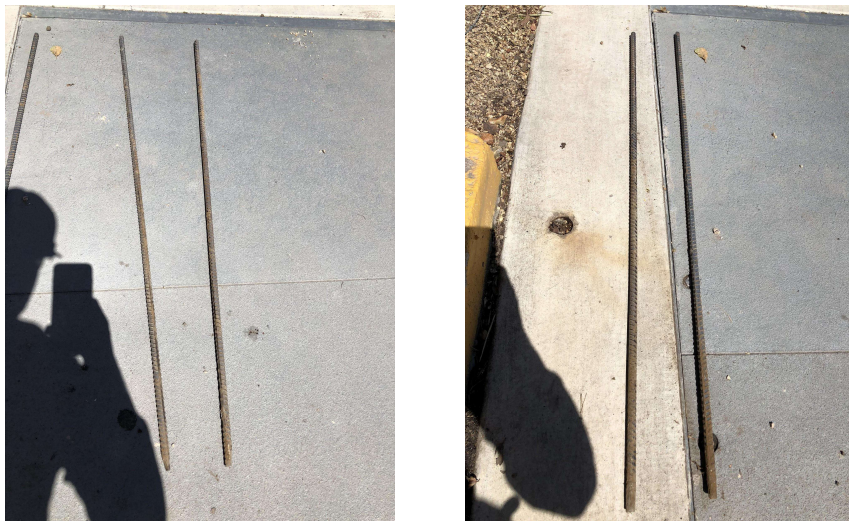
Figure 26 (L) and 27 (R): Rebar used in Wall 2.

Wall 2's rebar did not experience the same bending that the rebar from Wall 1 experienced. The team believes this result was because Wall 2 did not experience the same buckling failure that was observed in Wall 1.

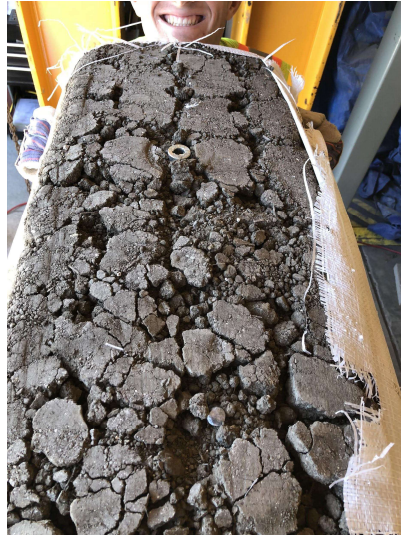
Figure 28: Crushed soil found at the top layer and bond beam interaction, Wall 2.

Another point of interest for the project team was the top course and the bond beam interaction. The team had expected to see minor crushing of the soil located

at this interaction, however what was observed was more crushing than what was expected. **Figure 28** shows the crushed soil that was seen after Wall 2's test. The crushing seen in **Figure 28**, below, was observed in both Walls 1 and 2.

The team can credit most of the crushing of the soil at the top course and bond beam interaction due to the movement of the bond beam throughout testing. The bond beam also began to lift and separate from the top course, which resulted in a seesaw motion that would crush one side of the top course. This resulted in the crushing of the side opposite of the direction the TDOF was loading in as the test progressed from side to side.

The bond beam was placed using sledgehammers as the nails in the bond beam had to be pushed firmly into the top course. The team believes this caused a significant amount of crushing of soil in the top course for both walls. Future teams should take greater care in the installation of the bond beam to control for this unwanted crushing soil. The team recommends placement of the bond beam as soon as the top course is compacted and placed, if possible. If not, the top course's soil should be rehydrated to allow for greater ease of installation, then allowing for enough time for the top course to dry around the nails from the bond beam.
