Long term performance of high RAP sections--- case studies

LONG TERM PERFORMANCE OF HIGH RAP SECTIONS – CASE STUDIES

THESIS

Civil Engineering

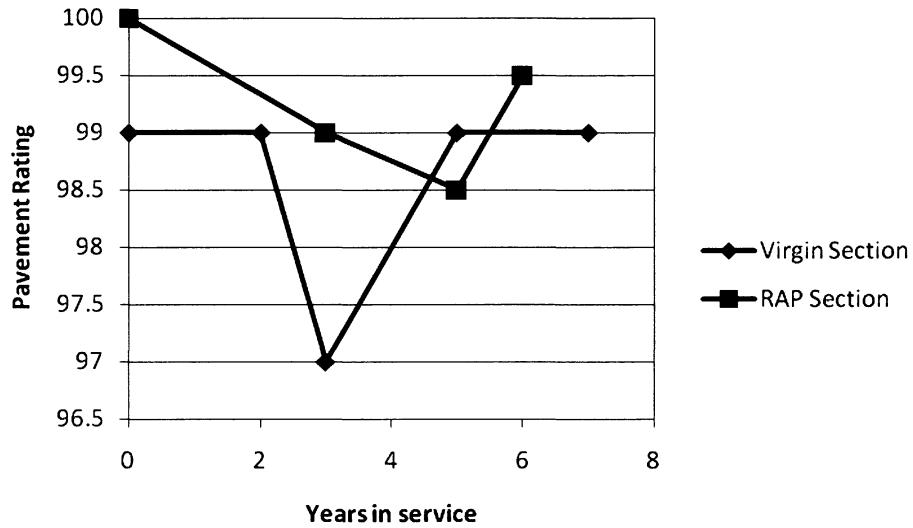
Figure 7: Pavement Rating of Washington Demo-39 Akima River to W. Ellensberg

As with the other Washington Demo-39 study, this mix was not paired with a virgin mix for direct comparison. Washington DOT was able to locate a virgin mix also along I-90 that was paved in three years later in 1981. Like the other study, it was also assumed that the pavements underwent similar traffic loading and weathering. The 0-100 pavement rating scale is also the same. Figure 7 shows the comparison of the pavement ratings between the recycled and virgin sections.

It was the conclusion of WS DOT that the use of a drum mixer was far more practical for the conservation of energy in the mixing process. They were able to meet their energy conservation and pollution goals in this study. However, as with the other Washington Demo-39 study, the recycling agent did not perform at the desired level so it was determined that further testing of the recycling agent was necessary (Peters 1986). Figure 7 shows that the RAP section performed at a level very similar that of a virgin section with neither section falling below a rating of 97 in the 6 years of available data.

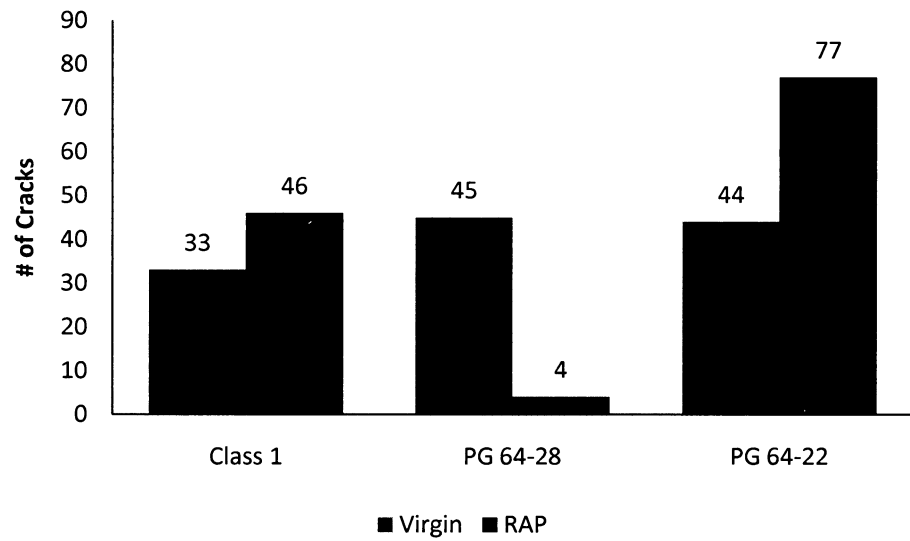
Figure 14: Transverse Cracking - Low Speed Lane

Figure 15: Number of Transverse Cracks - Low Speed Lane

Figure 16: Transverse Cracking - High Speed Lane

Figure 17: Number of Transverse Cracks - High Speed Lane

In 2003, it was observed that the PG 64-22 RAP section had significantly more transverse cracking than its virgin counterpart or any of the other sections in the low and high speed lanes as seen in figures 14-17. According to ConnDOT, this result was difficult to explain but it was thought to be the result of reflective cracking. The underlying conditions for the majority of this RAP section were far worse than any of the other sections (Larson 2003). When examining the degree of transverse cracking

between the virgin and RAP section of the CT Class 1 mix, almost identical results are observed in both the high and low speed lanes. This suggests that the two sections are directly comparable to one another. Examination of the PG 64-28 mix shows a lesser degree of transverse cracking overall in the RAP section when compared to its virgin counterpart. This result is especially apparent in the low speed lane with the RAP section exhibiting less than 15% of total crack length than its virgin counterpart.

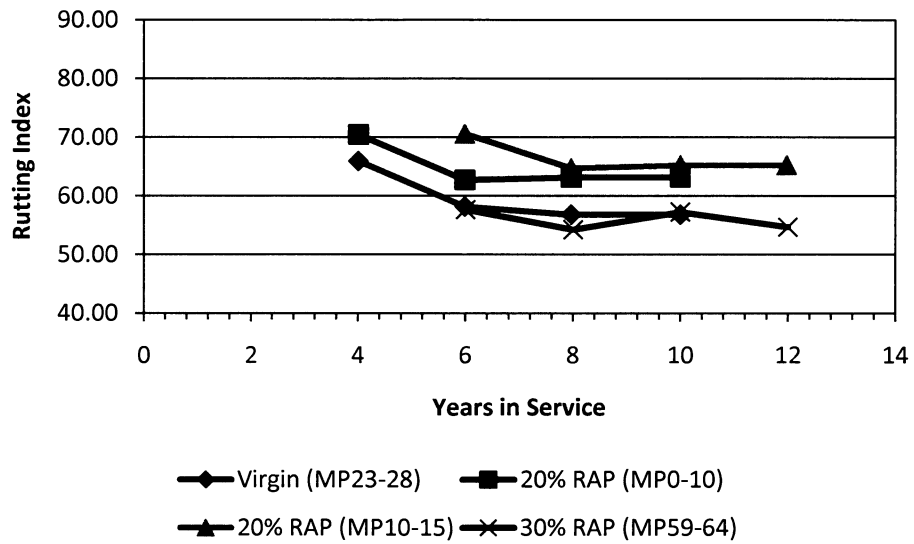
Figure 23: Ride Quality Index, I-90 Wyoming

Figure 24: Rutting Index, I-90 Wyoming

Figure 25: Pavement Cracking Index (PCI), I-90 Wyoming

Figure 26: PSR Composite Index, I-90 Wyoming

As seen in figure 23, all of the sections show a respectable quality, being greater than 65, but the 30% RAP and virgin sections perform about 15 points higher on the index in the long term. However, the opposite is seen in the rutting index in figure 24 with the two 20% RAP sections performing the best by a margin of about 10 points. None of the sections exhibited significant cracking with all of the values remaining above an index of 94 after 10 to 12 years of service. The PSR scores after 10 years of service

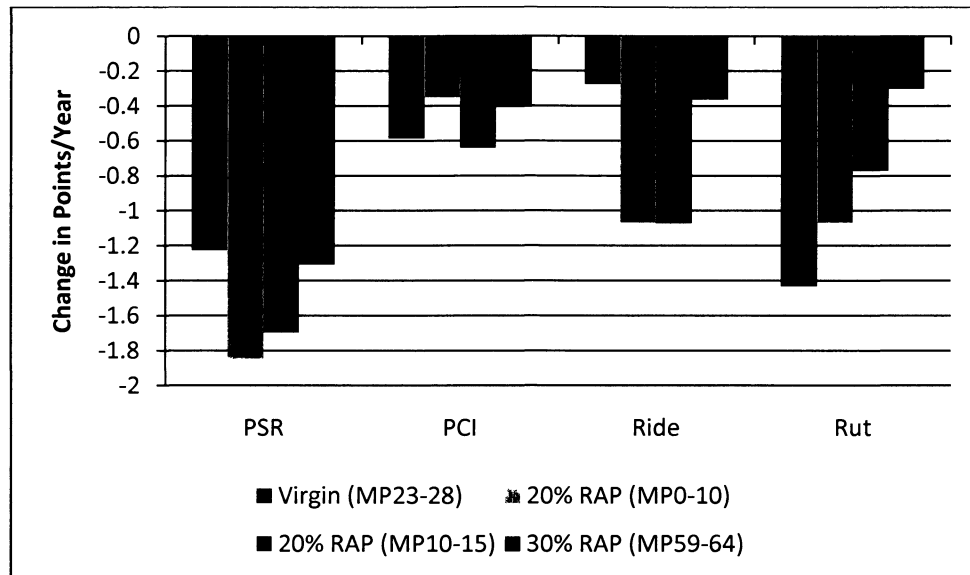
Figure 27: Wyoming I-90 Deterioration Rates

In addition to the final performance score of each section, the rate at which a section deteriorates is also of concern when evaluating a pavement. A line of best fit was constructed for each of the sections across all of the Wyoming performance indices in order to evaluate the rate at which a section index score had deteriorated. The resulting slope from the line of best fit gives the change in points of that index per year and thus provides a rate of deterioration for the section in the given index. By comparing these slopes, it becomes evident if the use of RAP in a pavement affects the rate at which a pavement degrades regardless of what its index score may have been. This is useful given that not all of the pavement sections started with the same initial score for any given index. It is possible that a pavement with an overall lower index score may have not have deteriorated as quickly as a section with a higher initial score. Figure 27 gives the slopes of each index for each of the pavement sections on I-90. A negative slope indicates deterioration of the index score over time.

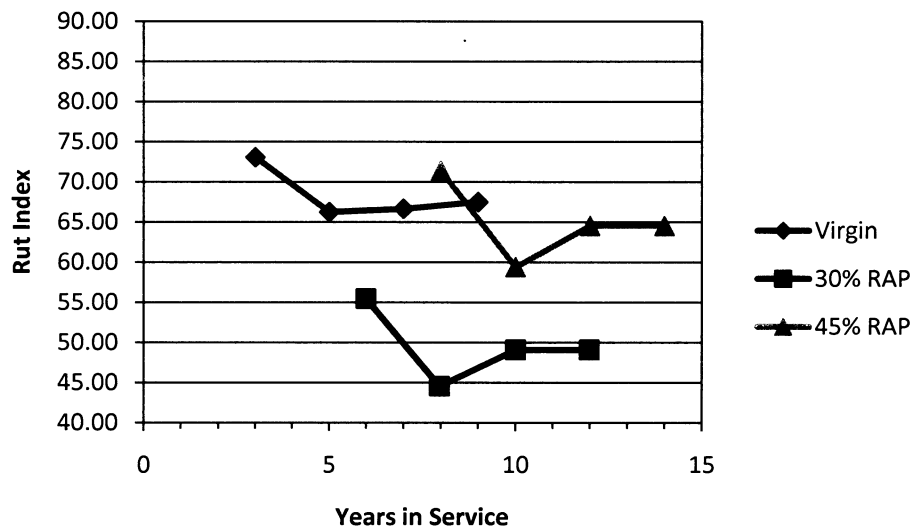
Figure 29: Ride Quality Index, I-25 WY

Figure 30: Rut Index, I-25 WY

Figure 31: Cracking Index (PCI), I-25 WY

Figure 32: PSR Index, I-25 WY

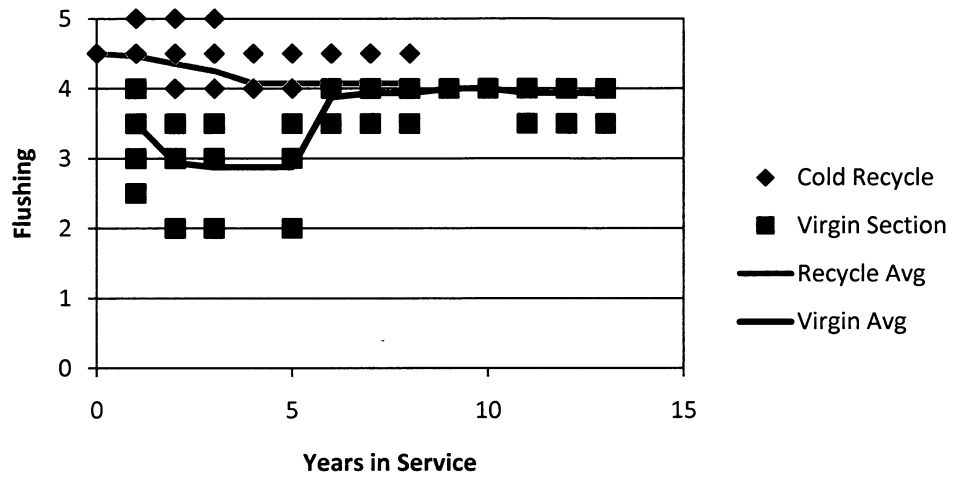
Figure 73: Flushing – AZ US-180

In the sections along US 180 in Arizona, a one point higher degree of flushing is seen in the virgin section initially. The virgin section also exhibits a poorer ride quality given the higher IRI values. The RAP section has stays in the “good” rating with IRI values less than 94 and the virgin section lies on the threshold of a “good” and “tolerable” rating. However, the recycled section does undergo more rutting than the virgin

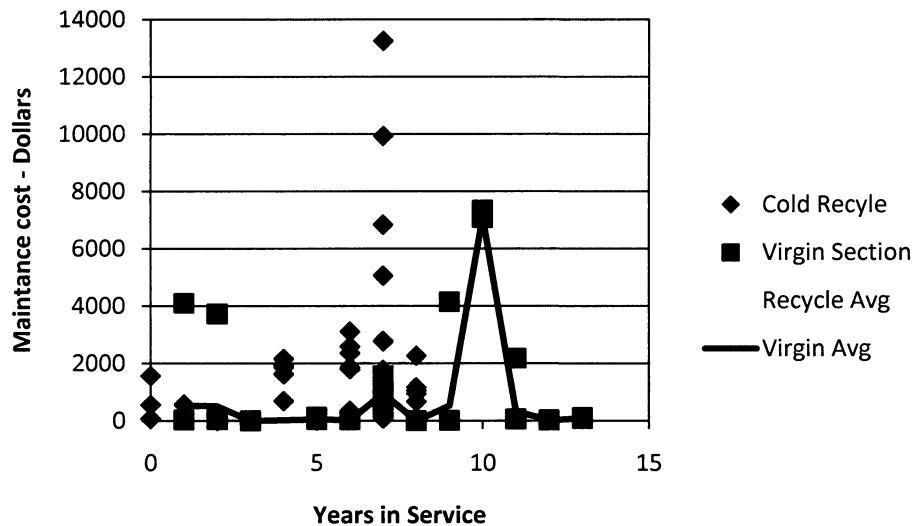
Figure 76: Maintenance Costs – AZ US-180

Figures 73-76 show the performance of the sections on US-180.
