Assessment of Road Crossings for Improving Migratory Fish Passage in the Winnicut River Watershed

**Ray Konisky, Director of Marine Science and Conservation
The Nature Conservancy, New Hampshire Chapter, Concord, NH**

December 2009

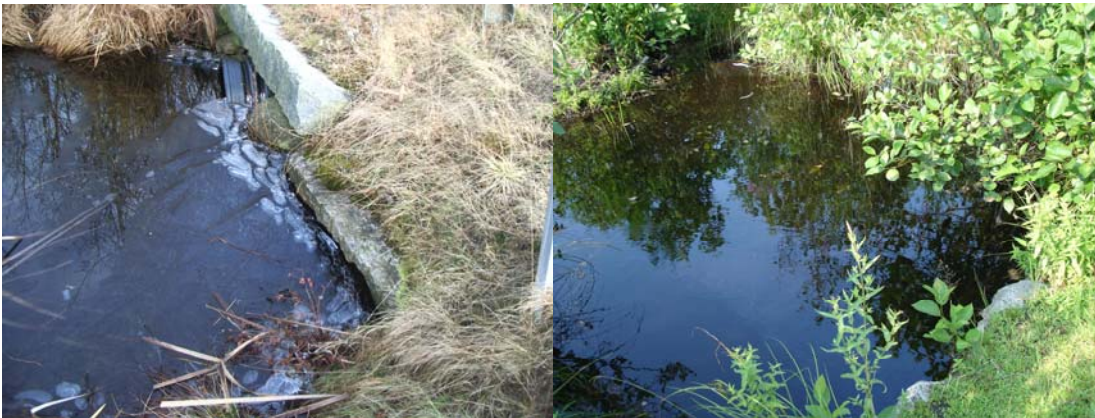
Crossing 20: Cornelius Brook at Lovering Rd, North Hampton

Notes: Twin plastic pipes (about 70' apart) near headwaters, signs of removable debris grates at inflow

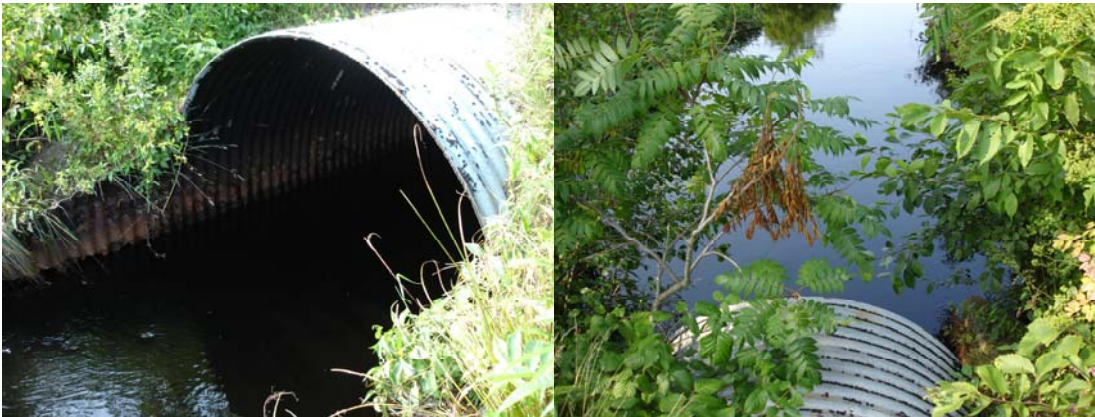
Crossing 22: Winnicut River at Walnut Ave, North Hampton

Notes: Near headwaters, slow flowing mainstem with some ponding

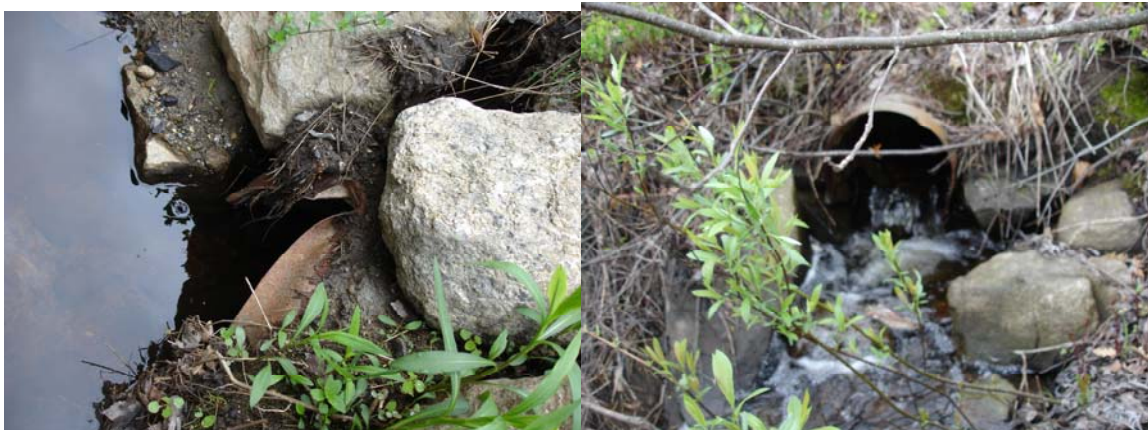
Crossing 27: Cornelius Brook at North Rd, North Hampton

Notes: Rusted and corroding culvert pipe with slight outlet perch, flows into golf course

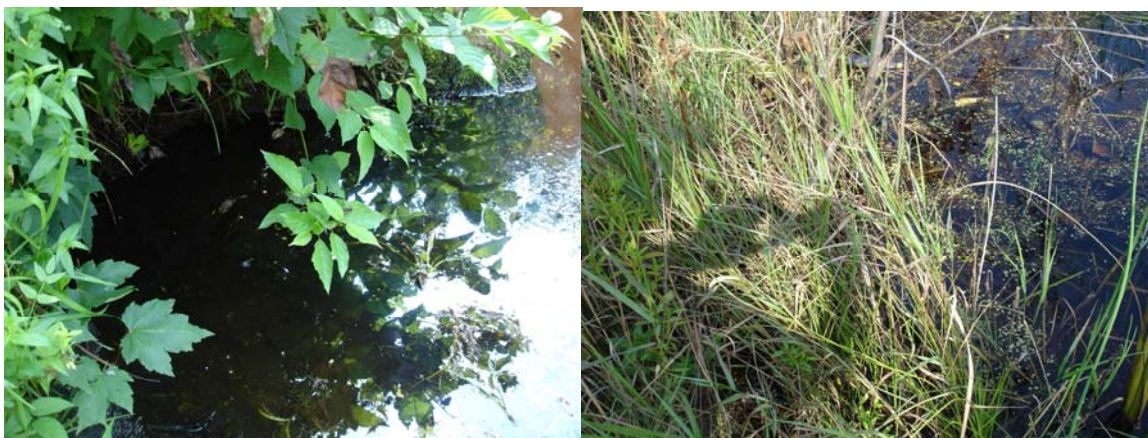
Crossing 28: Winnicut River at Exeter Rd, North Hampton

Notes: Dense scrub vegetation upstream and downstream; very slow flows and ponded conditions

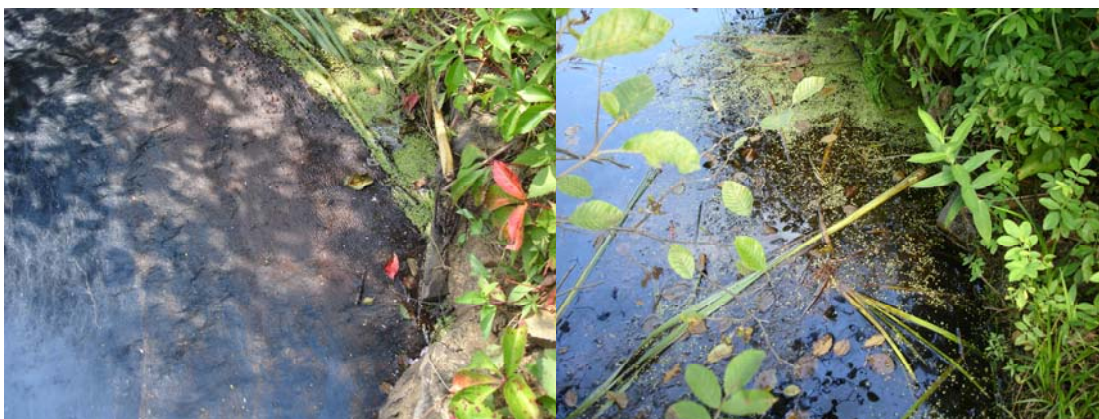
Crossing 30: Winnicut River at South Rd, North Hampton

Notes: Dense scrub vegetation upstream and downstream; very slow flows and ponded conditions
