Prepared by
The University of New Hampshire Stormwater Center
March 2014

**Pre-Construction, Construction, and Post-Construction Final Monitoring
Report for Greenland Meadows: July 2007- November 2013**

New England Development, RT 33, Greenland, NH

**Water Quality Certification#2005-003
In Compliance with Condition E-10,d**

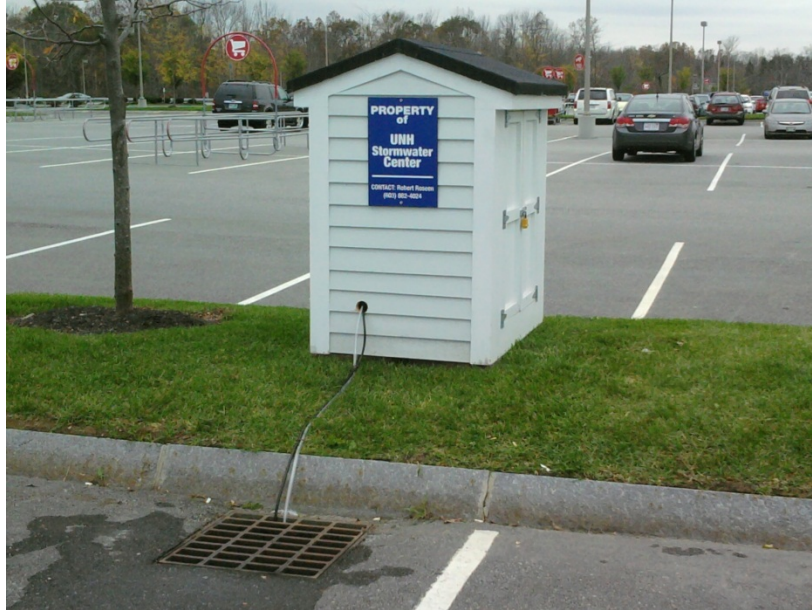
Figure 3: Influent monitoring of direct runoff sampling installation

During Phase 4 an additional site was selected for monitoring direct runoff to establish untreated stormwater contaminant concentrations that were entering into the stormwater management system. The direct runoff monitoring was located within an existing catch basin along a grassed median strip directly in front of the Target Retail Store (Figure 2, Figure 3). This location was selected for its high traffic count and used as a representation of the entire parking area.

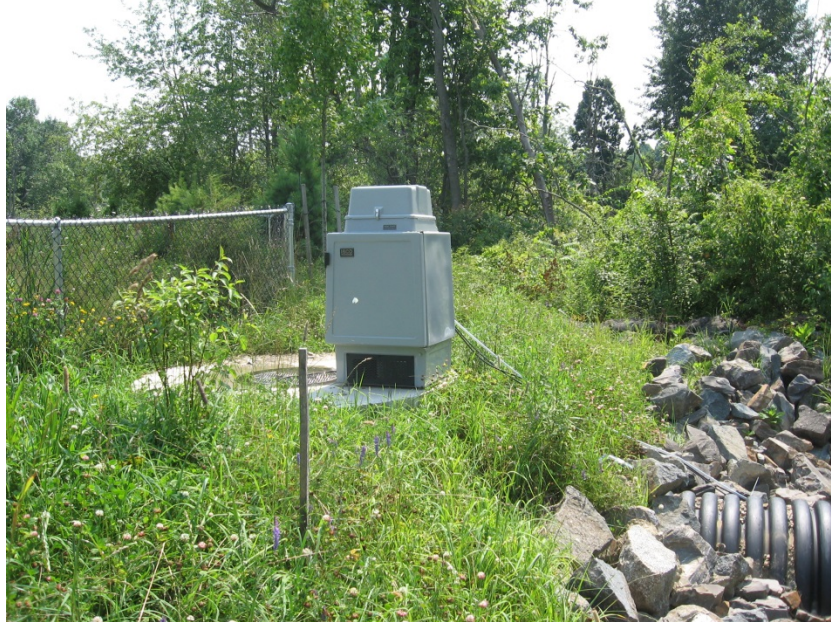
Figure 4: Teledyne ISCO 6712 Refrigerated Sampler installed at effluent location of subsurface gravel wetland.

Teledyne ISCO 6712 Refrigerated samplers (Figure 4) were used to monitor water quantity and water quality during storm events. Each sampler was outfitted with either an ISCO 720 Submerged Probe or ISCO 730 Bubbler module to continuously monitor water depth throughout each sampled rain event. YSI 600XL Multi-parameter Sondes are installed for real-time monitoring of pH, temperature, dissolved oxygen, and conductivity and recorded at 5 minute intervals. The samplers are equipped with twenty-four 1 liter sample bottles inside the refrigerated compartment and kept at 4°C at all times. The samplers are programmed to sample 100 milliliter aliquots at flow-weighted intervals into twenty-four 1 liter containers allowing for a maximum of 240 samples per event. The sampling program is designed to ensure adequate coverage of the storm event and is adjusted to accommodate seasonal fluctuations in rainfall patterns. Rejection criteria included minimum rainfall depth of 0.1 inches, minimum of 10 aliquots per sampling event, and at least 70% coverage of the total storm volume.

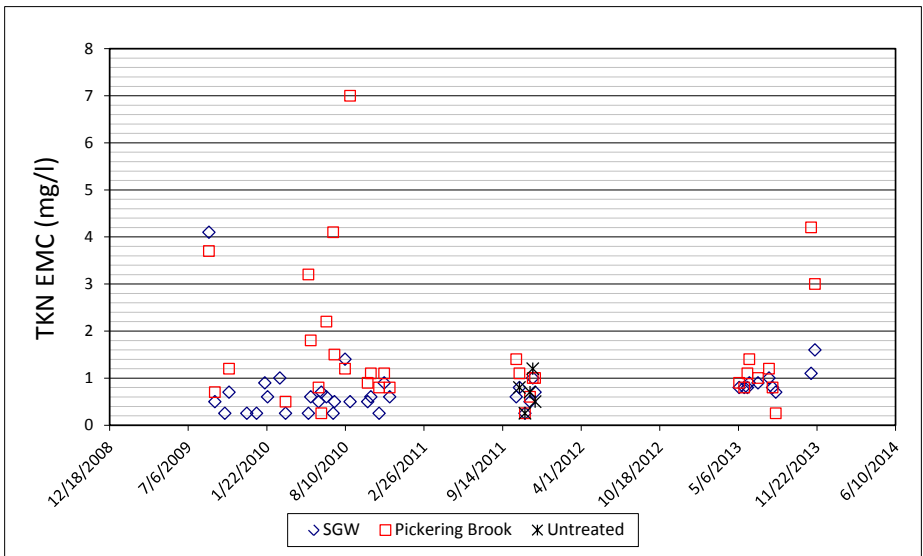
Figure 7: Influent, Effluent, and Receiving Water Contaminant Concentration Time Series Plots for the Range of Post-Construction Monitoring Data (cont).

Year 1 of post-construction monitoring coincided with the opening of Target in summer 2009. A total of 15 wet weather events were monitored from August 2009 through June 2010. The results are listed in Table 7 and Table 8 and plotted in Figure 5, Figure 6, and Figure 7 along with Phase 4 results. Monitoring was conducted in two locations: the primary discharge point from the SGW and in Pickering Brook where the treated runoff mixes with the receiving waters. Results indicate that effluent pollutant levels are typically at or below ambient stream concentrations across the range of contaminants. There are no water quality results for Pickering Brook during the '09-'10 winter months due to freezing of the monitoring location. Based on the storms observed thus far, the water discharging from the Greenland Meadows site is typically lower in pollutant concentrations than the receiving waters. It is suspected that the average nutrient concentrations in Pickering Brook are in reality higher than reported here because the 3 winter months are not included. These months are typically the period of time when highest nitrogen concentrations are observed.

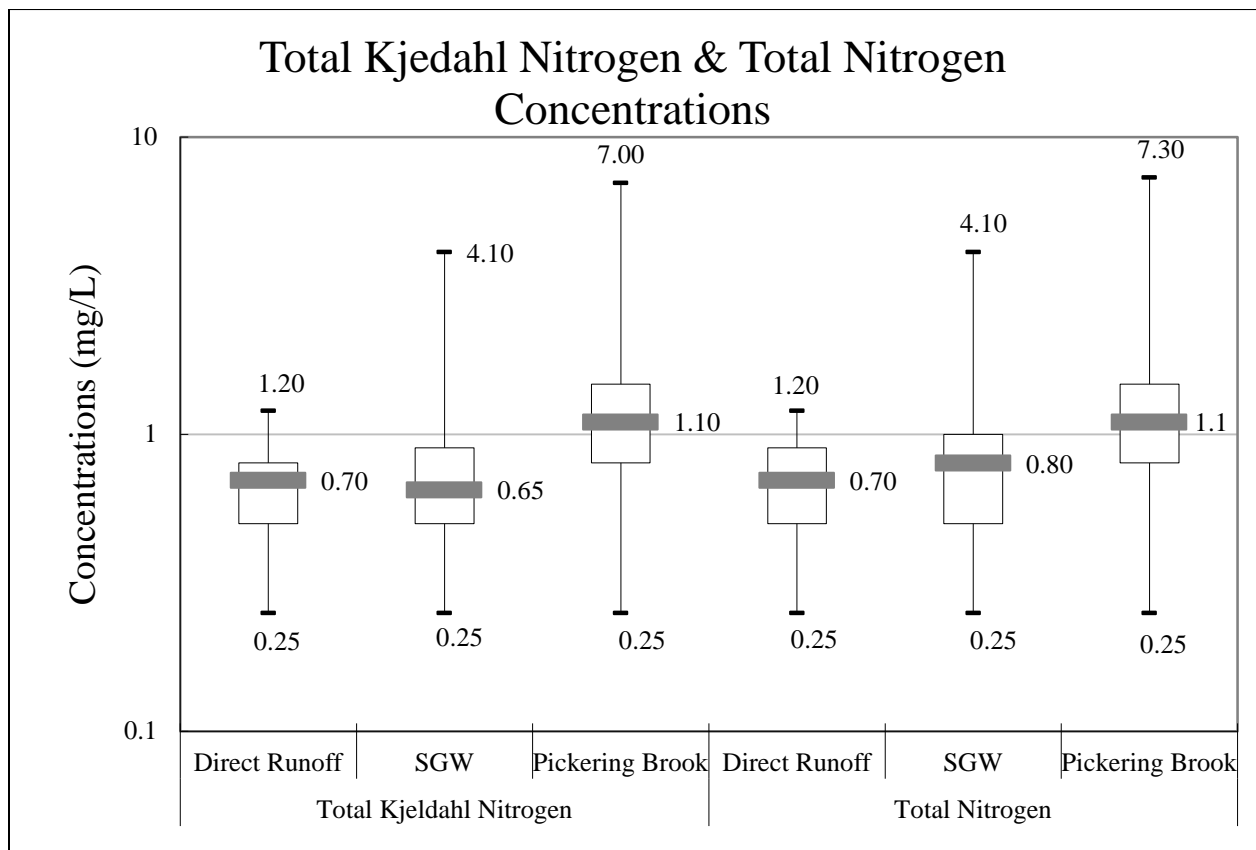
Figure 11: Box & Whisker plot of Total Kjeldahl Nitrogen & Total Nitrogen Concentrations.

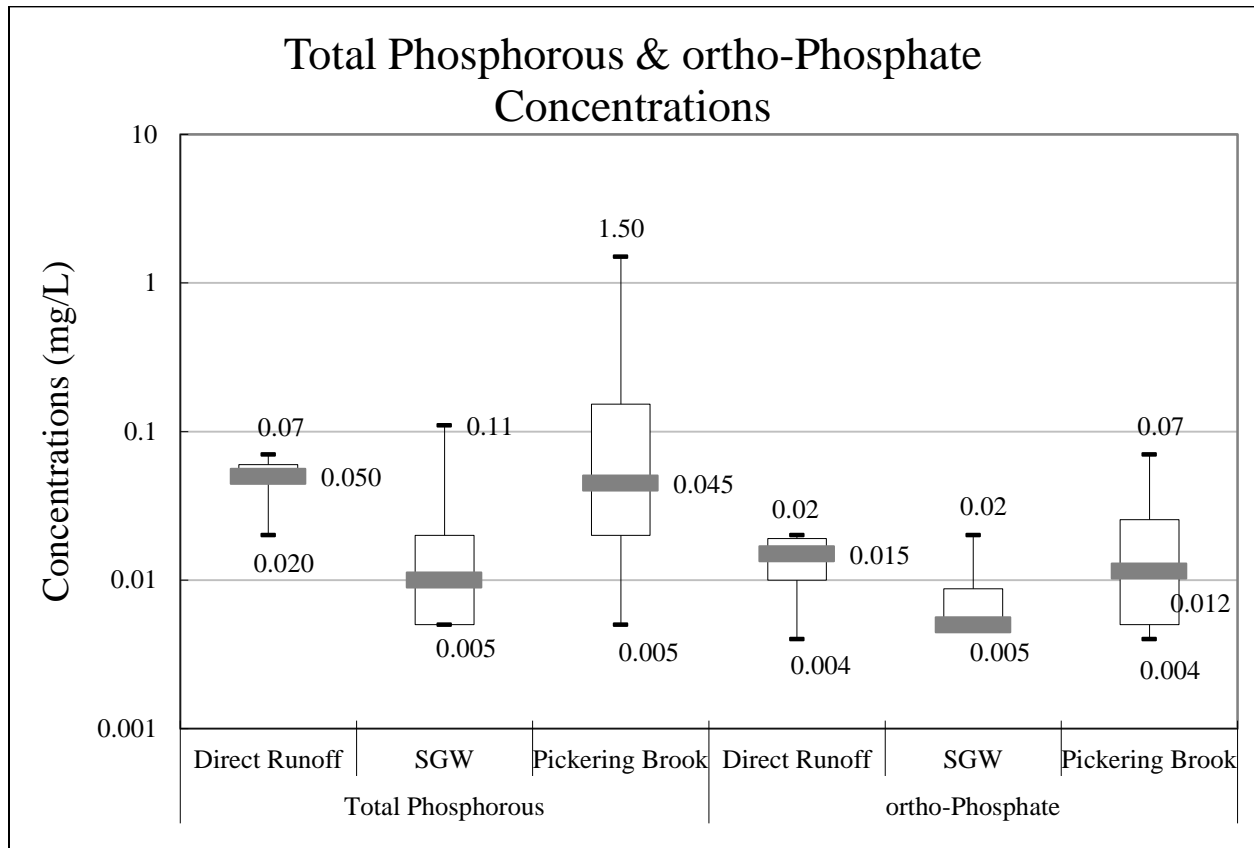
Figure 12: Box & Whisker plot of Total Phosphorous and ortho-Phosphate Concentrations.
