Anatomy of an Almshouse Complex

Sherene Baugher and Edward J. Lenik

The focus of this paper is to determine the age and function of a partial building foundation uncovered during archaeological testing in City Hall Park, New York City. The authors use evidence from historical maps, prints, and documents, as well as archaeological evidence, to determine the function of the building. The evidence suggests that the foundation is an outbuilding that was part of an 18th-century colonial almshouse complex. The foundation appears to be the remains of the almshouse kitchen.

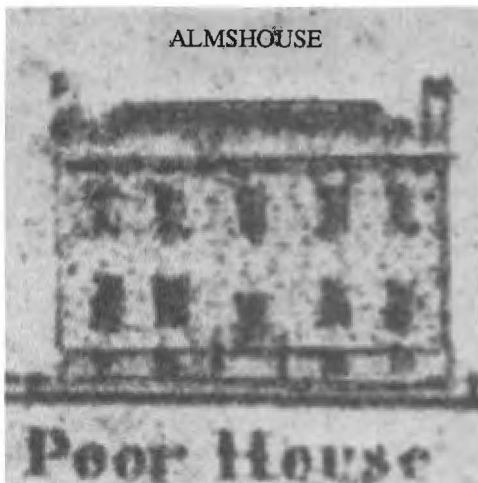
Figure 14. David Grim's pen-and-ink drawing made in 1813, depicting the almshouse in 1742–1744. The almshouse is one of 13 buildings that are illustrated across the top of the map, *A Plan of the City and Environs of New York*, by cartographer David Grim. (Stokes 1915, I: plate 32a.)

rapher David Grim in 1813 (Stokes 1915, 1: pl. 32-a). Thirteen buildings are illustrated across the top of the map, one of which is identified as the "Poor House" or almshouse (FIG. 14). This drawing also depicts the structure as being two and a half stories high, five bays on the first and second levels, with two chimneys. Two additional details are visible in this drawing, namely what appear to be stairs leading up to the central doorway on the first level and a basement with four windows on the front.

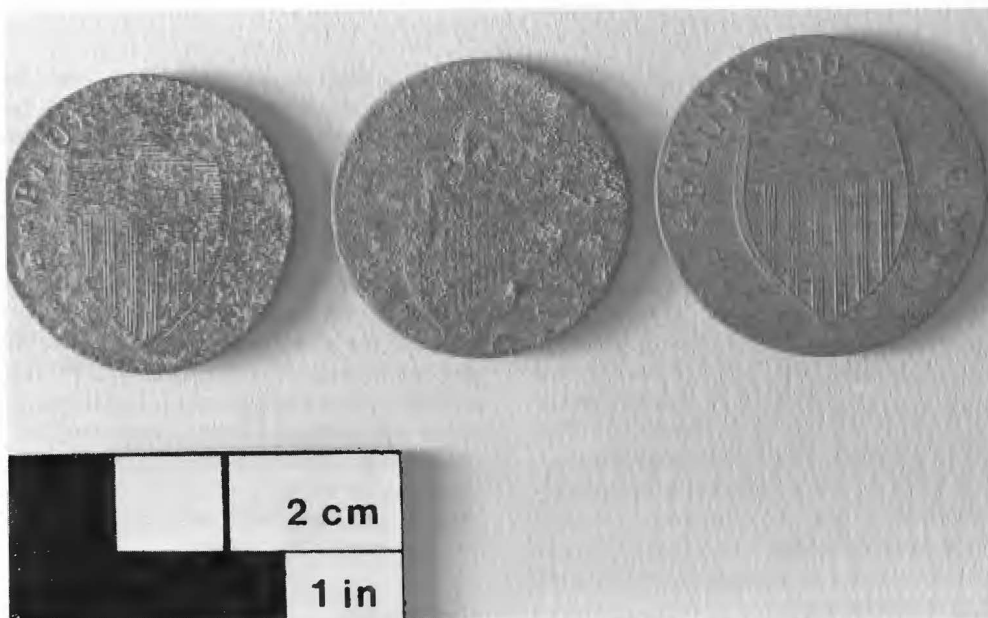
Figure 16. Three 18th-century coins. The left and right coins are 1787 New Jersey cents. The center coin is probably an Irish half penny issued between 1766 and 1783. The reverse side (shown in this photograph) has a crowned harp. (Photograph by Carl Forster.)

A total of four coins was unearthed in the colonial deposit. Three of the coins could be dated (FIG. 16). A fourth coin was also found; unfortunately, it was so badly eroded that it was unidentifiable. Two of the coins contained the same engravings. On the obverse was a horse's head and neck over a plow with the legend "Nova Caesarea" and the date 1787. On the reverse side of the coin was the United States shield and the legend "E Pluribus Unum" over the shield. This coin, a cent, was
