Volume 31 *Special Issue: Historic Preservation and the Archaeology of Nineteenth-Century Farmsteads in the Northeast*

# Burning Down the House: The Archaeological Manifestation of Fire on Historic Domestic Sites

Dena Doroszenko

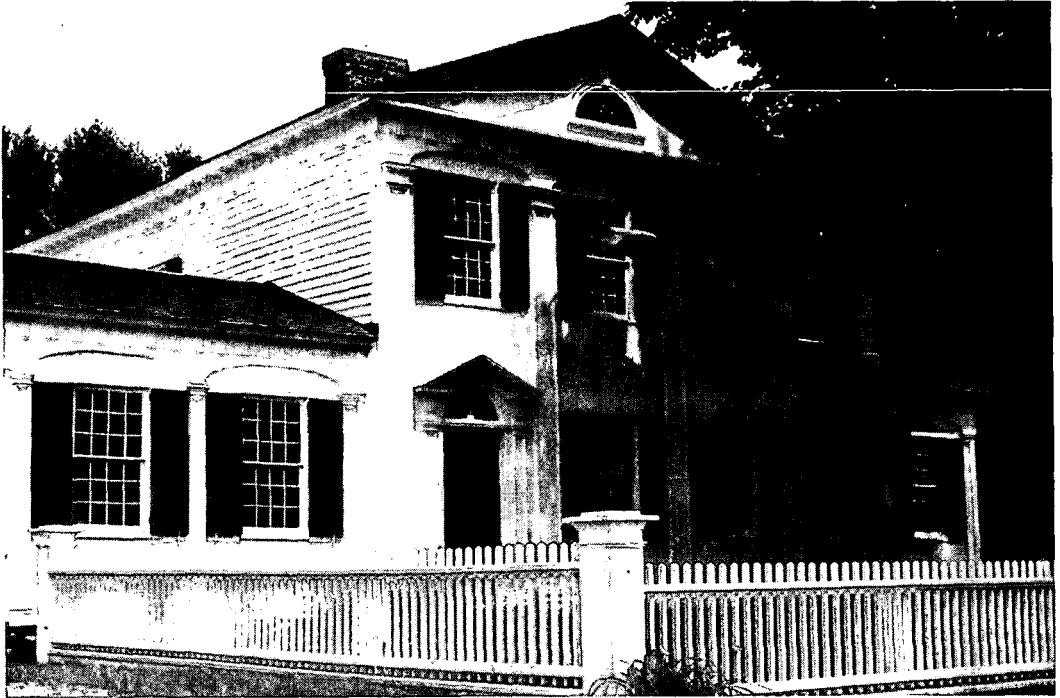
Figure 2. Barnum House in Grafton, Ontario.

Barnum House is without doubt one of the finest houses to survive from the early years of settlement in Ontario (FIG. 2). The property is located in the southwest corner of the south half of Lot 26, Concession One, of Haldimand Township along Highway Two, which served as the principal land route from Toronto to Kingston and Montreal in the 19th century.

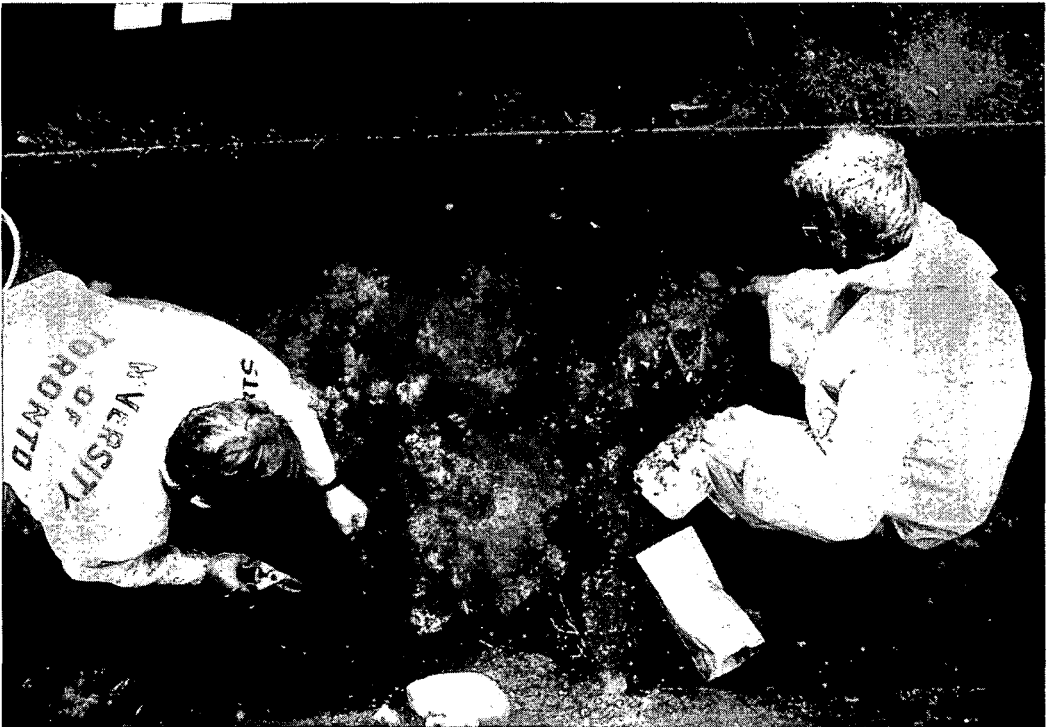
Figure 3. Barnum House. Excavation of burn layers in progress, 1990.

Archaeological excavations were conducted in 1982 (Warrick 1983), 1986 (Warrick 1987) and 1990 by Doroszenko. These excavations revealed that the foundations of the Norris house were reused by Barnum to build his house. These foundations had layers of ash

and burnt debris (FIG. 3) indicating stratigraphically, the destruction of Norris's house by fire, its subsequent razing, clean-up and rebuilding.

Layers of ash were noted around three sides of the house. More distinct layering was evident at the front of the house where alternating layers of charcoal, fire-reddened soil, ash, and heat altered artifacts were recorded within layers of plaster, which had been heat-reduced to lime. In front of the house, the deposit appears "compressed." This likely reflects the period of clean-up and razing once the fire had cooled. What this may also indicate is an example of a 90° angle collapse of a wall at the front of the building. Deposits of this type were only found in this location. The layer of charcoal and soot was noted to extend on the west side of the house as far away as 20 meters. This may indicate wind direction during the burning episode.

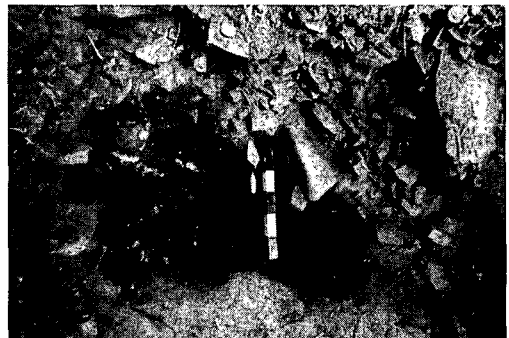
Figure 7. Excavation unit in area of Benares II fire. Note area of dark staining representing charcoal deposit.

Excavation behind an extant outbuilding called the potting shed, to the northeast of the house, revealed evidence of the second fire—the remains of Benares II. The most striking difference is in the analysis which reveals that nearly all of the artifacts below the collapsed building rubble show some evidence of heat alteration, whereas, those above are largely unaffected. Associated with these artifacts are several layers of building debris consisting of Credit River Valley stone rubble (largely undressed), metal roofing sheets, and a number of charred planks. In addition, there are large concentrations of charcoal and fire reddened soil (FIG. 7). The profiles on both the east and west walls of unit 8D (placed close to the north wall of the potting shed) show a definite slope or gradual cut through these natural strata creating a large hole or depression.

Although the very bottom layers have burned, or what is termed fire reddened soil and charcoal deposits, they are virtually free of artifacts. All of the rubble layers sit within this depression, and it is within the rubble layers that the large quantity of heat altered artifacts were recovered.

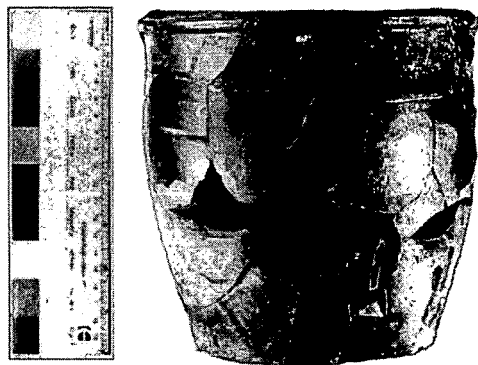
Figure 9. Red earthenware vessel exhibiting signs of heat alteration of the body and glaze. Benares II area.
