Lost within the Rubble: The Archaeological Findings from the Spring Street Presbyterian Church Burial Vaults

Douglas B. Mooney

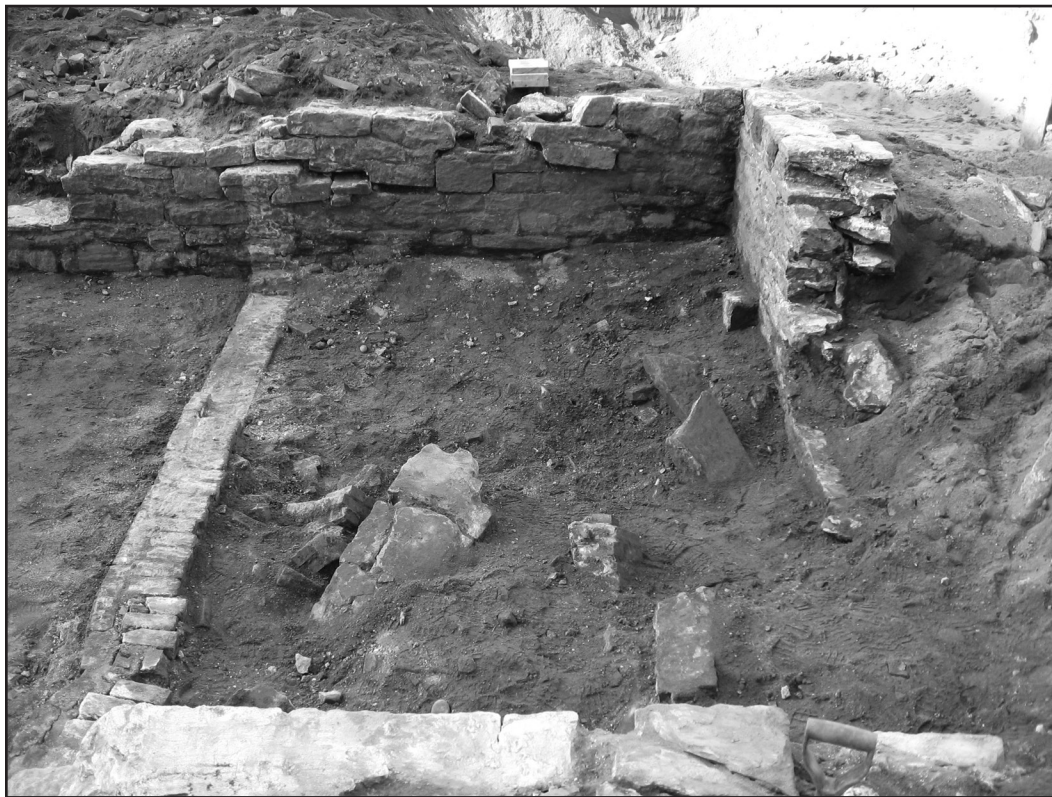
Figure 2. A section of the burial vaults as initially uncovered. (Photograph courtesy of URS Corporation.)

machinery was used to clear remnant demolition debris from the area and to assist in the search for any intact historic burials. This process gradually uncovered stone and brick walls framing a series of connected “rooms”, or chambers, oriented along a north-south axis within what had once been the far south-east corner of the former Spring Street Church property. Ultimately, a total of three partially intact rooms were discovered just to the north of the original find spot while a badly damaged fourth structure was uncovered beneath the find spot (FIG. 2).

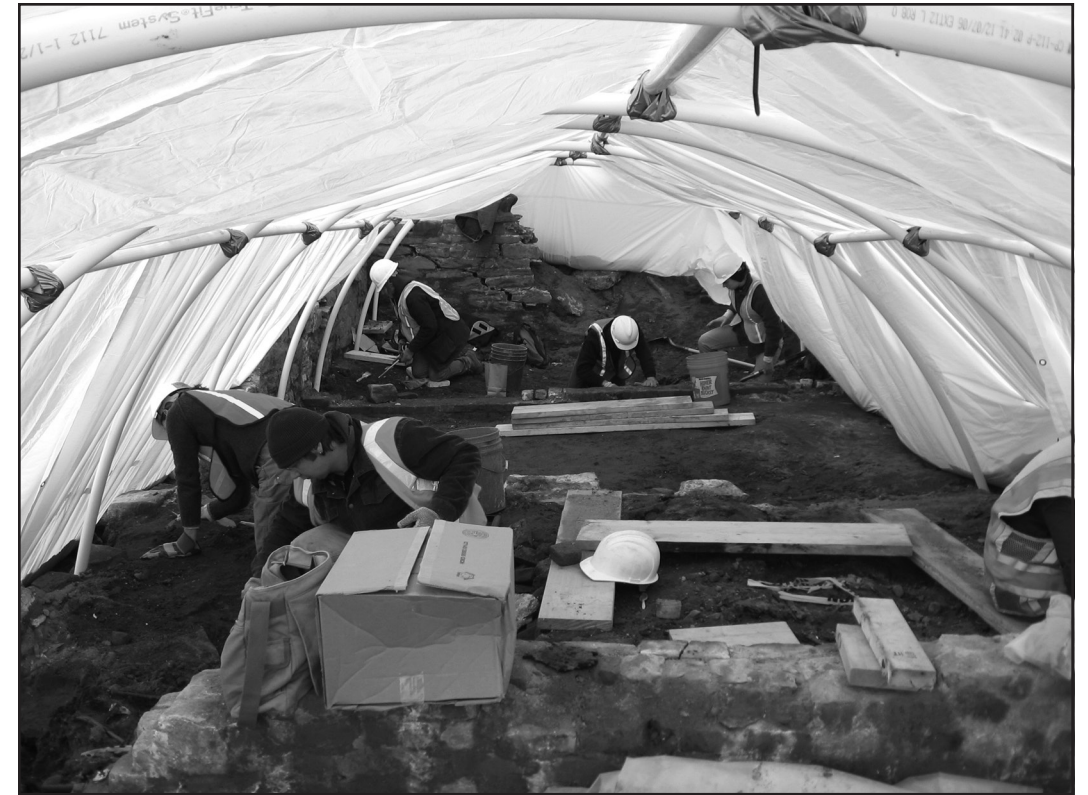
Figure 3. Excavating the burial vaults under the temporary shelter. (Photograph courtesy of URS Corporation.)

southernmost chamber arbitrarily designated Vault 1 and the northernmost Vault 4. All human remains and associated artifacts within each of these chambers were excavated, recorded, and mapped separately from those in adjacent vaults. Because the site remained an active construction zone, all archaeological activities were confined to the interior of the vault foundations. Available work space additionally was restricted by the temporary shelter erected over the vaults to protect remains from both the elements and the view of curious onlookers (FIG. 3).

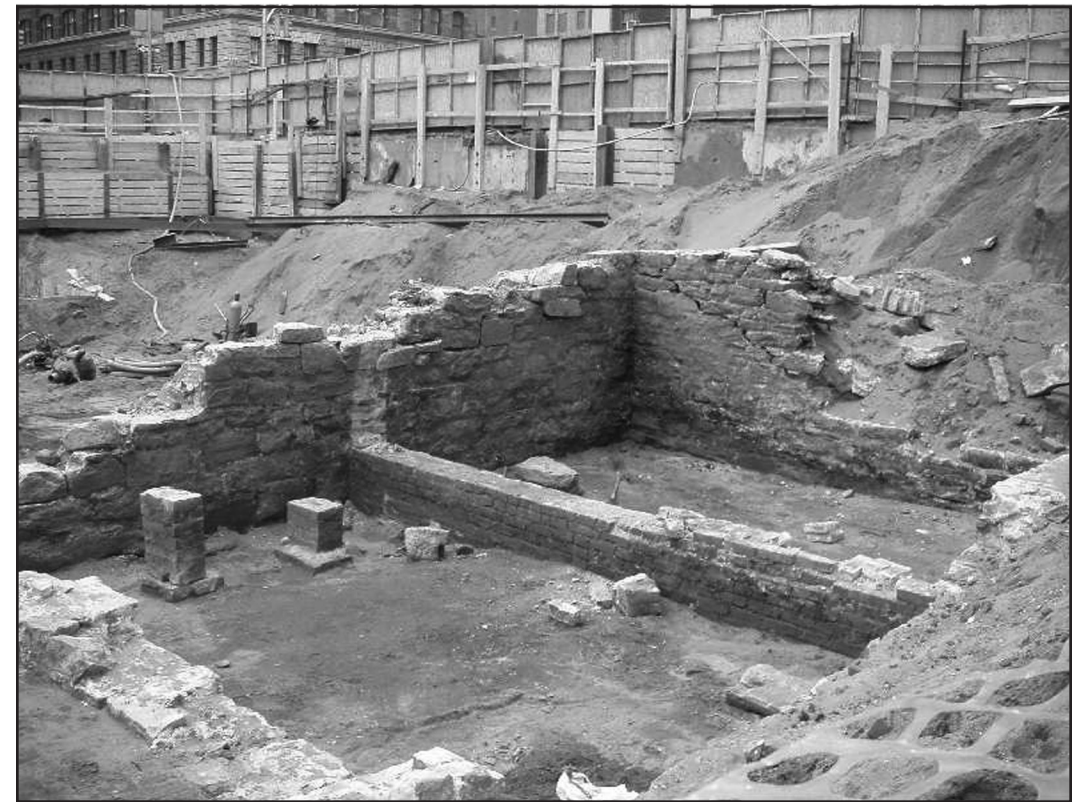
Figure 5. Overview of Vaults 3 and 4 after excavation. (Photograph courtesy of URS Corporation.)

total area of 126 ft.². These northern chambers did not have prepared floors, but rather bot-tomed out onto naturally occurring, moderately coarse, sand subsoil (FIG. 5).

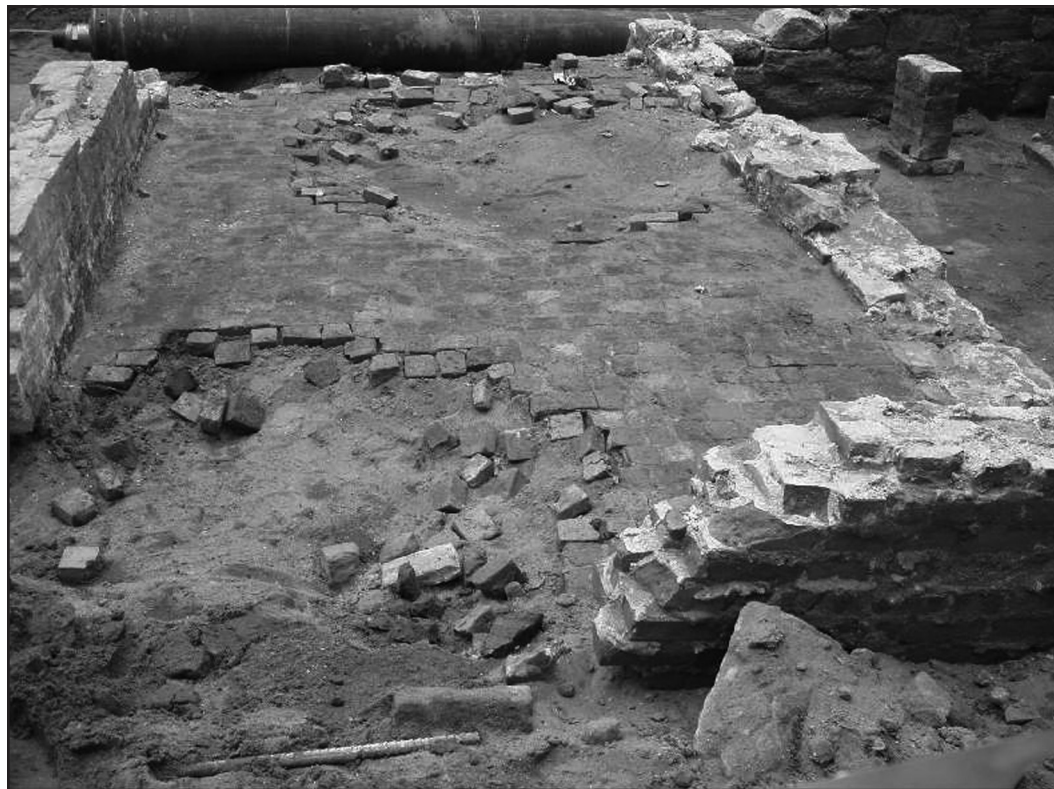
Figure 6. Overview of Vault 2 after excavation. (Photograph courtesy of URS Corporation.)

Unlike Vaults 3 and 4, the walls and physical structure of Vaults 1 and 2 were extensively impacted during initial construction activities for the new hotel/condominium. Vault 1 was the most heavily damaged of the two chambers and was extensively disturbed by excavation machinery. Archaeological investigations revealed that the only fragments of this vault surviving in situ consisted of a small segment of the eastern wall and interior floor, along with a tiny section of the southeast corner wall and associated brick floor. All remaining portions of this chamber had been completely removed. Vault 2, on the other hand, exhibited a considerably greater degree of preservation and was represented by truncated and fragmentary outer walls and a 60–70% intact brick floor (FIG. 6).

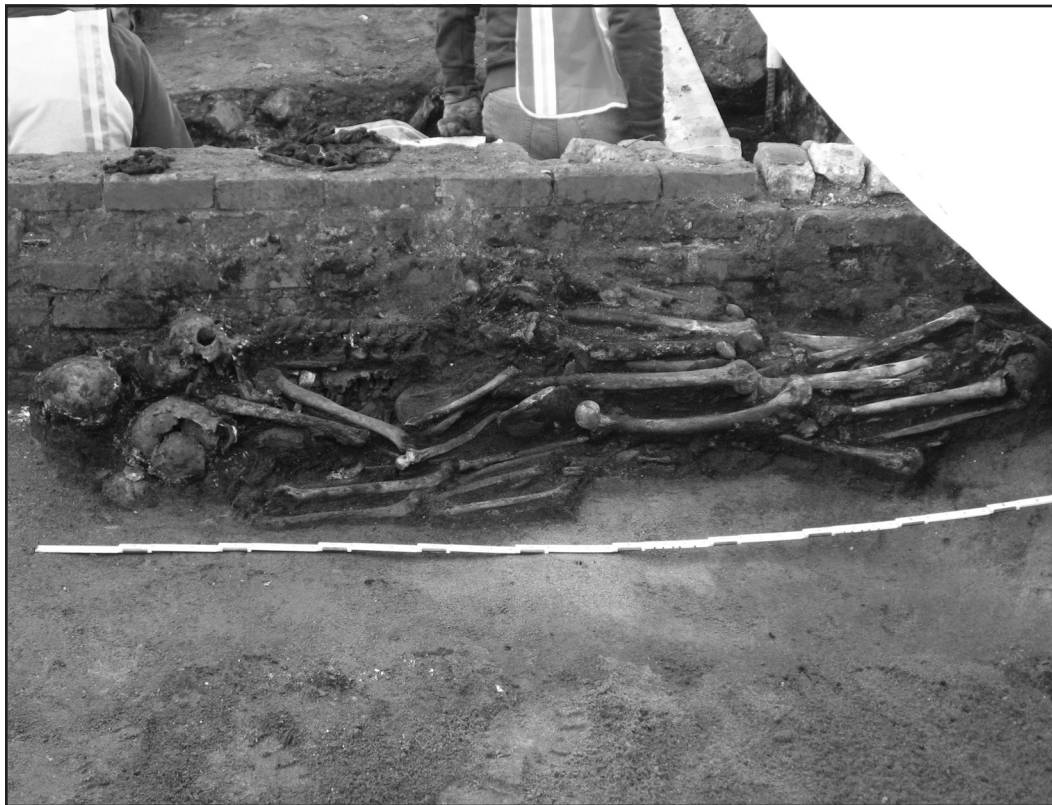
Figure 8. Stacked intact burials within Vault 3. (Photograph courtesy of URS Corporation.)

were represented both by groups of more or less complete remains stacked one atop the other (FIG. 8), as single and stacked truncated remains (FIG. 9), and as those that were apparently complete but badly crushed. In several instances, primarily in Vault 4, burials were identified within deep pockets of jumbled, disarticulated remains (FIG. 10). Lastly, in a small number of cases, partially intact burials were identified in more central parts of the vaults, away from walls and beneath dense fill and demolition rubble deposits. Remains recovered in these latter contexts were nearly always badly crushed with almost no intact bone remaining.

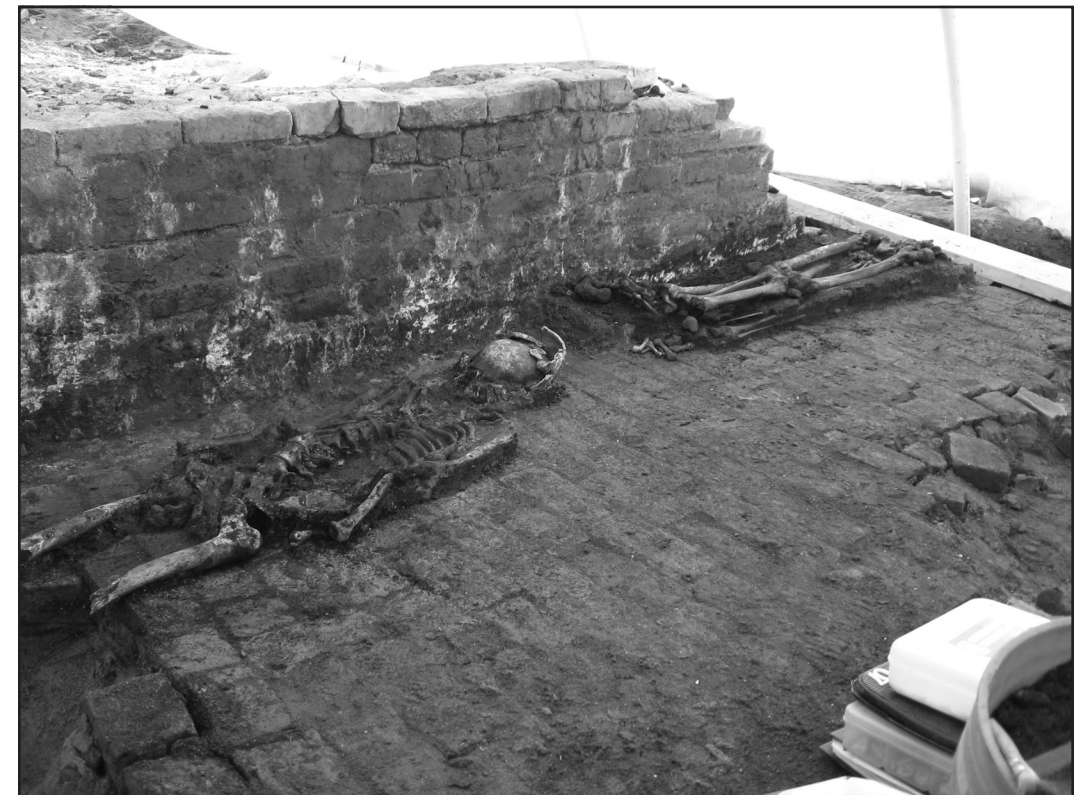
Figure 9. Stacked truncated and individual truncated burials in Vault 2. (Courtesy of URS Corporation.)

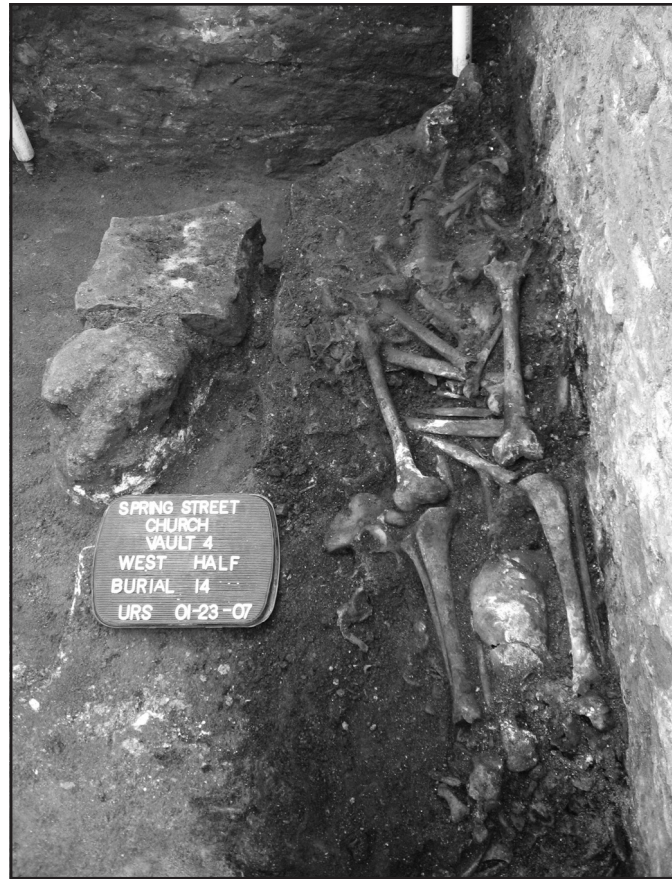
Figure 10. Partially intact burial within disarticulated remains in Vault 4. (Photograph courtesy of URS Corporation.)
