South Dakota State University Agricultural
Experiment Station

Environmental Control in Poultry Laying Houses

ENVIRONMENTAL CONTROL IN POULTRY LAYING HOUSES

Agricultural Engineering Department
AGRICULTURAL EXPERIMENT STATION
South Dakota State College, Brookings

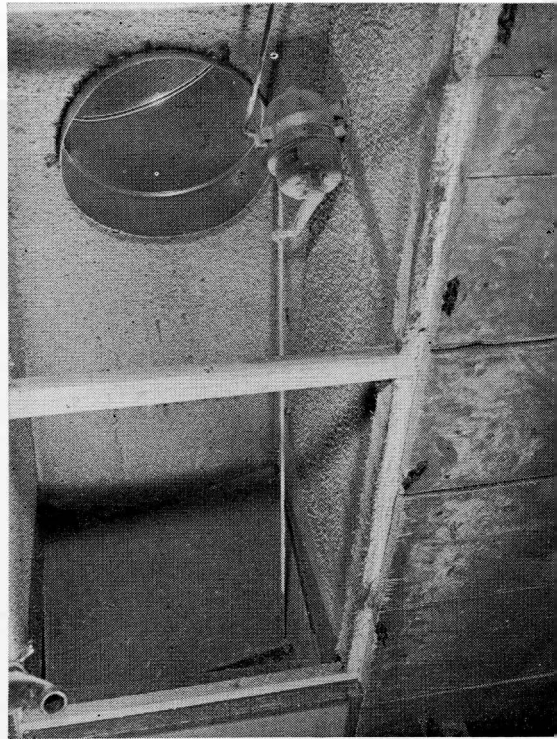
the extremely dusty condition in poultry houses. Figure 8 is somewhat the same view as figure 7 except all the filters are removed. The damper system for changing between fresh air and inside air going to the indoor coil is clearly shown. With the damper in the position shown, predominately fresh air is drawn into the house. With the damper in the alternate position, most of the air going into the house is recirculated air. The damper is automatically controlled by outside thermostats so that during hot or cold temperatures the damper moves to the recirculating position while during mild weather the damper is in the position shown in figure 8.

Figure 8. Filter bank with all filters removed.

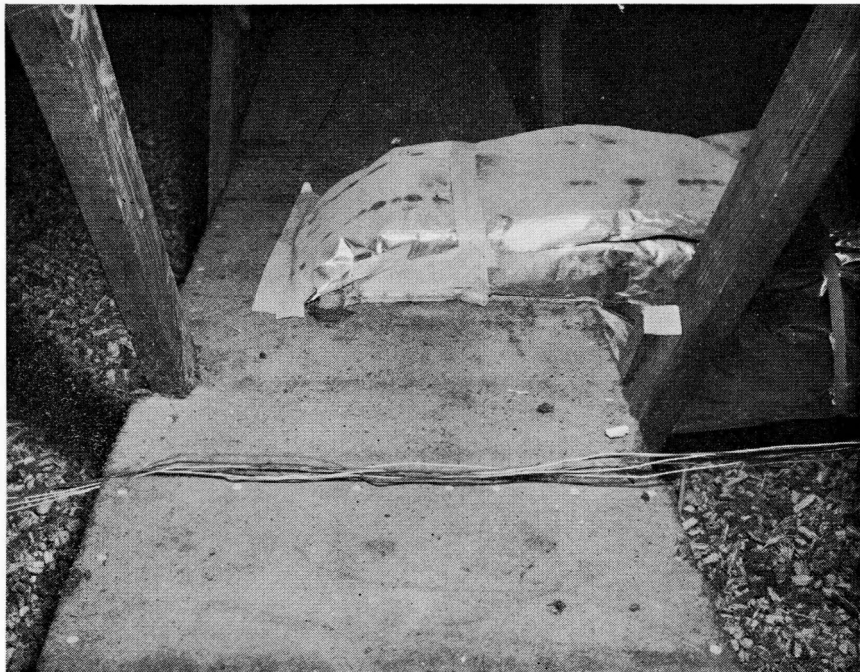
Typical duct construction can be seen in figure 9. All ducts were constructed using 1-inch insulation board except for the duct from the heat pump indoor coil to the cross-duct which was constructed of metal and covered with fiberglass insulation. This was necessary because of the high temperatures when operating the auxiliary resistance heating elements. Existing braces in the attic were used as a main frame for the insulation board ducts where possible. These ducts were oversized from one and one-half to two times the manufacturer's recommendations to allow for the relatively rough sides.

Figure 9. Typical duct construction.

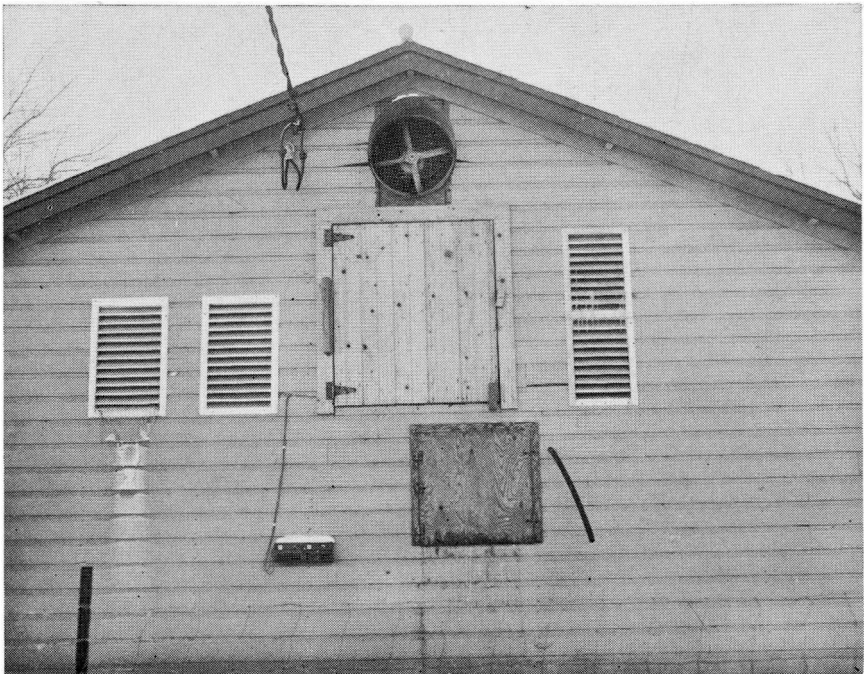
Figure 11. Heat pump mounted in end of poultry house.

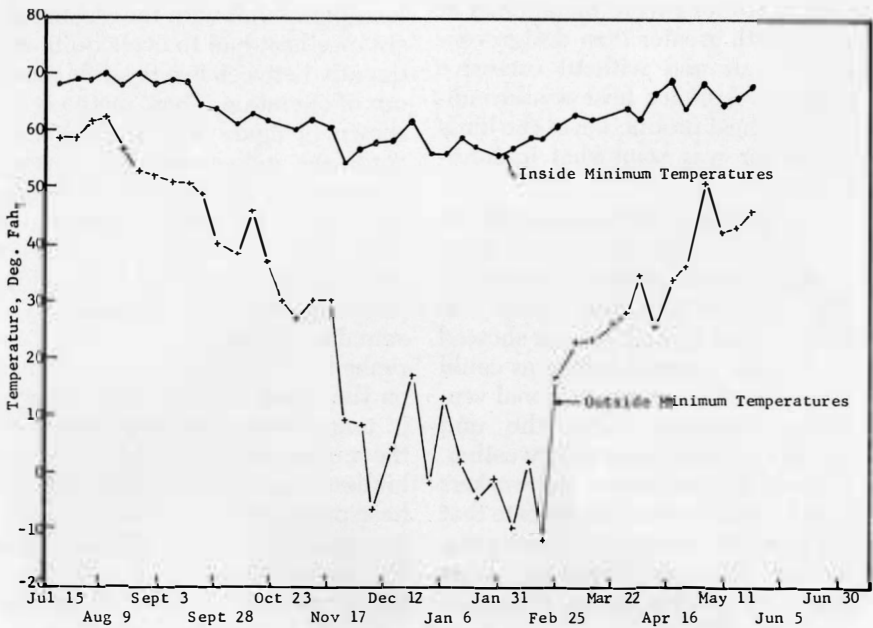
ble 2. Here the power consumption has been changed to an average rate for each component and an average rate for the entire system is also given. In this table, it is quite easy to compare variables such as the power consumption rate with conditions such as average inside temperature, outside temperature, relative humidity, or any minimum or maximum value. This data has also been segregated and plotted in figures 16 through 21. Figure 16 indicates how the average inside and outside temperatures varied during the test period. It is important to note that during the coldest winter months of December, January, and February the outside temperature did drop excessively but the average inside temperature dropped only a few degrees from its overall average. This was shown even more clearly in figure 17 when average mini-

imum inside and outside temperatures are plotted against dates during the year. Here the distance between the two plotted lines is greater because the outside temperature during a day varied much more than the temperature inside the poultry house. Although the average minimum outside temperature dropped as low as -12°F. , the average mini-

imum inside temperature dropped only to 54°F. This temperature also occurred early in the winter when the electric resistance heat was not operating properly. The lowest average minimum outside temperature occurred later in the winter and the average minimum inside temperature only dropped to 63°F. on this occasion. Since the desired tempera-

Figure 17. Comparison of weekly averages of inside and outside minimum temperatures, July 15, 1958-June 30, 1959.

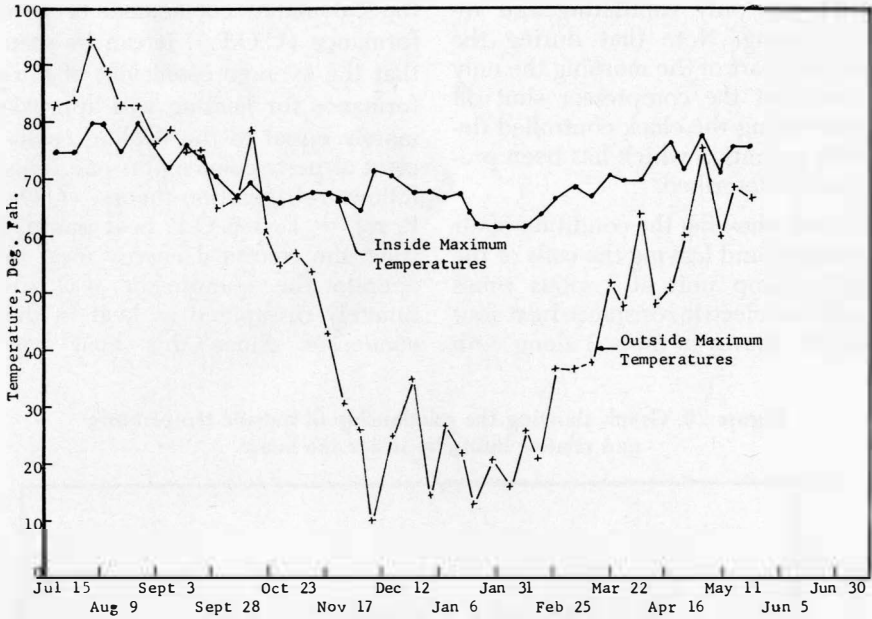
The effect of the system on inside temperature during warm weather can be seen in figures 16 and 18. During the warmest outside weather which was the first part of August, the outside average temperature rose above the average inside temperature by about four degrees. Using the average maximum values in figure 18, this temperature difference was greater. Note that at the extreme conditions the difference between inside and outside conditions is 15 degrees, even though the inside temperature has risen to 80°F. which is above inside design conditions. This indicates that the cooling capacity required was somewhat greater than that calculated. This result along with the fact that winter inside design conditions were maintained at times with greater than design ventilation air and without excessive electric resistance heat would indicate the heat production of the birds and litter was somewhat underestimated.

Figure 18. Comparison of weekly averages of inside and outside maximum temperatures, July 15, 1958-June 30, 1959.

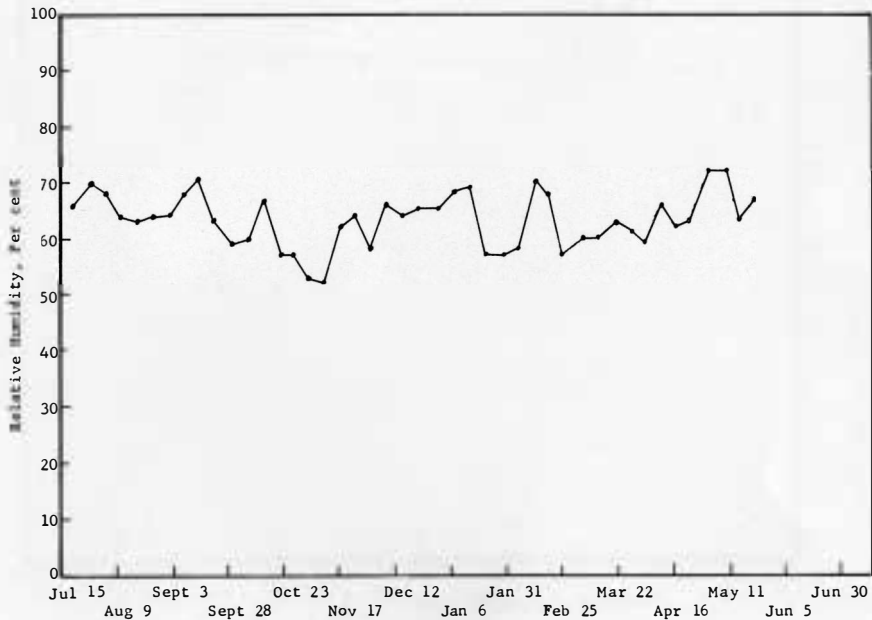
The average relative humidity in the house was plotted against dates during the test period in figure 19. The relative humidity varied between about 52 and 72% but showed no definite seasonal trends as could be expected from conventional ventilation systems where the unit would shut off during cold weather. General observations of the workers in the house seemed to indicate that the humidity range was quite satisfactory although somewhat drier than most poultry houses. Figure 20

Figure 19. Average relative humidity in the poultry house during the test period, July 15, 1958-June 30, 1959.
