Foundation Design of Low Volume Roads: Evaluation and Performance

Alyssa Clemen

A thesis submitted in partial fulfillment of the requirement for the

Major in Civil Engineering

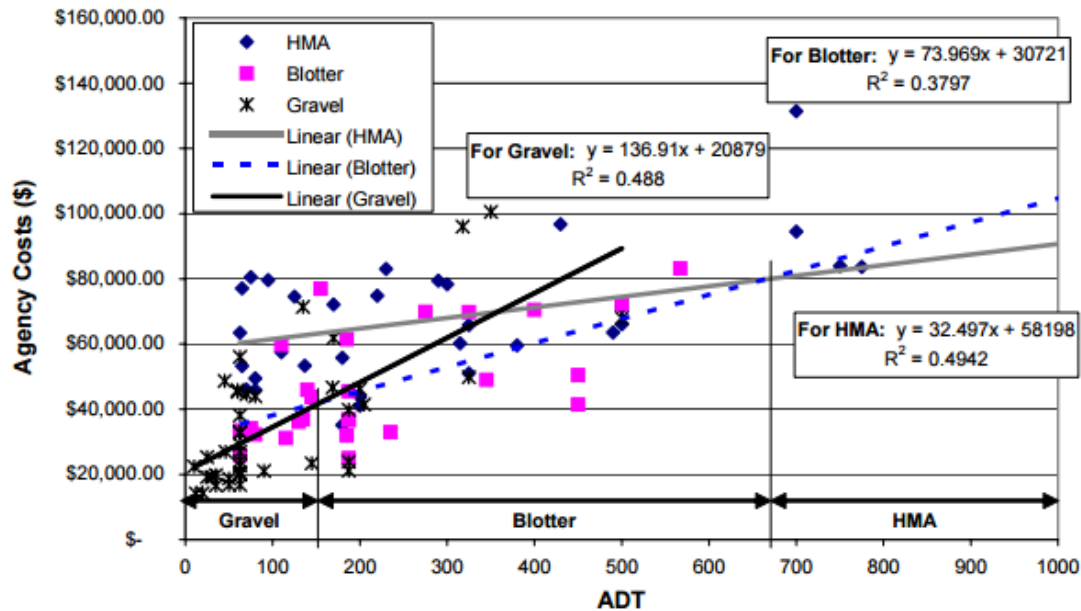
Figure 2.3: Default 20-Year Agency Cost Models (Per Mile), (Zimmerman and Wolter, 2004)

The primary function of a pavement structure is to carry the loads of the traffic travelling on it. Therefore, the traffic is a critical part of the design and performance of roads. In the geometric design (vertical curves, horizontal curves, etc.) of roads, the main traffic parameters used are average daily traffic (ADT) and peak hour volume. For the design of the pavement structure (surfacing, base, etc.), the amount and type of truck loads are commonly used in addition to ADT (ASCE, 1992). The greater the amount of traffic and the heavier the traffic is, the stronger the pavement structure has to be in order to support the load. Studies of the life cycle costs for different surfacing have shown which surface type is most cost effective at specific ADT's. An example of this for gravel, blotter, and HMA surfaces is shown in Figure 2.3 from the *Local Road Surfacing Criteria* (Zimmerman and Wolter, 2004). Using this chart, it can be seen that for roads with an ADT of 0 – 150, a gravel surface is most cost effective. However, blotter surfaces are most cost effective for roads with ADT's between 150 and 675, and HMA surfaces are for roads with over 675 ADT (Zimmerman and Wolter, 2004).

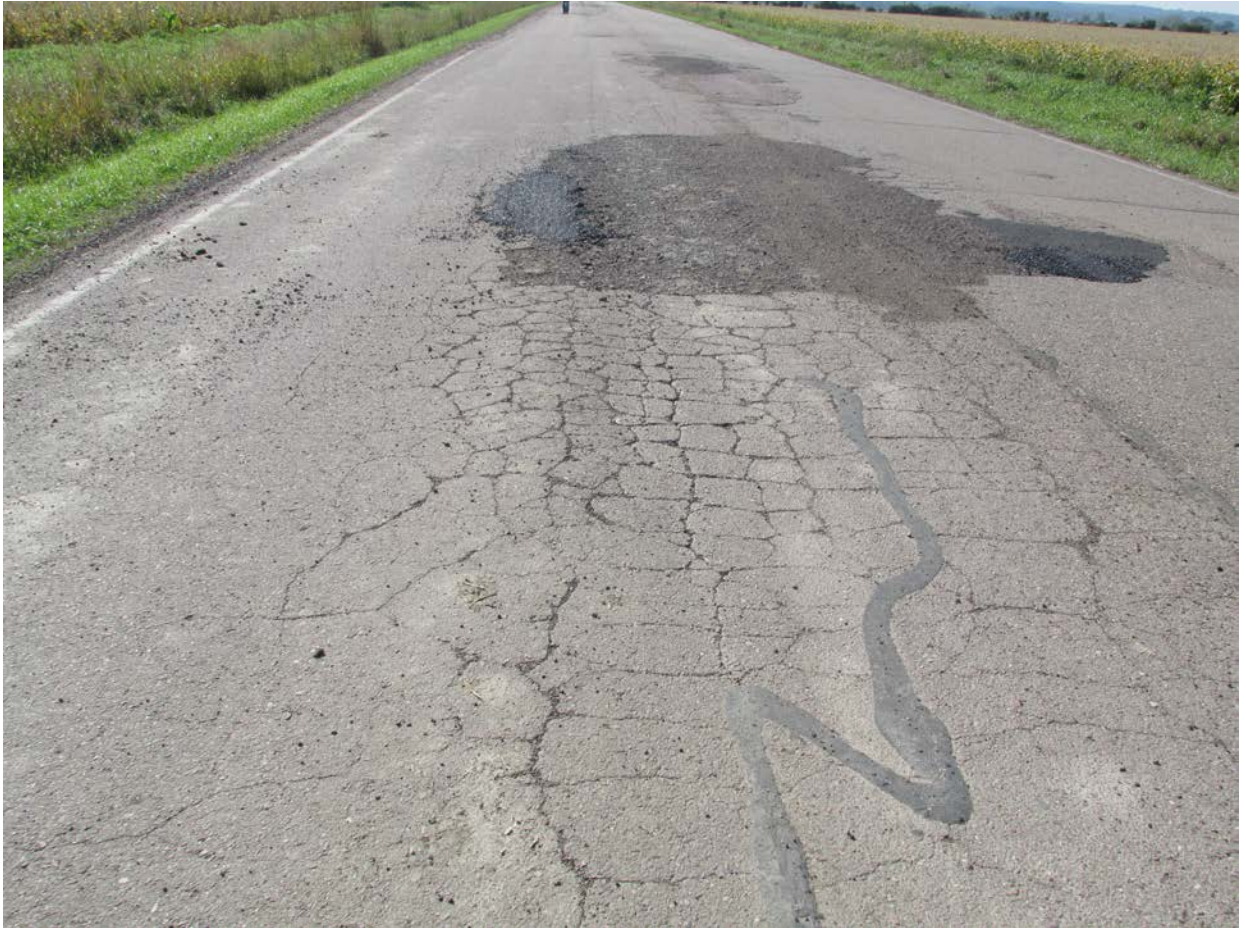
Figure 5.1: Category 1 Pavement Condition – Clay County Saginaw Avenue

Figure 5.1 shows an example of Category 1 pavement condition on Saginaw Avenue in Clay County. This pavement has severe fatigue cracking with disintegrating pavement in and around these cracks. This disintegration has resulted in some potholes. The multiple patches contain similar fatigue cracking and disintegration as the original pavement. There is also detrimental raveling and significant rutting present.

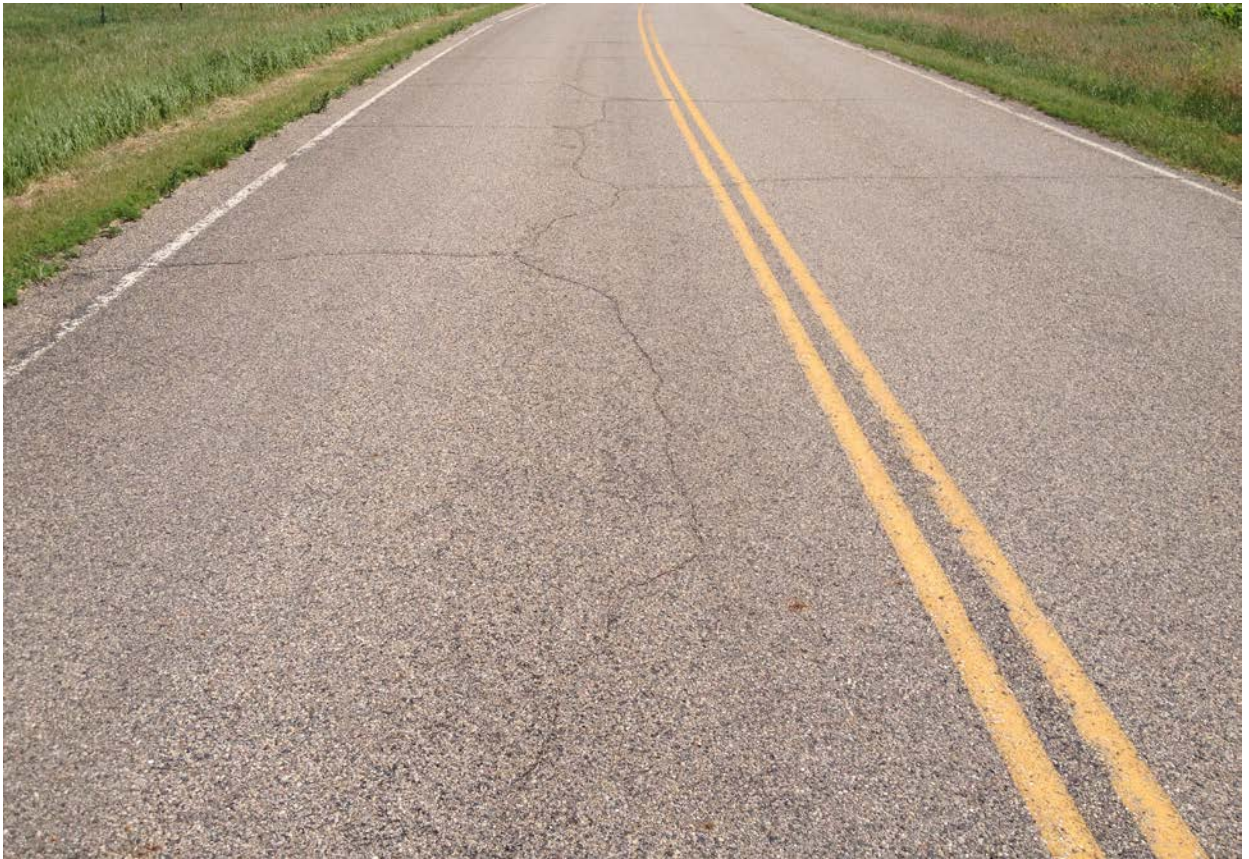
Figure 5.2: Category 2 Pavement Condition - Deuel County Highway 311-Original

The original section of Deuel County Highway 311 as shown in Figure 5.2 is an example of Category 2 pavement condition. The asphalt surface exhibits moderate signs of oxidation, which is typical of a pavement that is 51 years old. There is also some age related cracking, as seen by the wide crack spacing. The cracks also show signs of low severity deterioration. Finally, there is moderate rutting in the wheel paths and some edge deterioration.

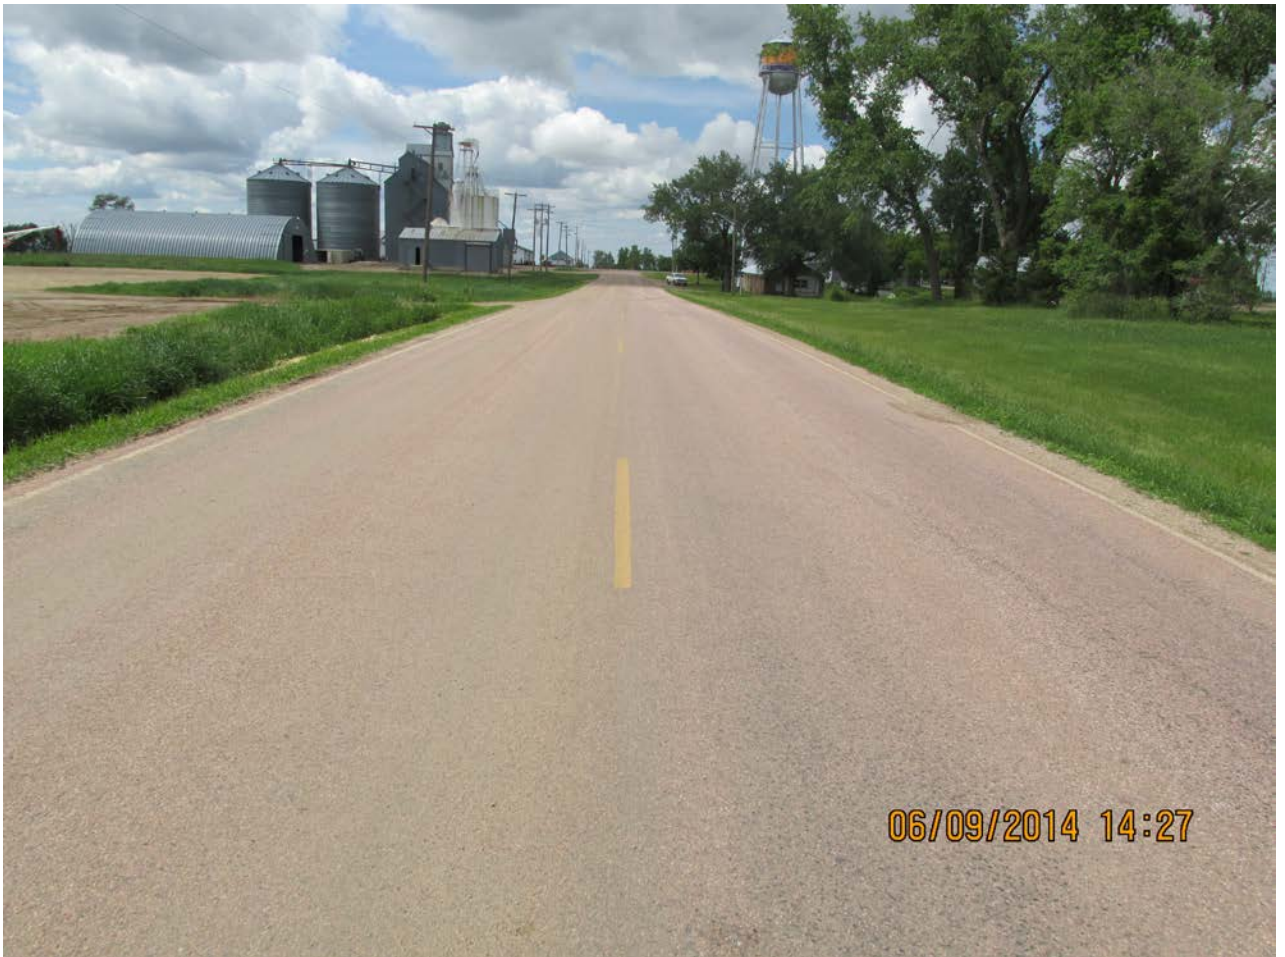
Figure 5.3: Category 3 Pavement Condition–Miner County Railroad St. (Canova)

Figure 5.3 shows Railroad Street in Canova, a town in Miner County. This road was classified as having Category 3 pavement condition. There is some partial weathering and oxidation. The visible cracking is minimal, and the cracks that exist are very narrow. There is essentially no rutting in the wheel paths.

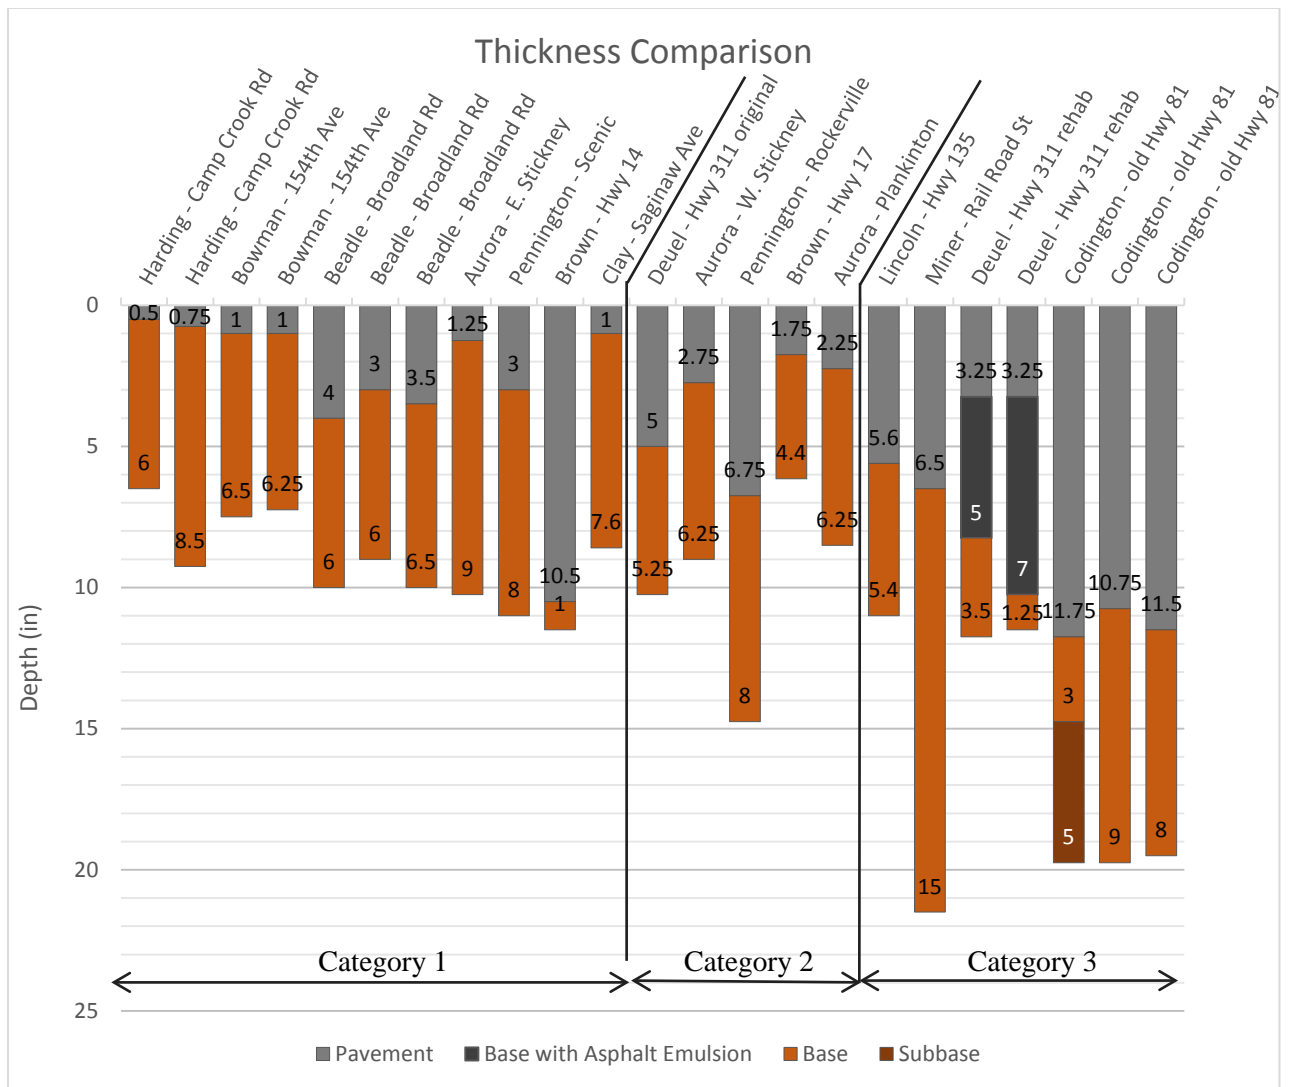
Figure 5.4: Actual Layer Thickness Comparison

Figure 5.4 is a comparison of the layer thicknesses for each of the sections of all the roads tested. The poor performing roads are at the left of the chart, the average performers are in the middle, and the good performers are on the right side. Most of the good performing roads have significantly greater pavement and base thicknesses than the other roads.

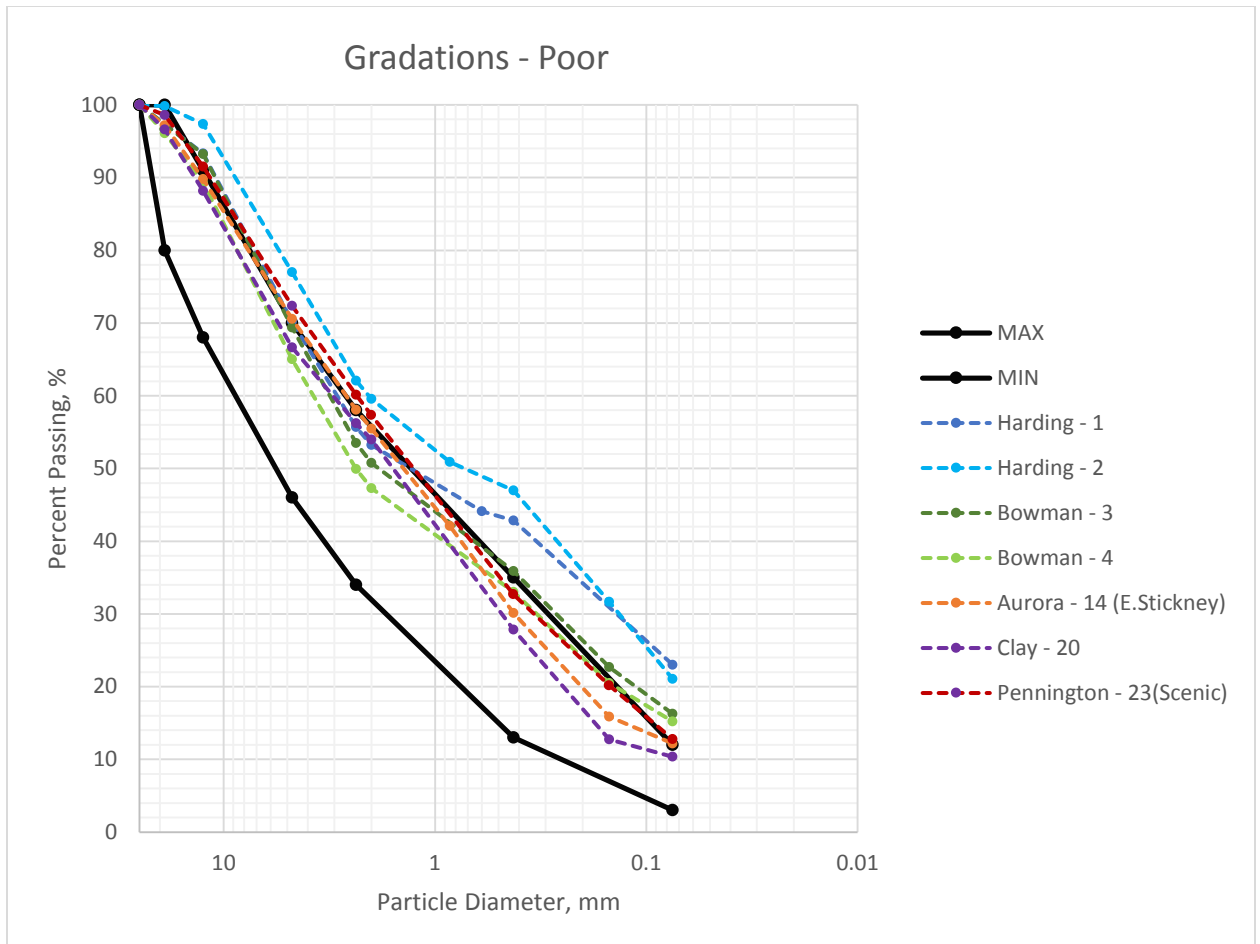
Figure B.1: Base Course Gradations for Poor Performing Roads

Figures B.1 – B.3 show the gradations of the base course for each of the sections tested and compare those gradations to the SDDOT base specification limits (the dark black curves). The gradations are grouped according to the performance of the road.
