DISSERTATION

**CHIPPING, FAILURE LOAD AND FATIGUE RESISTANCE OF  
ANTERIOR VENEERS MANUFACTURED WITH CAD/CAM  
TECHNOLOGY**

In the Department of Restorative Science and Biomaterials

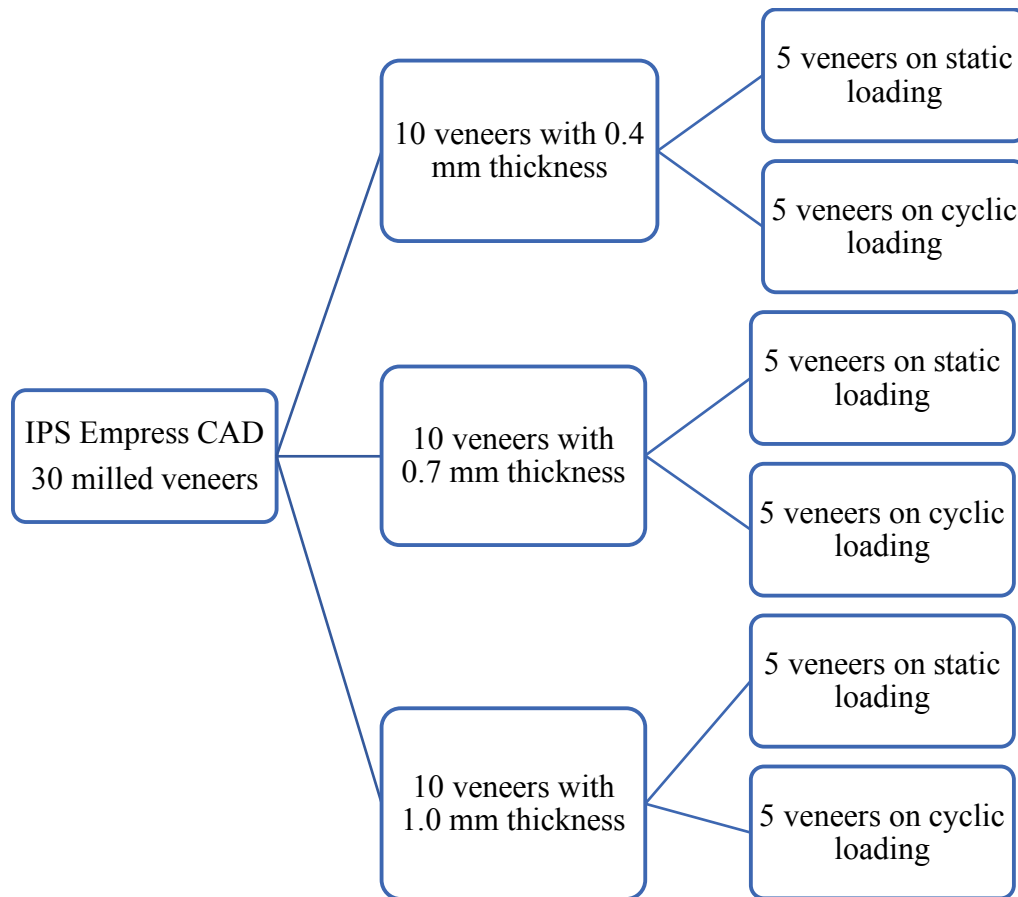
**Graph 1: Study design, IPS Empress CAD**

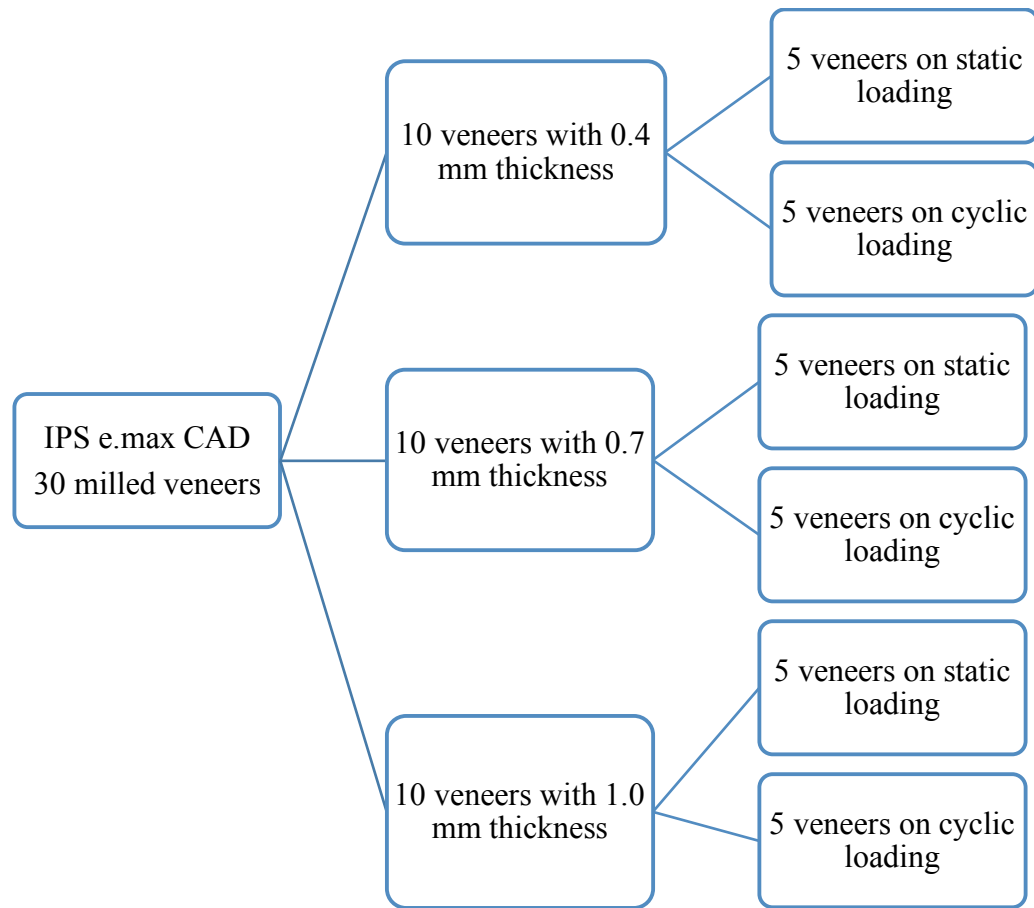
**Graph 2: Study design, IPS e.max CAD**

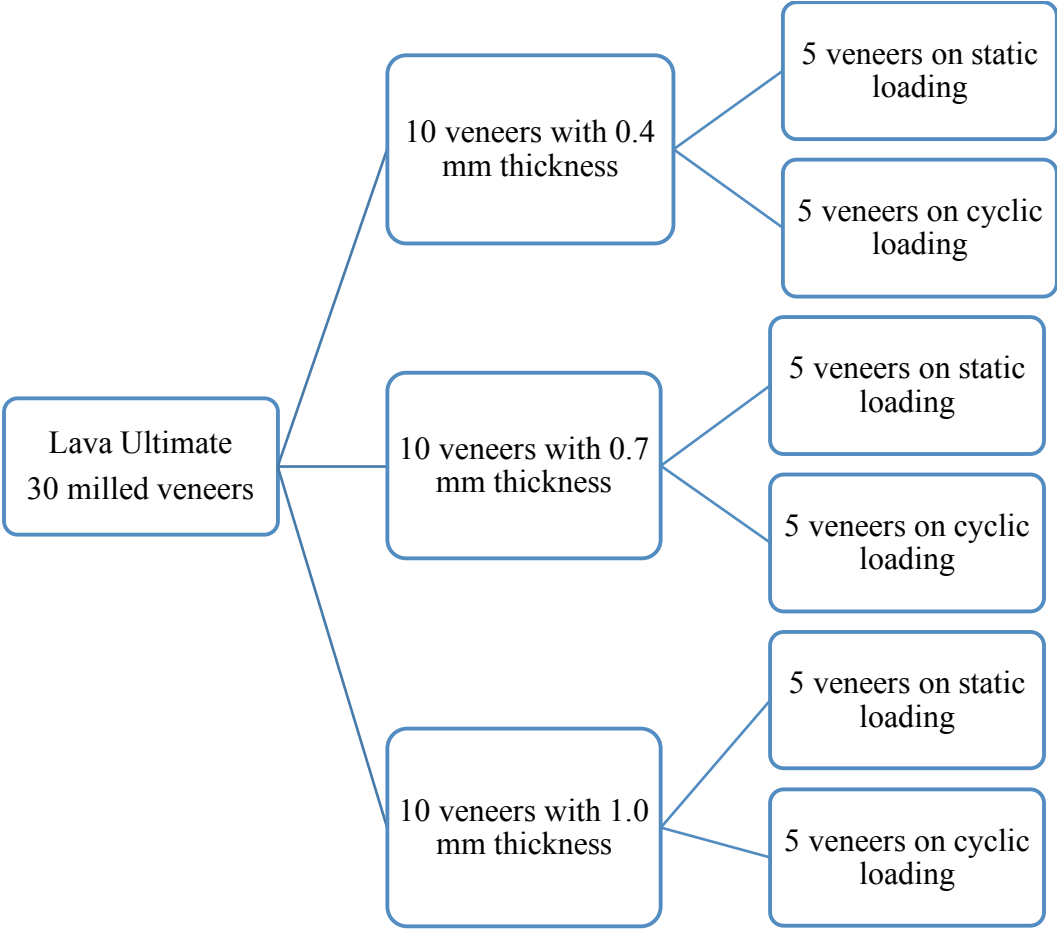
Graph 4: Study design, Lava Ultimate

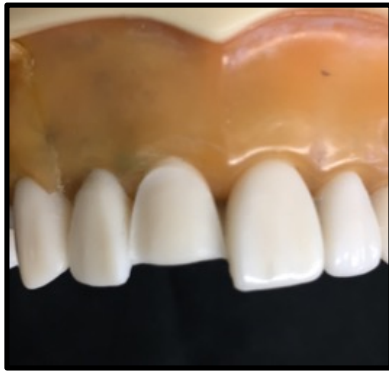
**Figure 1: Right central incisor veneer preparation**

An ivory typodont right central incisor (Model #D95SDP-200; Kilgore International, Inc., Coldwater, MI) (Figure 1) was selected to receive a veneer preparation. The tooth was prepared with a diamond rotary cutting instrument from a veneer preparation set (Brasseler USA® Dental, Savannah, GA). It was prepared with an incisal overlap preparation (IOP) having 0.5 mm depth reduction at the middle and incisal thirds and 0.3 mm chamfer margin placed 1.0 mm above the CEJ. The incisal edge was reduced 2.0 mm with a palatal chamfer and the interproximal finish line was located facially to the proximal contacts. All specimens were done by the same operator. The typodont tooth was sprayed with IPS contrast spray lab side (Ivoclar Vivadent, Liechtenstein) and scanned using an inEos Blue scanning camera (Sirona, Bensheim Germany) (Figure 2). Ceramic veneers were designed using Sirona InLab 3D software SW4 4.2.5 (Figures 3,4) and the designs were saved and used for all successive veneers. Four different ceramic materials were selected for the study; namely IPS Empress CAD (Ivoclar Vivadent, Liechtenstein), IPS e.max CAD (Ivoclar Vivadent, Liechtenstein), VITA ENAMIC (Vita Zahnfabrik, Germany) and Lava Ultimate (3M ESPE,USA) (Figures 5-8). Veneers were milled into three different thicknesses (0.4 mm, 0.7 mm and 1.0 mm) using a Sirona InLab MCXL milling machine. At the conclusion of the milling process, veneers were thoroughly cleaned and dried (Figure 9). Specimens were cut from their respective blocks using a diamond disc. Veneers from IPS e.max CAD were subjected to crystallization firing using a Programat P300/G2, (Ivoclar Vivadent, Liechtenstein) (Figure 10) following manufacturer's instructions (Table 3).

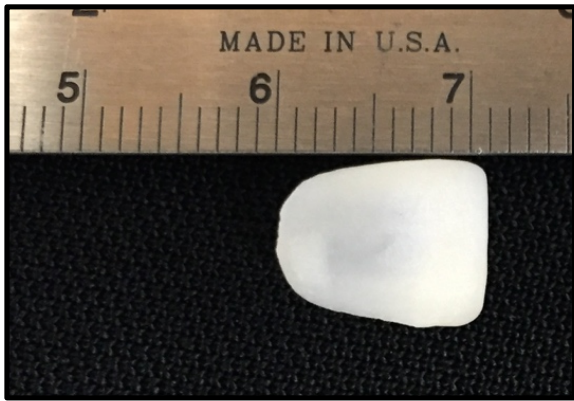
**Figure 9: Milled veneer**

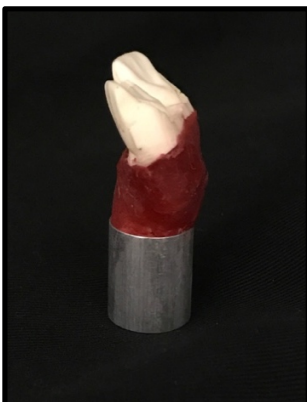
Figure 18: Epoxy resin master die fixed at 125° angle

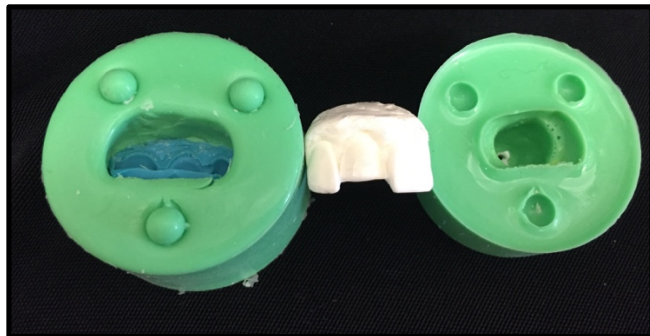
**Figure 21: Cured epoxy resin abutment**

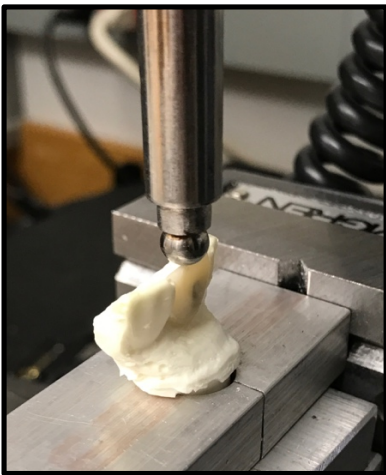
**Figure 25: Testing setup at the universal testing machine**

Five specimens per group were loaded under compression with a 6mm diameter stainless steel ball using an Instron universal testing machine (Model 5566A, Instron Co., Canton, MA) at 0.5 mm/minute rate until fracture (Figures 24-25). The Instron machine was connected to a computer with a specifically designed program (BlueHill 3 software, Instron, Norwood, MA). This software controlled the testing machine and recorded the breakage load of the veneer. Failure was defined as occurrence of visible cracks, porcelain chipping, or audible events accompanied by a drop in the load by 20%.

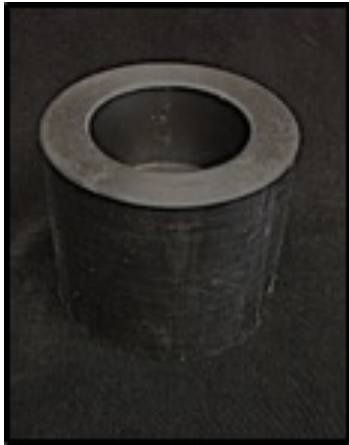
**Figure 26: Plastic specimen holder for the cyclic loading**

Another five specimens were subjected to cyclic loading by pneumatic powered cylinder and an electronic control device (Poher Industries, Waban MA) (Figures 26-28). The peak load applied on each specimen represented 30% of the mean fracture load of each material for 30,000 cycles at a frequency of 1 Hz. The load was applied perpendicular to and at the center of the veneers by 6mm stainless steel balls. After cyclic loading was completed, the remaining samples were loaded in the universal testing machine under compression at 0.5mm/ minute until fracture occurred. Failure loads in Newtons were determined and compared. Failure modes; cohesive failure (veneer chipping), adhesive failure (veneer delamination) or catastrophic fracture (total fracture extending through the veneer and abutment) were observed and recorded after each test.

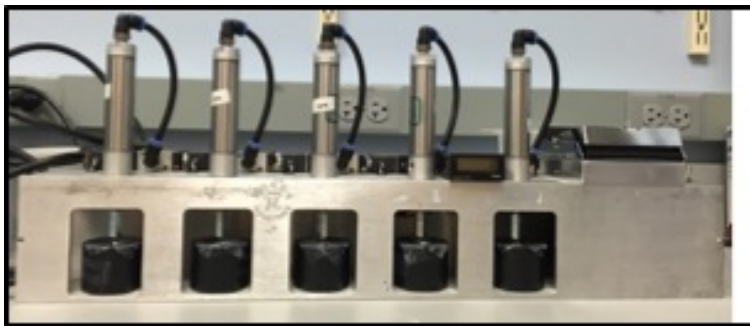
**Figure 27: Cyclic loading apparatus, Pober Industries, Waban MA**

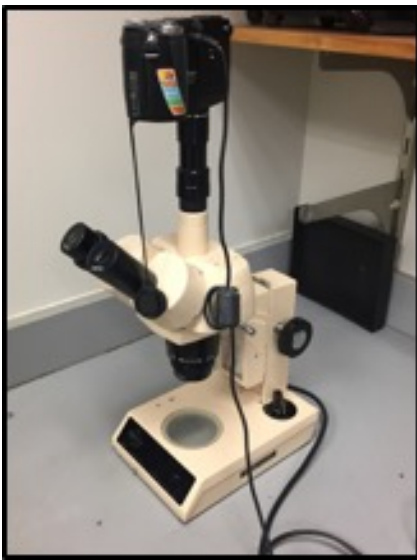
**Figure 29: Ultra Swift Lite microscope**

Two specimens were randomly selected from each group, cleaned in ultrasonic cleaner for 5 minutes then then dried with compressed oil-free air for 20 seconds. Samples were examined under a light microscope (Ultra Swift Lite Illumination system, Carlsbad, CA) at different magnifications (Figure 29).

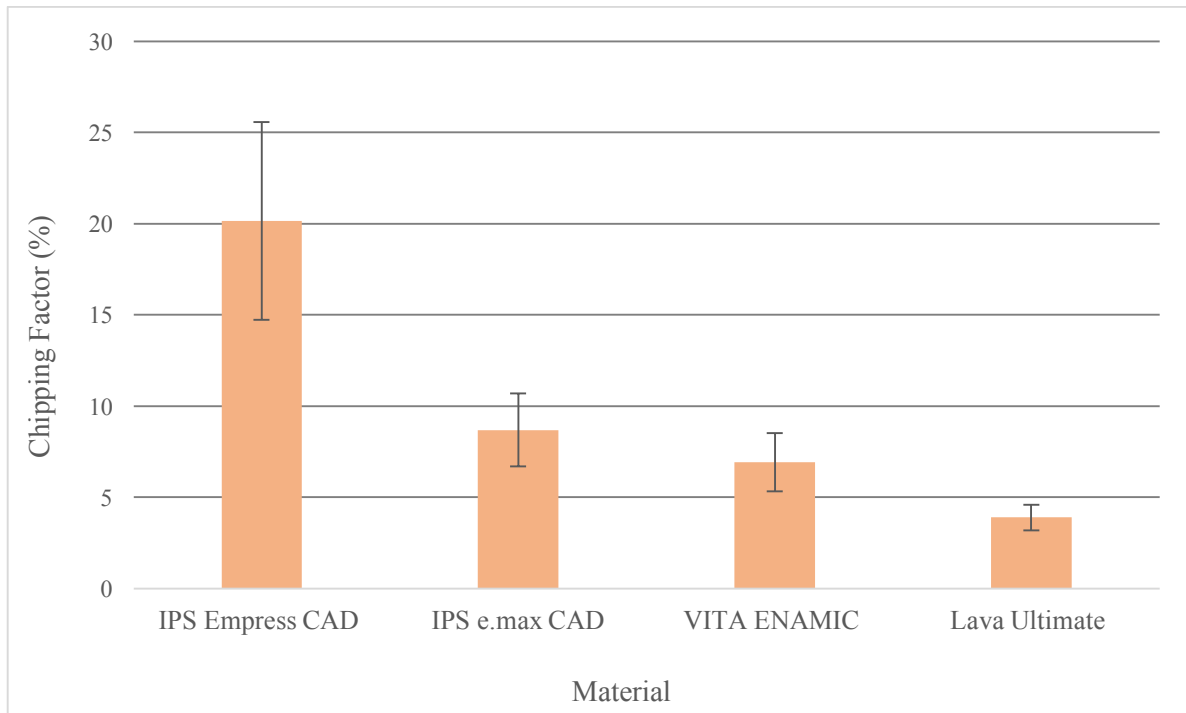
**Graph 5: Mean values of chipping factor(CF) of different veneer materials at 0.4 mm thickness**

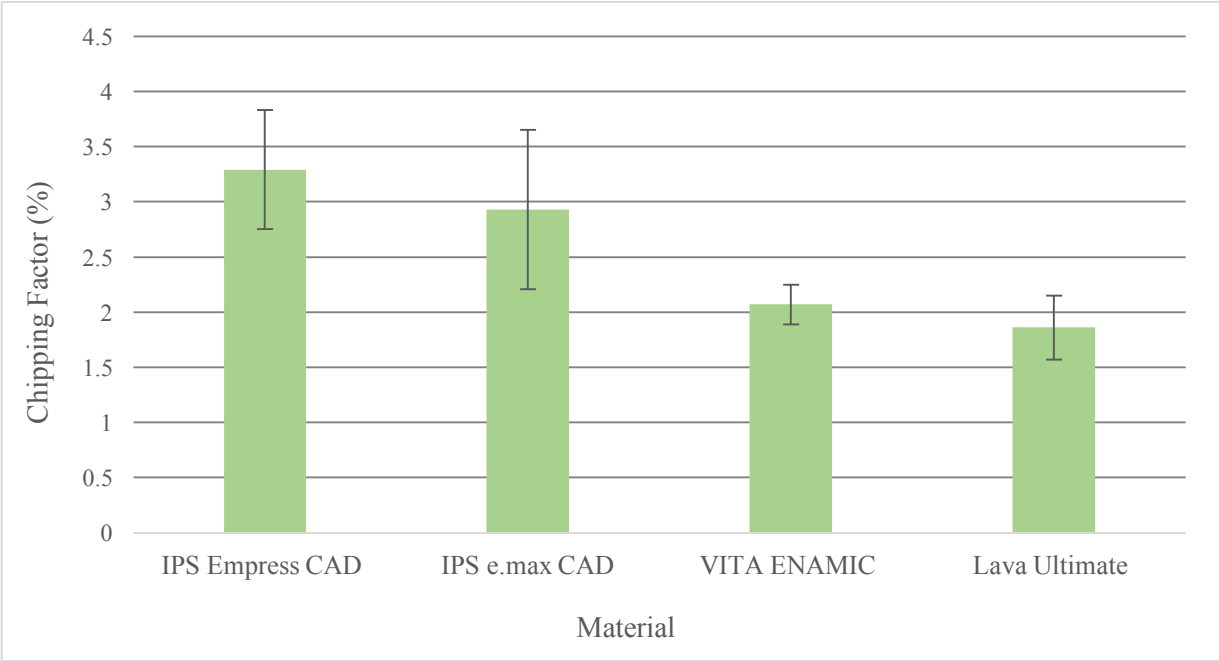
**Graph 7: Mean values of chipping factor(CF) of different veneer materials at 1.0 mm thickness**

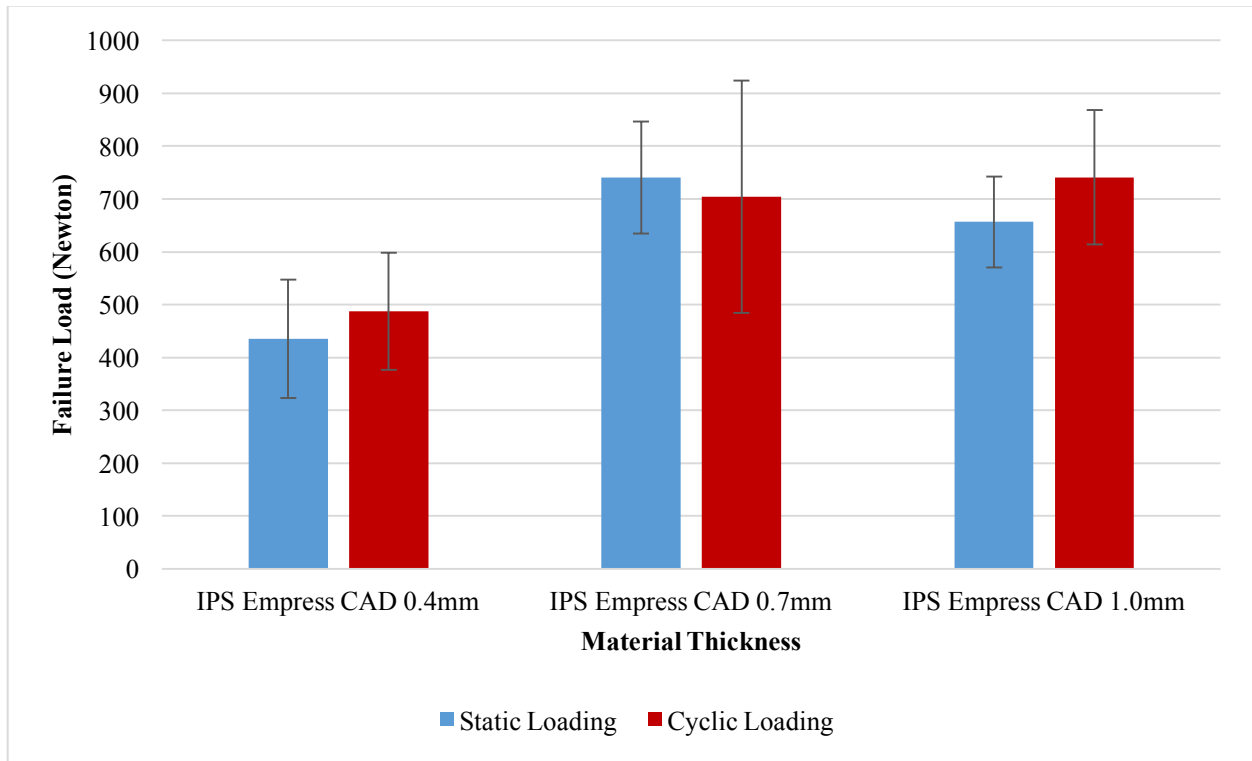
**Graph 8: Mean values of failure loads of different IPS Empress CAD thickness under static and cyclic loading**

Comparing the data of static and cyclic fatigue within the same group, there is no significant difference between static and cyclic fatigue. The null hypothesis, that cyclic fatigue has no significant effect on the failure load of different veneering materials and thicknesses, was accepted. However, comparing the data between groups, there is a significant difference between 0.4mm thickness (static and cyclic) and 0.1mm thickness (cyclic) and between 0.4mm thickness (static and cyclic) and 0.7mm thickness (static) (Graph 6). Levels not connected by the same letter are statistically different (Table 8).

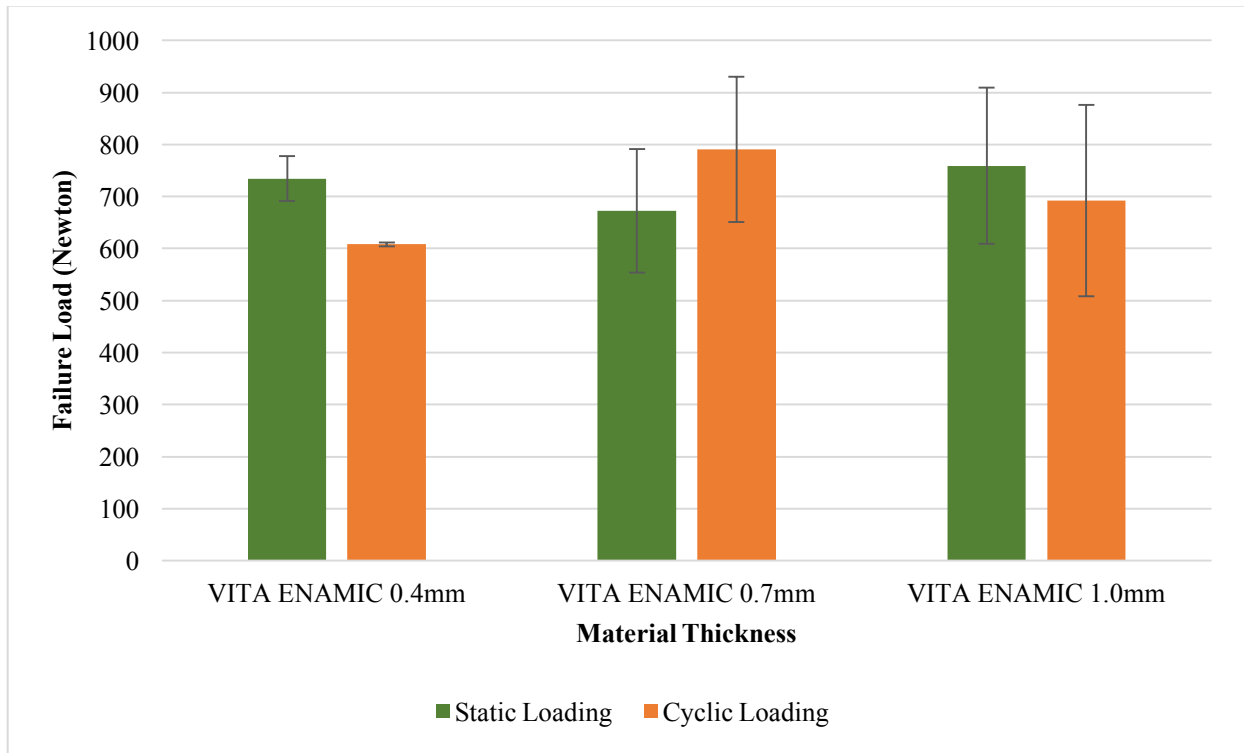
**Graph 10: Mean values of failure loads of different VITA ENAMIC thickness under static and cyclic loading**

Comparing the data of static and cyclic fatigue of VITA ENAMIC show that cyclic loading had no statistically significant effect on the material (Graph 8). The null hypothesis, that cyclic fatigue has no significant effect on the failure load of different veneering materials and thicknesses, was accepted. Levels not connected by same letter are significantly different (Table 12).

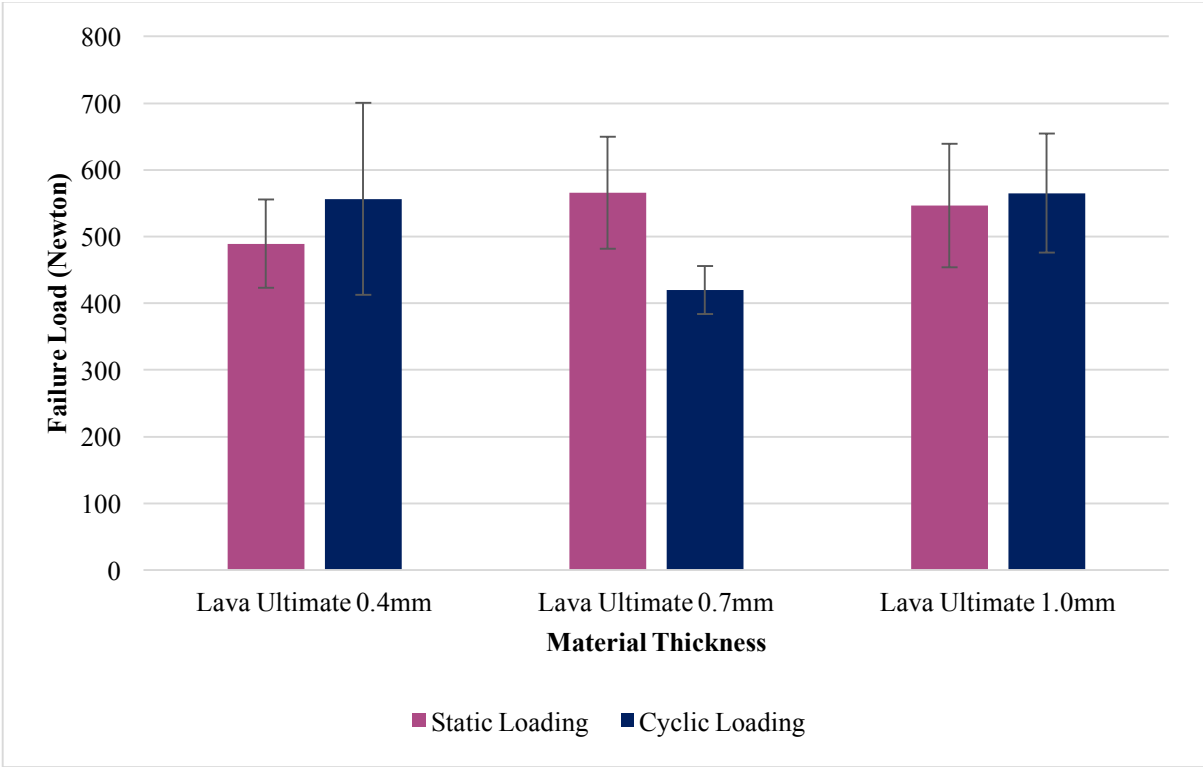
**Graph 11: Mean values of failure loads of different Lava Ultimate thickness under static and cyclic loading**

Comparing the data of static and cyclic fatigue of Lava Ultimate shows that cyclic loading had no statistically significant effect on the material (Graph 9). The null hypothesis, that cyclic fatigue has no significant effect on the failure load of different veneering materials and thicknesses, was accepted. Levels not connected by same letter are significantly different (Table 14).

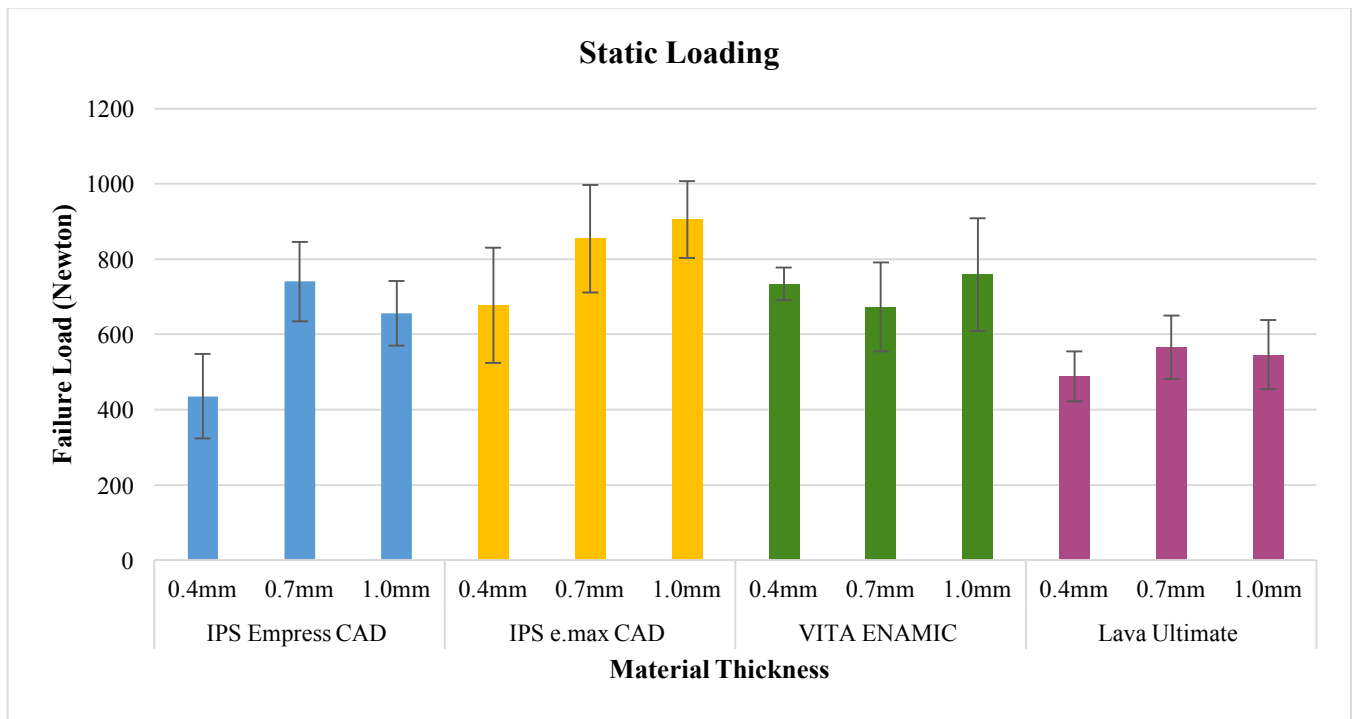
A statistically significant difference was observed in the failure load between groups under static loading (Graph 10). Failure load of IPS e.max CAD and VITA ENAMIC was significantly higher than IPS Empress CAD and Lava Ultimate. Levels not connected by same letter are significantly different (Table 15).

**Graph 12: Mean values of failure load of different veneer materials of various thickness under static loading**

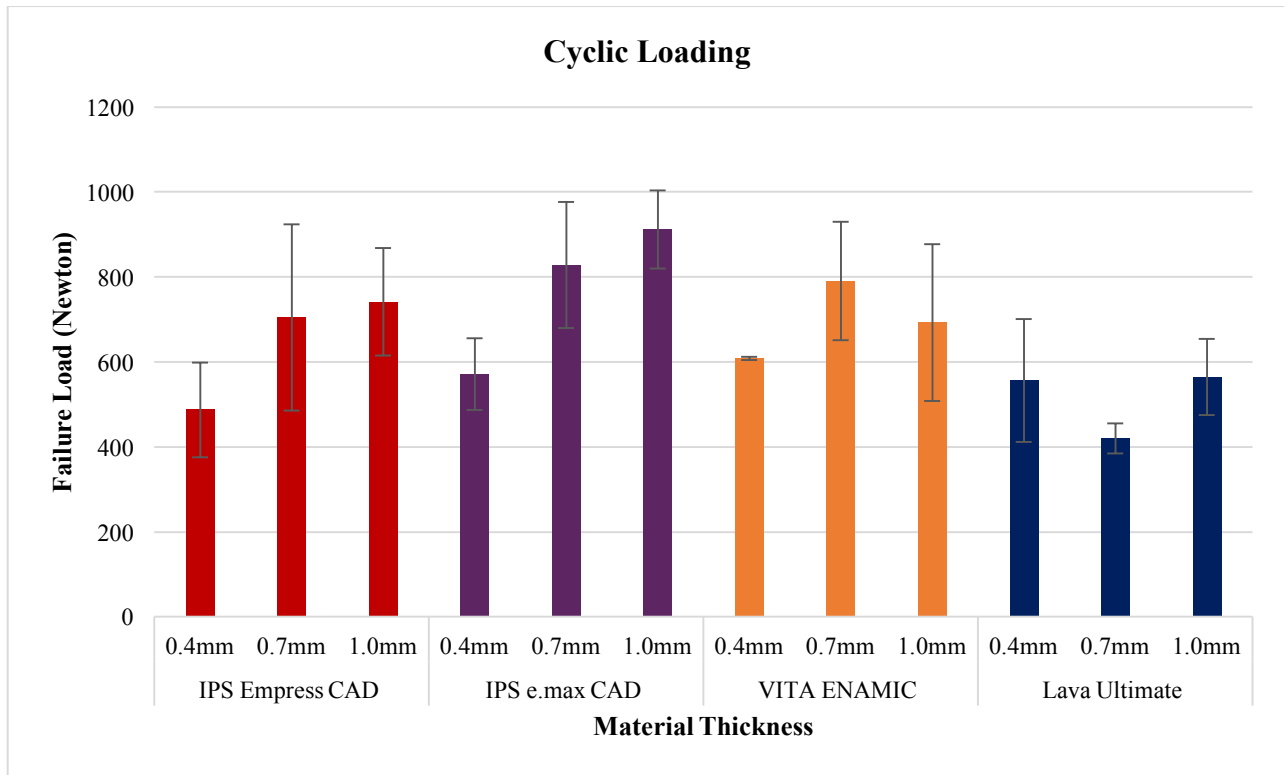
A statistically significant difference was observed in the failure load between groups under cyclic loading (Graph 11). Failure load of IPS e.max CAD, VITA ENAMIC and IPS Empress CAD was significantly higher than the load for Lava Ultimate. Levels not connected by same letter are significantly different (Table 16).

**Graph 13: Mean values of failure load of different veneer materials of various thickness under cyclic loading**

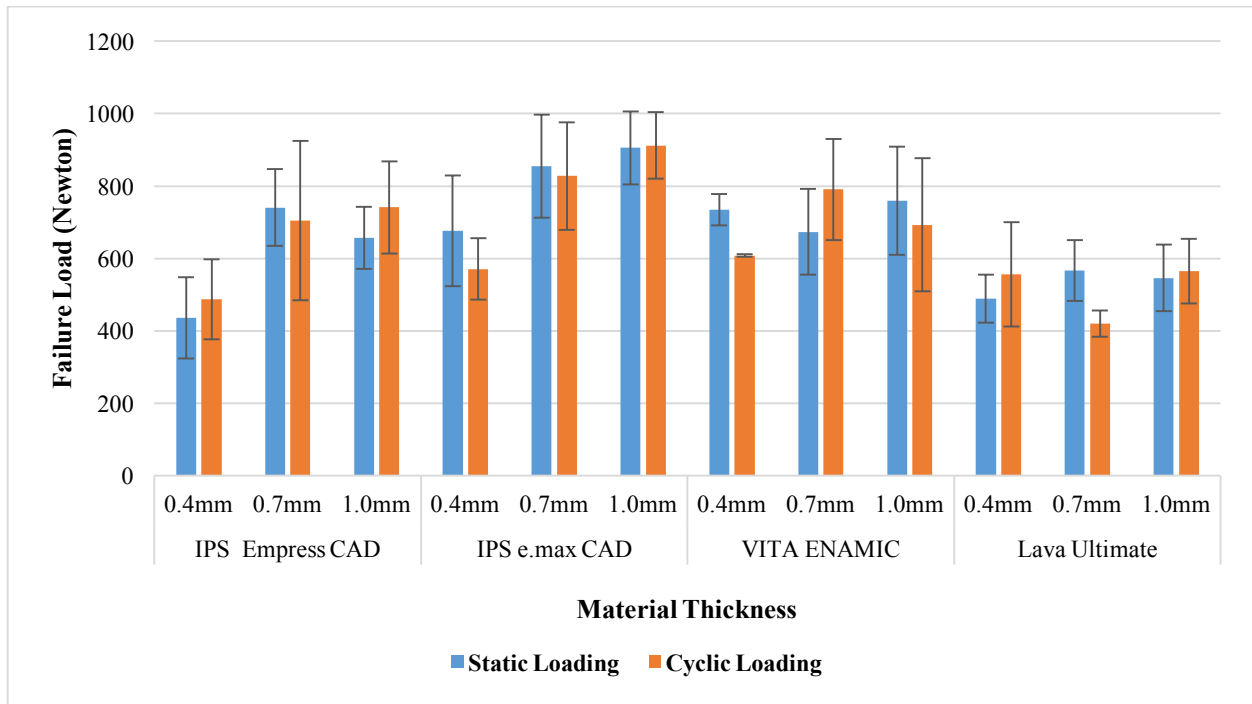
Comparison of all veneer materials of various thickness under static and cyclic loading was done with Tukey-Kramer HSD (Graph 12). Levels not connected by same letter are significantly different (Table 17).

**Graph 14: Mean values of different veneer materials of various thickness under static and cyclic loading**

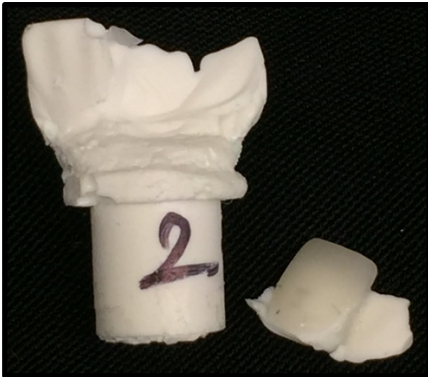
**Figure 32: Mode of failure of IPS e.max CAD at 0.4mm, 0.7mm and 1.0mm, Catastrophic failure**

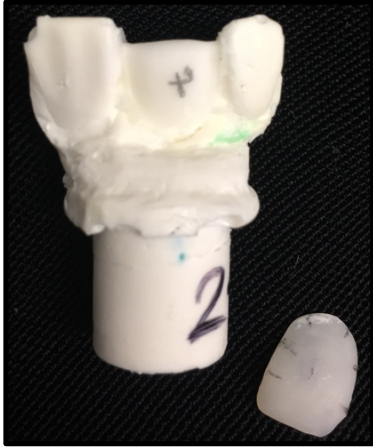
**Figure 36: Mode of failure of Lava Ultimate at 0.4mm, 0.7mm and 1.0mm, Adhesive failure**
