LA-5142

Oxidation Behavior of Transit Capsule T-47

ISSUED: April 1973

James R. Morgan and Stanley E. Bronisz

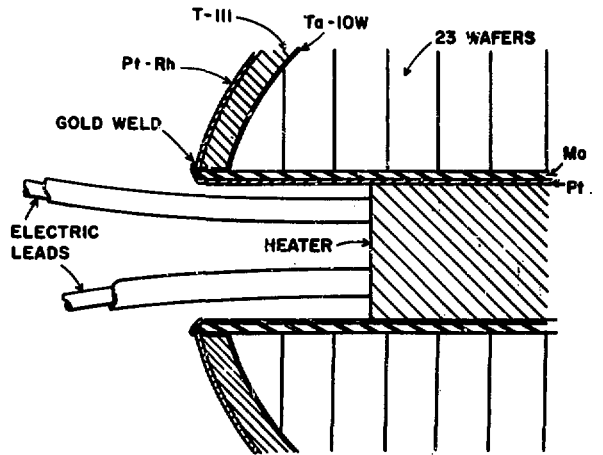
Fig. 3.

Platinum-iridium closure detail.

The integrity of the outer oxygen barrier was preserved by gold-welding a platinum thimble inside the molybdenum core drill, as shown in Fig. 3, after the capsule had been baked overnight in a vacuum furnace at about 175°C to remove all the chlorothene cutting fluid used in drilling.

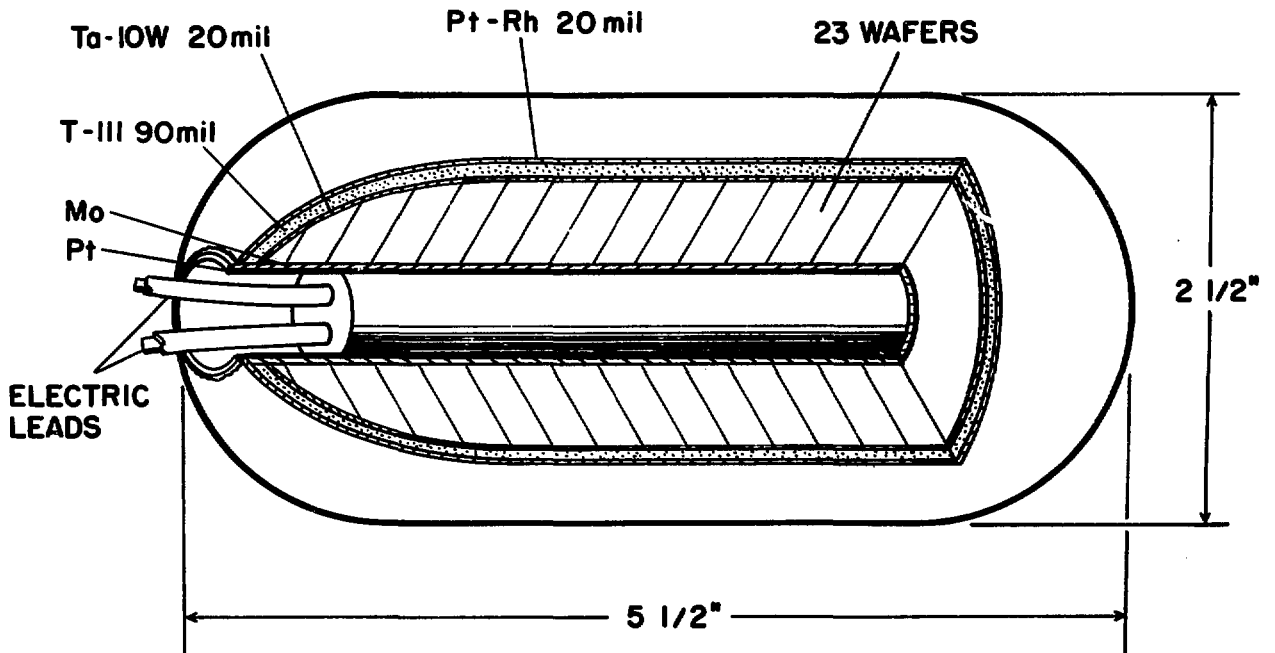
Fig. 2.

Heater installation detail.

The thermal power of a Transit heat source is 850 W. In the test, the fuel heat generation was simulated by an electrical heater inserted into the capsule. Figure 2 is a diagram of the capsule and heater. A diamond-tipped molybdenum core drill was driven along the principal longitudinal axis of the capsule to a depth of 4.65 in. to allow the 4-in. long electric heater to be centered in the final assembly. The core drill was made of molybdenum so that it could be left in the capsule without

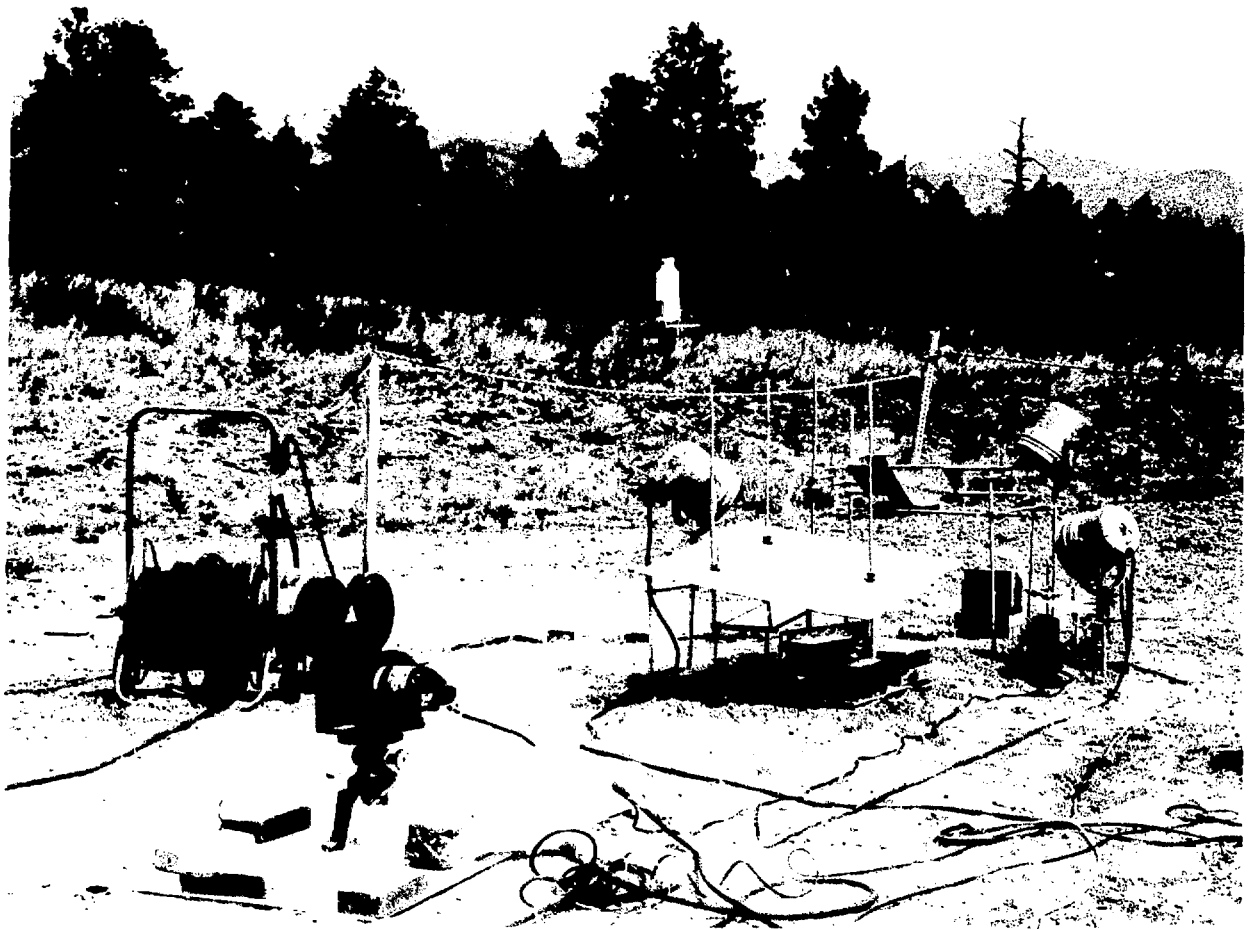
Fig. 4.
The capsule-oxidation experimental installation.

Time-lapse cinematography was used to document the progress of oxidation. Figure 4 is a general view of the experimental setup. Four front-silvered mirrors were arranged as shown in Fig. 5, so that the image on each frame of film exposed by the fixed main camera contained a plan view, an elevation view, and an end view of the capsule, as well as a view of the 24-h clock and day counter. Zero hour on the clock was 9:00 a.m. local time.

The three electric lamps shown in Fig. 4 were set about 4 ft from the capsule and gave a light intensity only about 1/2 to 1 f-stop lower than normal sunlight. This was a good level of illumination because it allowed day and night and the passage of clouds to be distinguished but avoided serious overexposure or underexposure. To minimize the possibility of the photo lamps' burning out during the night when the experiment was unattended, they were dimmed by a switching circuit that cut the power by one half except during a 2-sec pulse each time that the camera shutter operated.

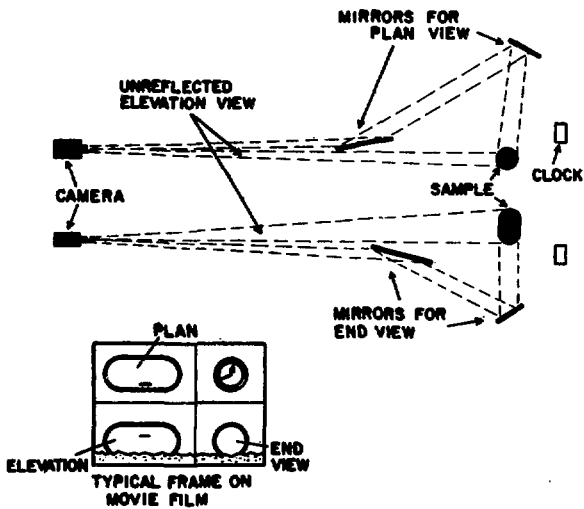
Fig. 5.

Mirror placement to provide three views of the capsule and a time record on each frame of film.

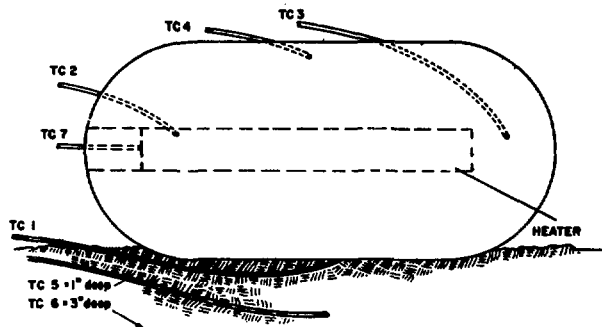
Thermocouple placement.

Four platinum-rhodium thermocouples were spot welded to the outer jacket of the capsule, two were positioned 1 and 3 in. deep in the soil beneath the capsule, and a seventh was spot welded to the edge of the heater sheath.

The thermocouple locations are shown in Fig. 6. The signals from the thermocouples were fed to a multipoint recorder.

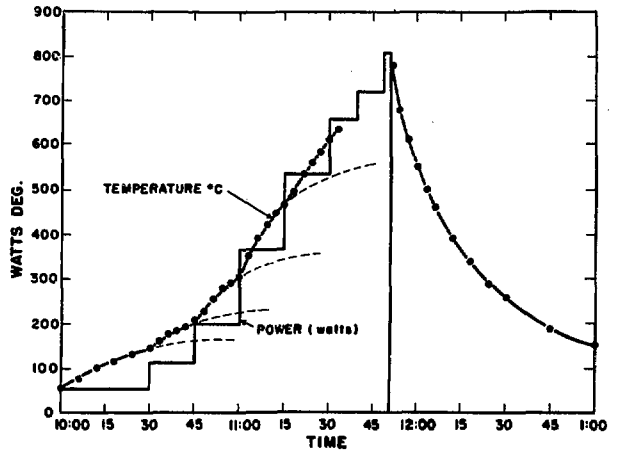
Fig. 8.
Temperature history of the capsule during the life of the first heater.

Power was applied to the heater at 10:00 a.m. May 11th, 1971, held at a low level for 0.5 h, and then increased comparatively rapidly, as shown in Fig. 8. However, the planned power level was not reached because the heater failed at 808 W. Before the failure, ac current evidently leaked from the heater to the thermocouples and caused the temperature recorder to show spuriously low values. The recorder worked properly as soon as the heater burned out completely and opened the heater circuit.

The capsule did not reach thermal equilibrium during this initial heating, but it was evident that the predicted equilibrium temperature extrapolated from Fig. 8 would be considerably higher than that calculated by TRW. Inquiry revealed that the TRW calculations were made for a capsule with an intact platinized-alumina emissivity coating. The fact that most of the black coating was missing from the capsule used in the experiment probably accounts for the observed temperatures' being significantly higher than the calculated values.

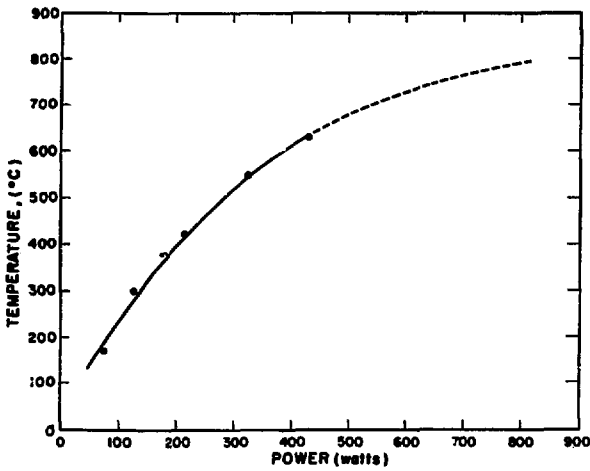
Fig. 9.
Power-as-surface temperature of the second heater.

The burned-out heater was replaced, and the test was resumed. This time, the power was increased much more slowly, and thermal equilibrium was nearly reached at each step. Figure 9 is a temperature-vs-power plot derived during this slow heating. The temperatures are nominal averages, because wind-velocity variations caused sizable fluctuations in the capsule surface temperature, especially at higher power levels. Power was held constant at 430 W

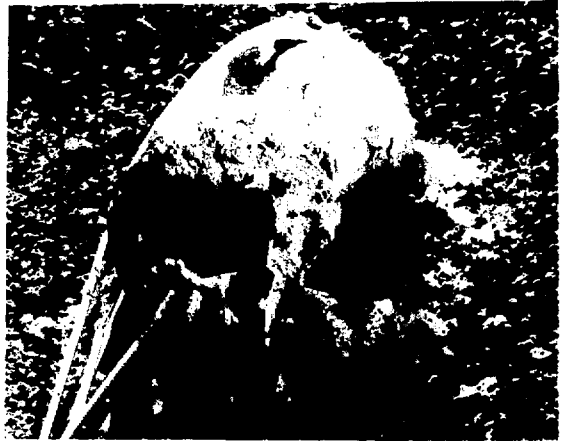
Fig. 14.

Capsule after failure of second beater.

The progress of the oxidation and its effects on the capsule are shown in Figs. 10 through 14. The first evidence of oxidation of the tantalum-alloy strength member was the development of a gold-colored temper oxide on this member beneath the crack in the cladding. This was observed approximately 2-1/2 h after the capsule reached 620°C. The crack was noticeably enlarged after 8 or 10 h at 620°C, and it grew progressively as the cladding was forced away from the strength member by the formation of oxide. The rate of tantalum oxidation as indicated by the cladding deformation appeared to increase as the rupture in the platinum-rhodium cladding grew.

The first visible fallout of tantalum oxide from the main rupture occurred after about 3.3 days at temperature. After about 4.5 days, a lump of tantalum oxide powder about 3/8 in. in diam fell from the capsule. This was taken to be the first effective uncovering of the thoria-molybdenum wafers. Visual inspection at about this time revealed the extensive network of acicular white crystals of MoO₃ shown in Fig. 15. It seems probable that the MoO₃ in this location was derived from the molybdenum in the fuel. After 114 h at 620°C, the second heater burned out and the test was terminated.

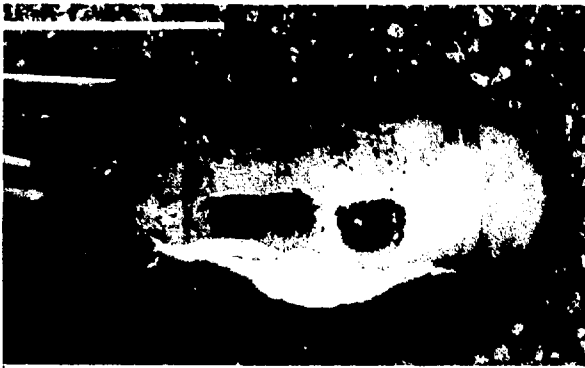
Fig. 12.

Capsule after 70 h, Monday, May 17, 1971, 9:00 a.m.

After 4 days, the crack had extended longitudinally to the junction of the cylindrical and hemispherical sections of the capsule and had branched to form two roughly circumferential cracks that tended to separate the hemispherical end sections from the cylindrical body. The circumferential crack at the end of the capsule where the cap had been welded to the jacket followed a path adjacent to the weld on the hemispherical cap.

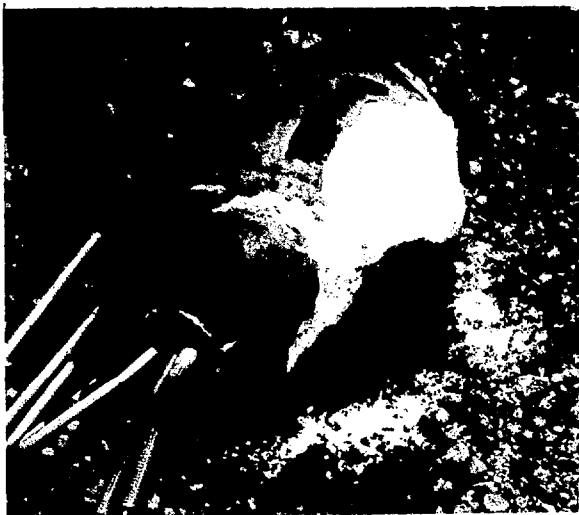
Fig. 13.

Capsule after 99 h, Tuesday, May 18, 1971, 2:00 p.m.

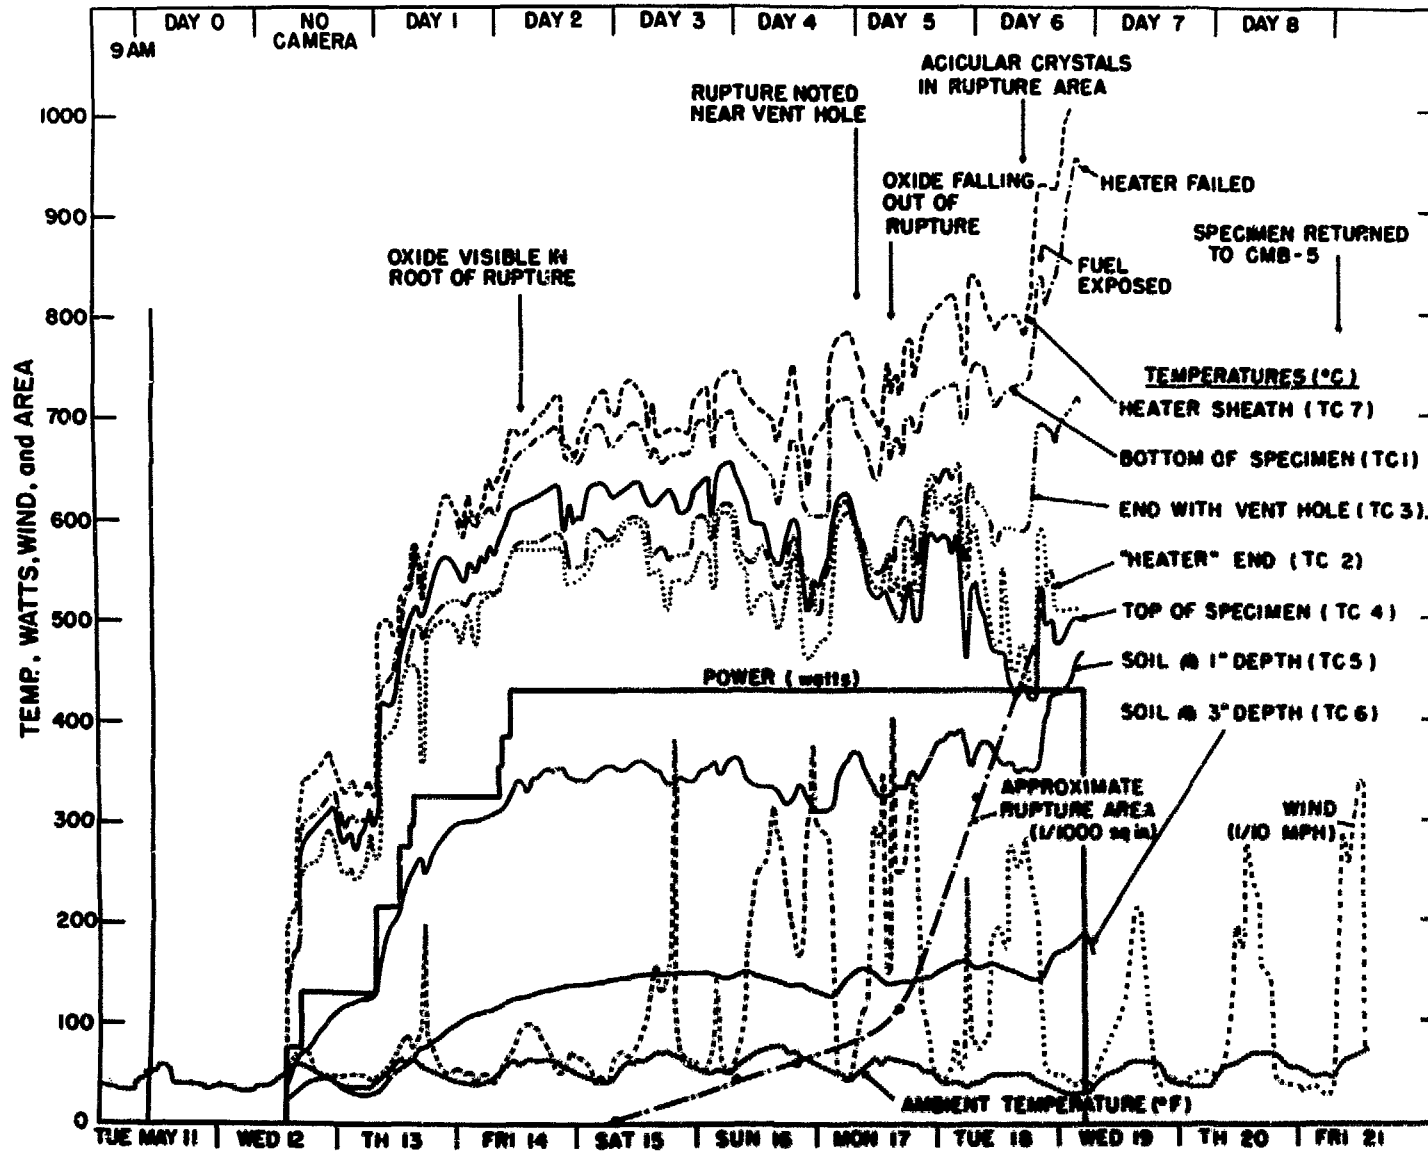
Fig. 16.

Power, temperature, wind-velocity, and rupture-area data throughout the oxidation experiment.

Figure 16 is a summary of the measurements made during the oxidation test. The wind velocity varied considerably, from about 3 to 40 mph, during the test, and the temperature at each of the seven thermocouple locations reflected the changes in velocity. The response was not immediate because of the capsule's heat capacity and the insulating effect of the ground, and equilibrium was not attained. However, the data plotted in Fig. 16 suggest that each mile per hour increase in wind velocity cools a

Transit capsule by about 3°C. Only a trace of precipitation occurred during the test, so no information about the effect of rain on the oxidation process was obtained.

The general trend of temperature with time shown in Fig. 16 is worth some comment. The thermocouples so located that they were not directly affected by the formation of oxide (TC's 1, 5, 6, and 7) showed a general overall increase in temperature, whereas those that were pushed outward and insulated by the formation of the oxide tended to reflect a decrease in temperature. This suggests that the overall effect of the oxidation is to add an insulating layer to the capsule, which increases the temperature at the oxidation interface beneath the layer and also, assuming the easy availability of oxygen, increases the oxidation rate.
