Effects of High Mean Stress on the High-Cycle Fatigue Behavior of PWA 1480*

March 1985

PWA 1480 is a potential candidate material for use in the high-pressure fuel turbine blade of the Space Shuttle Main Engine. As an engine material it will be subjected to high-cycle fatigue loading superimposed on a high mean stress due to combined centrifugal and thermal loadings. The present paper describes the results obtained in an ongoing program at Argonne National Laboratory, sponsored by NASA Lewis, to determine the effects of a high mean stress on the high-cycle fatigue behavior of this material.

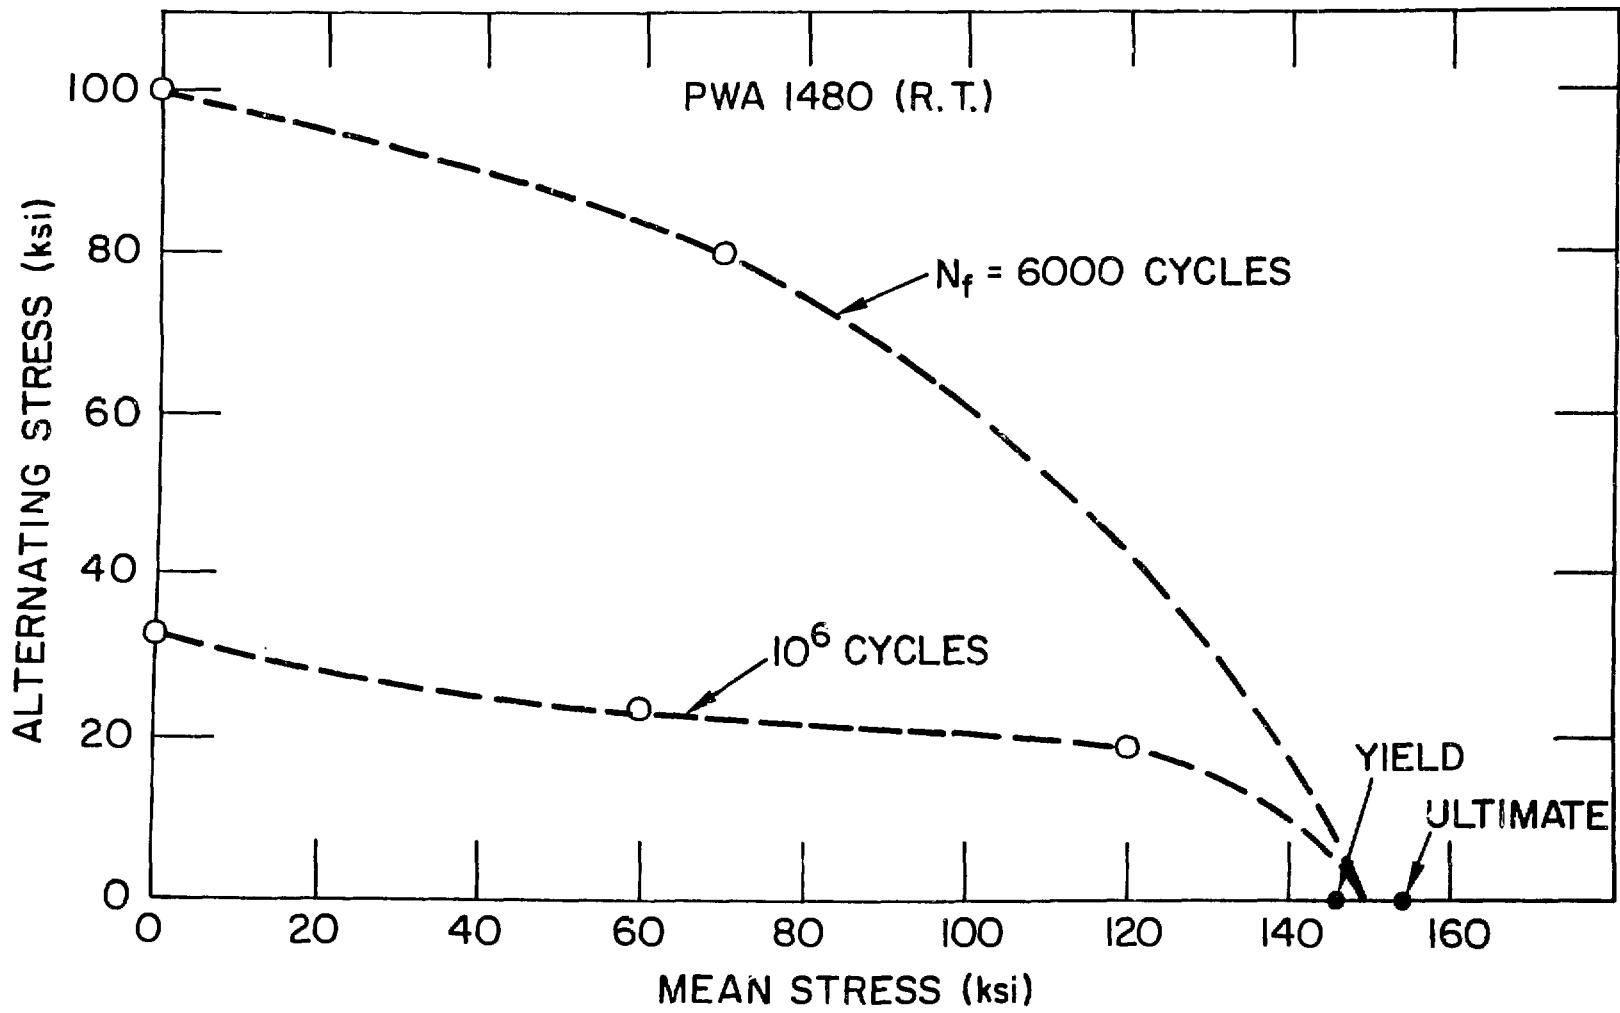
Fig. 3

3. Goodman diagram for PWA 1480 for lives of 6000 and 10^6 cycles at room temperature.
4. The optical micrograph at the top illustrates typical micropore density in specimen #15-3 (unetched). The scanning electron micrograph at the bottom shows a "stepped" fracture surface in specimen #112-3, which was cycled at a stress range of 38 ksi with a mean stress of 120 ksi at room temperature.

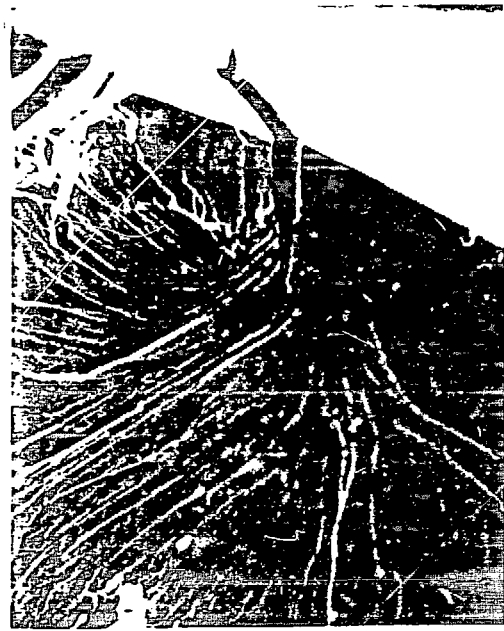
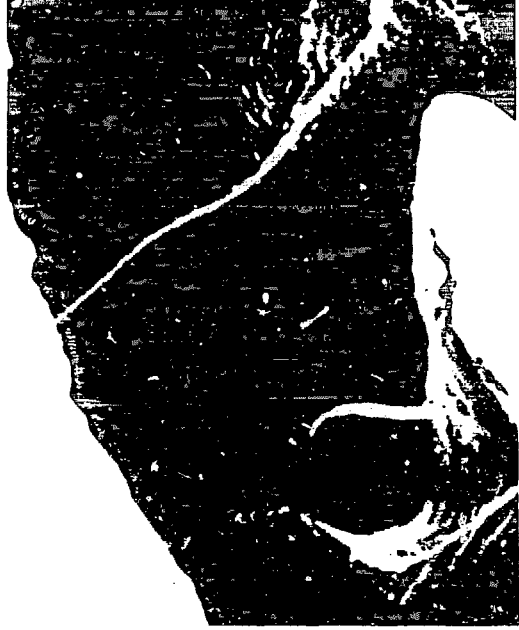
Fig. 5

5. Fracture morphology in specimen #15-3, which was cycled at a stress range of 120 ksi with zero mean stress at room temperature. The micropore initiated two cracks on different planes. One of these cracks led to failure of the specimen.

Several specimens were analyzed by scanning electron and optical microscopy after fracture. Each specimen contained a large number of micropores (figure 4, top) and crack initiation always occurred from one of these micropores. Figure 5 shows crack initiation from a micropore in a specimen (#15-3) that was cycled at a stress range of 120 ksi with zero mean stress. A similar mode of crack initiation was also observed in a specimen (#112-3) that was cycled at a stress range of 38 ksi with a mean stress of 120 ksi, as shown in figure 6. Crack propagation was crystallographic during most of the life; it apparently occurred along {111}-type planes. In both specimens #112-3 and #15-3, the crack that led to failure was initiated by a crack on a different slip plane (figures 4 and 5). Crack growth also appeared to preferentially follow microporosities

Several slight differences were observed between specimens with zero and high mean stress. The specimen with high mean stress (#112-3) appeared to have cracks initiated at several sites, whereas the zero-mean-stress specimen (#15-3, figure 5) had a single crack origin. The high-mean-stress specimen also had a rougher, more textured fracture surface, which may be indicative of a higher crack propagation rate. It also contained several "steps" on the fracture surface (figure 4, bottom). These steps were probably caused either by the linking of two parallel cracks on the same type of octahedral plane or by the intersection of cracks on non-parallel octahedral planes.

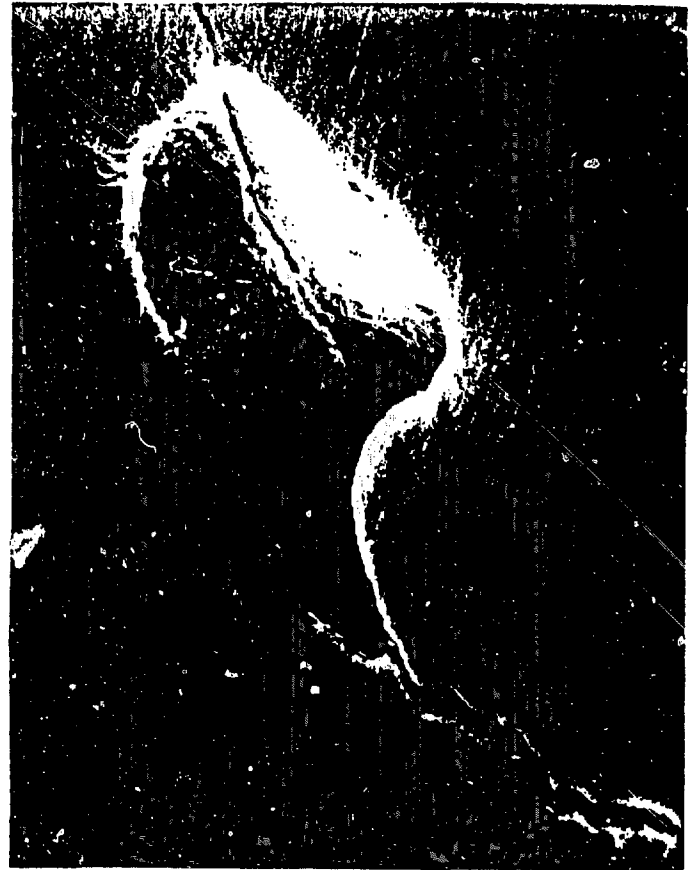
Fig. 6

6. Scanning electron micrographs showing a surface pore from which a crack was initiated under high-cycle fatigue loading with a stress range of 38 ksi and mean stress of 120 ksi at room temperature.

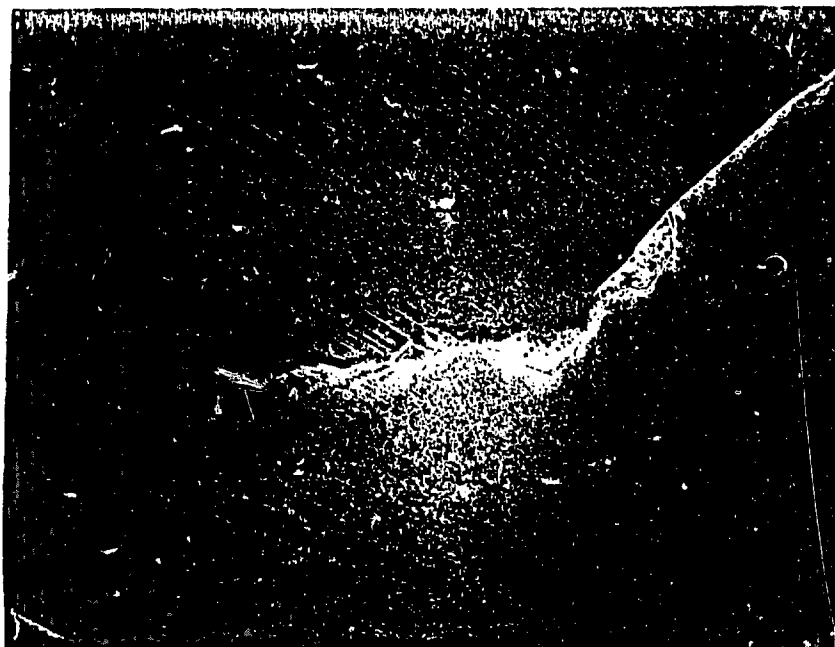
Fig. 7

7. Scanning electron micrographs showing crack propagation in PWA 1480 under 0-0.8% strain range testing at room temperature.

(figure 7). (The distinct slip band marks along $\{111\}$ -type planes in the figure are for a test with a rather large (0.8%) strain range. Such slip bands were not observed in the low-strain-range, high-cycle fatigue test specimens.)
