**WELD REPAIR OF HELIUM DEGRADED
REACTOR VESSEL MATERIAL (U)**

A paper proposed for presentation at the
*Fifth International Symposium on Environmental Degradation
of Materials in Nuclear Power Systems - Water Reactors*
Monterey, California
August 25-29, 1991

Welding methods for modification or repair of irradiated nuclear reactor vessels are being evaluated at the Savannah River Site. A low-penetration weld overlay technique has been developed to minimize the adverse effects of irradiation induced helium on the weldability of metals and alloys. This technique was successfully applied to Type 304 stainless steel test plates that contained 3 to 220 appm helium from tritium decay. Conventional welding practices caused significant cracking and degradation in the test plates.

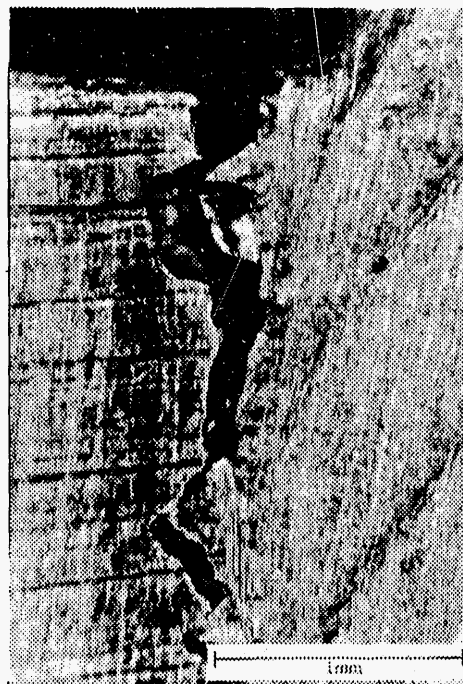
B. Surface photograph of run-on toe crack

Figure 2. Toe cracks at run-on end of stringer beads

Surface examination of the welded plates revealed no toe cracks or porosity associated with the overlay welds. However, welds made by the conventional GTA process had both toe cracks and extensive surface porosity. Toe cracks for the highest heat input stringer beads were typical of those seen during repair of the reactor tank. Numerous toe cracks were present at the run-on end of the GTA stringer beads. The crack location relative to the plate and the welding direction is shown schematically in Figure 2a. The surface appearance of a toe crack at a run-on location is shown in Figure 2b.

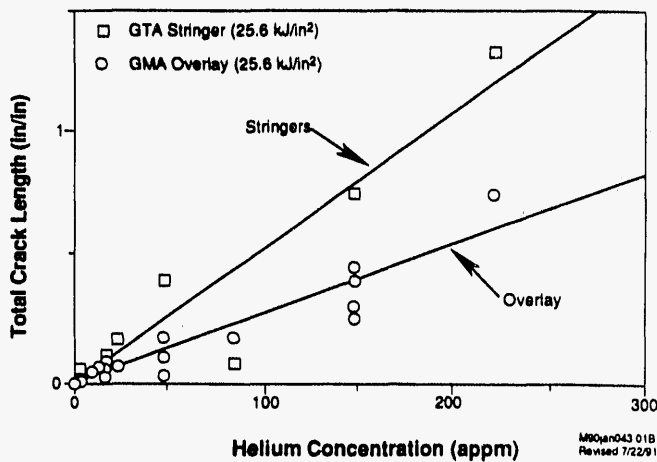
Figure 5. A comparison of underbead cracking for overlay welds and stringer beads made at approximately 25 kJ/in²

The extent of cracking increases with helium concentration as can be seen in both Figures 5 & 6. More important for choosing a weld repair procedure for irradiated material is the effect of the type of weld. The overlay technique reduces underbead cracking compared to GTA stringer beads at equivalent weld heat inputs of approximately 25 kJ/in² (Figure 5). This result, along with the elimination of toe cracks, is strong evidence for the promising use of the overlay technique for welding on helium-bearing material.

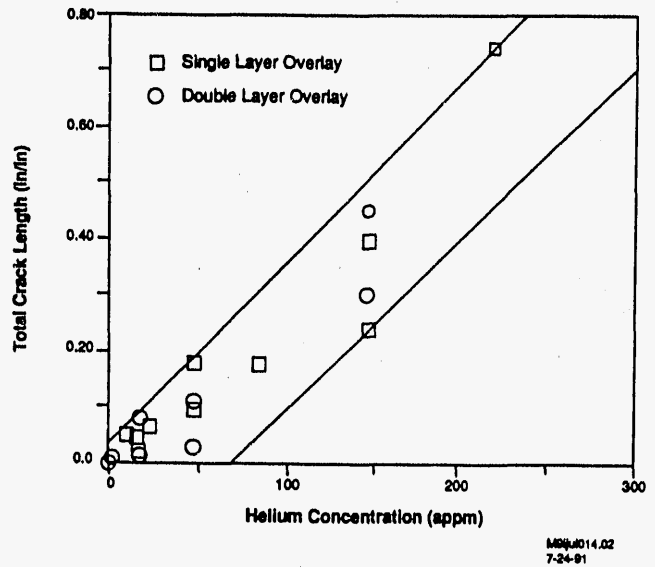
Figure 7. Negligible effect on underbead cracking of adding a second layer of overlay metal

An additional practical advantage of use of overlays is the ability to build up multiple layers should a thick overlay be needed. This study has shown that the effect on underbead cracking of adding a second layer is negligible. The data for single and double layer overlays can be seen in Figure 7 to be within the same scatter band.

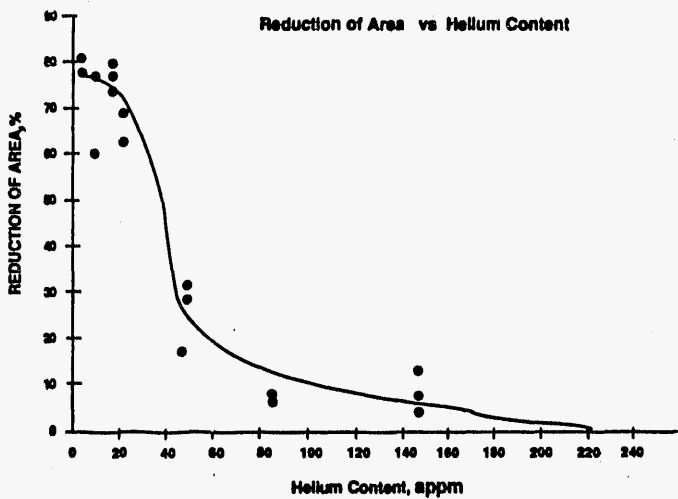
MB14014.04

Figure 9. Tensile test reduction of area results as a function of helium content

The change in mechanical properties due to helium embrittlement can best be seen from reduction of area (Figure 9). A pronounced drop at about 35 appm helium indicates a change from failure in the base metal to failure in the weld HAZ. In the uncharged specimen the reduction of area was 81.6%, which dropped to virtually zero at 220 appm helium. Similarly, elongation at fracture is only about 0.5%, compared to about 37% at 17 appm helium, or to 42% in an uncharged specimen. Ultimate tensile strength decreases slowly to half its initial value with increasing helium content.
