STRESS CORROSION OF ASTM GRADE-2 AND GRADE-12 TITANIUM

IN SIMULATED ROCK SALT BRINES AT 83°C*

H. Jain, T. M. Ahn and P. Soo
Department of Nuclear Energy
Brookhaven National Laboratory
Upton, New York 11973
USA

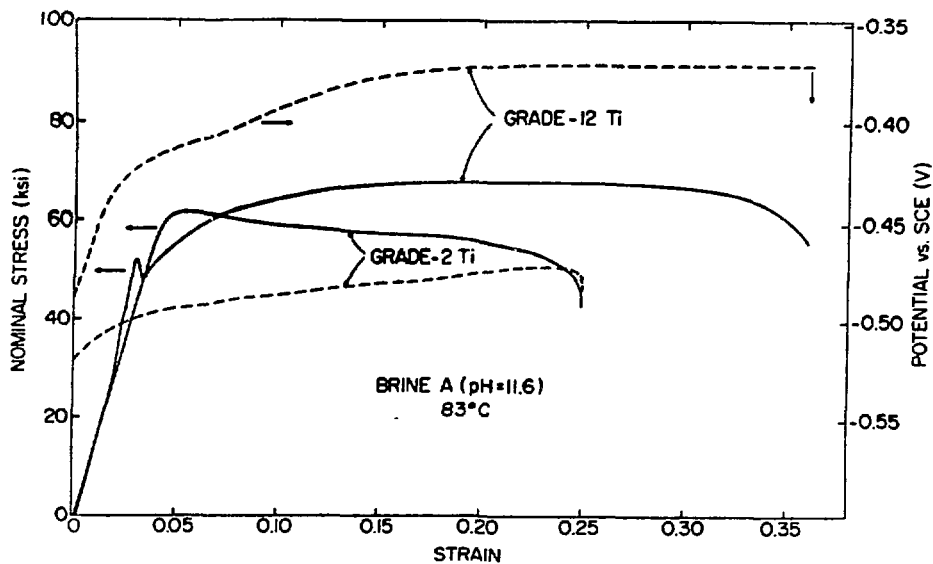
Figure 3 - Typical engineering stress vs strain curves for Grade-2 and Grade-12 titanium specimens (solid line). Variation of simultaneously measured potential of both the specimens is shown by the broken lines.

Typical stress-strain as well as corrosion potential versus nominal strain curves for Grade-12 and C.P. titanium are shown in Figure 3. Ultimate tensile strength and total elongation are determined from such curves for both alloys. The reduction in area is measured from SEM photographs of the fracture surface. The results obtained on cylindrical specimens are listed in Table III for different test environments. All the specimens were deformed at a nominal strain rate of 3.0×10^{-7} /sec, except for Tests 6 and 7 where a faster rate of 1.5×10^{-6} /sec was used. The results of tensile tests on sheet specimens in as-received and after hydrogenation are listed in Table IV. These tests were performed under ambient conditions and at nominal strain rates of 1.2×10^{-2} /sec or 2.5×10^{-5} /sec. The difference between the two sets of data of room temperature mechanical properties shown in Tables III and IV could be primarily due to the difference in strain rates, or size and texture of the grain structure.

Figure 3 and Table III describe some interesting differences between the two metals. Grade-12 titanium shows a well defined yield point indicative of strain aging effects. C.P. titanium starts necking at a very early stage, and does not show a sharp yield point which has been noticed earlier under different conditions of strain rate and temperature (10). The reduction in area for the two metals is comparable, but Grade-12 titanium has a much larger value for total elongation. This observation is consistent with the fact that compared to C.P. titanium, the neck in Grade-12 titanium is more shallow. Such differences in the behavior of the two metals can be explained by the presence of the alloying elements and small amounts of beta phase which cause much stronger strain hardening in the alloy. An order of magnitude smaller grain size in the Grade-12 titanium may also contribute to its strain hardening. Because of strong work hardening, the plastic strain in Grade-12 titanium tends to propagate into previously undeformed areas, thus producing many voids of small size (Figure 9) as well as forming a shallow neck. On the other hand, due to low strain hardening in C.P. titanium, a neck that is formed continues to shrink locally due to higher stress intensity. For C.P. titanium, the larger grain size offers fewer nucleation sites for the formation of voids, but once a void is formed it continues to grow easily in a transgranular fashion (Figure 8).
