THE EFFECT OF NEUTRON IRRADIATION ON THE TENSILE PROPERTIES  
AND MICROSTRUCTURE OF SEVERAL VANADIUM ALLOYS\*

D. N. Braski

Metals and Ceramics Division, Oak Ridge National Laboratory  
Oak Ridge, TN 37831

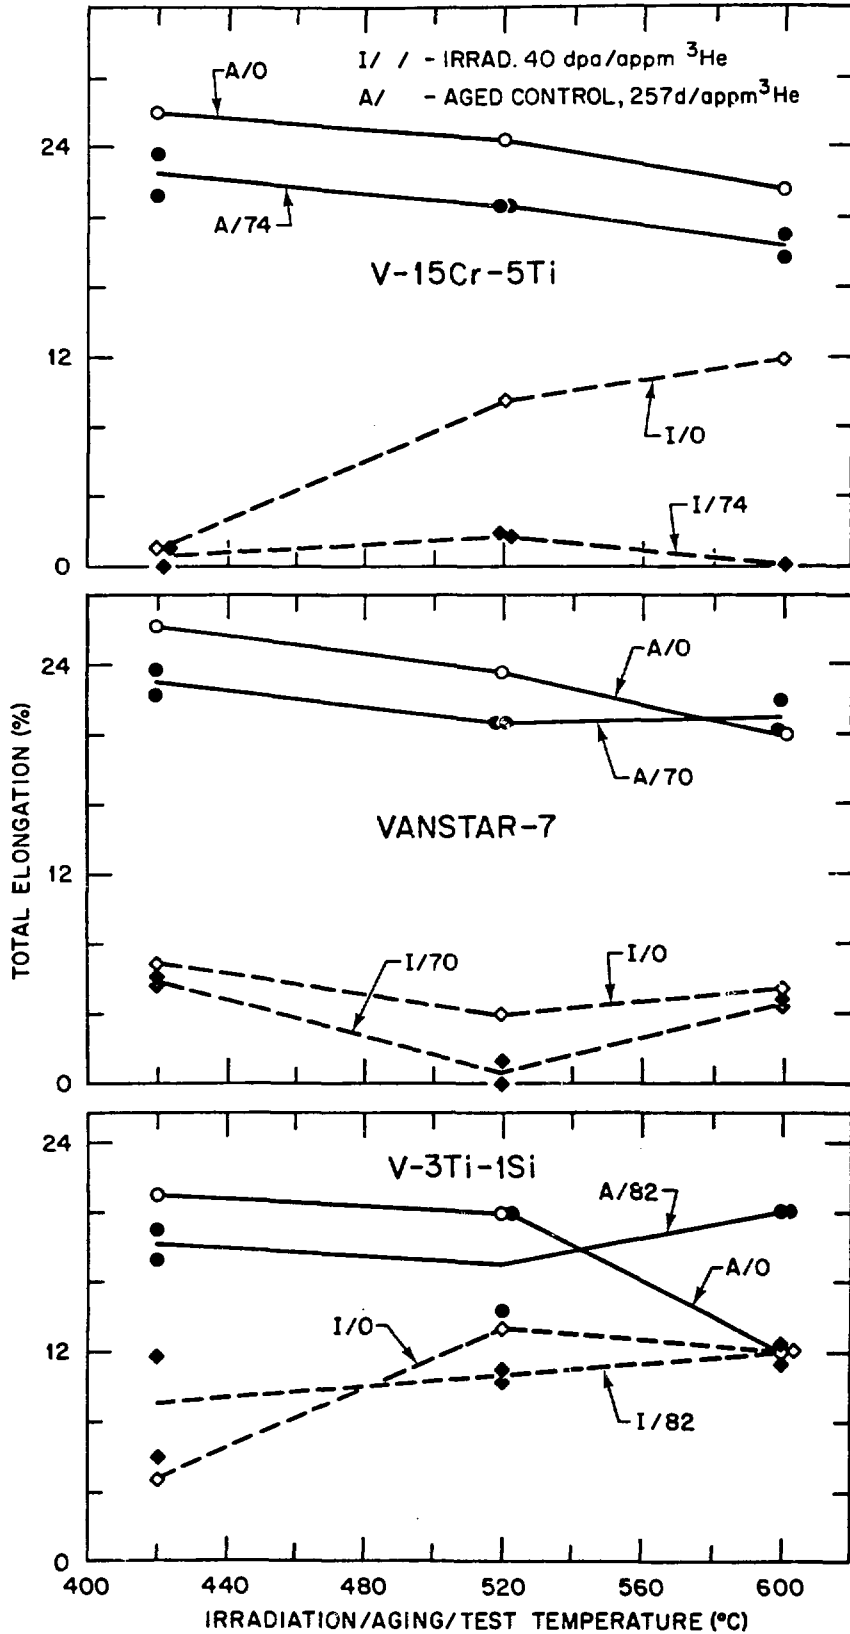
FIG. 5—Total elongation of vanadium alloy aged control specimens (A) and specimens irradiated in FFTF(MOTA) to 40 dpa (I) as a function of temperature.

Ductility - The effects of irradiation, irradiation temperature, and helium on the ductility of the three vanadium alloys are shown in Fig. 5, where total elongation is plotted as a function of temperature. Starting at the top of the figure with V-15Cr-5Ti, a small but consistent difference is seen between aged specimens containing helium and those without helium. The difference was probably caused by the slight hardening due to  $^3\text{He}$  implantation and the introduction of small  $^3\text{He}$  bubbles in the microstructure.

Irradiation to 40 dpa had a drastic effect on elongation at 420°C due to irradiation hardening that abated with increased irradiation temperatures. The V-15Cr-5Ti specimens were particularly sensitive to the presence of helium in the microstructure as relatively low elongations were measured in all of the irradiated specimens containing helium. Thermally aged VANSTAR-7 specimens also had slightly lower elongations at 420 and 520°C than those without helium, but this difference disappeared at 600°C. Irradiation hardening substantially lowered the ductility of VANSTAR-7 across the entire temperature range, but the effect of helium was less than observed for V-15Cr-5Ti. Finally, for V-3Ti-1Si, some large scatter in the results for the aged specimens with and without helium prohibits any conclusions to be made concerning helium and its effects on aged specimens. However, it is seen that both irradiation and helium had less effect on the ductility of V-3Ti-1Si specimens compared to those of the other alloys. Of the vanadium alloys tested, the V-3Ti-1Si alloy clearly had the best performance as far as postirradiation ductility is concerned.

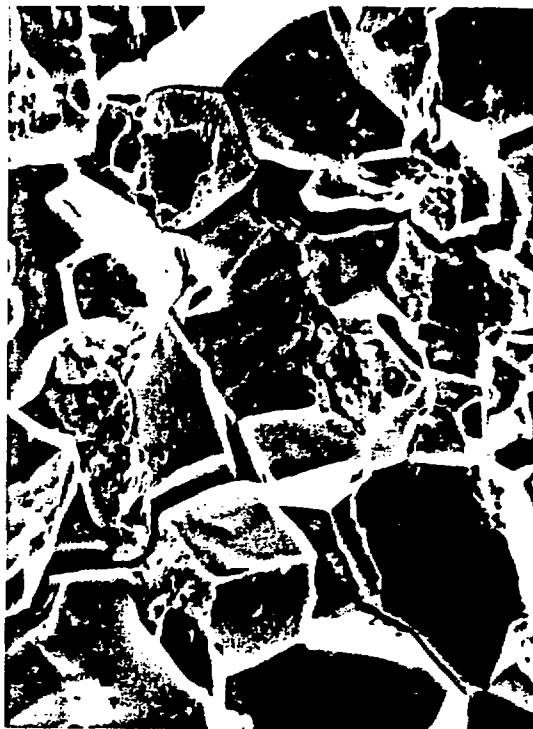
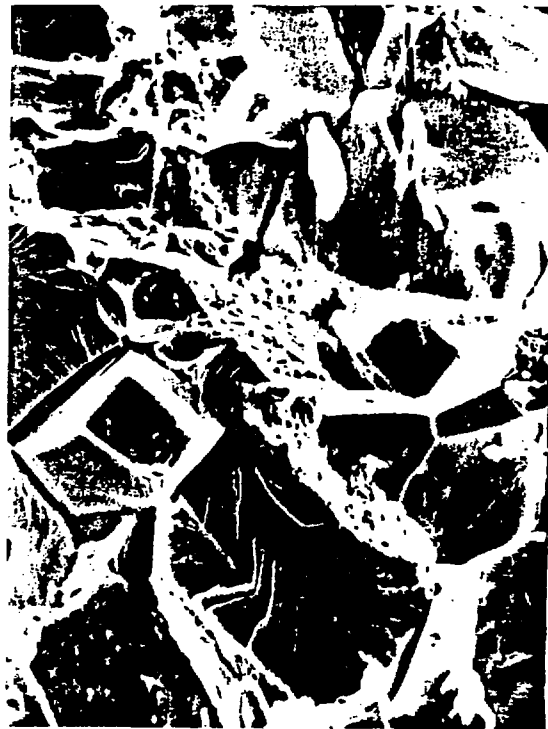
FIG. 6—Fractographs of V-15Cr-5Ti after irradiation in FFTF(MOTA) and tensile testing at the irradiation temperature (refer to Table 4).  
(a) No helium, irradiated at 420°C to 40 dpa, cleavage.  
(b) 300 appm He, irradiated at 420°C to 10 dpa, intergranular.  
(c) 74 appm He, irradiated at 420°C to 40 dpa, cleavage to intergranular,  
(d) 74 appm He, irradiated at 520°C to 40 dpa, intergranular plus cleavage

V-15Cr-5Ti -- Referring to Table 4, it is seen that V-15Cr-5Ti specimens, without helium and irradiated at 420°C, failed by a cleavage-type of fracture [Fig. 6(a)]. This suggests that irradiation hardening has elevated the yield strength of the material above the fracture (cleavage) stress, causing the material to fail transgranularly along cleavage planes. The "river" patterns on the cleavage faces [Fig. 6(a)] distinguish this type of fracture from intergranular, in which such patterns are missing from the exposed grain boundary surfaces [see Fig. 6(b)]. With 300 appm He, V-15Cr-5Ti specimens failed intergranularly after irradiation to 10 dpa at 420°C [Fig. 6(b)]. As will be shown later in TEM micrographs, helium bubbles formed in the grain boundaries and weakened them, thus causing intergranular failure (helium embrittlement) upon testing in tension. With less implanted helium and higher damage level (see 74 appm He in Table 4), the mechanisms of irradiation hardening and helium embrittlement overlap, producing a fracture surface characteristic of both (i.e., cleavage and intergranular separation), as shown in Fig. 6(c). For the V-15Cr-5Ti specimen conditions represented in this figure, the fraction of cleavage-type fracture outweighs that due to intergranular separation. At 520°C, 40 dpa, and 74 appm He, the situation was reversed (refer to Table 4) and the fracture mode was mostly intergranular with a small amount of cleavage as shown in Fig. 6(d). Three different fracture modes appeared after testing the specimen with 14 appm He, irradiated to 17 dpa at 520°C (see Table 4). Specimens of V-15Cr-5Ti without helium that were irradiated and tested at 520 and 600°C failed in a ductile manner and exhibited the familiar cone-like structure shown in Fig. 7(a).

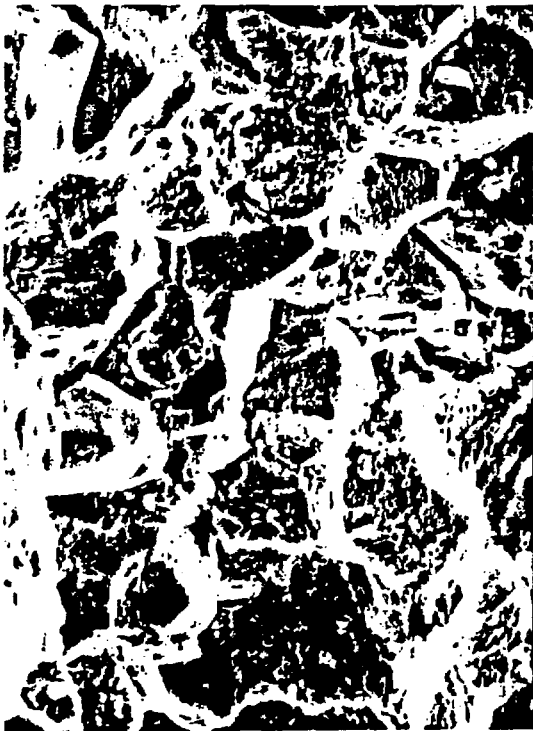
FIG. 7—Fractographs of vanadium alloys after irradiation in FFTF(MOTA) and tensile testing at the irradiation temperature (refer to Table 4).  
(a) V-15Cr-5Ti, no helium, irradiated at 600°C to 40 dpa, ductile.  
(b) VANSTAR-7, no helium, irradiated at 520°C to 40 dpa, ductile plus cleavage.  
(c) VANSTAR-7, 70 appm He, irradiated at 520°C to 40 dpa, intergranular,  
(d) V-3Ti-1Si, no helium, irradiated at 420°C to 40 dpa, ductile.

VANSTAR-7 — All of the VANSTAR-7 specimens irradiated and tested at 420 and 600°C displayed ductile-type fracture surfaces similar to those shown in Fig. 7(a). At 520°C, irradiation to 40 dpa produced enough hardening in a specimen without helium to cause some cleavage fracture areas on a generally ductile surface [Fig. 7(b)]. Under these same conditions, a specimen with 70 appm He failed intergranularly as shown in Fig. 7(c), accounting for the low ductilities shown in Figs. 3 and 5. Intergranular fracture surfaces and some cleavage fracture were found at 17 dpa with 150 appm He.

V-3Ti-1Si — The relatively high ductility of this alloy demonstrated in the postirradiation tensile tests is also reflected in the results of the SEM examinations (Table 4). All of the irradiated V-3Ti-1Si specimens, with and without implanted helium, failed in a ductile manner. As an example, the ductile-type fracture surface of a specimen irradiated at 420°C without helium is shown in Fig. 7(d).
