LA--10034-SR

**General-Purpose Heat Source Development:  
Safety Test Program**  
**Postimpact Evaluation, Design Iteration Test 3**

# GENERAL-PURPOSE HEAT SOURCE DEVELOPMENT: SAFETY TEST PROGRAM

## Postimpact Evaluation, Design Iteration Test 3

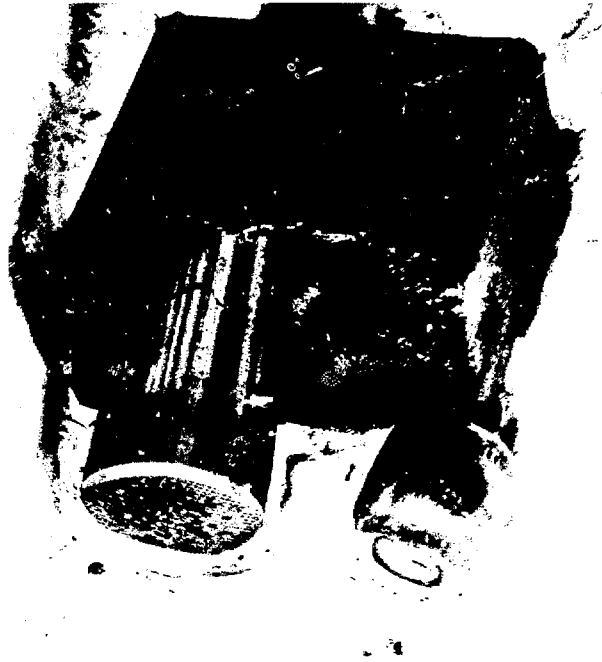
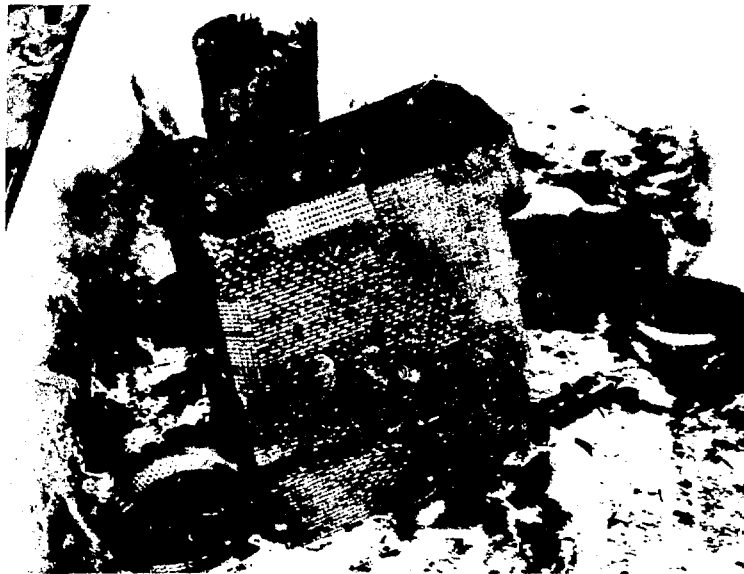
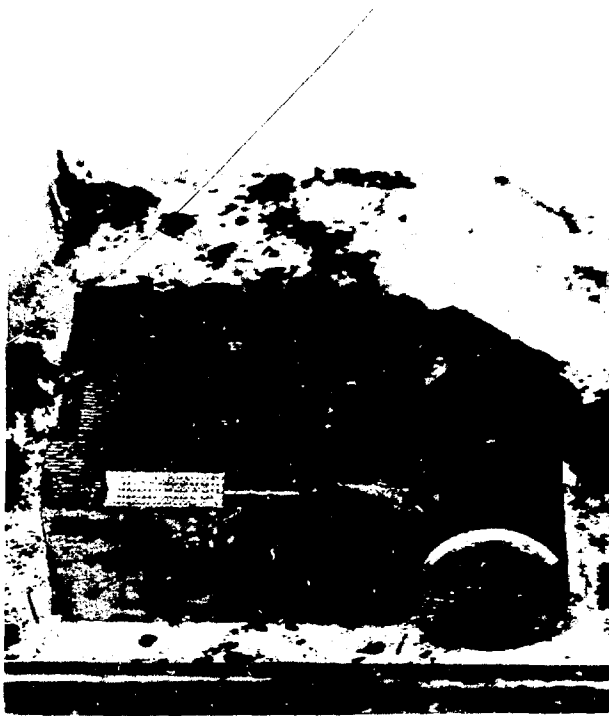
Fig. 5a.

**Fig. 5.** The re-entry shell used in the DIT-3 impact. (a) As extracted from the catch tube; (b) impact face of the module with the right vertical edge being the leading edge; and (c) impact face of the aeroshell, with the near upper edge as the trailing edge. All at 0.5X.

Previous experience with the DIT-1 and DIT-2 tests expedited postimpact disassembly. The catch tube was opened without difficulty, and only low levels (<2000 counts/min/cm<sup>2</sup>) of <sup>238</sup>PuO<sub>2</sub> contamination were encountered. The inner nickel can (a radiation shield assembly) was extracted with tongs, and the can/aeroshell/heat source assembly was placed on a bed of solid CO<sub>2</sub>. The CO<sub>2</sub> cooled the assembly rapidly, and in a few seconds the temperature had dropped enough to eliminate the possibility of graphite combustion. The aeroshell was severely fractured. Postimpact photographs of the test module (Fig. 5) illustrate the extensive mechanical damage. Damage to the two GISs (Figs. 6 and 7) was significant but not unusual.

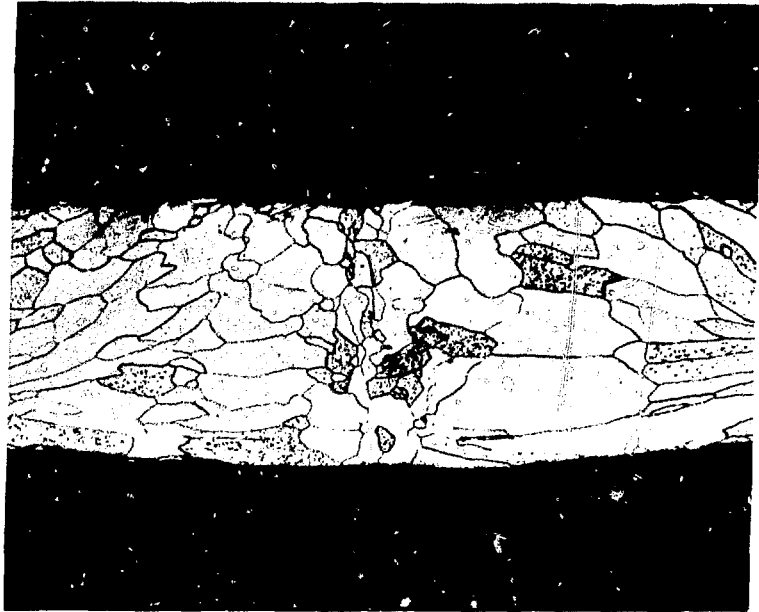
submergence. The microstructures of the single-pass and face-on specimens (Figs. 12 and 13) were typical, with no observed defects.

**Fig. 12.** Microstructure of the single-pass weld section taken from SRP-127, 50X.

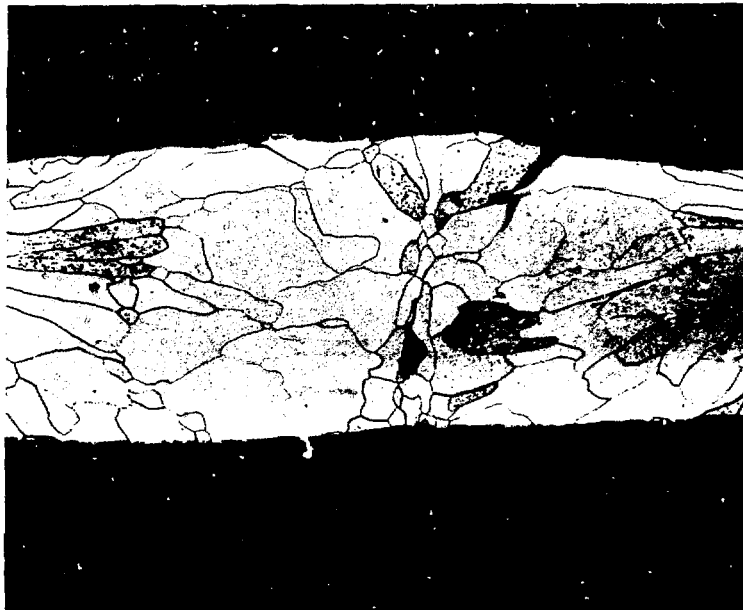
3. **SRP-251.** The overlap weld section containing the point of weld submergence is shown in Fig. 9c. SRP/NDT indicated that this capsule contained a magnitude 8.0 defect. Although macroscopic examination did not reveal any large weld defects, metallographic examination of the overlap weld revealed the crack seen in Fig. 17a. This crack traversed more than 30% of the wall thickness. The overlap microstructure was typical and otherwise free of defects (Fig. 17b). The single-pass and face-on specimens were also typical and contained no observable defects (Figs. 18 and 19).

**Fig. 17.** A crack in the overlap weld on capsule SRP-251 penetrated over 30% of the wall thickness. (a) As polished and (b) as etched. Both at 50X.

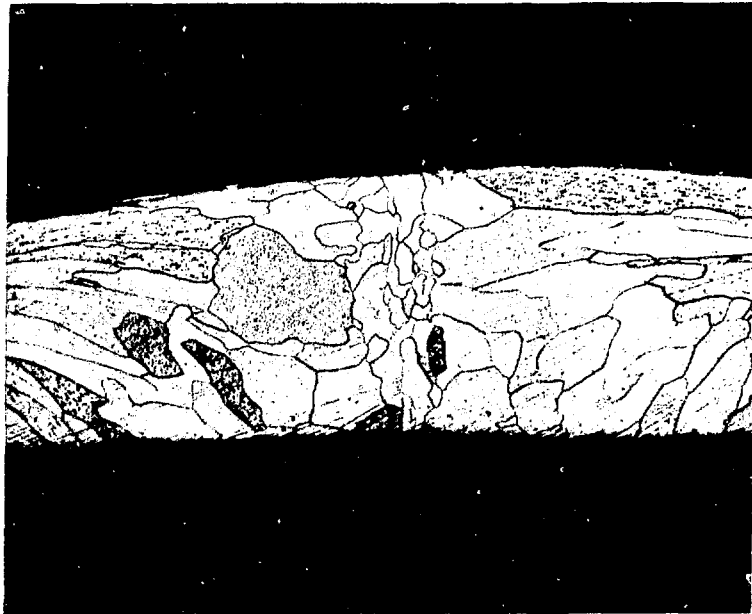
**Fig. 18.** The single-pass weld specimen removed from capsule SRP-251 had a typical microstructure, 50X.

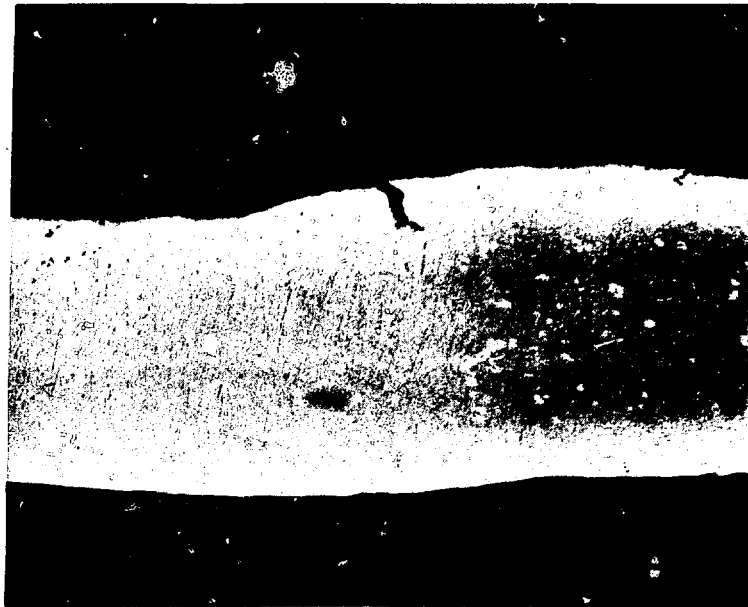
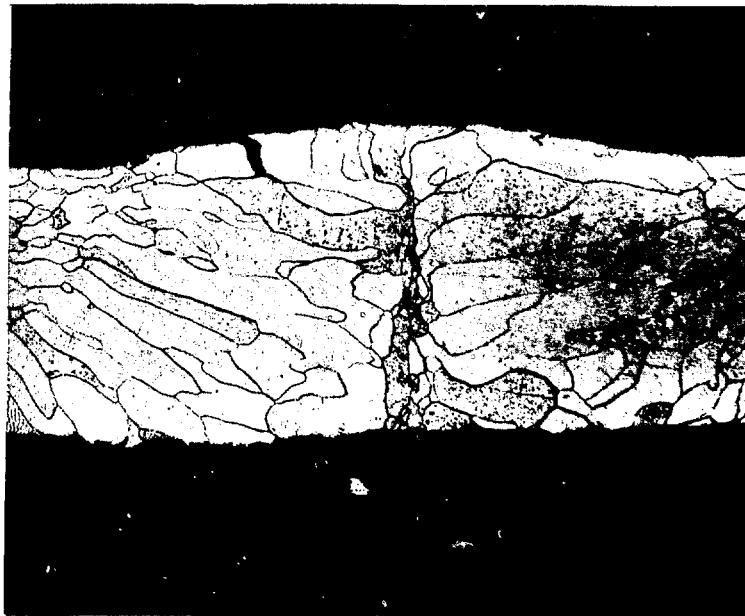
4. **SRP-317.** A large crack was observed in the overlap weld on capsule SRP-317 (Fig. 9d). SRP/NDT indicated that this capsule contained a magnitude 10.4 defect. Metallographic examination of the overlap section revealed that the crack penetrated over 15% of the wall thickness (Fig. 20a). The overlap weld microstructure was otherwise normal and free of defects (Fig. 20b). The single-pass and face-on microstructures were typical (Figs. 21 and 22).

**Fig. 20.** A crack in the overlap weld of capsule SRP-317 penetrated over 15% of the wall thickness. (a) As polished and (b) as etched. Both at 50X.

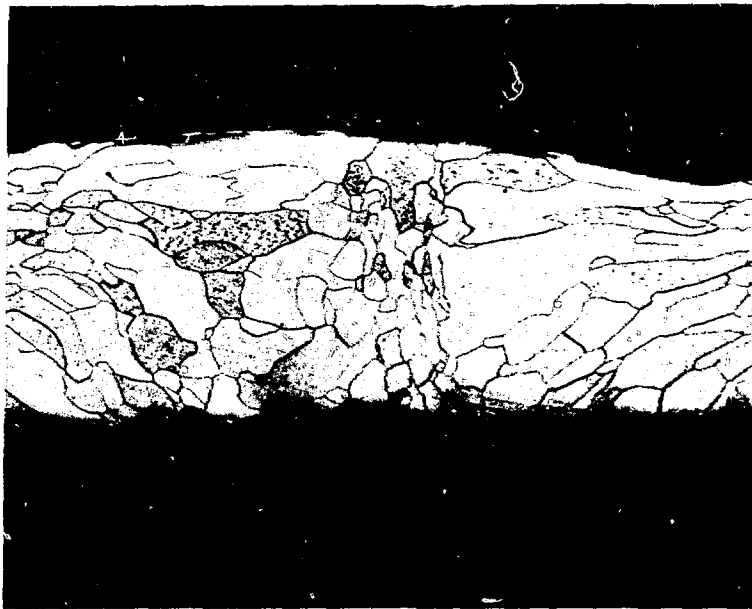
**Fig. 21.** The single-pass weld section taken from SRP-317 had a typical microstructure, 50X.

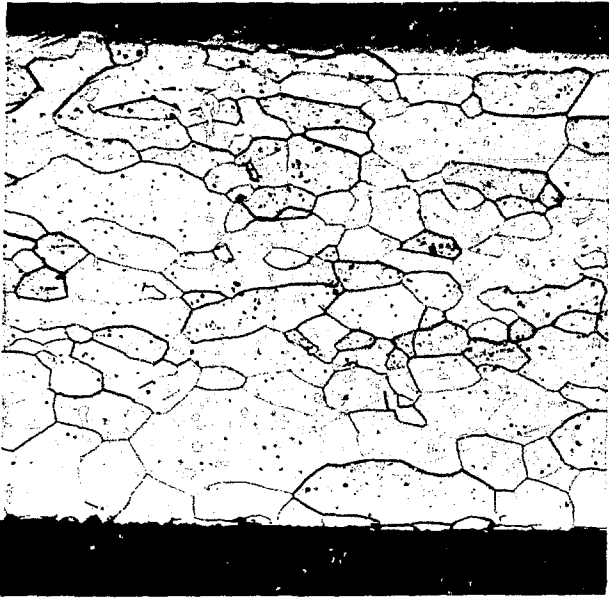
**Fig. 31.** Microstructure of a specimen removed from the vent cup of capsule SRP-251, 100X.

Each of the eight iridium-alloy cups composing the DIT-3 capsules (SRP-127, SRP-140, SRP-251, and SRP-317) was sampled to provide a specimen for metallographic examination. Before testing, the capsules were given a heat treatment (30 days at 1312°C) to simulate the minimum expected service life. Because the heat sources were not exposed to temperatures in excess of the preimpact heat treatment, the postimpact grain size and microstructure were expected to be nearly identical to the preimpact condition (except in severely deformed areas). Microscopic examination revealed that the cup grain sizes ranged from 14 to 21 grains/0.025 in. wall thickness (Table VI). The cup microstructures may be seen in Figs. 27 through 34. The wall section removed from the SRP-127 vent cup contained several excessively large grains (Fig. 35); the orientation and appearance of the grains suggest that recrystallization has occurred. The postimpact hardnesses of the iridium-alloy cups are presented in Table VII. Except for the atypical area observed in the SRP-127 vent cup (no similar areas were observed in any other cup), the cup microstructures were normal.

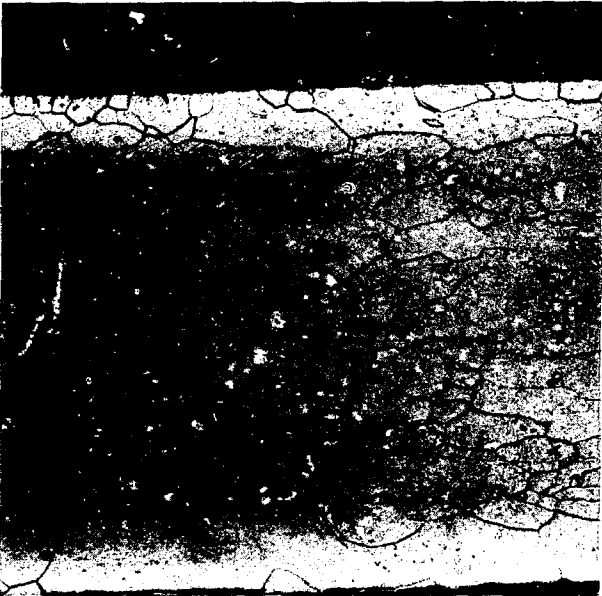
**Fig. 33.** Microstructure of a specimen removed from the vent cup of capsule SRP-317, 100X.

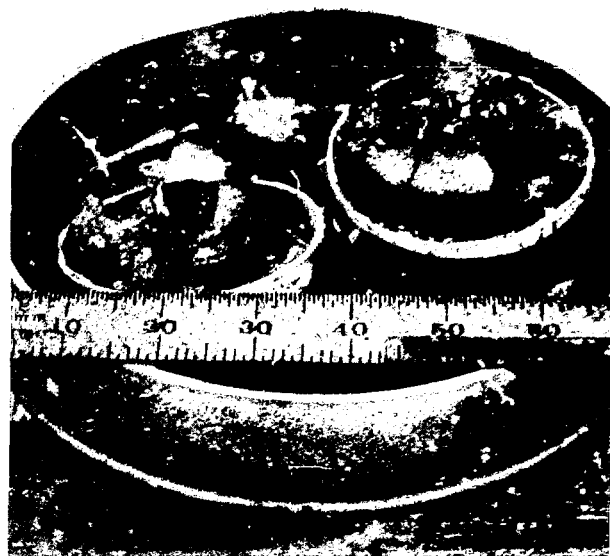
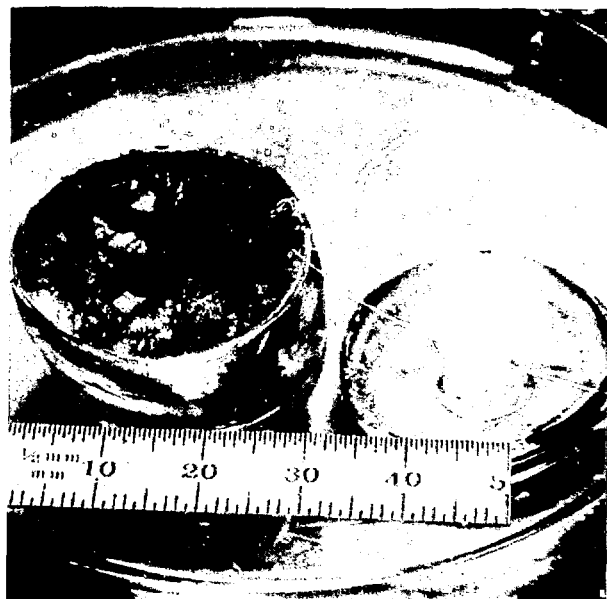
Fig. 36. Macrographs of opened DIT-3 capsules, illustrating the patterns of fuel breakup. (a) SRP-127, (b) SRP-140, (c) SRP-251, and (d) SRP-317. All at 1.4X.

Figs. 3 and 4. Postimpact examination revealed that each fuel pellet responded to the impact stresses by fracturing in a completely brittle mode, and that all of the fuel pellets fractured in a similar manner. The general patterns of fuel breakup may be seen in Fig. 36. Although pellet 251 exhibited a well-defined cleavage surface (Fig. 36c) that matched a point of high local shear strain in the iridium clad, the fuel pellets usually fractured in a random manner.

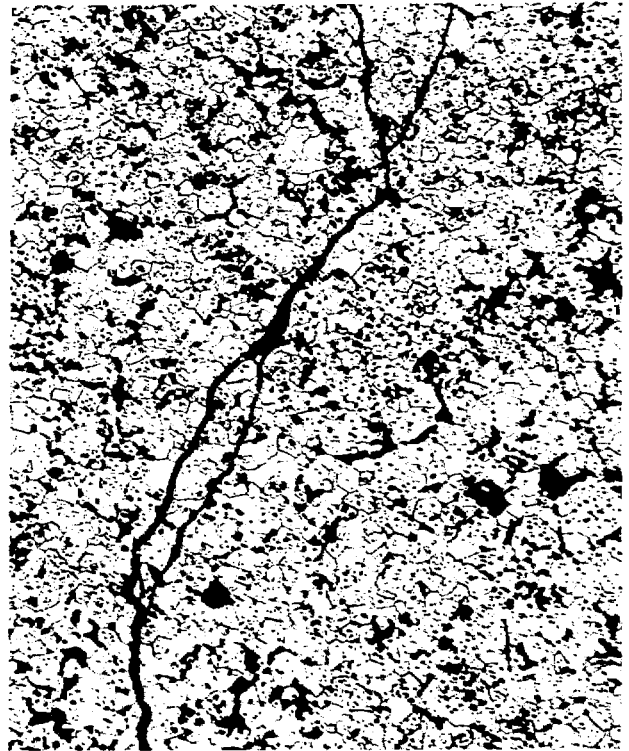
Fig. 44. Ceramographic specimen obtained from the external portion of SRP-317. (a) Macrograph, as polished, 10X; (b) micrograph, as polished, 100X; and (c) as etched, 100X.

Ceramographic specimens were obtained from the center and outer edge of each fuel pellet. The pellet microstructures are shown in Figs. 37 through 44. The photomicrographs reveal slight microstructural variations between pellets and from point to point within a given pellet. Because the mechanical responses of all four pellets were essentially the same, the slight microstructural differences apparently did not affect overall pellet performance.
