NUREG/CR-3841  
PNL-4712

# Steam Generator Group Project

## Task 6 - Channel Head Decontamination

**Pacific Northwest Laboratory**  
Operated by  
Battelle Memorial Institute

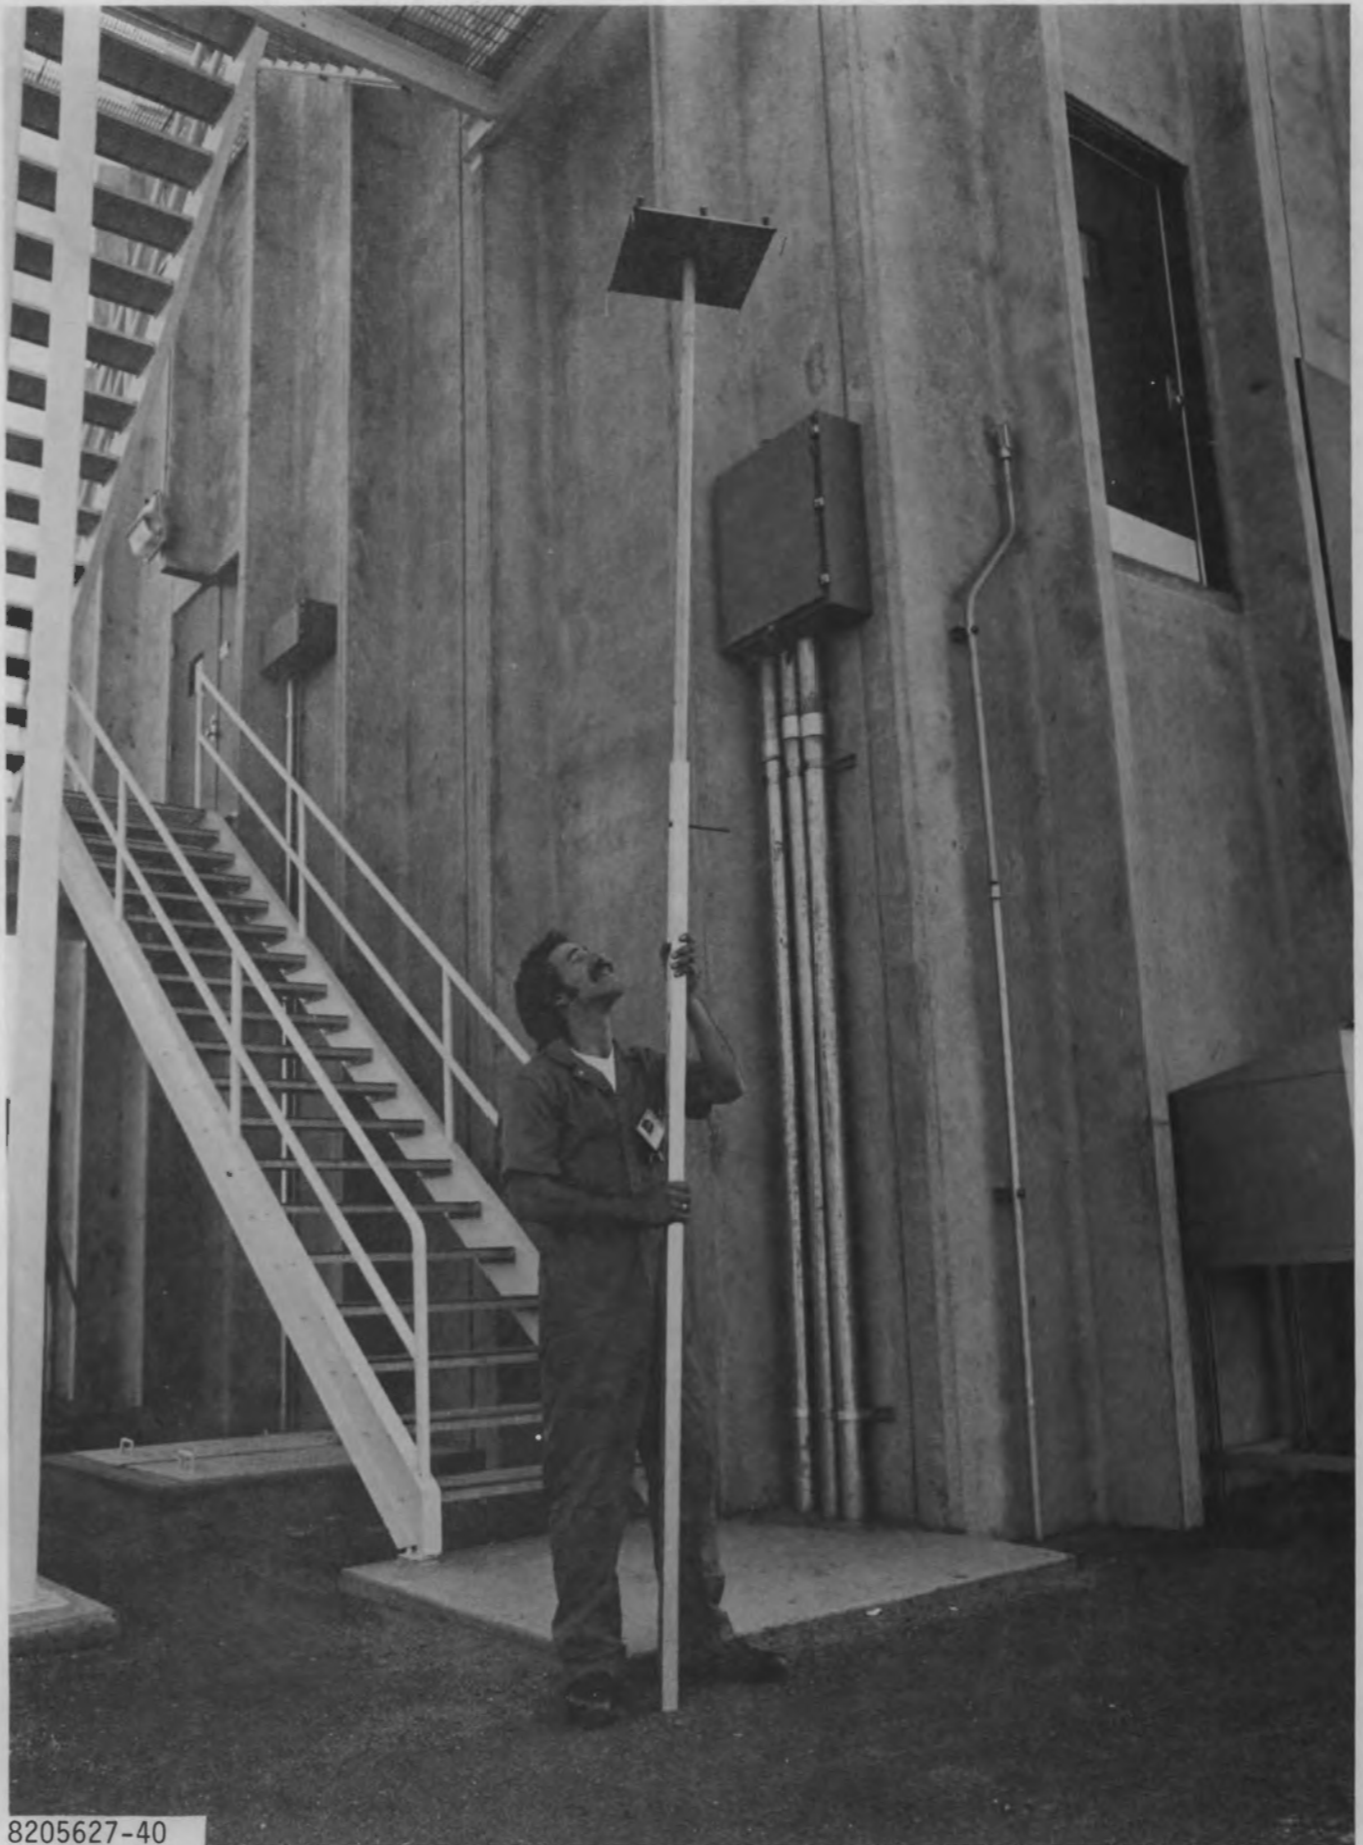
8205627-40

FIGURE 2-4. Special Fixturing Developed to Remotely Install the Protective Plate

In order to preserve a section of the contaminated tube sheet bottom surface on each side for future studies, a special protective plate covering an approximate 30 cm x 30 cm area was developed and installed prior to each of the decontamination operations. The plate (Figure 2-3) was stainless steel with 6-in. lead anchor fasteners designed to lock into selected tubes around its perimeter. A silicone rubber sealing compound was applied around the edge just before installation as an added protection against intrusion of the decontamination solutions. Radiation exposure during installation of the protective plate was minimized by developing the special fixturing illustrated in Figure 2-4. Installation of the plate was accomplished in less than 20 minutes working from outside the channel head through the manway.

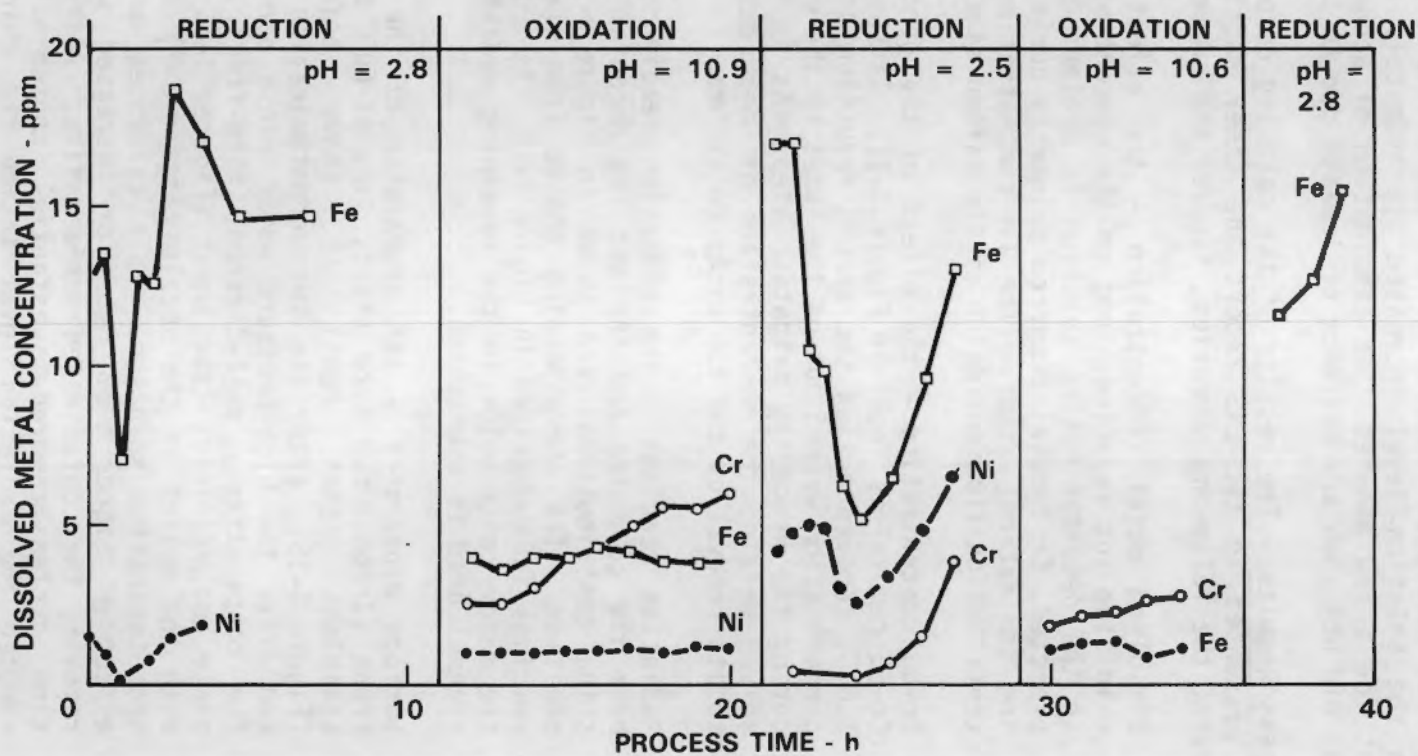
FIGURE 3-11.

## COLD LEG DECONTAMINATION - EFFECT OF PROCESS STEPS ON DISSOLVED METAL CONCENTRATION

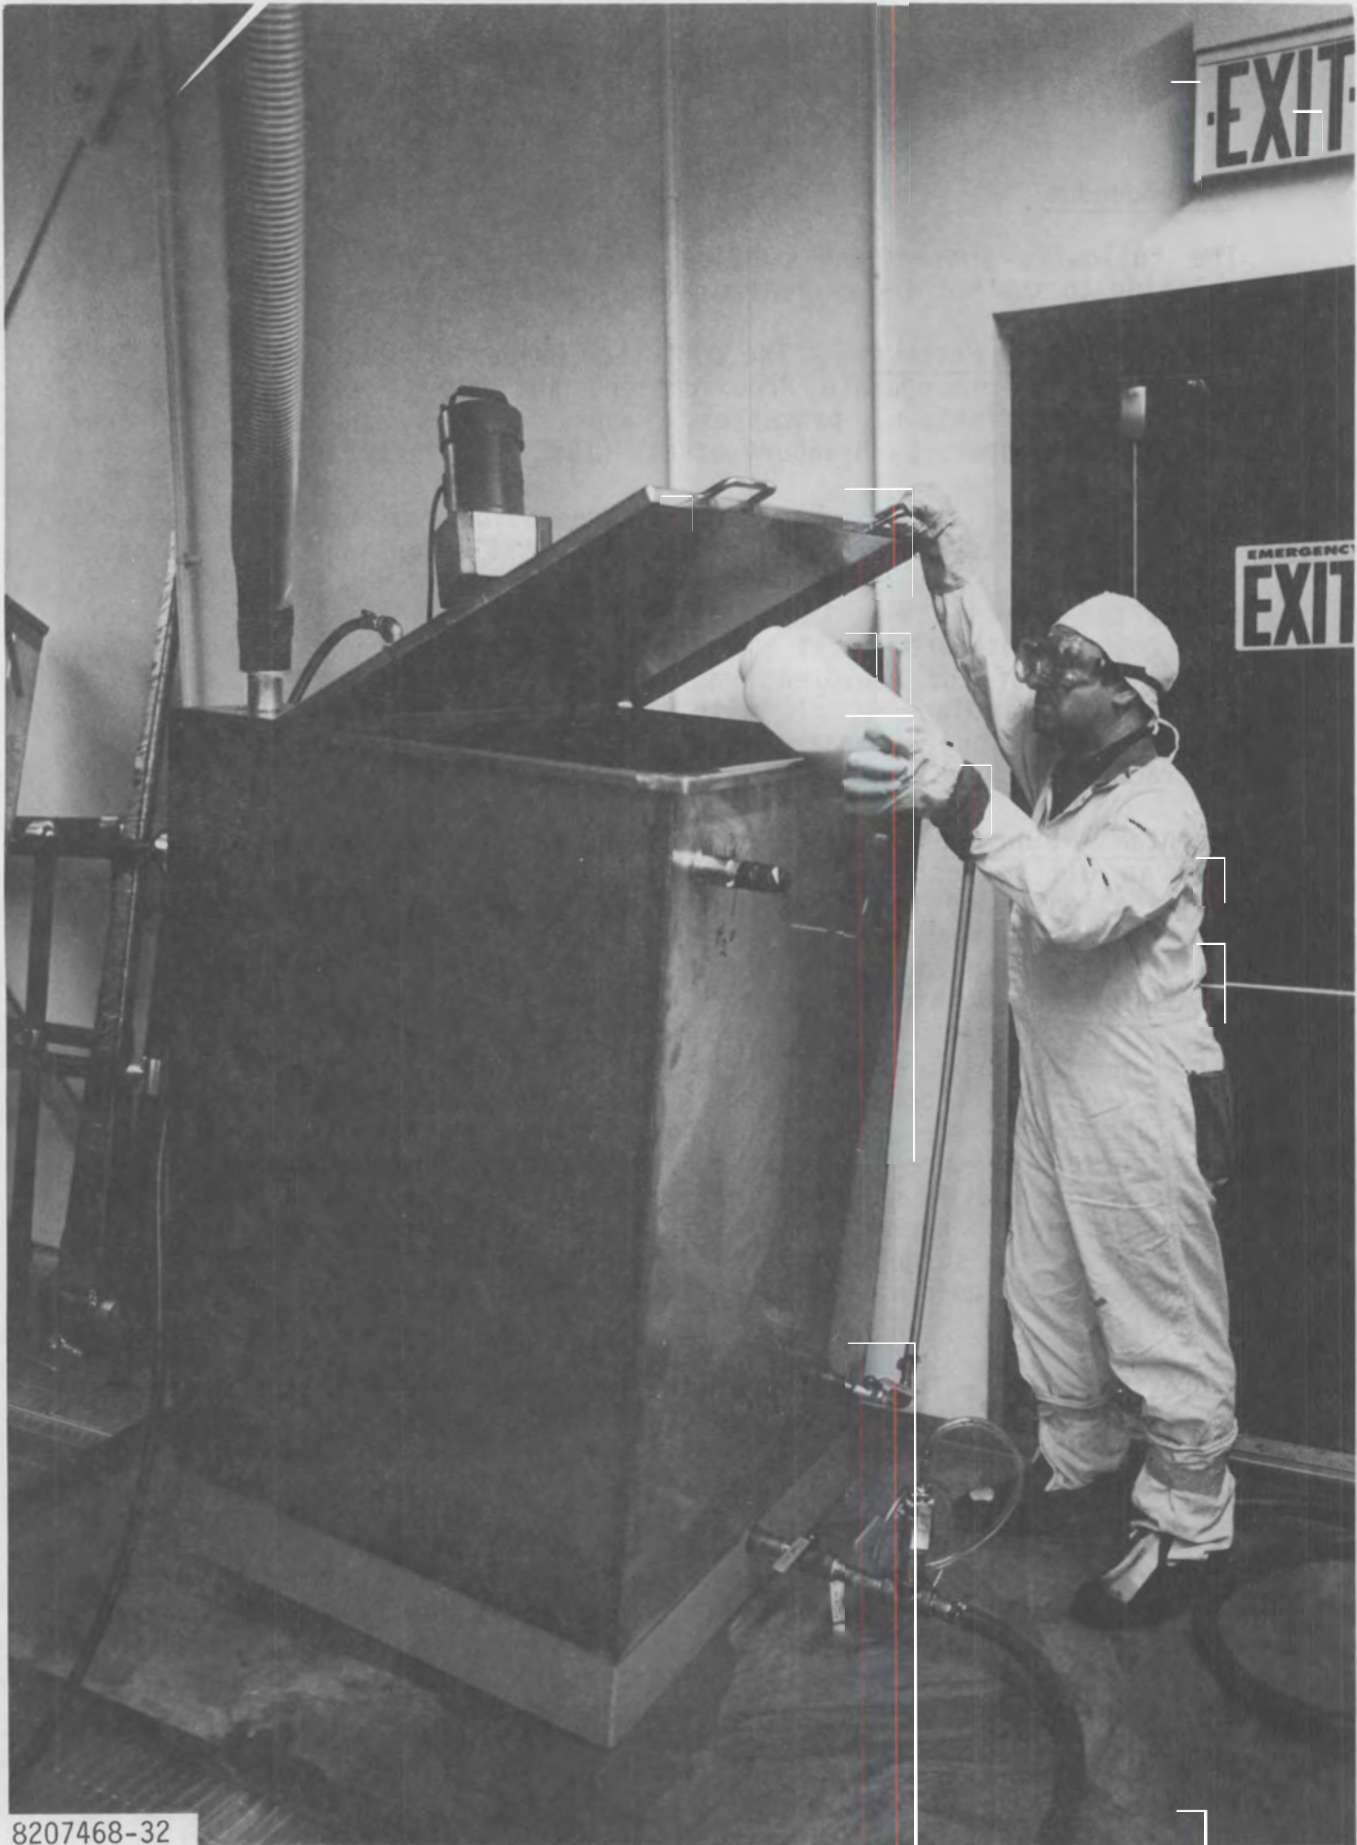
8207468-32

FIGURE 4-1. Chemical Addition/Mixing Tank for Hot Leg Decontamination

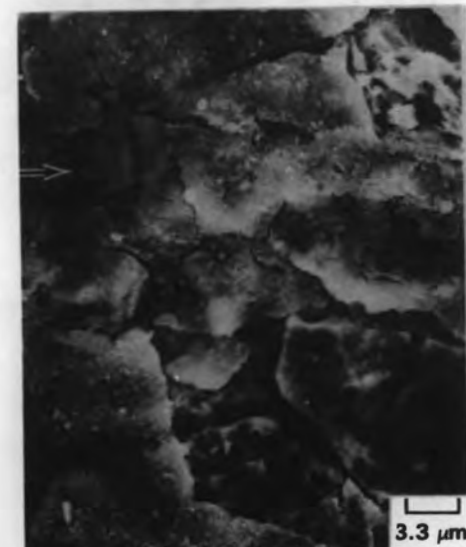
FIGURE 7-36. SEM Examination of a Specimen From the Unprotected Area of the Hot Leg Tube Sheet

- Very little Mn contamination was found.
- The residual oxide has a higher Fe content than the base metal.
- Intergranular etching of the base metal was present; the etching may have existed under the oxide film prior to decontamination.
