CHARACTERIZATION OF HYDROFRACTURE GROUTS FOR  
RADIONUCLIDE MIGRATION\*†

D. P. Stinton  
Metals and Ceramics Division  
and  
E. W. McDaniel and H. O. Weeren  
Chemical Technology Division

Oak Ridge National Laboratory  
Post Office Box X  
Oak Ridge, Tennessee 37830

†Presented at the 85th Annual Meeting, The American Ceramic Society, Chicago, Ill., April 24-27, 1983.

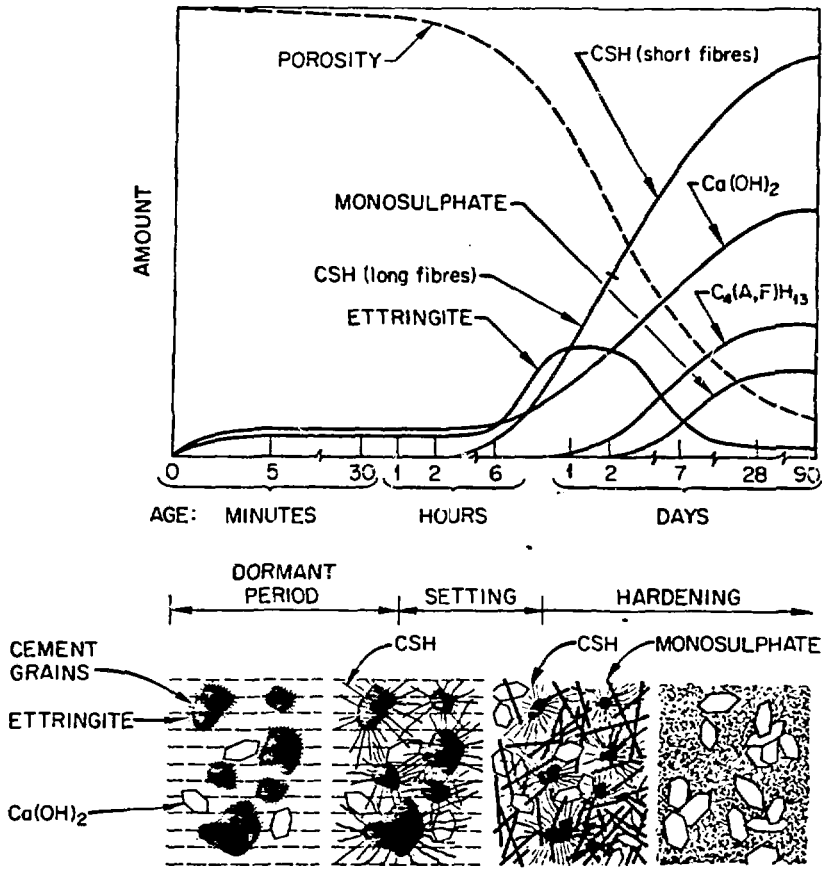
Fig. 2. (a) Hydration of various components of portland cement at various rates. (b) Microstructures resulting from reactions shown in (a). Courtesy of I. Soroka, *Portland Cement Paste and Concrete*, Chemical Publishing Co., New York, 1982.

These hydration reactions occur at various rates, as shown in Fig. 2, which also shows the microstructures that develop from these reactions. The phases present in the hydrofracture grouts are certainly more complex than those present in portland cement pastes; however, the phases produced

difficulty results from the intergrowth of the cement phases as they hydrate. After three to six months, the phases are so intergrown that no single phase material can be isolated (Fig. 2).
