ORIGIN OF SPURIOUS ULTRASONIC ECHOES IN STAINLESS STEEL PIPING  
WITH WELD OVERLAY\*

David S. Kupperman

Materials and Components Technology Division  
ARGONNE NATIONAL LABORATORY  
Argonne, Illinois 60439

Paper to be published in the Proceedings of the Review of Progress in Quantitative NDE, held in La Jolla, CA, August 3-8, 1986, sponsored by the Center for NDE at Iowa State University and Ames Laboratory.

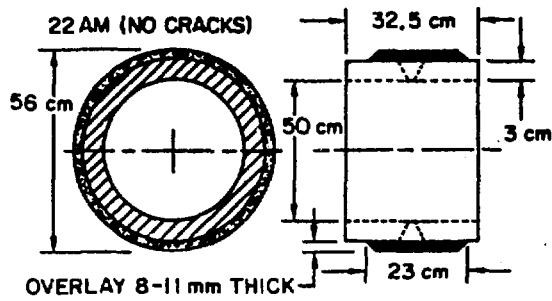
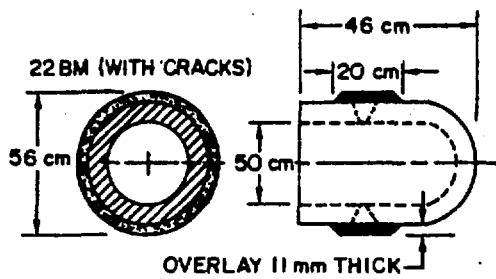
Fig. 1. Schematics of the Two Pipe-to-Endcap Weldments Used in the 1985 NDE Workshop.

An NDE workshop on inspection of 12-in. Schedule 80 pipe-to-elbow weldments with weld overlays, from the Georgia Power Co. Hatch-2 reactor, was held at ANL in May 1984 [2]. Because of the positive response to this workshop, a second one was held at ANL in January 1985. The ten participants included personnel from KWU (West Germany), Commonwealth Edison, Battelle Pacific Northwest Laboratory (PNL), Southwest Research Institute, and ANL. Two pipe-to-endcap weldments with weld overlays, also from Hatch, were studied in the second workshop. Figure 1 shows the dimensions and configurations of these weldments. The endcap is intact on weldment 22BM, a photograph of which is shown in Fig. 2. The inner surfaces of the weldments have been ground in some areas so that they contain a mixture of smooth areas and areas where the weld root is clearly evident. The weld overlay has a relatively smooth surface texture.

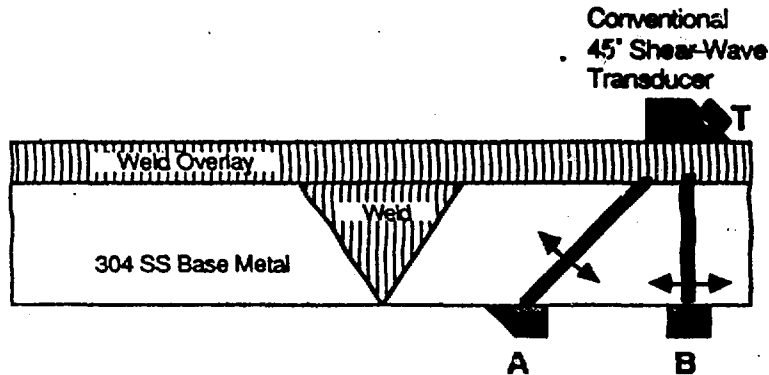
- T: Conventional 45° Shear-Wave Transducer Injects Ultrasonic Wave Into Overlay
- A: Conventional 45° Shear-Wave Transducer Detects SV-Wave in Through Transmission
- B: Normal-Incidence Shear-Wave Transducer Below Transmitting Transducer Detects Shear Wave with Polarization Parallel to Surface of Sample

Fig. 3 Schematic of Pipe Section, Overlay, and Transducers Used to Identify the Source of Spurious Echoes Found During Ultrasonic Inspection of Pipes with Overlays. The total specimen thickness is 22.5 mm. The overlay is 5 mm thick. A signal can be detected by 45° shear-wave transducer A (at relative position indicated) for all locations of transmitter T. However, signals detected by normal-incidence shear-wave transducer B vary in amplitude depending on the position of T. A spurious echo is detected by T (in pulse-echo mode) only when a relatively strong signal is detected by B. The difference in transit times for signals received at A and B for a given T position is consistent with the difference in acoustic path length.

An important experimental observation indicates that because of the complex microstructure of the overlay, the mode-converted shear wave is split into two parts [3]. One is an SV-wave propagating at  $N35-45^\circ$  and the other is a wave propagating essentially normal to the pipe surface. The SV-wave was detected by a conventional  $45^\circ$  shear-wave transducer at the approximate position expected for a  $45^\circ$  shear wave (corresponding to transducer A in Fig. 3 and trace 3 in Fig. 4). The other shear wave is reflected off the bottom of the pipe and returns to the transducer providing a strong ultrasonic echo (trace 2 in Fig. 5). An electromagnetic acoustic transducer (EMAT) and a normal-incidence shear-wave transducer were used to confirm the presence of this wave (transducer B in Fig. 3). A radially polarized EMAT was used to scan the inner surface of the sample. A shear wave was detected at a position just below or very slightly ahead of the  $45^\circ$  shear-wave transducer wedge. A normal-incidence shear-wave transducer was used to establish that the polarization of this shear wave is parallel to the inner surface of the specimen and in the plane of the polarization of the conventional SV-wave (Fig. 4, trace 4). This wave cannot be detected by finger-damping techniques because there is no significant component of particle motion perpendicular to the surface. This also explains why the wave cannot be detected by conventional  $45^\circ$  shear-wave transducers (transmission between two isotropic media across a fluid boundary is not possible for shear waves with this polarization). When the normal-incidence shear-wave transducer B shows a relatively large amplitude (Fig. 49, trace 4), a strong spurious signal is detected by the transmitting  $45^\circ$  shear-wave transducer T in the pulse-echo mode (Fig. 5, trace 2). When the normal-incidence shear-wave transducer B shows a relatively weak signal amplitude there is no spurious echo.

When the  $45^\circ$  shear-wave transducer is replaced by a  $60^\circ$  transducer, the spurious pulse-echo signal is considerably reduced. In contrast, the through-transmitted signal detected by the normal-incidence shear-wave probe B is large. Apparently, less of the reflected energy is transmitted to the wedge than for a  $45^\circ$  probe. Furthermore, the spacing of the multiple echoes received at B, corresponds to the thickness of the specimen. Even more curious is the observation that the relative amplitude of the first and second signal received at B depends on the polarization of the receiving probe. If the polarization is as shown in Fig. 3, i.e., in the plane of the figure, the first signal is larger in amplitude than the second. If the polarization is rotated  $90^\circ$ , so as to be out of the plane of Fig. 3, the first signal is almost extinguished but the second maintains about the same amplitude.

One other relevant test has been carried out. A  $60^\circ$ , 2.25-MHz, 6-mm shear-wave transducer was placed on a flat piece of 1-cm-thick SS weld metal at a location corresponding to T in Fig. 3. The grain orientation in this specimen is generally the same as in the overlay of Fig. 3, but does not follow the zig-zag pattern of the overlay (Fig. 6). The weld metal sample has a much more nearly ideal transverse isotropic symmetry

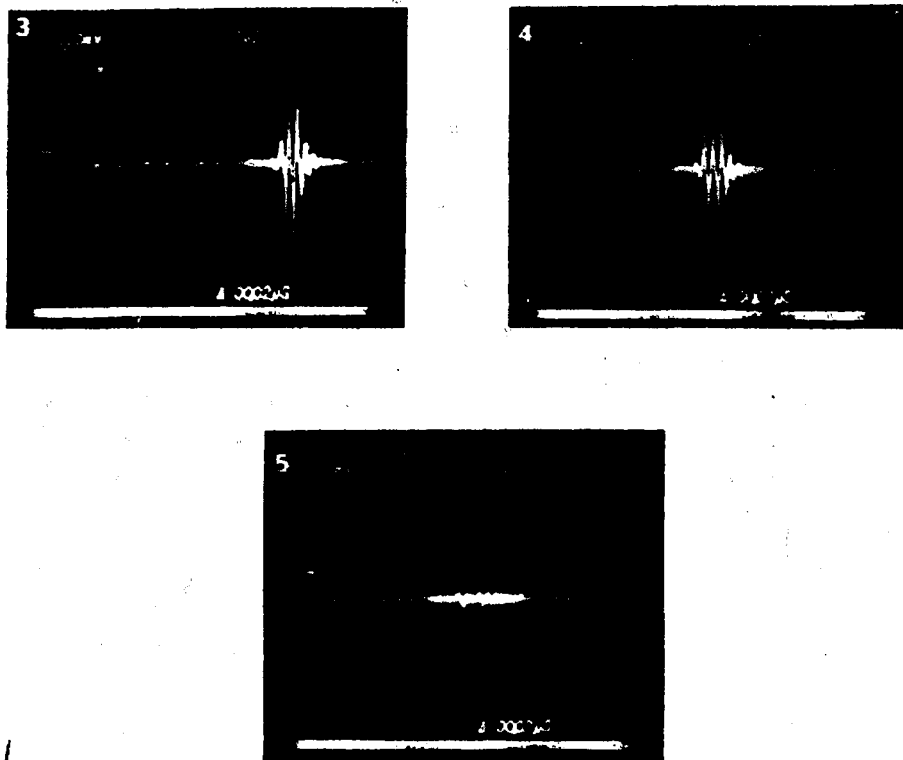
Fig. 9 Signals Associated with a Given Position of  $45^\circ$  Shear-Wave Transducer T (See Fig. 3). Trace 3: signal received by  $45^\circ$  shear-wave transducer at A. Trace 4: signal received by normal-incidence shear-wave transducer at B, with polarization as indicated in Fig. 3. Trace 5: signal received by normal-incidence shear-wave transducer at B, with polarization out of the plane of Fig. 3. A Panametrics 2.25-MHz, 13-mm, normal-incidence shear-wave transducer (B), KB-Aerotech 2.25-MHz, 6-mm,  $45^\circ$  shear-wave MSW-QC transducer (T and A), and Panametrics 5052UAY pulse-receiver were used in con-

is no significant component of particle motion perpendicular to the surface. This also explains why the wave cannot be detected by conventional  $45^\circ$  shear-wave transducers (transmission between two isotropic media across a fluid boundary is not possible for shear waves with this polarization). When the normal-incidence shear-wave transducer B shows a relatively large amplitude (Fig. 49, trace 4), a strong spurious signal is detected by the transmitting  $45^\circ$  shear-wave transducer T in the pulse-echo mode (Fig. 5, trace 2). When the normal-incidence shear-wave transducer B shows a relatively weak signal amplitude there is no spurious echo.

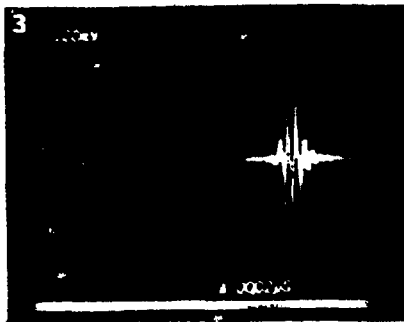
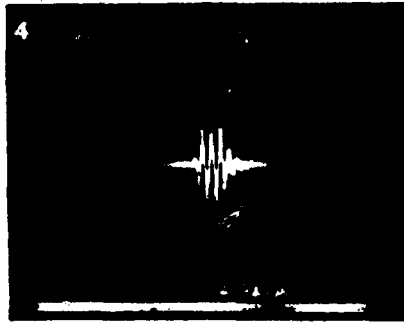
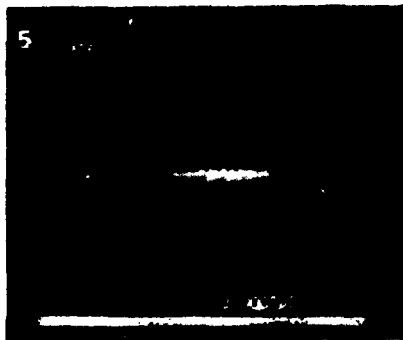
Fig. 9/ Signals Associated with a Given Position of  $45^\circ$  Shear-Wave Transducer T (See Fig. 3). Trace 3: signal received by  $45^\circ$  shear-wave transducer at A. Trace 4: signal received by normal-incidence shear-wave transducer at B, with polarization as indicated in Fig. 3. Trace 5: signal received by normal-incidence shear-wave transducer at B, with polarization out of the plane of Fig. 3. A Panametrics 2.25-MHz, 13-mm, normal-incidence shear-wave transducer (B), KB-Aerotech 2.25-MHz, 6-mm,  $45^\circ$  shear-wave MSW-QC transducer (T and A), and Panametrics 5052UAX pulser-receiver were used in conjunction with a Tektronix 7904 oscilloscope with 7B85 and 7B80 time bases.

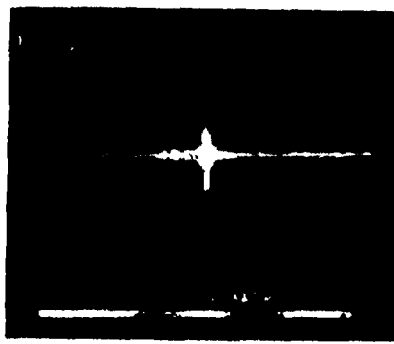
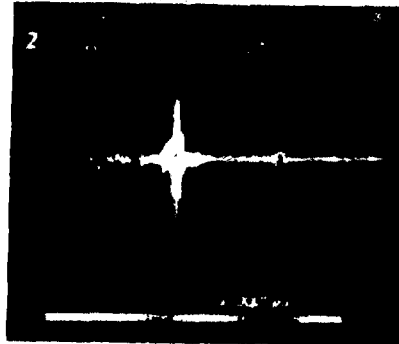
Fig. 1A. Trace 1: Radio-Frequency Signals from Corner Reflector, Detected by Probe T after Propagating through the Overlay. Trace 2: Spurious Echo Detected by Probe T in the Pulse-Echo Mode (Signal Cannot be Finger Damped). Same instrumentation as for Fig. 3.

The transit times for the spurious echo received at T (Fig. 5, trace 2) and the echo received from a corner reflector (Fig. 5, trace 1) differ by 6 ms. This corresponds to a path difference of about 18 mm ( $6 \text{ ms} \times 3000 \text{ m/s}$ ). This acoustic path difference corresponds to the difference between a  $45^\circ$  shear wave and a normal-incidence shear wave [ $(22.5 \text{ mm}/\cos 45^\circ - 22.5) \times 2 = 18.6 \text{ mm}$ ] and so is consistent with the explanations provided above.

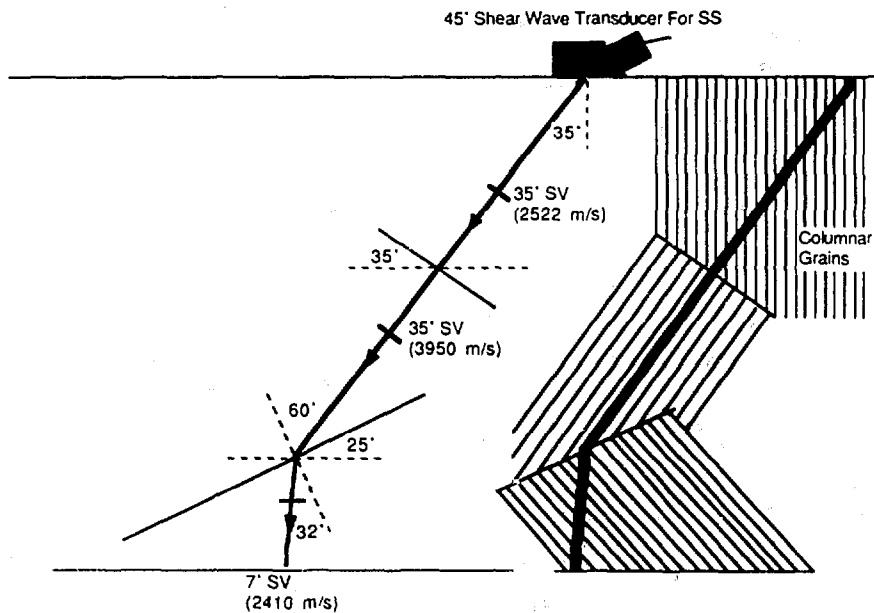
Fig. 7. Path of Shear Wavefront Normal in Weld Overlay.

Despite the indications that longitudinal rather than shear-wave testing may be more reliable for pipes with overlays, shear-wave techniques are widely used in the field. As indicated, while scanning a weld overlay sample with shear waves, intermittent spurious or "phantom" echoes are generated. The data presented here supports the premise that these echoes are the result of part of the injected ultrasonic wave being refracted downward, reflecting off the inner wall of the pipe and returning to the transmitting probe. While it is difficult to see how this is possible, Fig. 7 illustrates a plausible path that results in a shear wave at almost normal incidence to the bottom surface. Close observation of the micrograph (Fig. 6) shows that this seemingly contrived arrangement of columnar grain structure is a strong possibility. By crossing boundaries that change the shear-wave velocity drastically, the shear wave can be refracted as indicated (see Ref. 4 for shear-wave velocity as a function of propagation direction in columnar structures.) Other arrangements of columnar grain structures will result in part of the beam refracted in different directions but these will not be reflected back to the transmitting probe giving a false echo and possibly interpreted as originating at a crack.
