Nondestructive Evaluation Techniques for Enhanced Bridge Inspection

Graham Thomas, Steven Benson, Philip Durbin, Nancy Del Grande,
Jerry Haskins, Albert Brown and Daniel Schneberk

This paper was prepared for submittal to the
Quantitative Nondestructive Evaluation (QNDE) '93 Conference
Brunswick, Maine
August 1-6, 1993

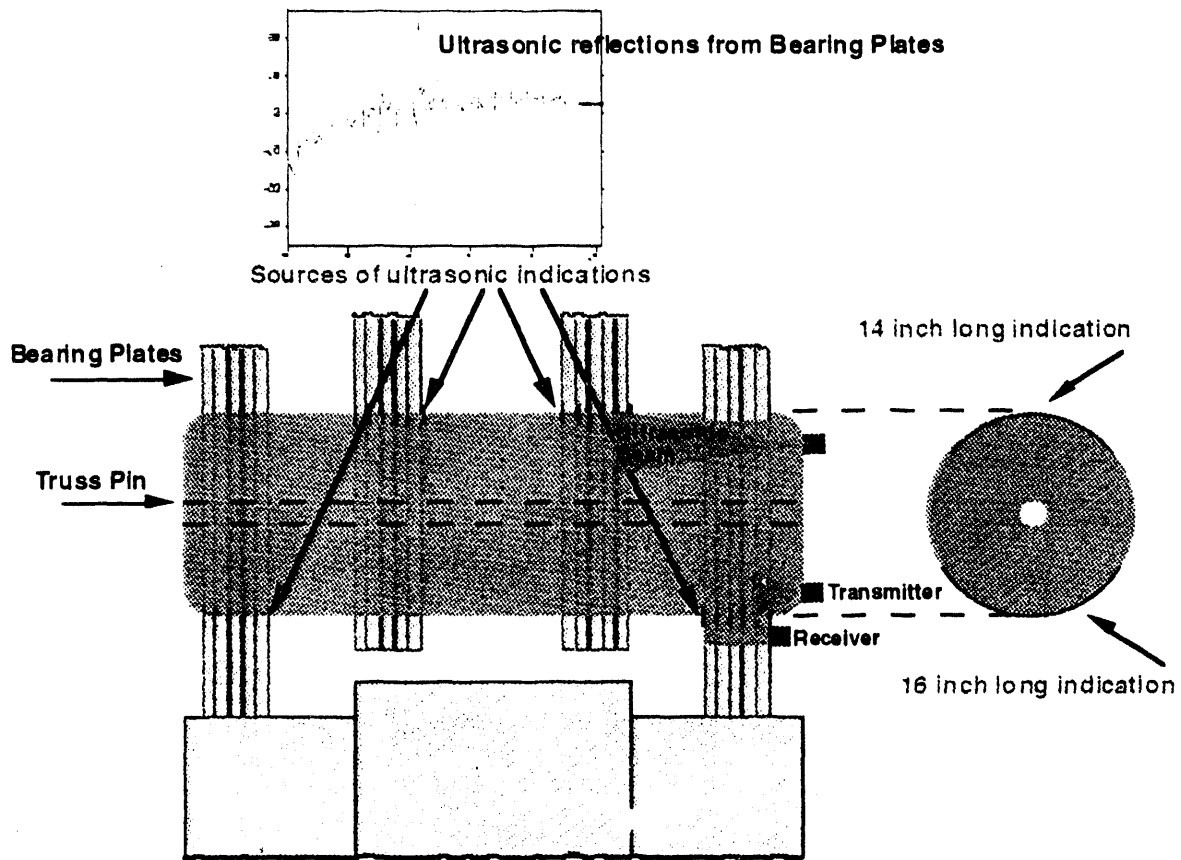
Figure 1 - Diagram of ultrasonic inspection of San Francisco Bay Bridge Pin which supports Pier E-9. Note the ultrasonic reflections.

Lawrence Livermore National Laboratory and California Department of Transportation have been collaborating to develop and field NDE techniques to improve bridge inspections. One particular effort has been to ultrasonically evaluate the steel pins in the E-9 pier on the San Francisco Bay Bridge. After the Loma-Prieta earthquake in 1989 and the road way collapsed at the E-9 pier, a complete nondestructive evaluation was conducted by Caltrans on that structure. A result of the inspection was ultrasonic indications in two of the large steel pins. These ultrasonic indications were located in the pin where there was a gap between eye bars, see Figure 1. The indications were detected by a contact, pulse-echo, longitudinal wave ultrasonic technique from the end of the pins. Before expensive corrective actions were implemented, the indications needed to be confirmed as cracks.

The original longitudinal ultrasonic inspection was complemented with other ultrasonic techniques to determine the nature of the reflector in the pin. A specially designed wand with angle beam transducers was fabricated to fit in the central hole in the pin. The angle beam technique insonified the reflector with 45 degree, shear waves which provided another viewing angle. Since it is difficult to distinguish a crack from other reflectors with a single view longitudinal wave evaluation, adding another view with the shear wave helps characterize the reflector. A crack will interact with the ultrasonic energy differently than other reflectors. A calibration reference pin was fabricated with notches (crack-like reflectors) and indentations to test the longitudinal and shear wave techniques. Ultrasonic signals from the reflectors in the reference pin and the pin on the bridge were digitized and processed in a computer. The acoustic signals were extracted from the record and a Fourier transform was performed to display the frequency spectrum. A portable, computer based ultrasonic data acquisition system was fielded on the bridge to acquire the ultrasonic data. This data was processed in the laboratory for comparison with the reference data taken on a calibration specimen, Figure 2 shows the comparison.

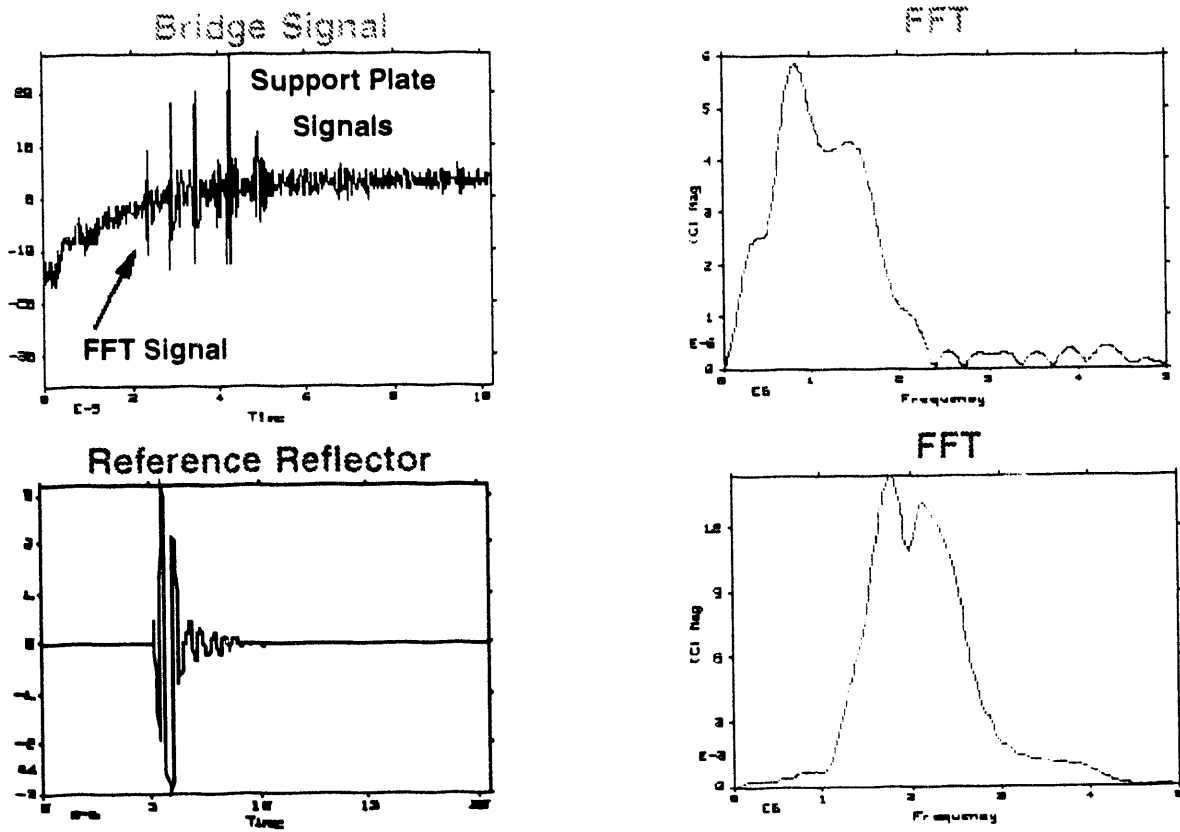
Figure 2 - Comparison of ultrasonic data between signals from bridge and signals from crack like reflector in laboratory reference. Signals do not appear to correspond.

The ultrasonic signals from the bridge and the signals from the reference reflector were not similar. It was speculated then that the pin might be fused to the eye bars and thus the acoustic signal could be couple from the pin into the plates. Figure 3 is a schematic which diagrams this situation. If this coupling of ultrasonic energy was occurring, the reflected ultrasonic signals could appear to be cracks in the pin. On the bridge, ultrasonic energy generated at the pin was received on the surface of the eye bar. For the ultrasonic energy to pass from the pin to the eye bar, the interface needs to be fused.

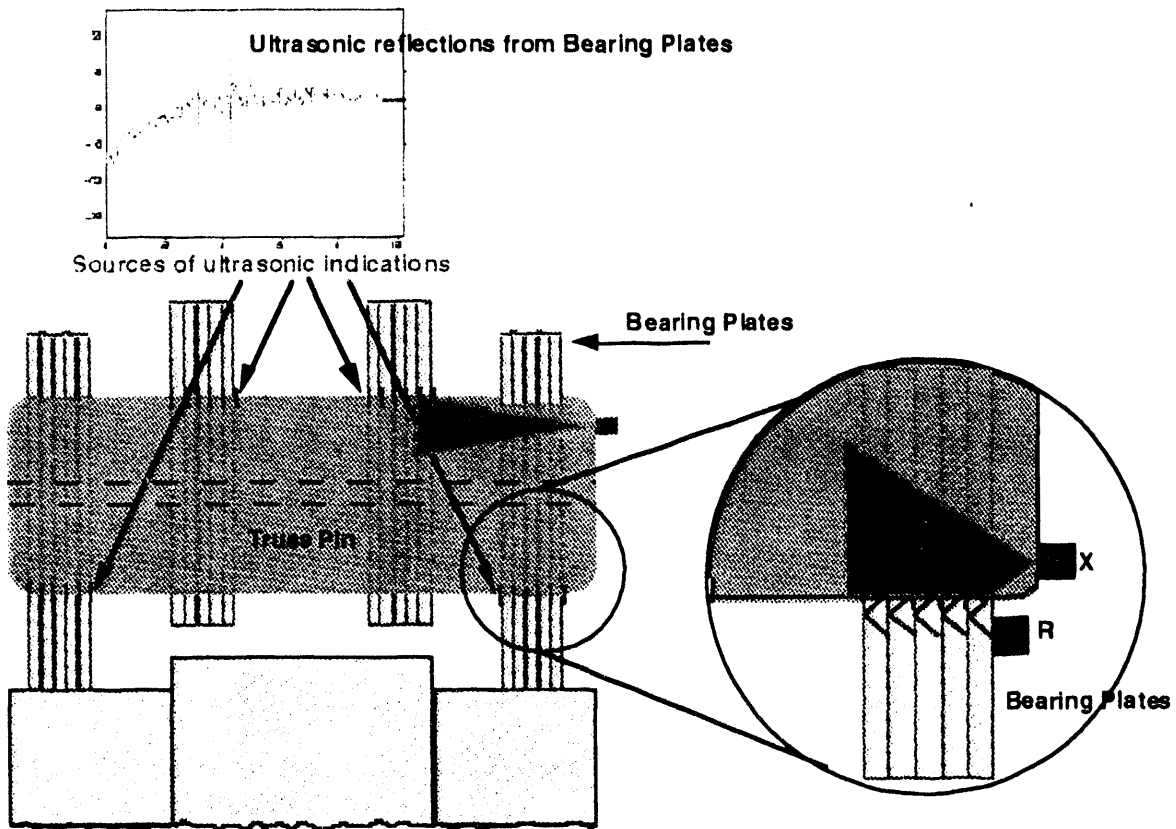
Figure 3 - Diagram of experiment to demonstrate the coupling of ultrasonic energy through the pin to bearing plate interface.

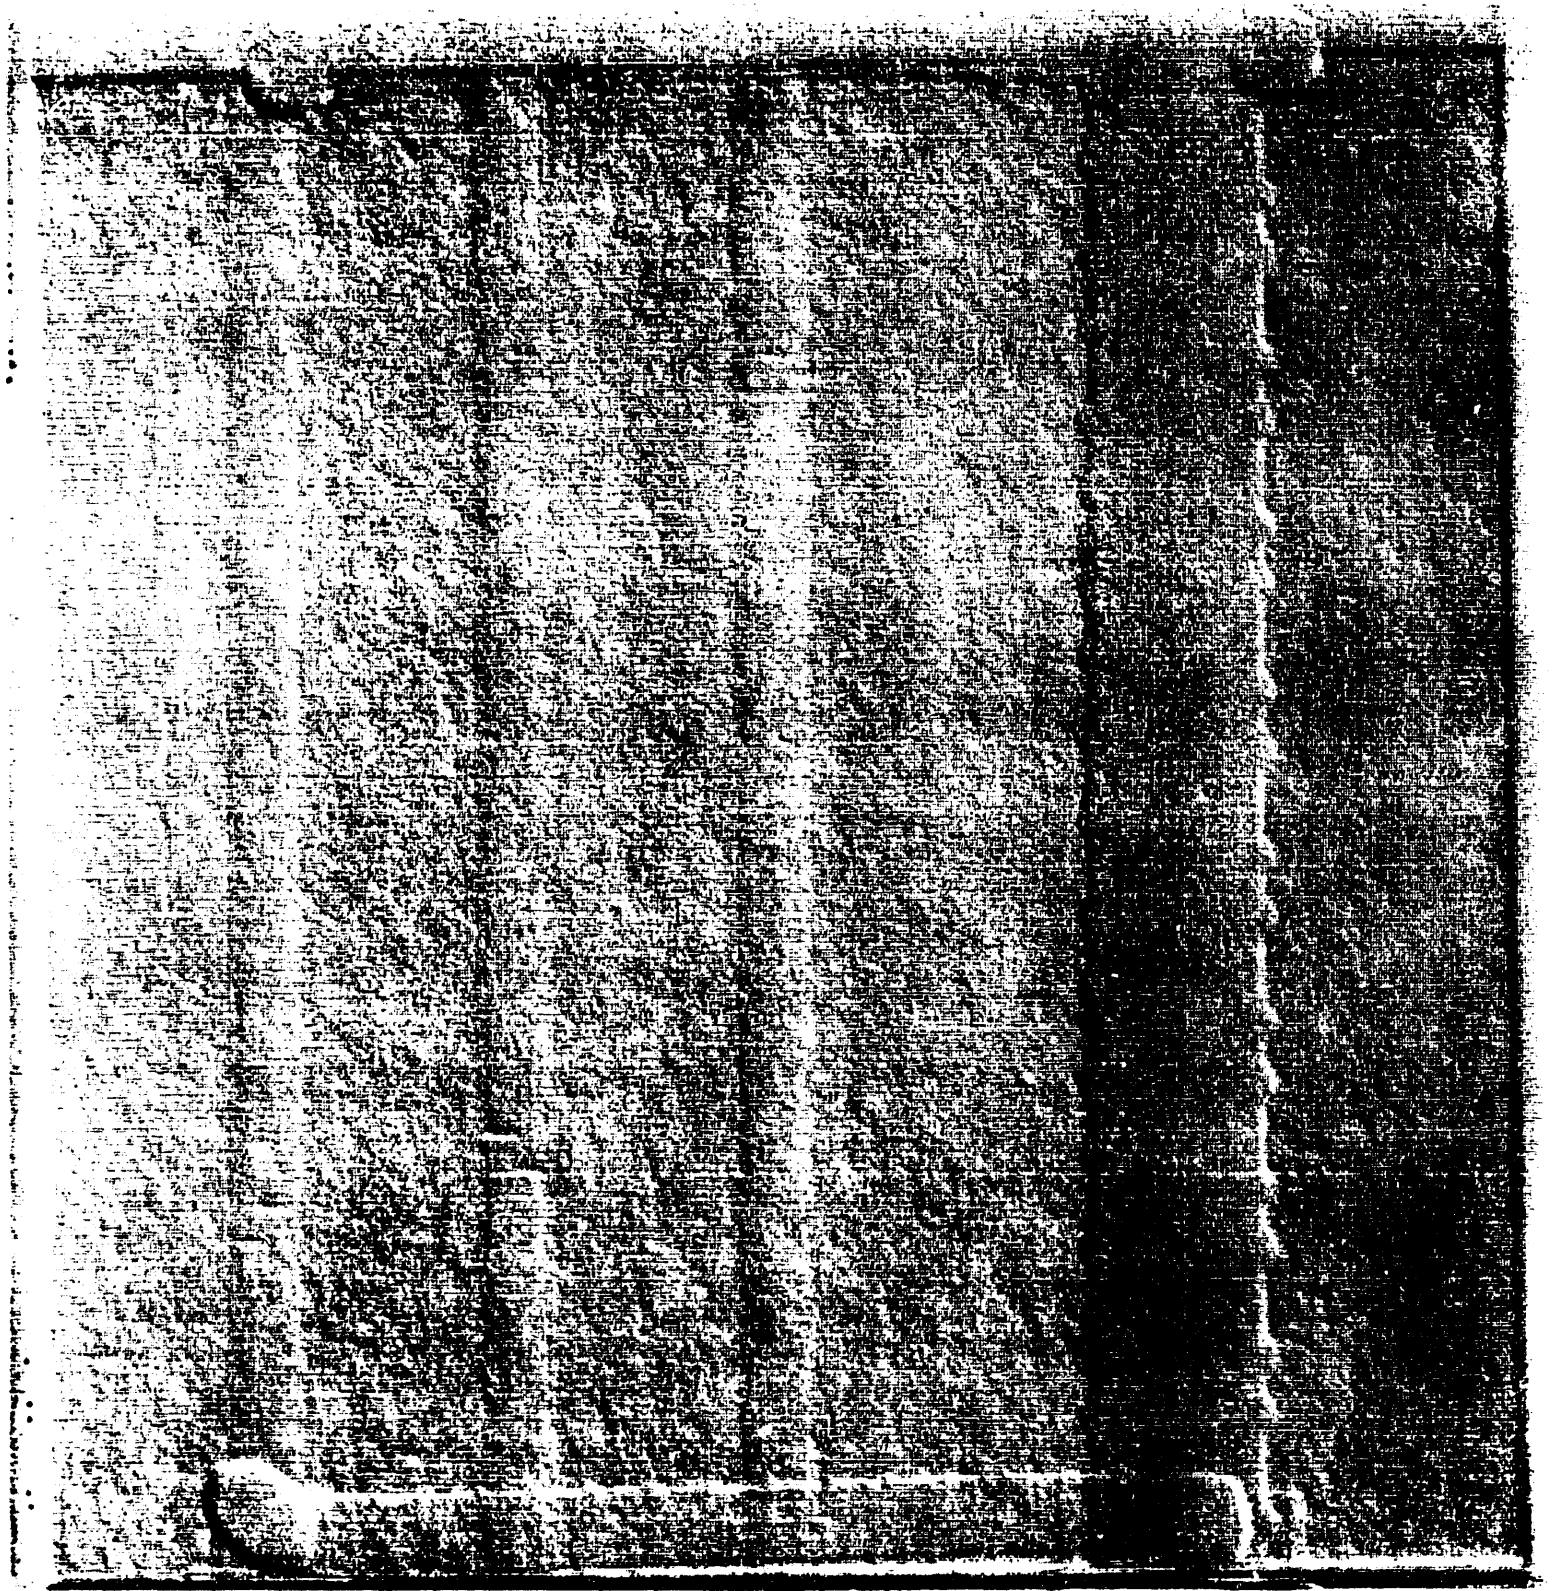
Figure 4 - High energy x-ray of rebar in a one foot cube of concrete. Note resolution of notches sawn in rebar.

Practical and cost effective digitization of radiographs is now possible using commercially available equipment. Digitization of radiographic images allows the computer enhancement and quantitative analysis of the images to improve sensitivity and probability of detection. Signal processing software can minimize system and random noise, improve edge sharpness using point spread function deconvolution of system unsharpness, filter out scatter related noise using models, and color code the images. These techniques provide improved defect detection and damage assessment. Our signal processing is performed using an LLNL code called VIEW which readily handles image data in an open ended environment . This permits selection of appropriate application specific techniques. The VIEW code contains over 300 commands and handles 1, 2, 3, or 4 dimensional data in bit, byte , word, real and/or complex format. We demonstrated our image enhancement capabilities on two bridge components, rebar imbedded in concrete and steel cables enclosed in an end cap. Figure 4 displays a digitized image of several different sizes of rebar buried inside a one foot cube of concrete. The rebar had a variety of notches cut into it to simulate defects. Figure 5 is a digitized radiograph of a cable end socket. The enhanced image of the steel cable clearly displays corrosion damage and broken strands.

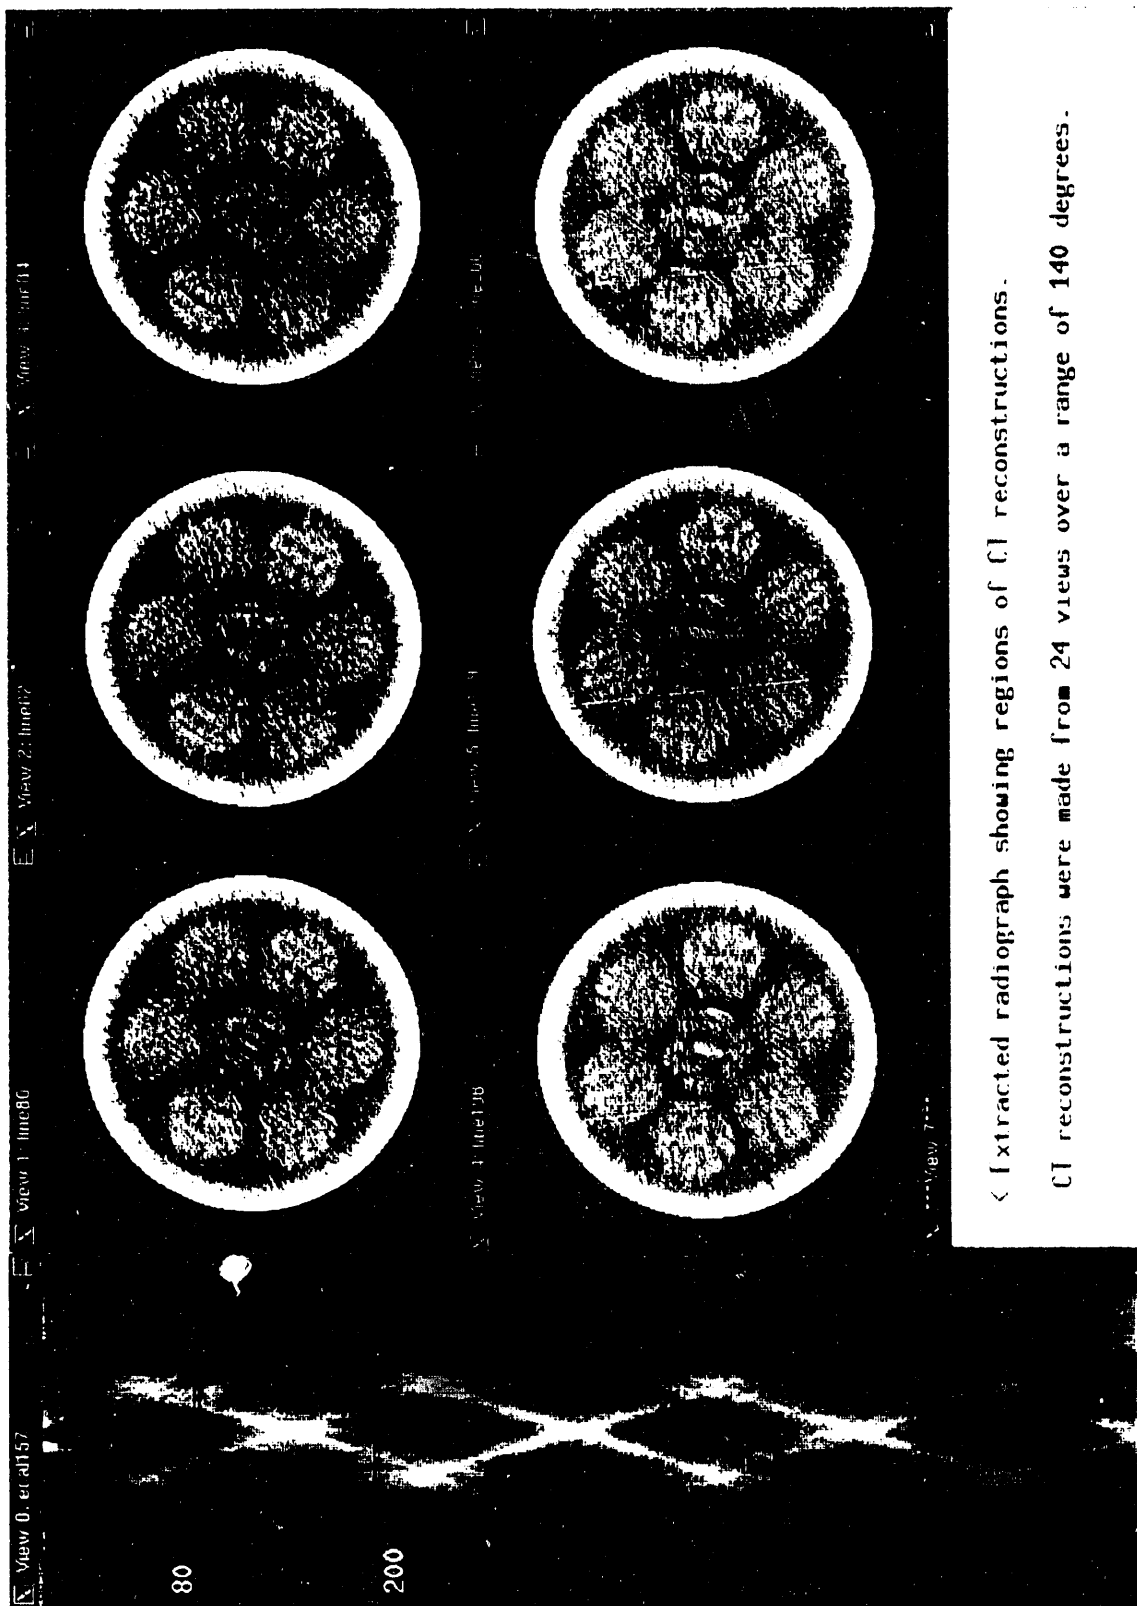
< Extracted radiograph showing regions of CI reconstructions.

CI reconstructions were made from 24 views over a range of 140 degrees.

Figure 6 - Computer tomographic slices of bridge cable. Individual steel strands are visible.

The limited view CT technology was applied to a bridge cable and end cap which had been removed from a bridge. A portable linear accelerator was the radiation source and film packets detected the x-ray energy. The experiment produced 2-dimensional images at 23 views over 138 degrees around the cable end cap. The 23 films were digitized and all views were normalized to the same attenuation mass. CT reconstructions were performed on the digitized data sets. Figure 6 is the CT reconstruction of the end cap. Locations and amounts of cable separation and loss of mass were determined.
