**Long-Term Durability Testing of  
Ceramic Cross-Flow Filter**

**Final Report  
September 29, 1987 - December 31, 1992**

**Work Performed Under Contract No.: DE-AC21-87MC24022**

**By  
Westinghouse Electric Corporation  
Science and Technology Center  
1310 Beulah Road  
Pittsburgh, Pennsylvania 15235**

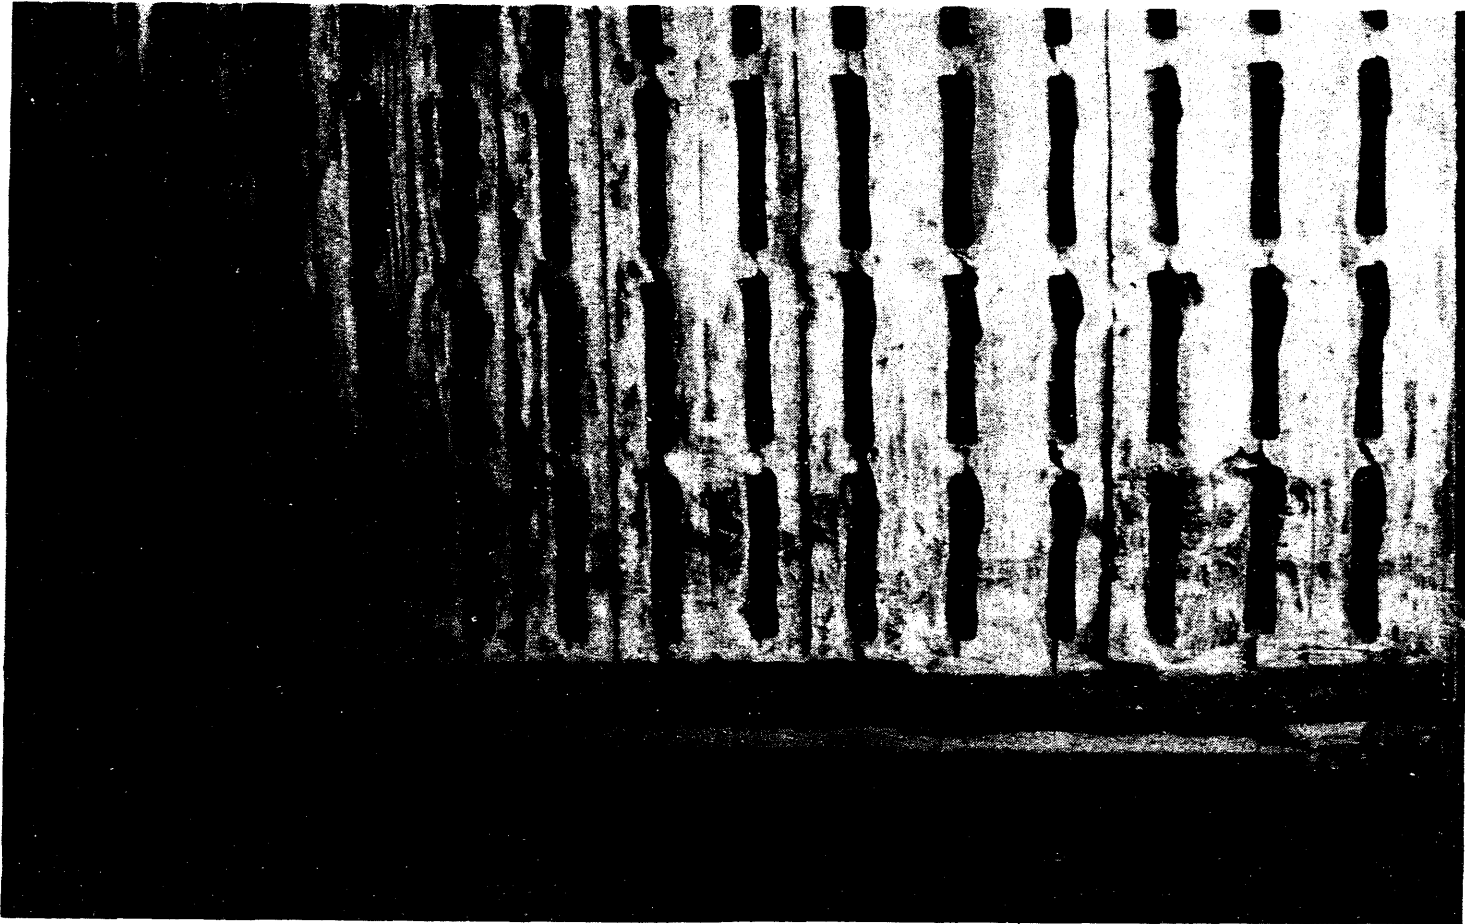
Figure 3.5 - Photograph Showing Flange Failure Experience in Cross Flow Filter WRTX-10

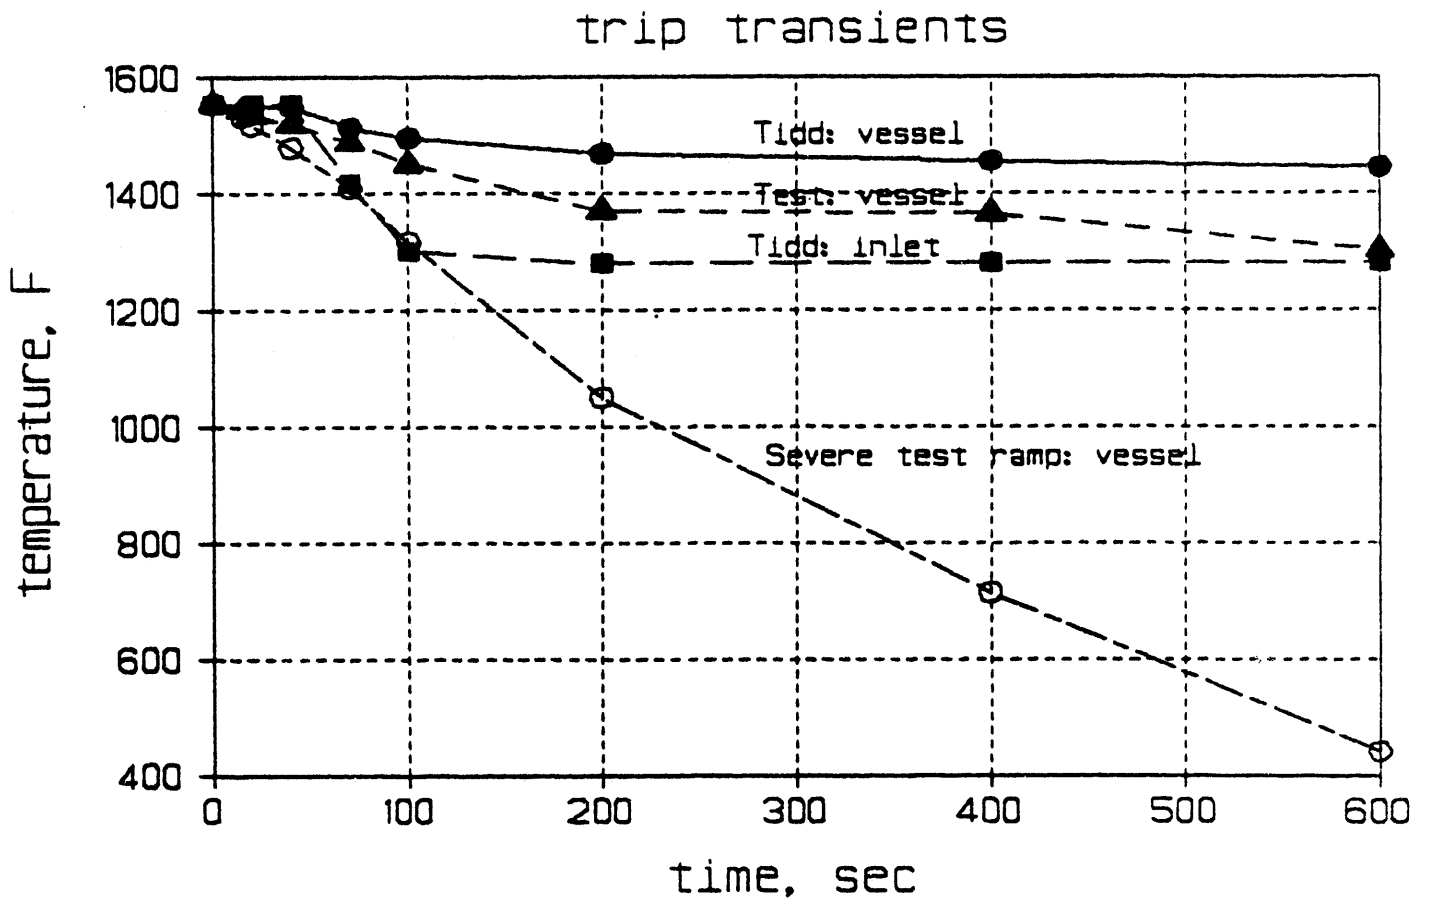
Figure J.1 - Projected Gas Temperature Versus Time Profiles in the Filter Vessel During a Turbine Trip Transient

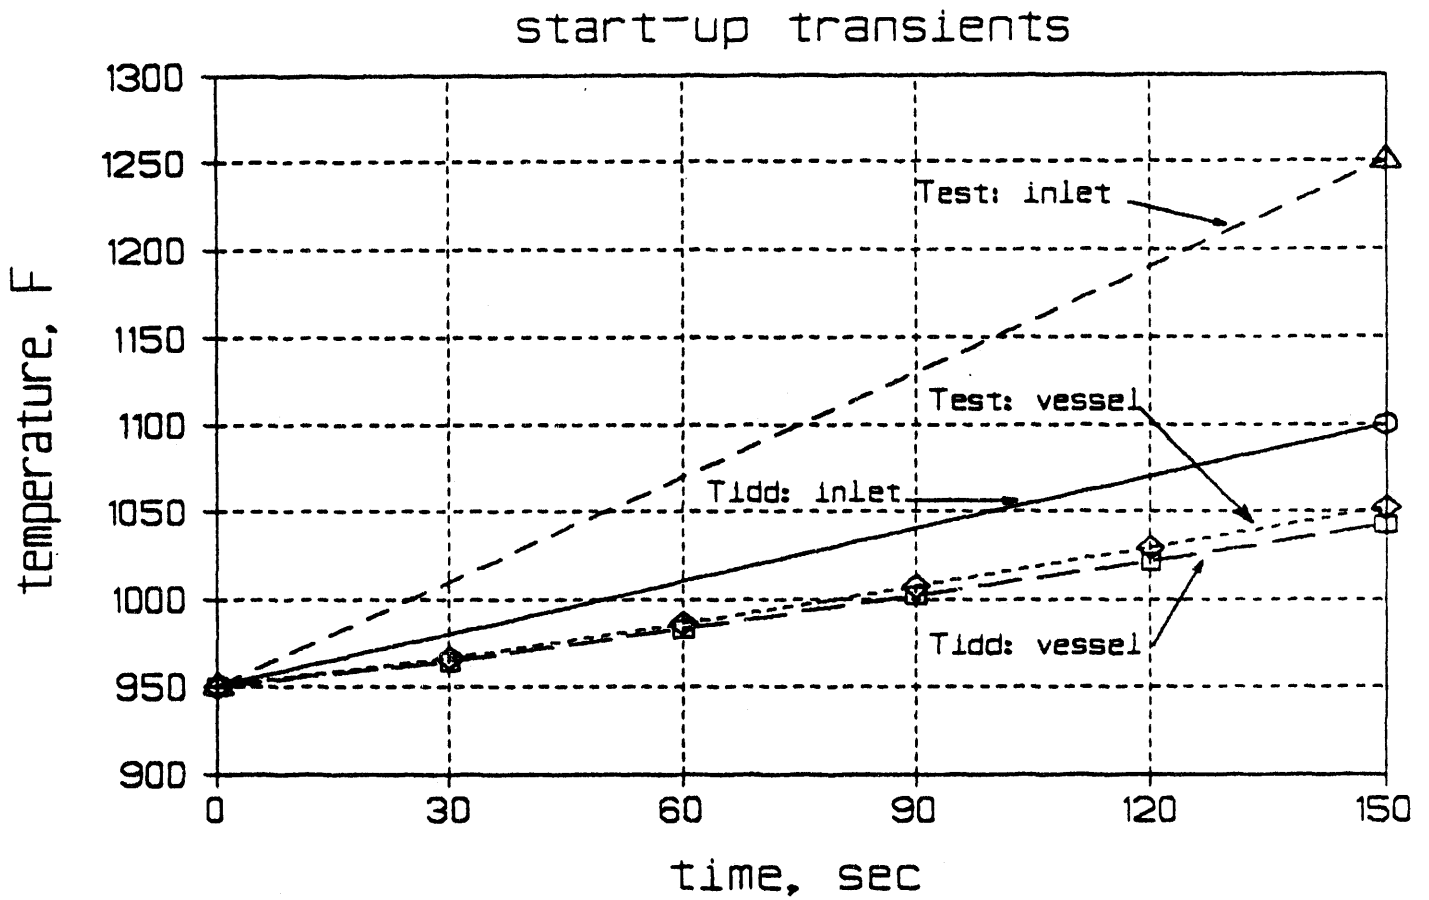
Figure J.2 - Projected Gas Temperature Versus Time Profile in the Filter Vessel During a Startup Transient

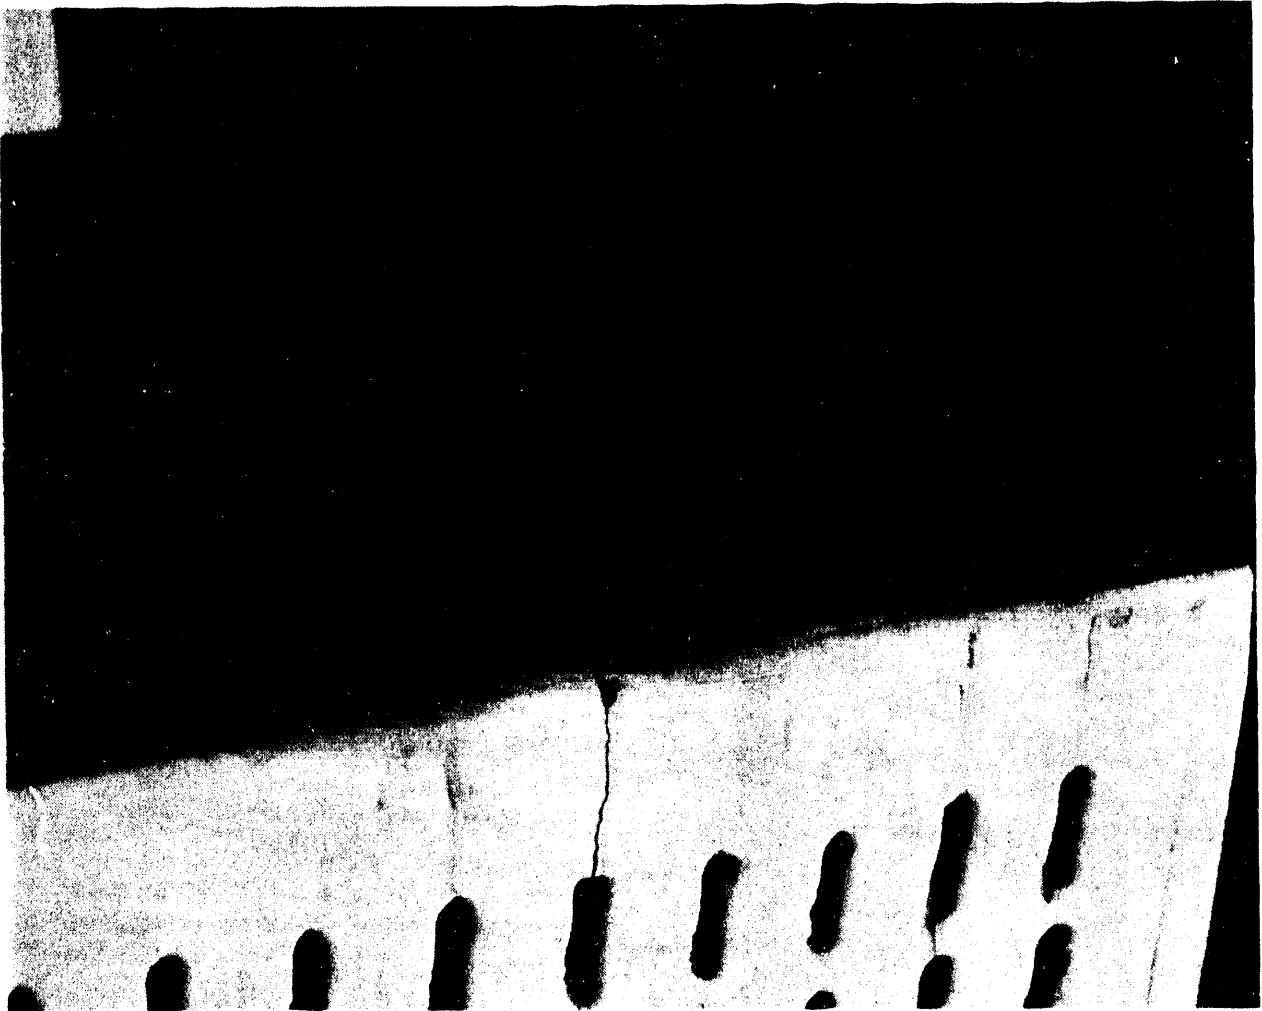
Figure J.6 - Patched Cracked Area of Cross Flow Filter WRTX-53  
After Durability and Transient Testing
