ATTACK OF SUPERHEATER TUBE ALLOYS, COATINGS, AND CLADDINGS
BY COAL-ASH CORROSION

S. Van Weele and J. L. Blough
Foster Wheeler Development Corporation
12 Peach Tree Hill Road
Livingston, NJ 07039

J. H. DeVan
Oak Ridge National Laboratory
Building 4500 S
Oak Ridge, TN 37831

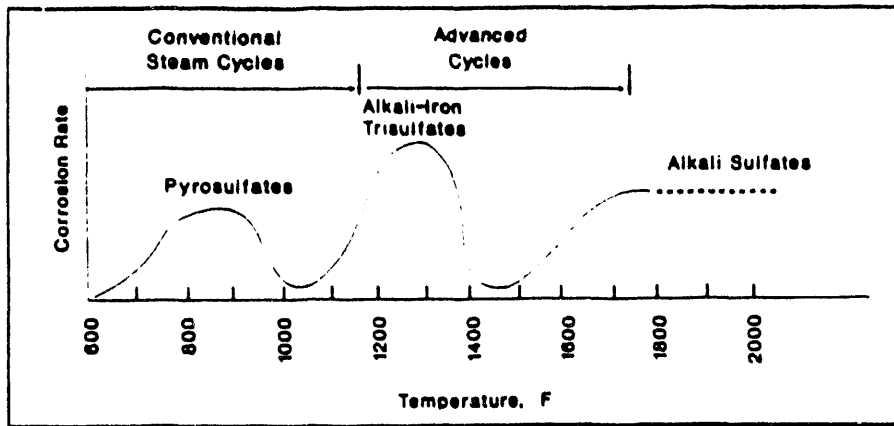
FIGURE 1 - Corrosion from alkali-sulfur compounds

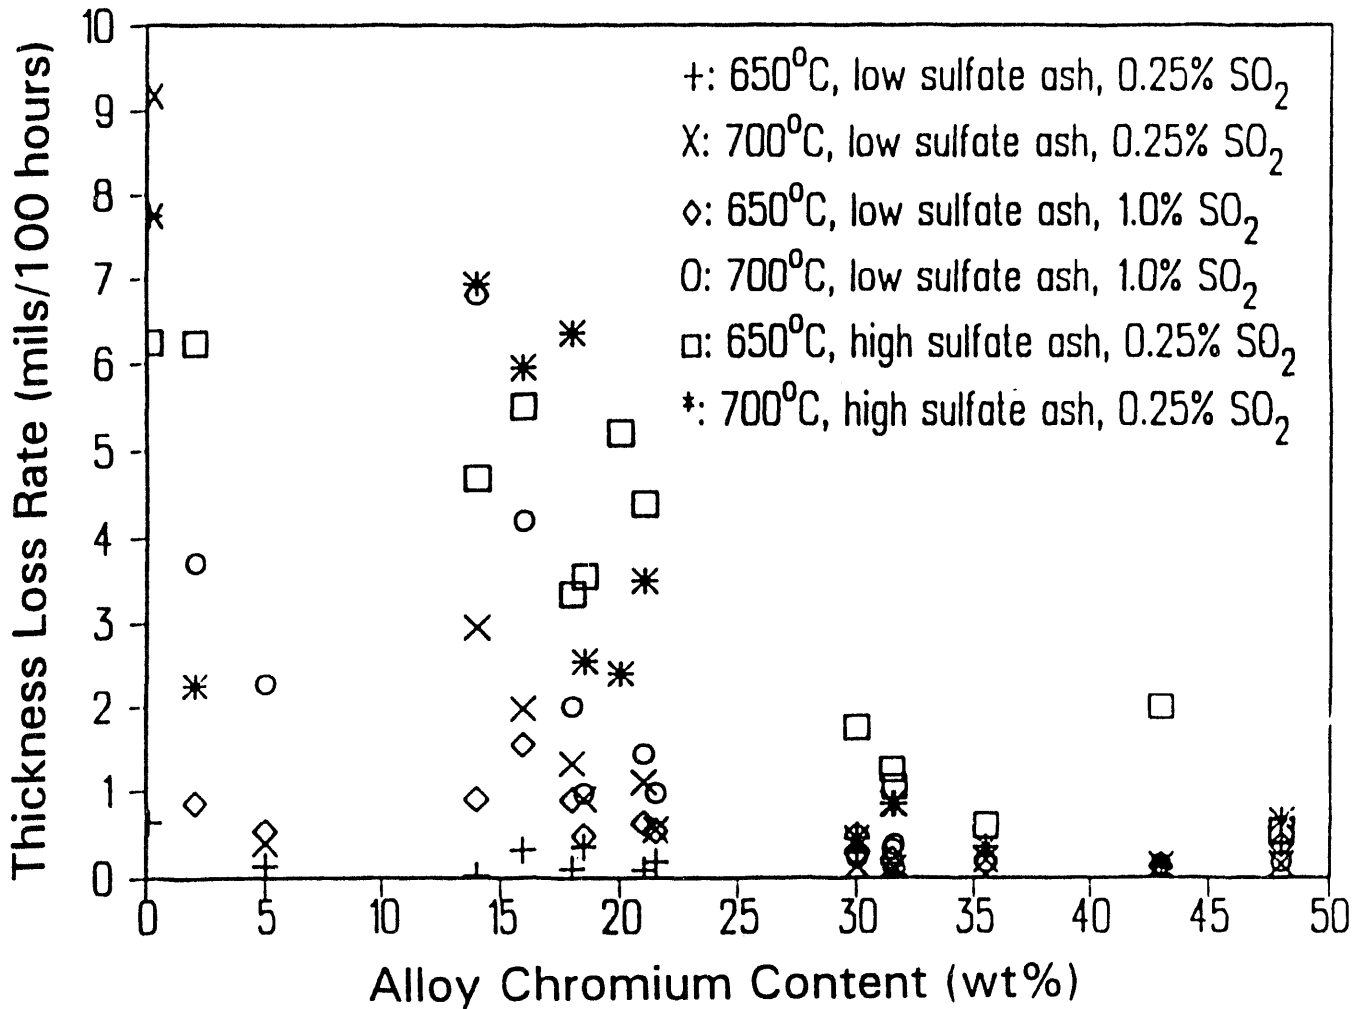
FIGURE 2 - Average thickness loss rate of alloy compared with chromium content of alloy (plot contains data for all alloys exposed under every environment tested in program)

Chromium content was found to be the largest factor in determining the resistance of an alloy to liquid AIT attack. Figure 2 is a compilation of sample thickness loss-rate data of all tests. For stainless steels and nickel alloys, additions of chromium up to 25% provide increased resistance to coal-ash attack; however, above the 25% chromium level, there does not appear to be any added benefit from more chromium. Silicon and aluminum were also beneficial, but to a lesser extent. The iron aluminide intermetallics also show a chromium dependence. Aluminides containing 5% chromium performed markedly better overall than those containing 2% chromium.

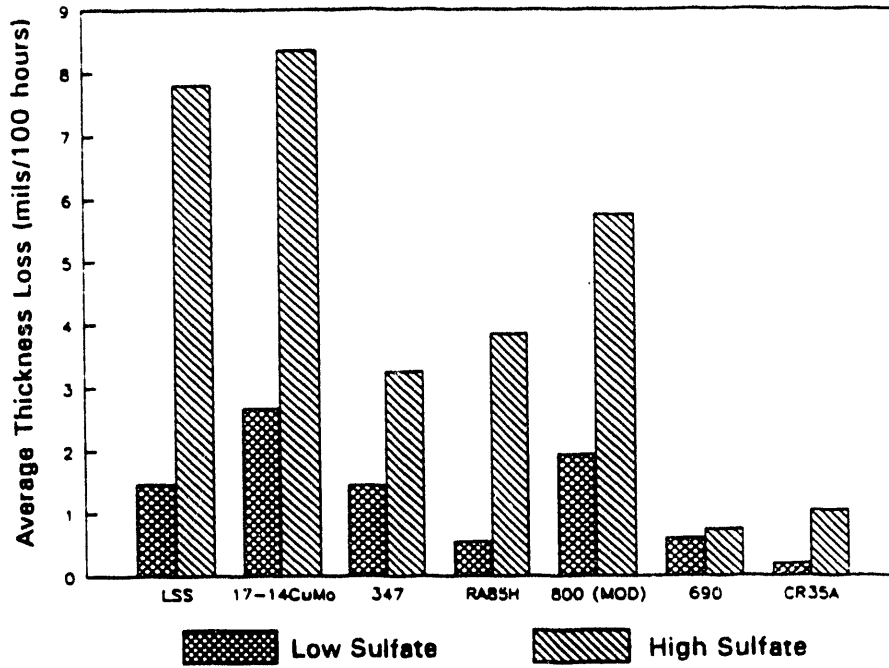
FIGURE 5 - Average thickness loss rates of representative alloys coated with ash containing either 10 or 75 wt% alkali sulfates and exposed at 700°C (1292°F) for 200 or 800 hours respectively to flue gas containing 0.25 vol% SO₂

Both the alkali content in the ash and SO₂ concentration in the flue gas affect the corrosivity of the alkali-iron trisulfates in the ash layer. As Figures 5 and 6 show, an increase in either results in a more corrosive environment and higher wastage rates.

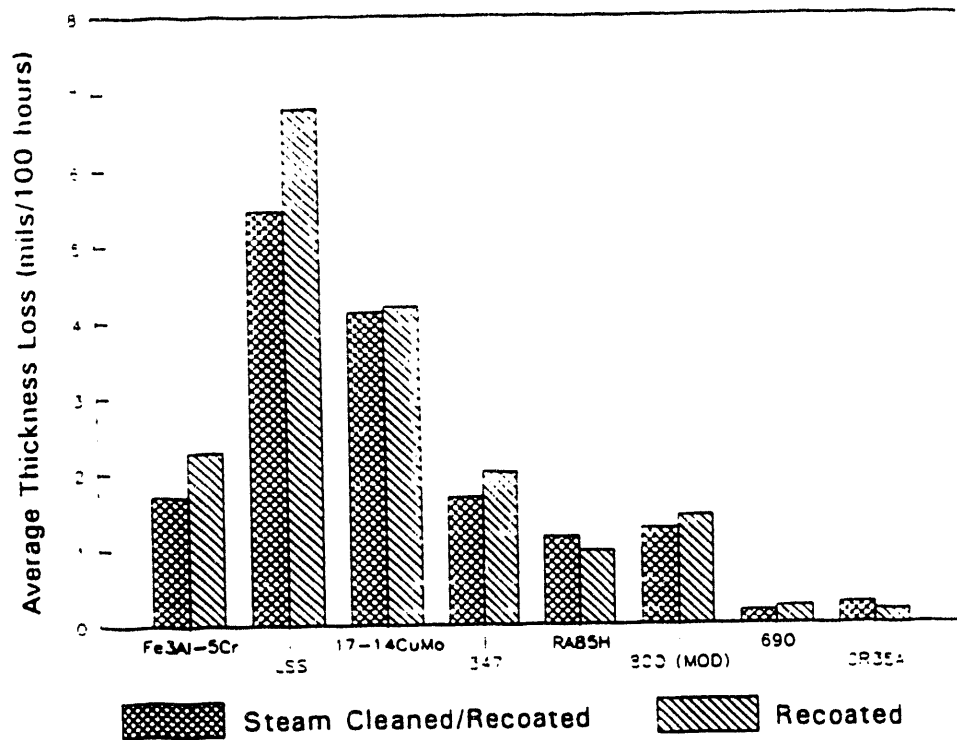
FIGURE 7 - Average thickness loss rates of representative alloys coated with ash containing 10 wt% alkali sulfates and exposed at 700°C (1292°F) for 800 hours to flue gas containing 1.0 vol% SO₂

The specimens that had the preexisting ash layer removed between cycles suffered slightly less attack than those that had fresh ash added atop the older ash layer (Figure 7). The corrosion rates of specimens cleaned between cycles may be lower because an induction period is needed for the alkali-iron trisulfate to reform. Specimens with an intact ash layer would be exposed to molten trisulfates as soon as they reached temperature.
