Fabrication and Testing of a Nonstandard Thin-Film Heat Flux Sensor for Power System Applications

FABRICATION AND TESTING OF A NONSTANDARD THIN-FILM HEAT FLUX
SENSOR FOR POWER SYSTEM APPLICATIONS

MASTER OF SCIENCE IN MECHANICAL ENGINEERING

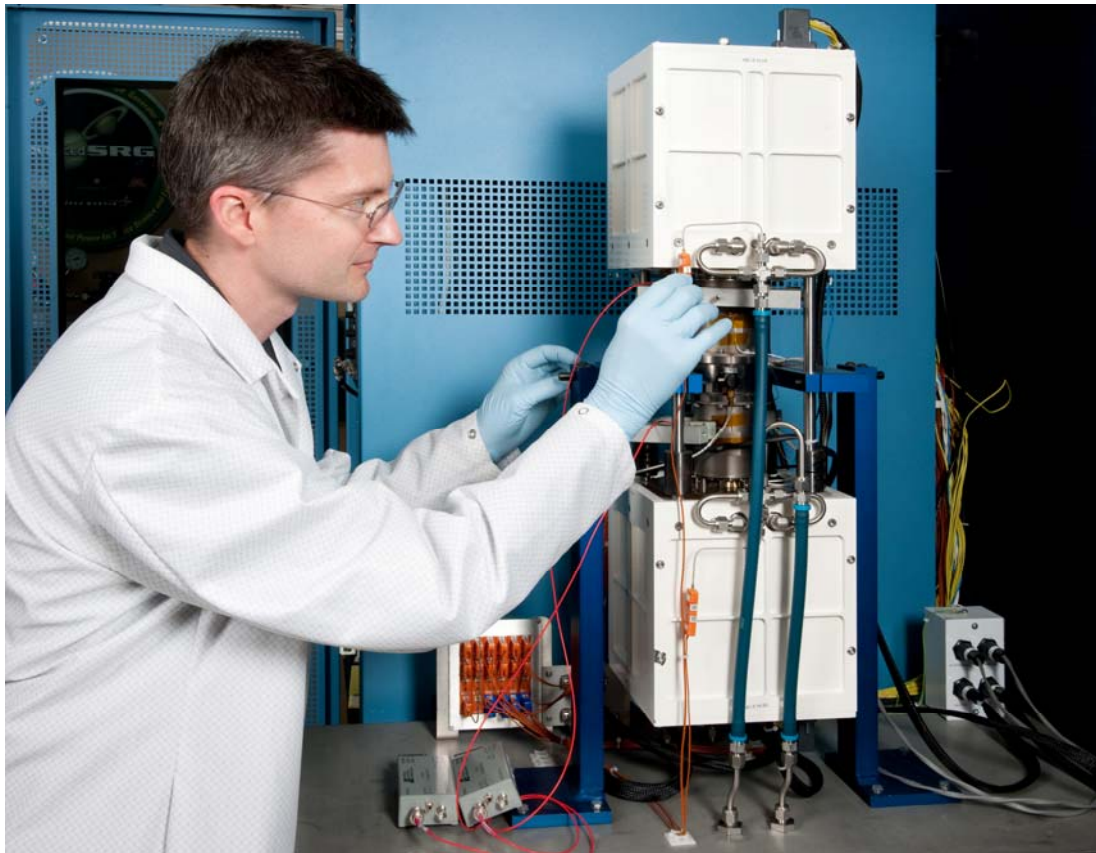
Figure 2. Test Setup for Advanced Stirling Convertor Engineering Unit (ASC-E).

The sensors were planned for use in testing the Advanced Stirling Convertor Engineering Unit (ASC-E) serial numbers #1 and #4.¹⁰ The convertors were planned for extended operation testing used to accumulate hours of operation for life and reliability purposes. The test setup is shown in Figure 2 along with the author. Each Stirling laboratory test setup is supported using an electronics rack which records performance data, enables fault protection against anomalous operation, and provides control over the convertor operating parameters such as temperatures, operating frequency, and piston stroke. The white boxes, shown in Figure 2, house the insulation, the hot end of the convertor, and electric heater. One heat flux sensor is installed in each white box.

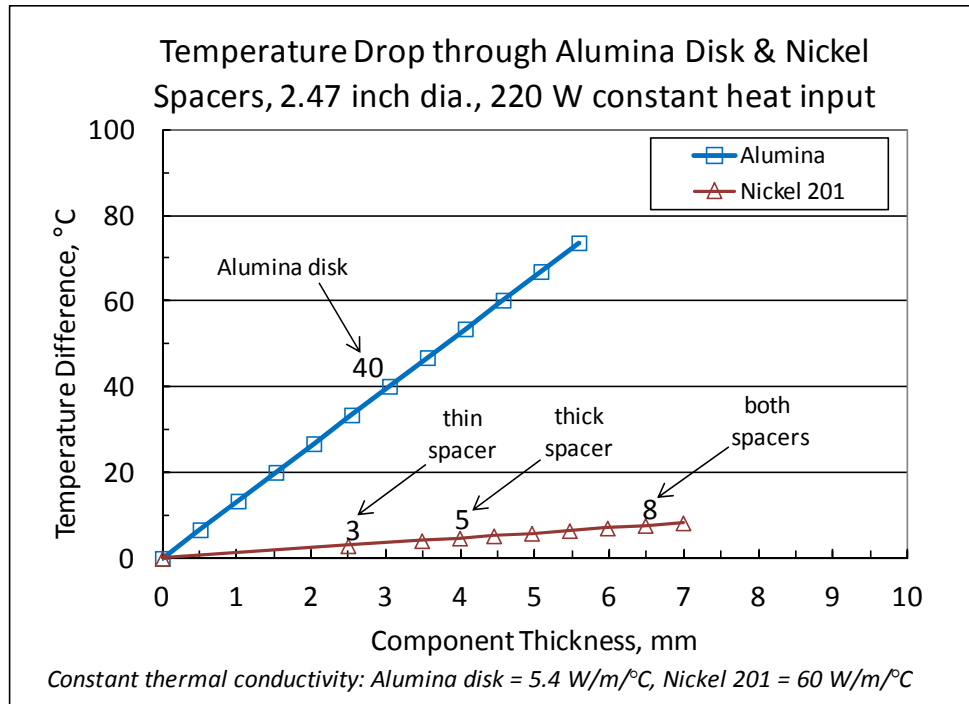
Figure 5. Analytical Results for Axial Temperature Drop.

Figure 5 shows the individual temperature difference across the Alumina ceramic disk and the both nickel spacers used in the heat flux sensor assembly for the 220 W heat flow case (nominal value expected in application). Figure 6 shows the resulting axial temperature profile through the heat flux sensor assembly. The resulting temperature drop through the thick spacer, ceramic disk, and thin spacer were 3 °C, 40 °C, and 5 °C, respectively.

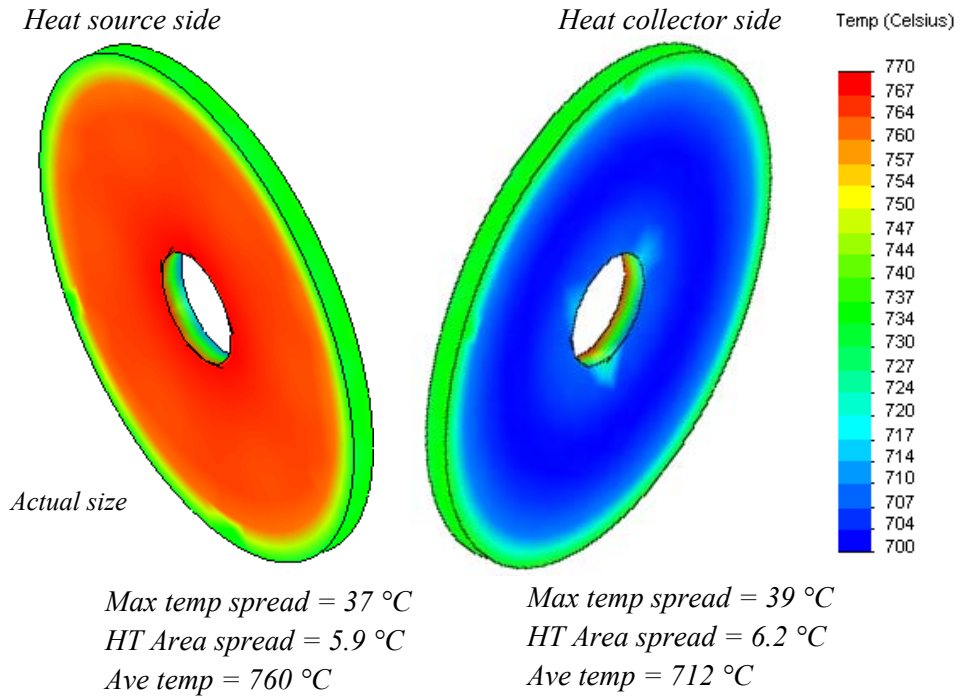
Figure 9. FEA Temperature Results for Alumina Ceramic Disk, *Both Sides Shown*.

The FEA generated temperature gradients shown in Figures 8, 9, and 10 are results from the unlikely case of 360 W heat input. The exploded view of the assembly and both sides of the heat flux sensor are shown. The proposed implementation used Alumina coated spacers to protect the thin metallic films from diffusing into the nickel ASC-E heat collector and heat source. One disk was made to be thicker in an attempt to better distribute nonuniform temperature gradients expected from the locally heated zones directly under the heaters. The FEA results, seen in Figure 8, did show local heat zones in a cartridge heater pattern on the thicker nickel spacer and a relatively uniform circular temperature profile on the mating face of the ceramic disk itself, suggesting that the spacer thickness was sufficient for achieving an significantly improved temperature distribution.

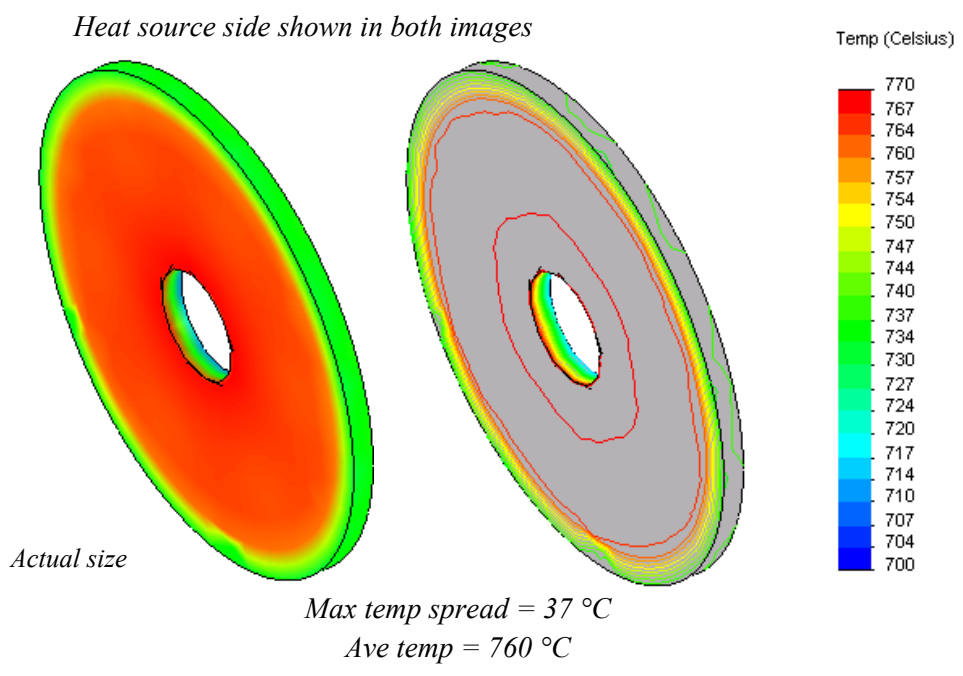
Figure 10. FEA Temperature Results for Alumina Ceramic Disk, *Hot Side Only*.

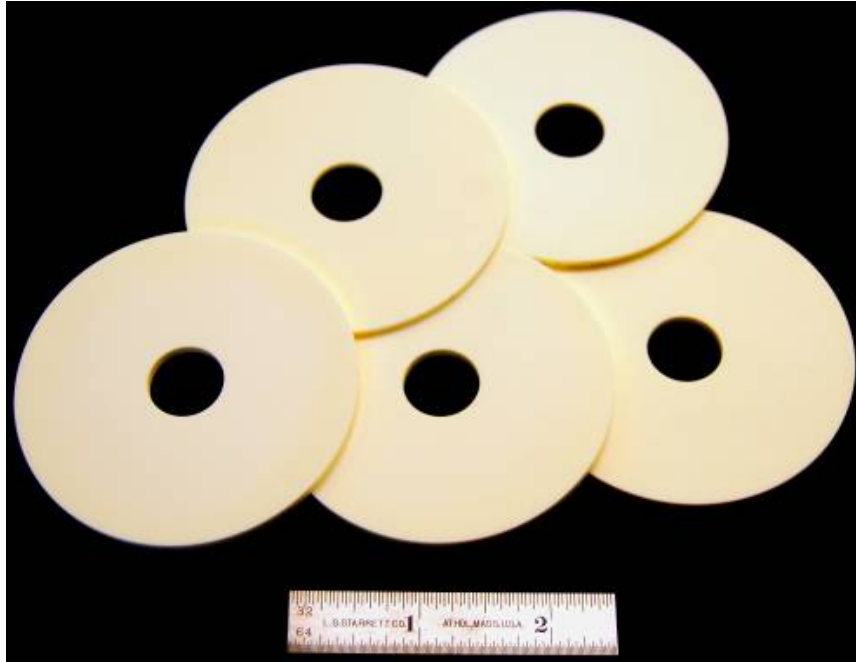
Figure 11. Production Alumina Ceramic Substrates.

The ceramic substrate thickness was chosen for the Stirling application based on an assumed robustness of a roughly 1/8 inch thick disk and the desire to maximize the temperature difference and sensor output. The Alumina substrates shown in Figure 11

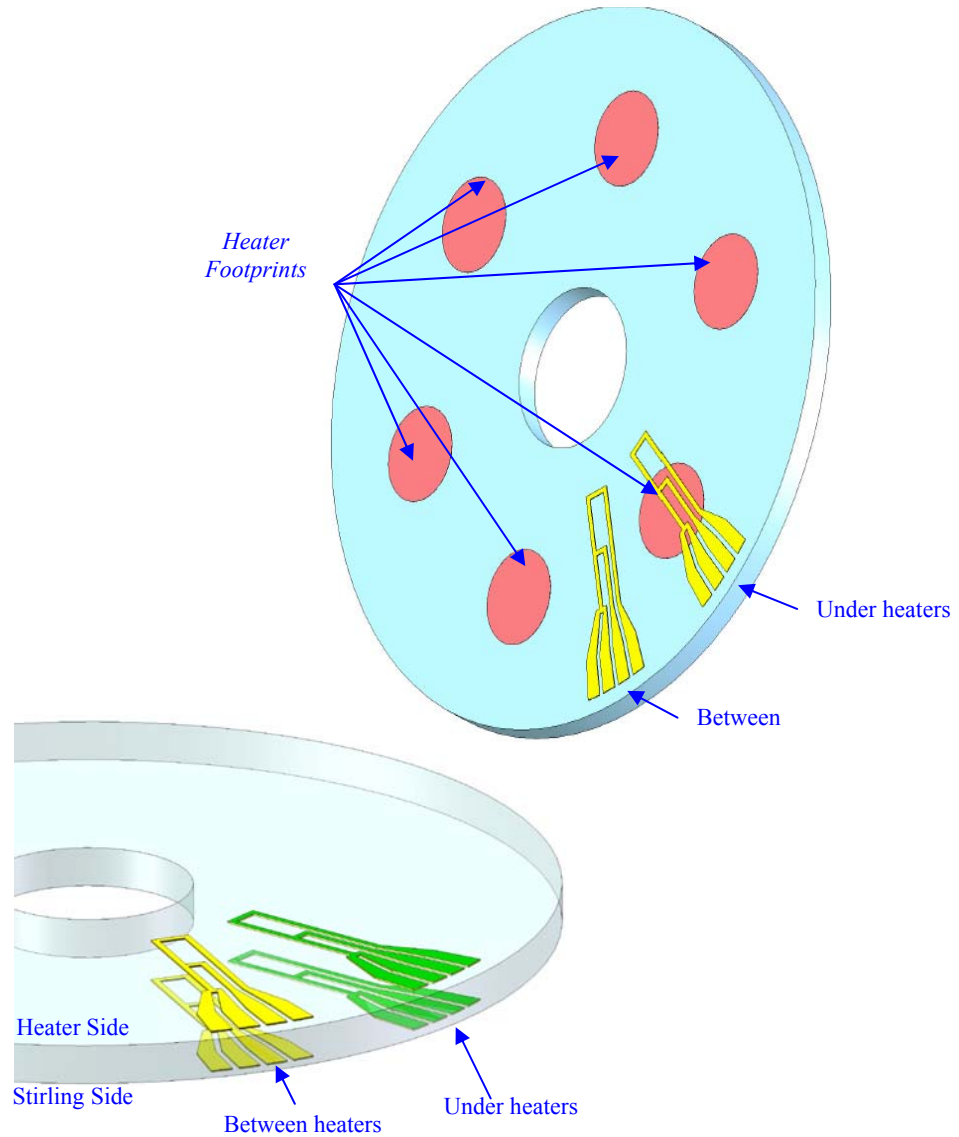
Figure 15. Thermocouple Arrangement.

Each side of the sensor has an arrangement of (12x) thermocouple arrays although only two arrays are wired and the other 10 serve as spares in case wire connections were not successful or some of the films were damaged during fabrication.

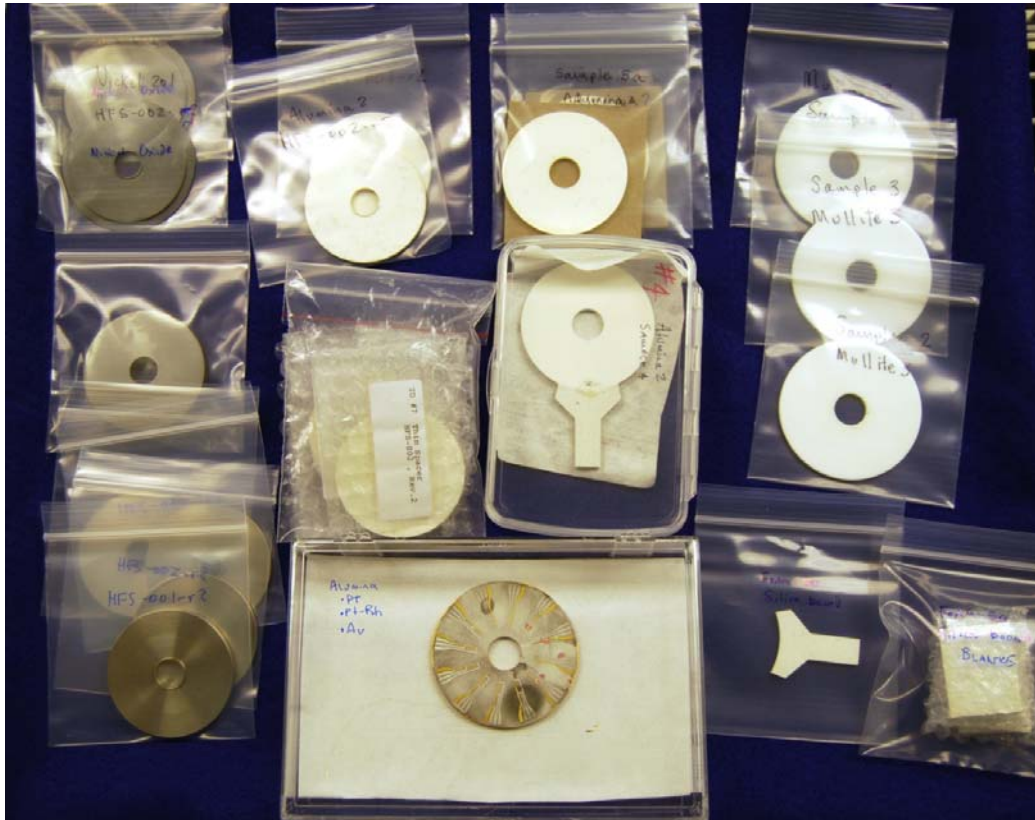
Figure 27. Ceramic and Metallic Test Samples for Robustness Testing.

Six combinations of test article were tested including Alumina and Mullite ceramic substrates, nickel and Alumina spacers, and nickel disks with and without nickel oxide layers and aluminum oxide layers. Figure 27 shows the numerous test samples tested.

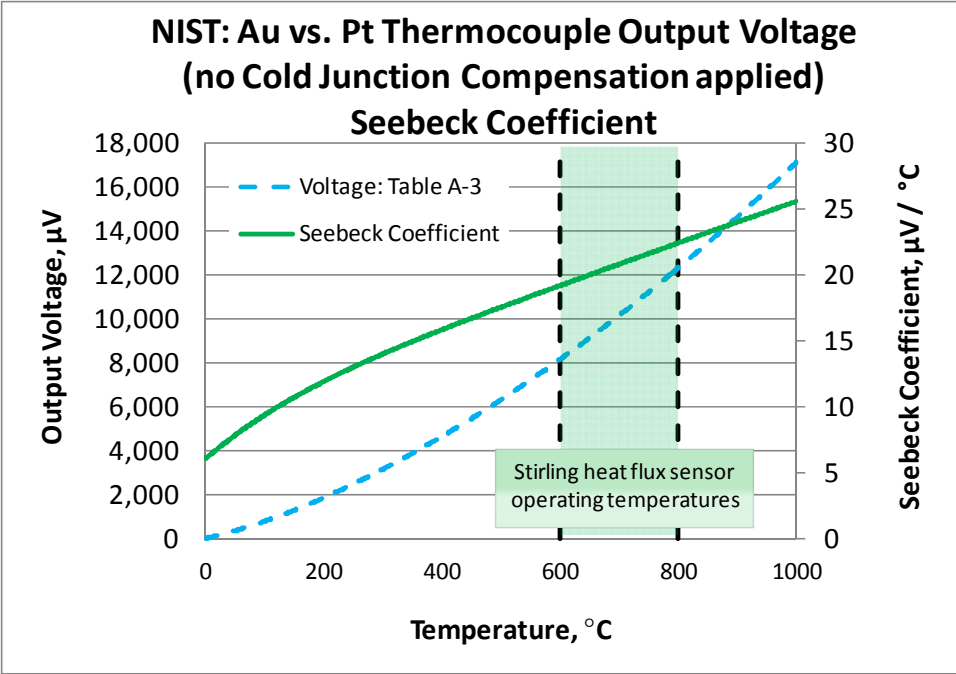
Figure 30. Output Voltage (Table A-3) and Seebeck Coefficient.

The output available from Au vs. Pt thermocouples ranges from 6 to 17,000 μV while the thermocouple signal strength expected during steady state operation in the Stirling application ranges from 8,000 to 12,000 μV . Similarly, the total output resolution, or Seebeck Coefficient, ranges from 6 to 25 $\mu\text{V}/^\circ\text{C}$ while the output resolution expected during steady state operation in the Stirling application ranges from 18 to 24 $\mu\text{V}/^\circ\text{C}$.

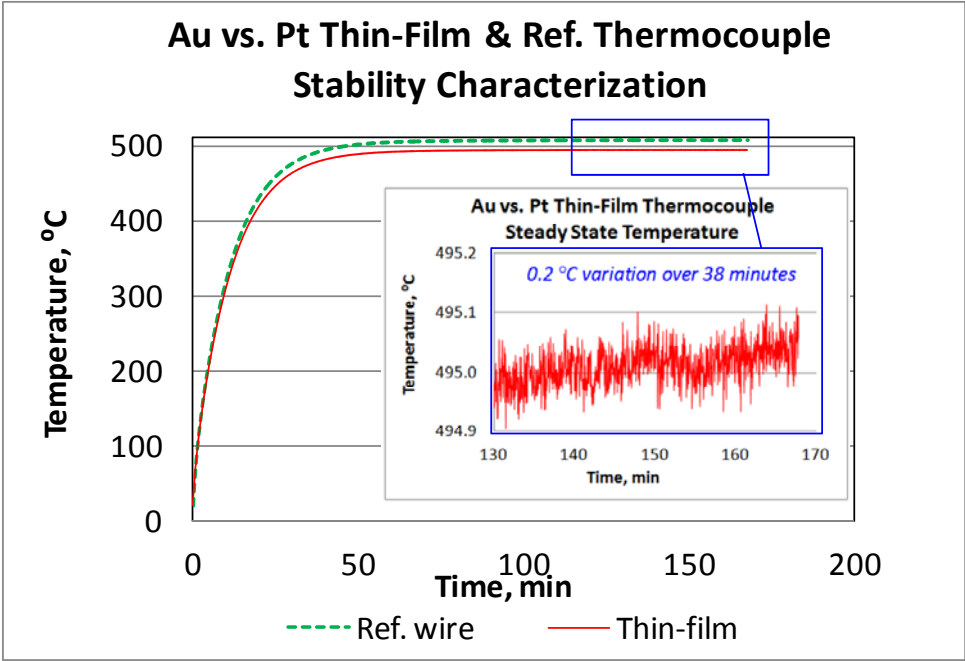
Figure 38. Au vs. Pt Thin-Film & Ref. Wire Thermocouple Test Temperatures.

The second characterization study was a steady-state test used to characterize the stability of the thin-film thermocouple. The test setup maintained a steady-state temperature of 495 °C (heater temperature limit). Throughout the test, LabVIEW was commanded to record the emf voltages at a scan frequency of 2 seconds. The emf voltages from both thermocouples were then converted to temperature using the NIST reference functions and the cold junction temperature. Figure 38 shows the temperature data from the thin-film and reference wire thermocouple. The maximum temperature variation was about 0.2 °C, mostly because the temperatures were still slowly increasing. Plotting the same data over only ten minutes results in about 0.1 °C variation. This variation was on the order of what was expected from a Au vs. Pt thermocouple.

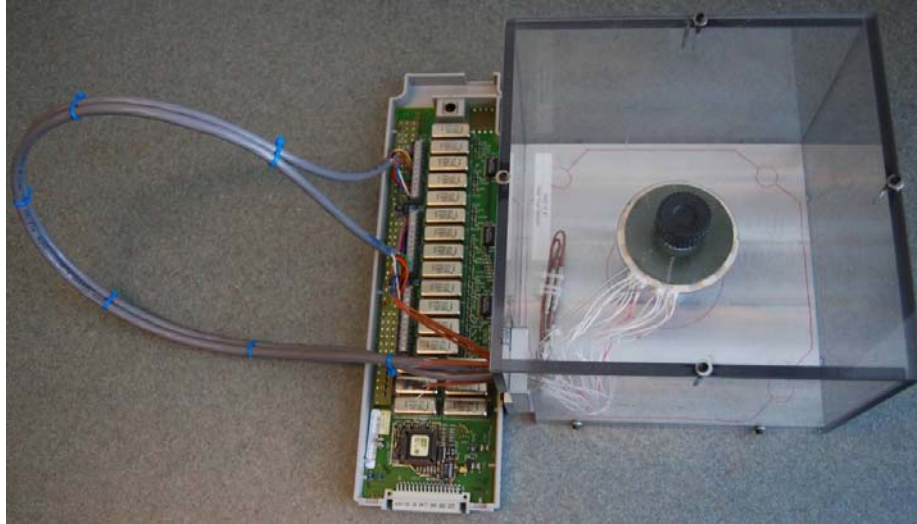
Figure 39. Completed Sensor & Spacer Assembly Wired to Agilent Multiplexer Card.

After the cold junction compensation and NIST calibration tables had been programmed into the DAS, the final assembly was tested using the Agilent data logger. Figure 39 shows the finished sensor wired up to the multiplexer card for use in the Agilent data logger. When this step was performed on Sensor 2, a gold leg was found to have failed since the initial delivery. Sensor 2 had been delivered with one failed gold junction so an additional failed common leg rendered the sensor unable to measure heat flux on one entire station. This indentified the issue of low bond strength between the gold films and Alumina substrate. The work performed to mitigate this issue is discussed in the conclusions. Table III shows the D-subminiature connector pin-out diagram used to connect the extension wire to the Agilent and Figure 40 shows a graphic to complement the table.

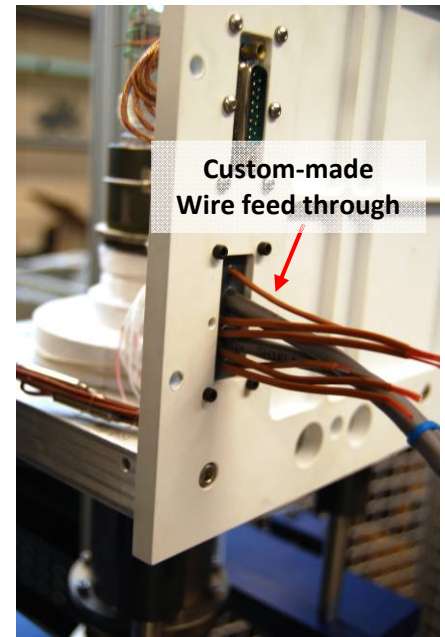
Figure 42. ASC-E #1 & #4 Test Setup Assembly.

(D) Exterior view of custom-made wire feed through.

The convertors were installed onto the enclosure base with one vertical wall installed. Microporous insulation Parts A, B, and C were installed and the CSAF and hot-end thermocouples were routed to a separate D-sub connector, shown in Figure 42 (A). The caption for each component installed during the assembly process is highlighted with red text in Figures 42 through 44. The heat flux sensor installation was a delicate process where the sensor was lowered into position by using forceps to hold the inner diameter of the ceramic substrate. Great care was given to minimizing the distance of travel from the holding fixture to the convertor heat collector.

Figure 42 (B) shows the sensor wires loose and unorganized and the heat source present as part of an orientation checkout. The wires were then carefully bundled together so as not put any tension on any of them, as shown in Figure 42 (C). Finally, Figure 42 (D) shows the un-terminated Type-T and Type-N thermocouples and copper extension wire feeding through the aluminum enclosure. The enclosure was originally designed and tested with an Argon environment inside of the box because Type-R thin-films were originally planned and the heat source life would benefit from the inert environment. The enclosure turned out to contain too many gross leaks, making it difficult to maintain an Argon supply over the 10,000 hours of operation. The Argon supply was replaced a few times before it was decided to drop the capability from the scope of the test. Not having the inert environment was not believed to have a significant impact on preventing oxidation of the gold or platinum films, and the nickel parts were not at high risk of oxidation due to the relatively low test temperatures.

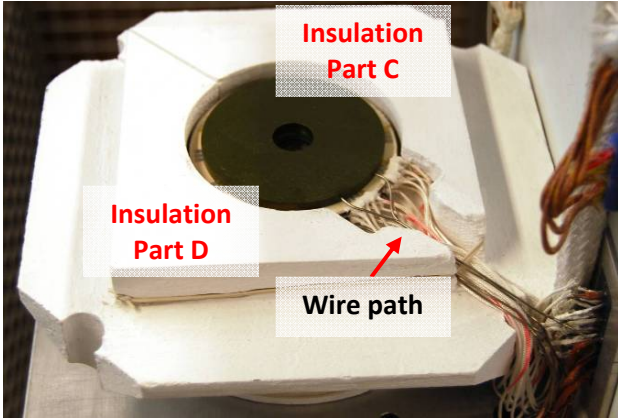
(A) Insulation Part C , Part D, and wire path.

Figure 43. ASC-E #1 & #4 Test Setup Assembly.

The wire path used to protect the delicate sensor wires is clearly shown in Figure 43 (A). With Insulation Part C installed and wires routed and partially bundled, Part D was installed to create the wire path. Insulation Part E simply fit over the top, ensuring that the wires were not crushed or pinched. The wire path can be seen from a top view in Figure 43 (C) and from a side view where the wires exit through a small window in Figure 43 (D). The exit window was carefully stuffed with blanket insulation to prevent line-of-sight losses. With Insulation Part E in position, the heat source assembly was installed along with the rest of the insulation parts. Figure 44 shows the sequence in which Insulation Parts F, G, H, and I were installed. The remaining enclosure walls were installed and a mechanical load was applied to the heat source at room temperature.

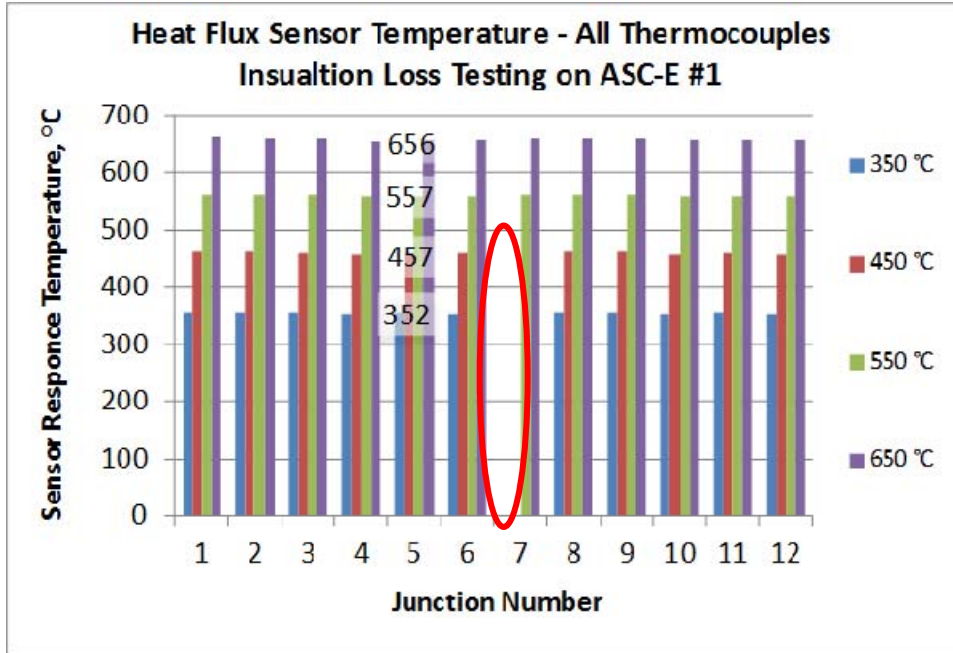
Figure 45. ASC-E #1& #4 Insulation Loss Test Data.

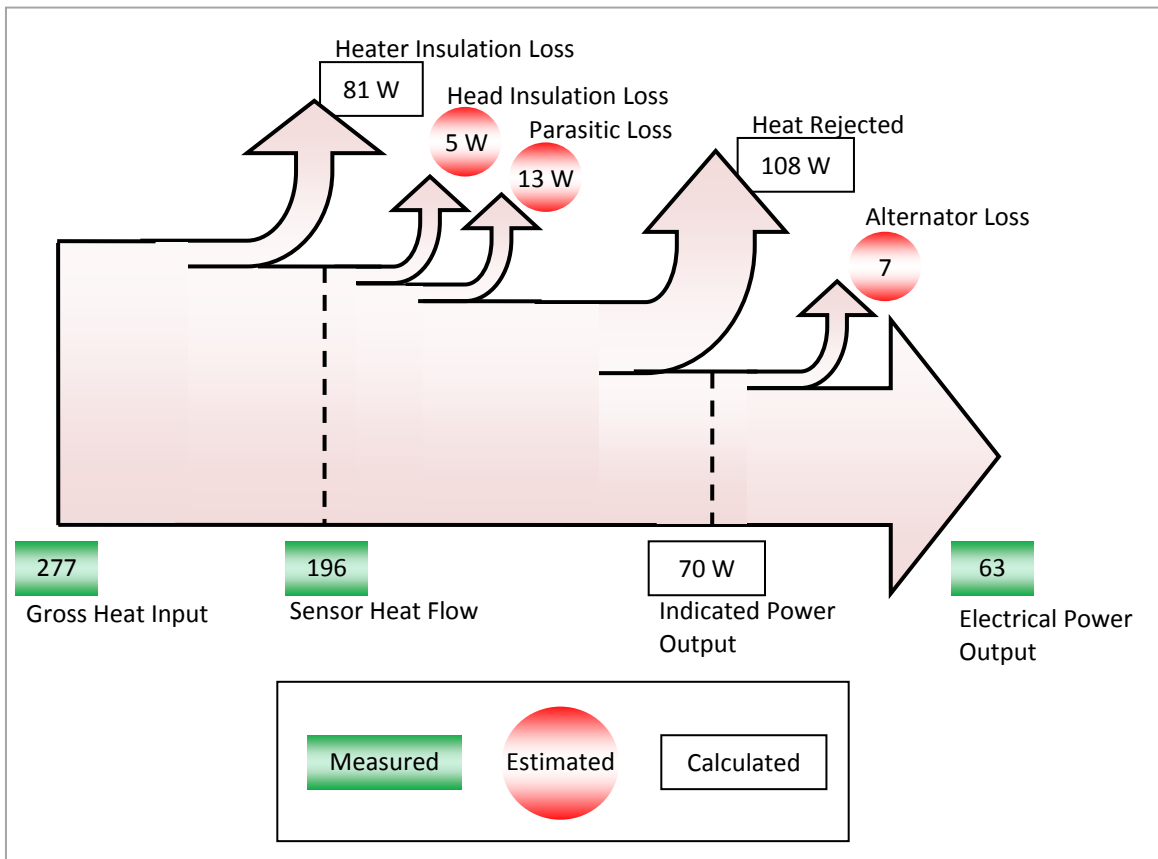
Figure 82. Sankey Diagram of ASC-E #1 Energy Balance Performed at 9,000 hrs.
