Hydrologic and Water Quality Assessment of Miller Run: A Study of Bucknell University's Impact

An Honors Thesis Submitted to the Honors Council

For Honors in Environmental Studies

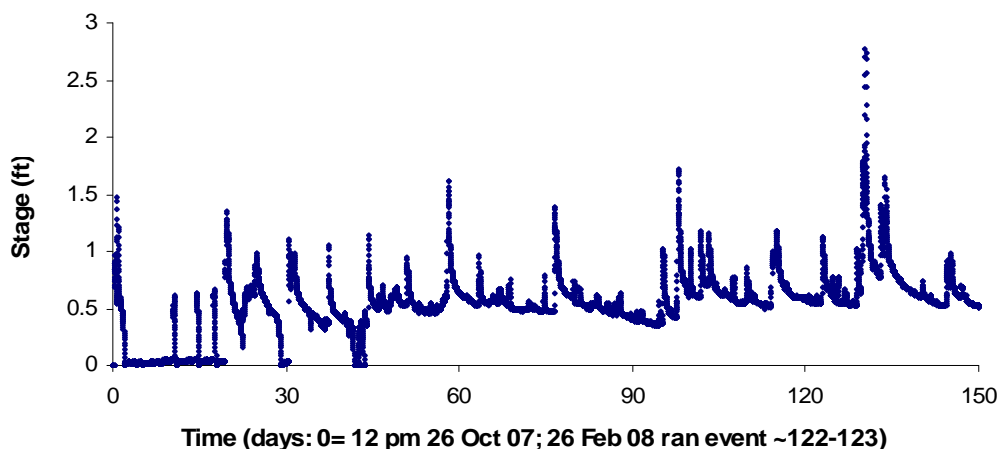
Figure 8: Hydrograph of the downstream site from 26 Oct 2007 to 30 Mar 2008 in days after the stage gauge installation on 26 Oct 2007. The 26 Feb 2008 rain event is located at 122-123 days.

upstream site starting in early December (Table 1). Peaks in the hydrograph represent high flows during rain events (Figure 8). A stage of 0 ft indicates that the stream was dry when there was no rain, suggesting that the downstream reach of the stream was not being continually fed by groundwater. Average stage during base flow conditions for the downstream site ranged from 0 ft in October to about 0.6 ft in February. The hydrograph for the 26 Feb 08 rain event at the upstream site had to be constructed manually since a stage gauge was not installed at this site. Unlike the downstream site, which was dry up until 9 Dec 07, the upstream site maintained visible flowing water from at least 2 Dec 07 to 30 March 08. The upstream site was not as affected by the dry climatic conditions as

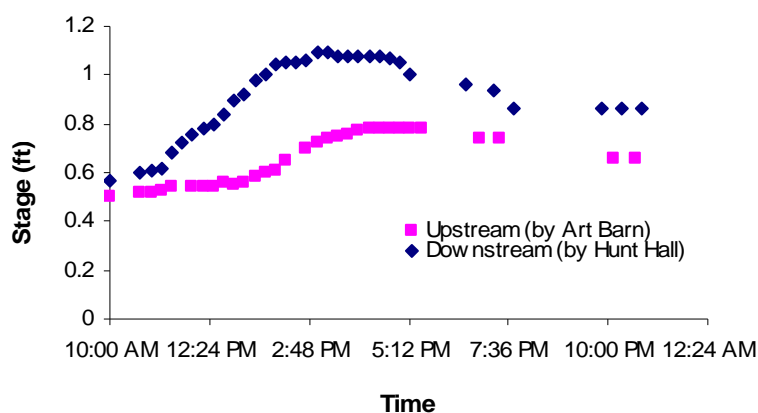
Figure 10: Upstream and downstream comparison of stage over time during 26 Feb 2008 rain event.

The start of the 26 Feb 08 rain event (at 10:00 AM) was characterized by light rain and sleet. Starting at 10:15 AM, a slow, steady rain persisted for 7.25 h (the rain ended at 5:30 PM), generating 0.59 inches of rain over this period. Stage increased at a faster rate and reached a higher maximum level at the downstream site (peak 1.09 ft, 1.42 ft/h) compared to the upstream site (peak 0.78 ft, 0.05 ft/h) (Figure 10). Comparatively, stage peaked earlier downstream than upstream (5 h and 6.25 h after the start of the rain event, respectively). At both sites, once stage peaked, it gradually decreased over the remainder of the sampling period, with water levels decreasing at a faster rate downstream compared to upstream.

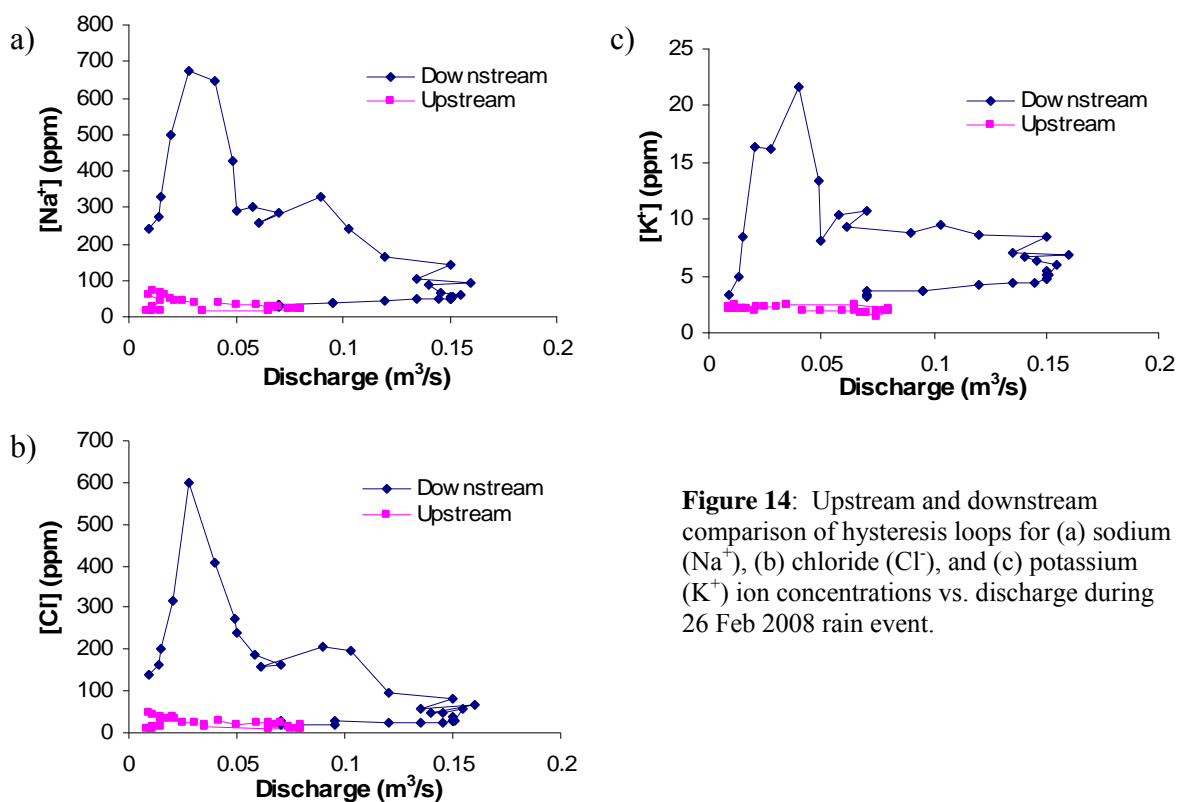
Figure 14: Upstream and downstream comparison of hysteresis loops for (a) sodium (Na^+), (b) chloride (Cl^-), and (c) potassium (K^+) ion concentrations vs. discharge during 26 Feb 2008 rain event.

Concentrations increased at 23.72 ppm/h for sodium, 15.53 ppm/h for chloride, and 0.06 ppm/h for potassium at the upstream site. Rates of increase at the downstream site were much higher (286.05 ppm/hr for sodium, 308.49 ppm/hr for chloride, and 12.61 ppm/hr for potassium). Hysteresis loops for sodium, chloride, and potassium (concentration vs. discharge) were all clockwise positive loops (Figure 14). For all three ions, the upstream loop is smaller and flatter as compared to the downstream loop, which shows a sharp spike in concentration in the rising limb of the loop.

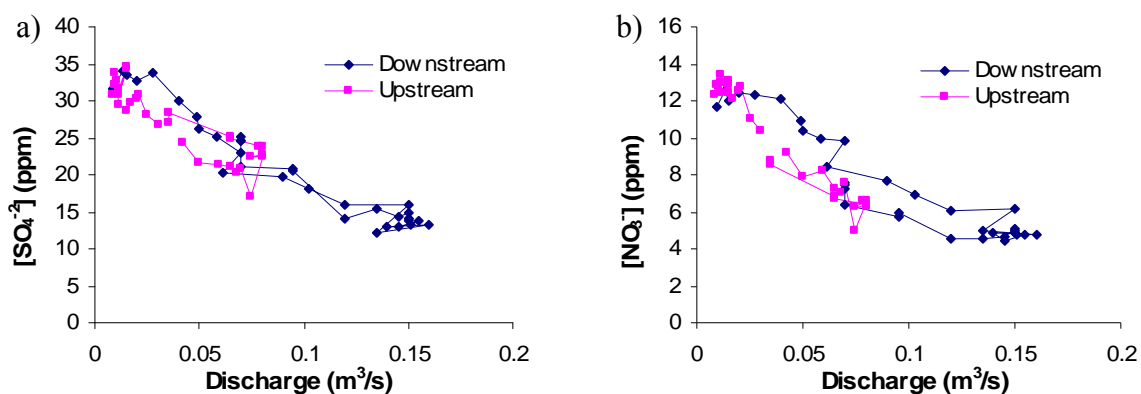
Figure 18: Upstream and downstream comparison of hysteresis loops for (a) nitrate (NO_3^-) and (b) sulfate (SO_4^{2-}) ion concentrations vs. discharge during 26 Feb 2008 rain event.

Similar to calcium and magnesium, the hysteresis graphs do not show distinct circular loops; rather, they show elongated, almost linear patterns of decreasing concentration with increasing discharge followed by increasing concentration with decreasing discharge (Figure 18). The only data set that resembles an elongated, clockwise ‘loop’ shape is the downstream nitrate concentrations, which shows higher

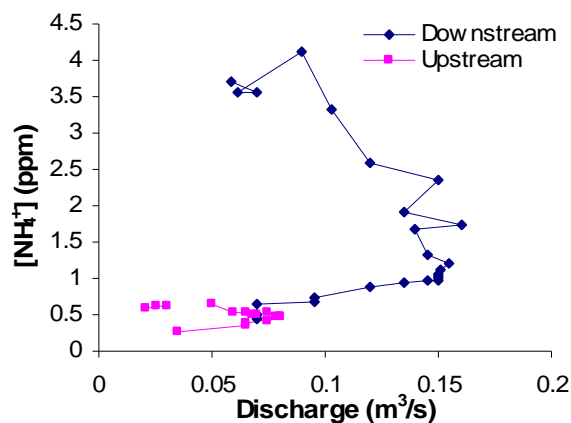
Figure 20: Upstream and downstream comparison of hysteresis loops for ammonium concentrations vs. discharge during 26 Feb 2008 rain event

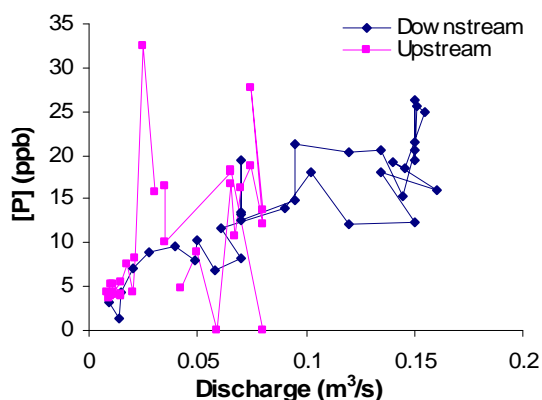
Figure 22: Upstream and downstream comparison of hysteresis loops for soluble reactive phosphorus concentrations during the 26 Feb 2008 rain event.

both sites, with some degree of variability. Neither site showed a distinct hysteresis pattern; however, upstream peaks in SRP are distinguishable (Figure 22). As a general pattern, the downstream 'loop' extended horizontally in an almost linear pattern, with a very slight increase in SRP concentration as discharge increased, followed by a slight decrease in SRP concentration as discharge decreased. The upstream 'loop' did not

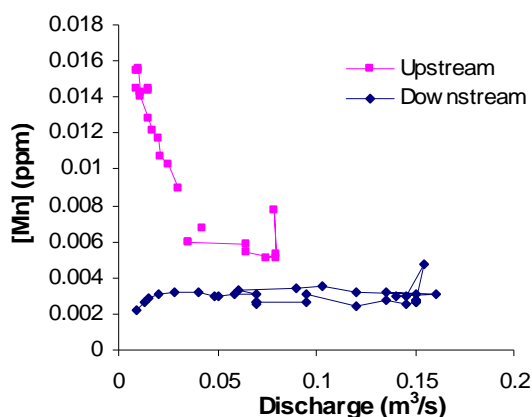
Figure 24: Upstream and downstream comparison of hysteresis loops for dissolved manganese during 26 Feb 2008 rain event.

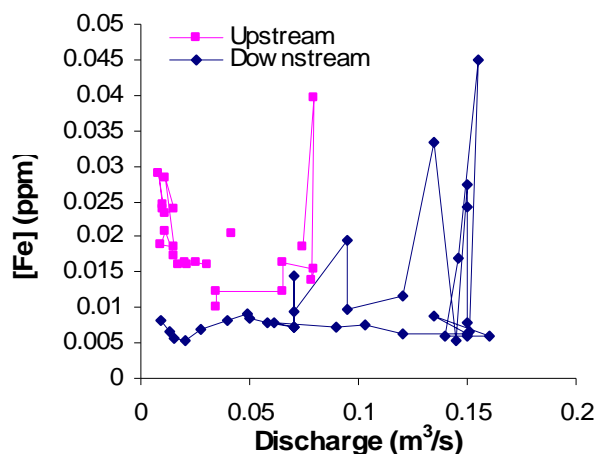
Figure 26: Upstream and downstream comparison of hysteresis loops for dissolved iron during 26 Feb 2008 rain event.

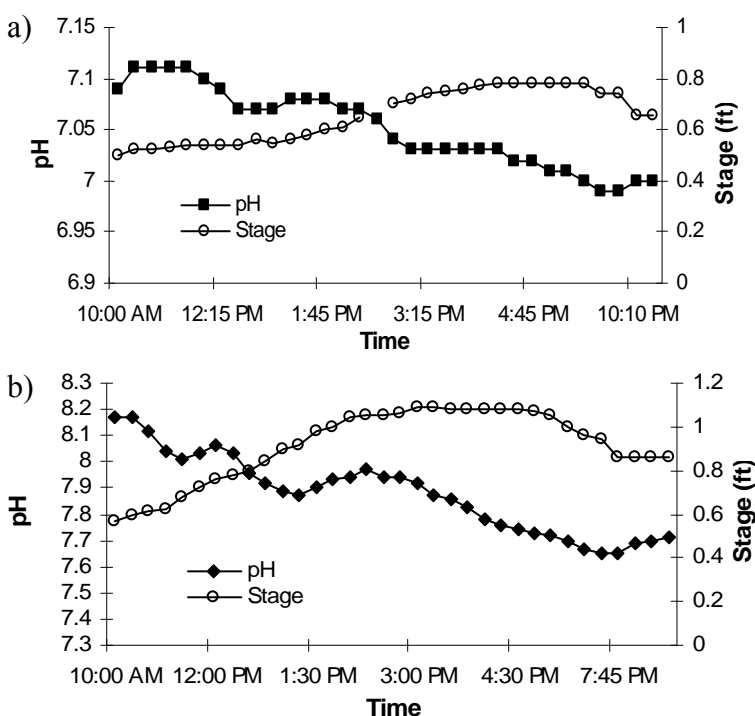
Figure 28: Comparison of stage and pH at (a) upstream site and (b) downstream site during the 26 Feb 2008 rain event.

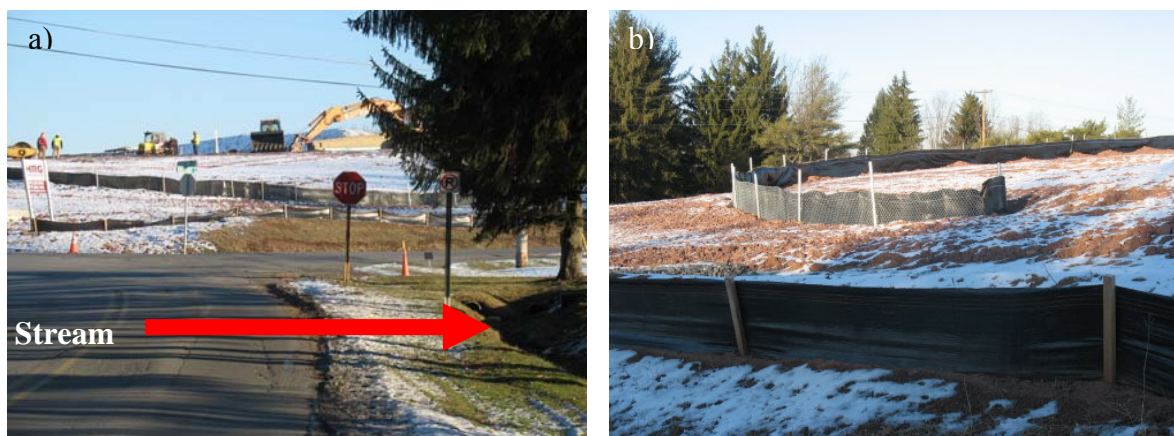
Figure 32: (a) Upstream construction site between Smoketown Road and Beagle Club Road. (b) Construction site with sediment guards.

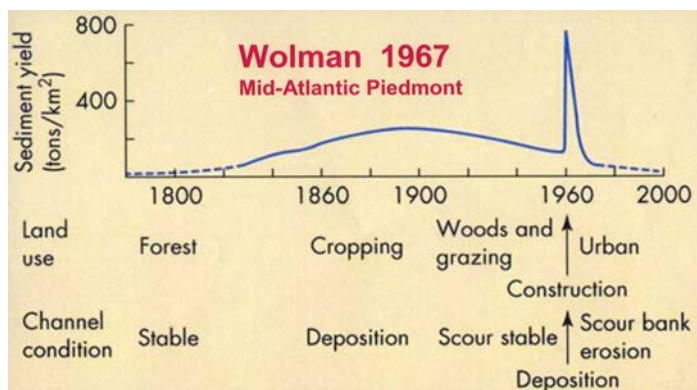
Figure 33: Land-use, sediment yield, and channel response in a watershed (Wolman 1967).

Based on the above evidence, the excess sediments from the construction site provided one major source of sediments in the stream. Typically, stream sediment loads dramatically increase during construction phases, leading to increased sediment deposition in the stream channel, as was seen in Miller Run (Wolman 1967) (Figure 33). However, once the construction is complete, the sediment dynamics will more than likely change once again, possibly reflecting sediment loads found in urbanized streams that are past the construction phase.

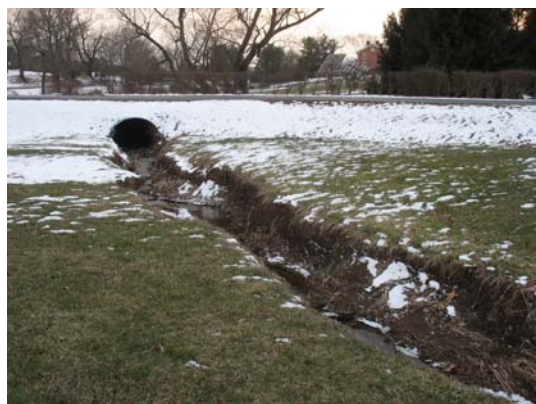
Figure 34: Highly eroded banks along the upstream reach of Miller Run (west of U.S. Highway 15).

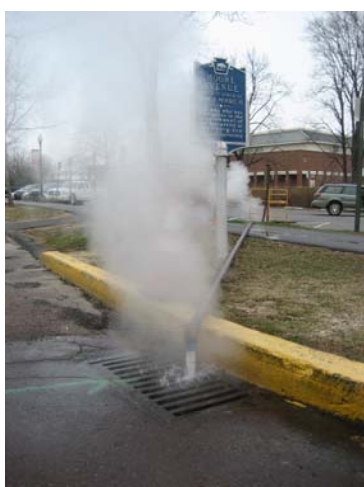
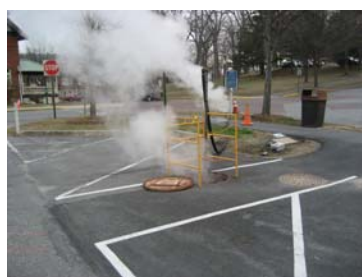
Figure 36: Hot storm water being removed from a manhole and pumped into a storm drain that flows directly into Miller Run (10 March 2008).

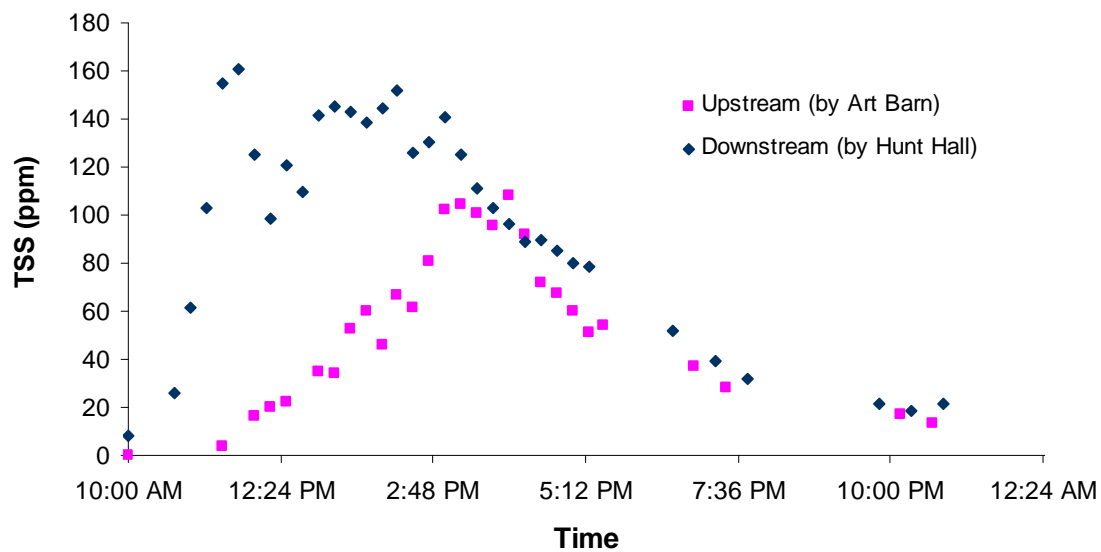
Figure 1: Upstream and downstream comparison of TSS concentrations over time during 26 Feb 2008 rain event.

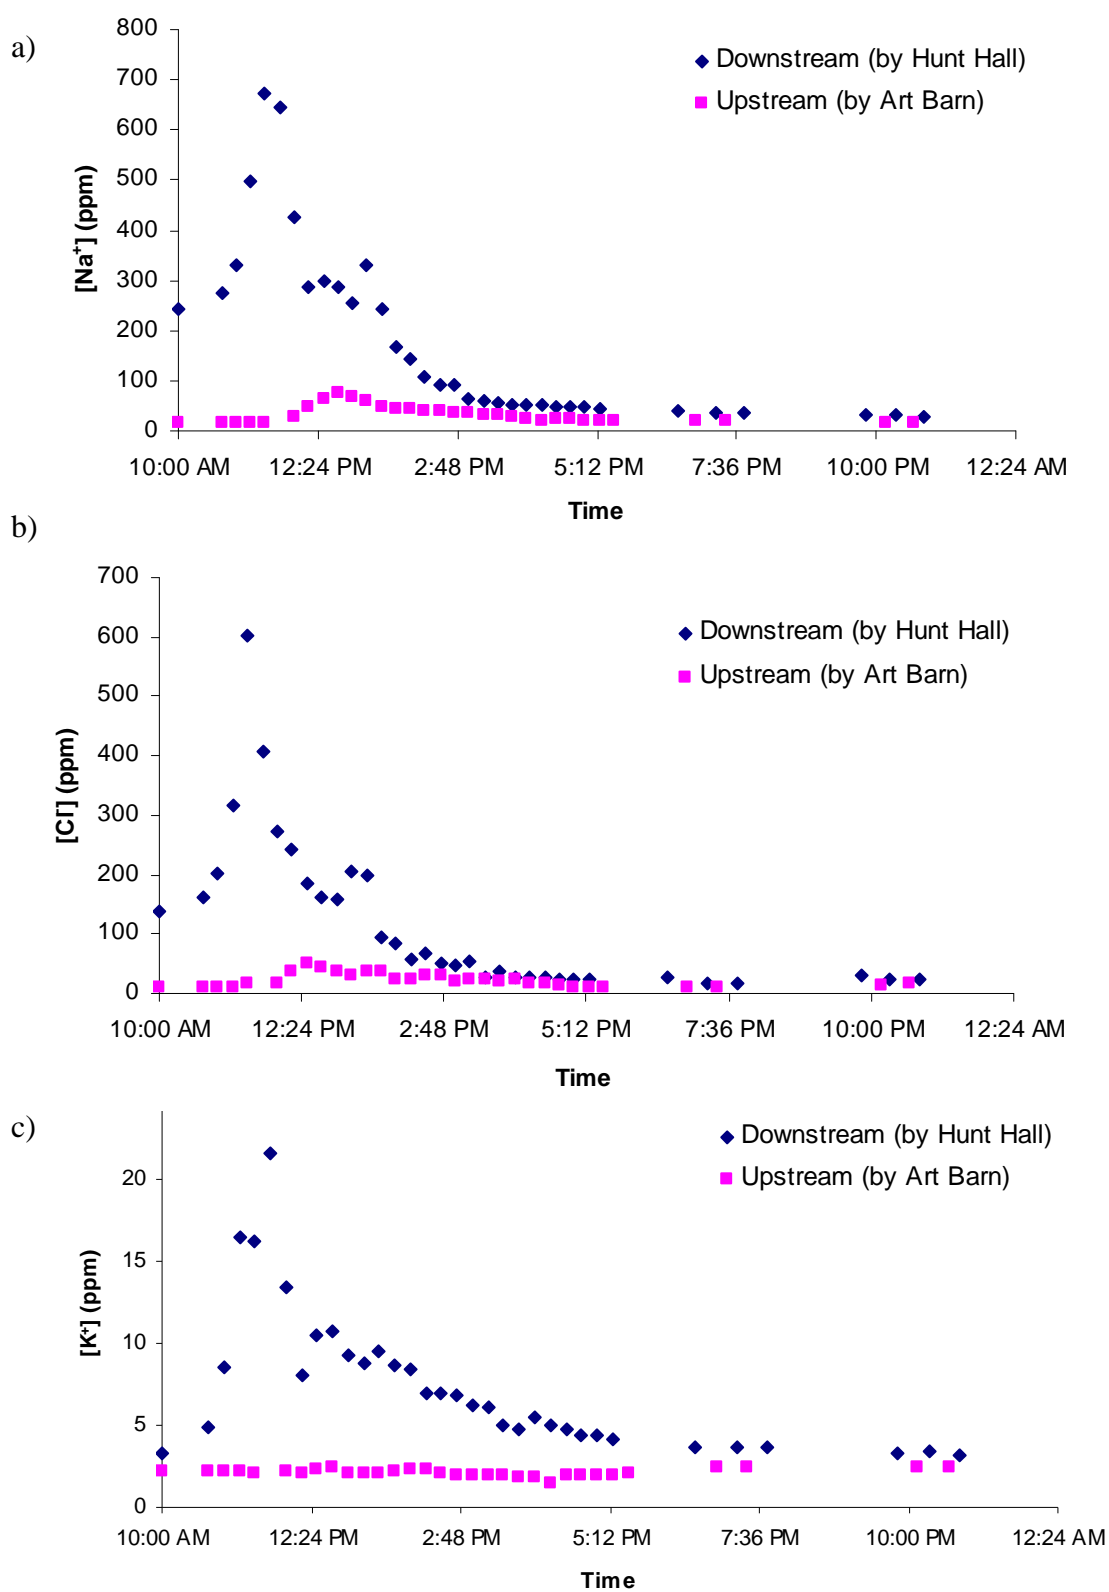
Figure 2: Upstream and downstream comparison of (a) sodium, (b) chloride, and (c) potassium concentrations over time during 26 Feb 2008 rain event.

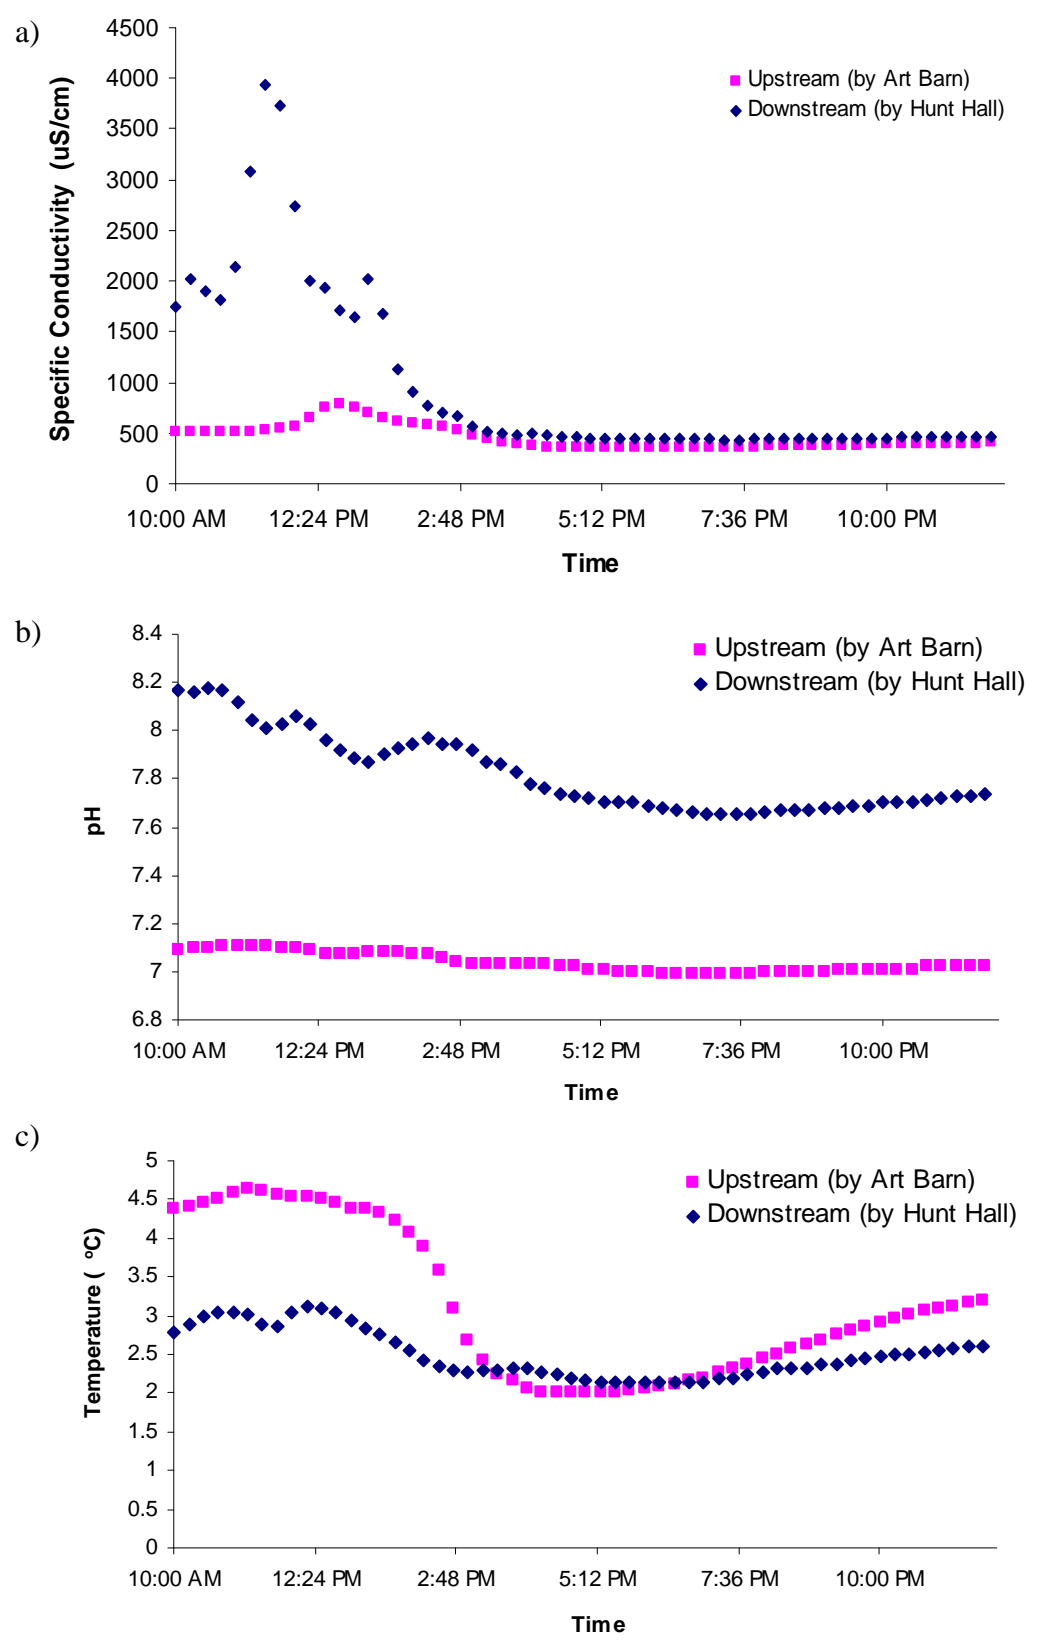
Figure 8: Upstream and downstream comparison of (a) specific conductivity, (b) pH, and (c) temperature during 26 Feb 2008 rain event.

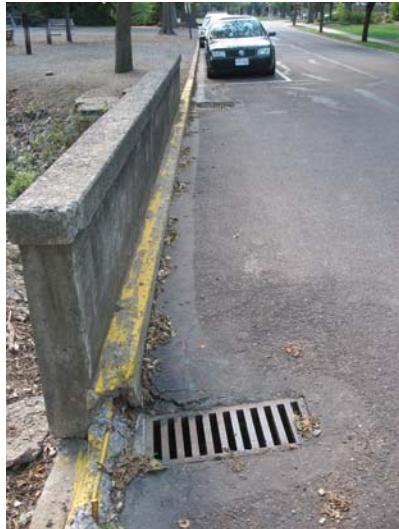
A

- A: Storm water drain on Loomis Street directly above Miller Run.
- B: Bridge under Art Building.
- C, D, E: Storm water pipes located in the downstream reach of Miller Run.
- F: Storm water drain next to Art Building.

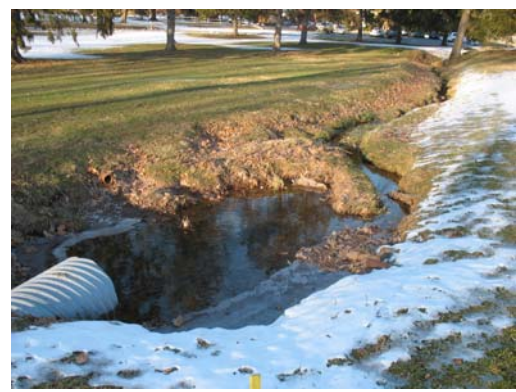
A

A, B: Upstream at the Bucknell Golf Course.
 C: 7-8 Mar 2008 rain event. Upstream reach of the stream (by Art Barn) reached bankfull and spilled over onto the flood plain.
 D: Drainage pipes in the stream at the golf course.
 E: Upstream reach of Miller Run, between the Art Barn and U.S. Highway 15, during a rain event.
 F: Upstream at the Bucknell Golf Course.

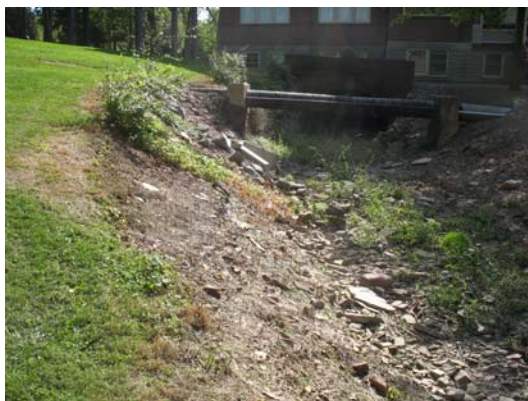
E

E: Downstream reach of the stream in front of the Art Building.

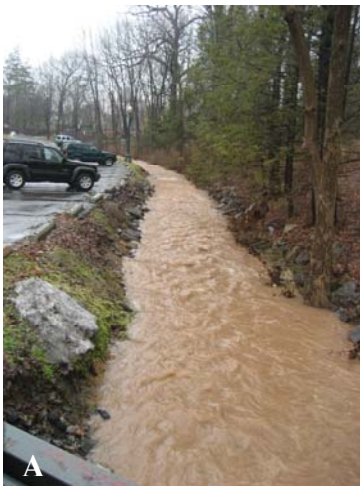
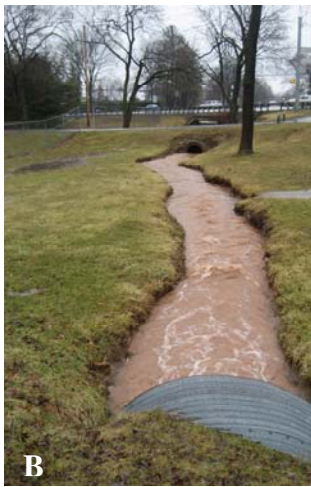
A, B: Downstream (A) and upstream (B) reach of the stream impacted by high sediment loads during 7-8 Mar 2008 rain event.

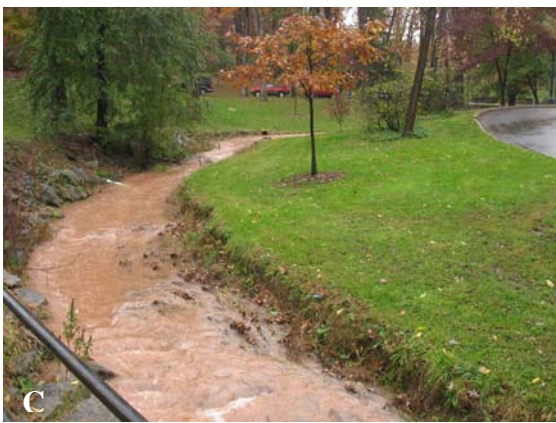
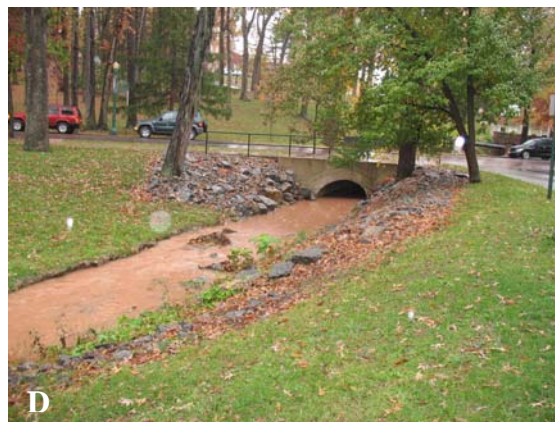
C, D: Downstream reach impacted by sediment runoff from construction site during 11 Nov 2007 rain event.

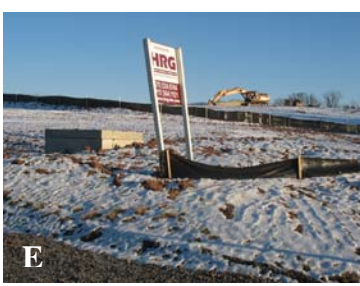
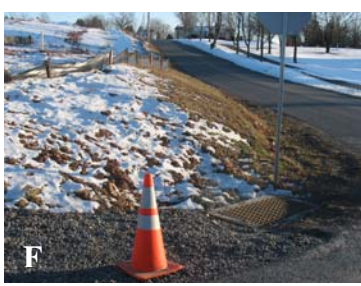
E, F: Upstream construction site along Smoketown Road. 23 Jan 2008

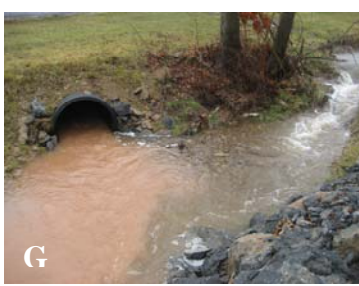
G: Confluence between small tributary (right) and main stem (left) of Miller Run. The tributary drains the northern half of the golf course and athletic fields. The main stem received direct runoff from the construction site (8 Mar 2008)

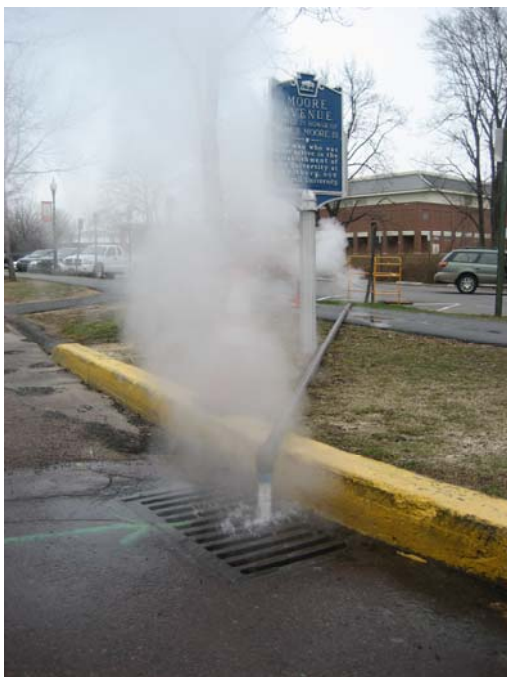
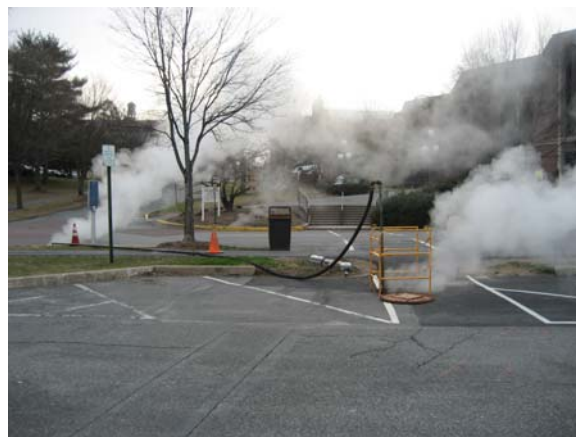
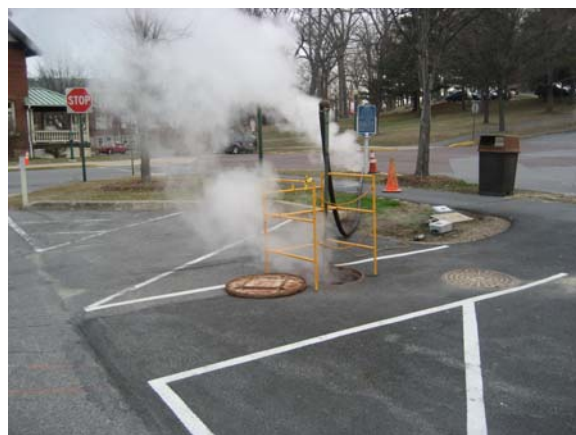
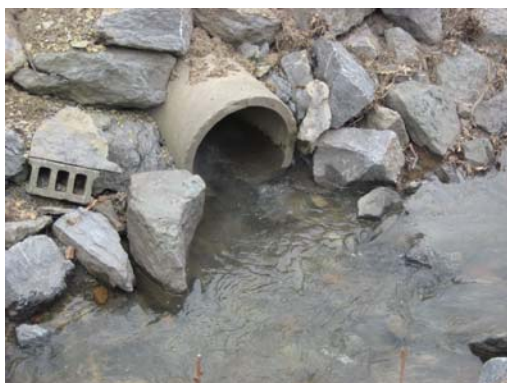
10 March 2008

Hot storm water being removed from a manhole and pumped into a storm drain that flows directly into Miller Run.

One important side note is that on 10 March 08, University facilities members were seen pumping hot water, approximately 52 °C, into the downstream reach of Miller Run (Figure 36). According to Dennis Hawley of Facilities, a steam manhole pump stopped working, thereby filling the manhole with water. The unwanted water was removed by pumping it into a storm drain, which leads directly into Miller Run, thus raising stream temperatures and specific conductivity dramatically (52 °C and 4150 µS/cm, respectively). Although not a frequent occurrence, this type of condition (i.e. extreme water chemistry fluctuation and temperature change) more than likely has a negative impact on aquatic organisms living in Miller Run.
