# Corrosion Characteristics And Mechanical Properties Of Aluminum Coatings Applied By The Cold Spray Process

Ben Bouffard  
*Bucknell University*

Presented to the Faculty of  
Bucknell University  
In Partial Fulfillment of the Requirements for the Degree of  
Master of Science in Mechanical Engineering

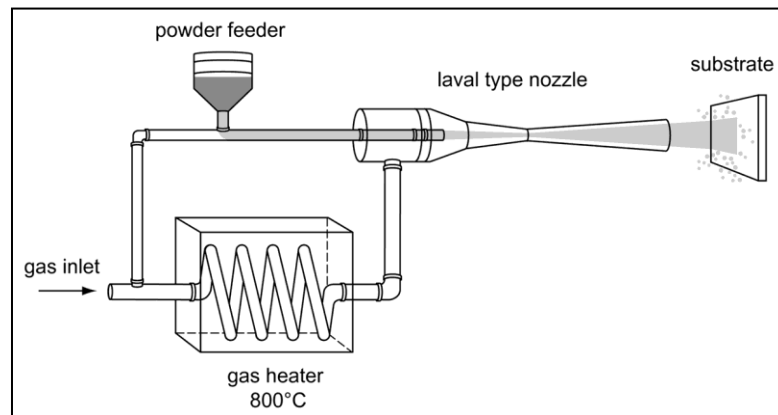
**Figure 2-2. Conceptual drawing of the cold spray equipment and process [16]**

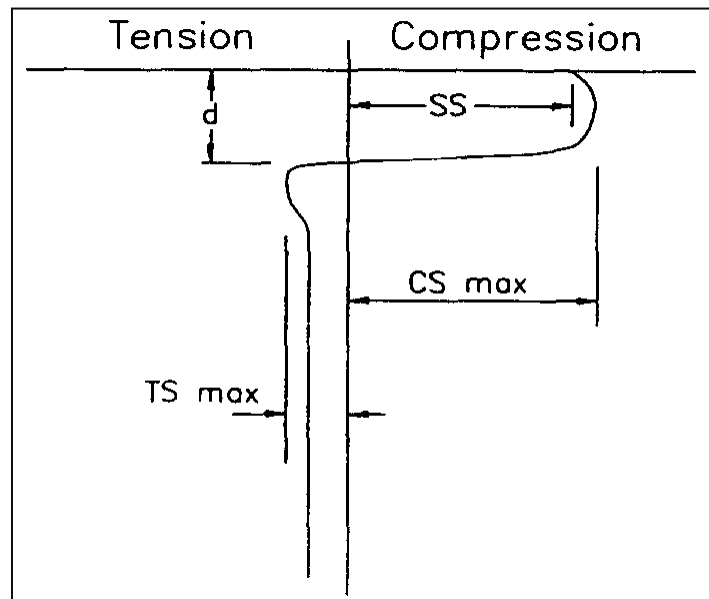
**Figure 2-3. The residual stress distribution of a shot peened substrate [35].**

The compressive residual stress has a magnitude that can vary up to a maximum stress of one half the yield strength of the material [36].

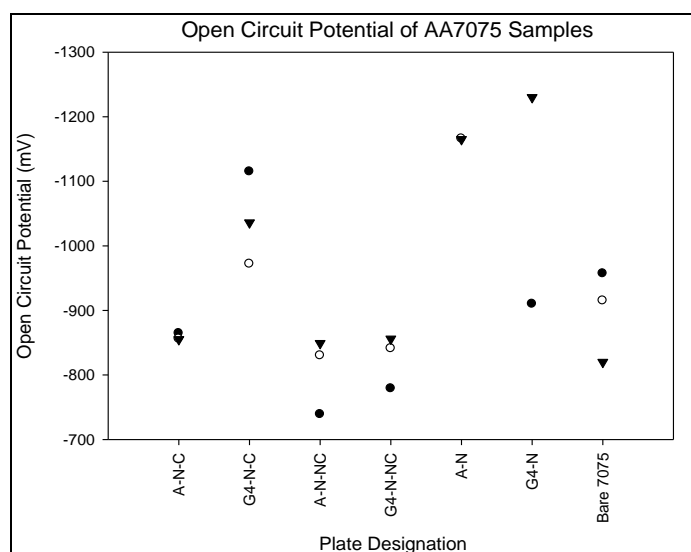
**Figure 3-4. Open circuit potential for AA7075-T6 samples**

There didn't appear to be a significant difference between the sealed specimen, with or without chromate. The samples prepared with the alumina grit blast had a more negative OCP in the sealed with chromate condition than in the sealed without chromate coating. This means that, thermodynamically, the sample with the chromate coating has a higher tendency to corrode than the sample without the chromate coating.

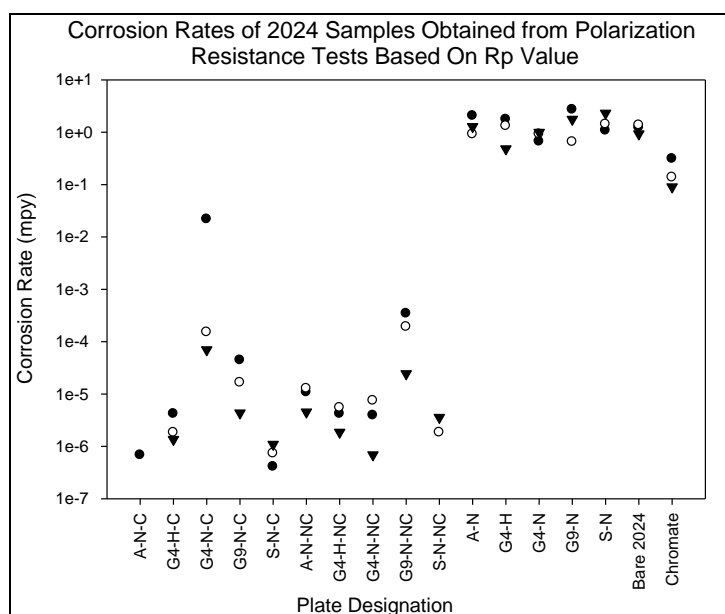
Figure 3-5. Corrosion rate data for AA2024-T3 specimen.

corrosion rates similar to the bare AA2024 substrate. One as-sprayed plate, that was surface prepared by glass bead grit blast at 45° and used nitrogen as the carrier gas (G4-N), consistently yielded a lower corrosion rate (0.3 mpy on average) than bare AA2024. The chromate coated AA2024 showed lower corrosion rates than the bare and as sprayed AA2024 coatings by almost an order of magnitude. All sealed AA2024 samples produced graphs much more erratic than those of the as-sprayed plates, but showed significantly lower corrosion rates than bare or chromate coated AA2024. A significant difference in corrosion rates between chromate and non-chromate sealed samples was not noted.

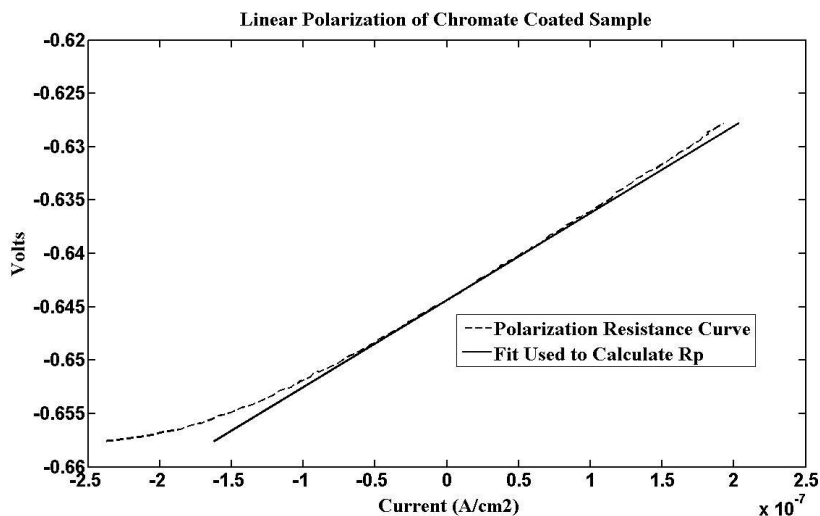
Figure 3-6. Linear polarization curve and curve fit used to calculate  $R_p$  of chromate coated sample.

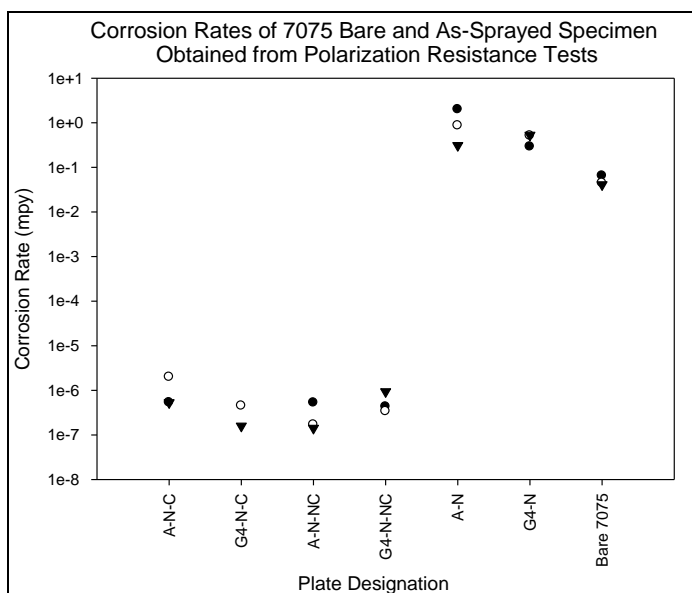
Figure 3-8. Corrosion Rates obtained from polarization resistance tests of AA7075-T6 samples.

magnitude lower than the as-sprayed samples. There was no observed difference in corrosion rates between the chromate and non-chromate sealed samples. An example of a polarization resistance curve and fit is shown in Figure 3-9. The average corrosion rates obtained from all samples can be found in Appendix I: Table 3-3.

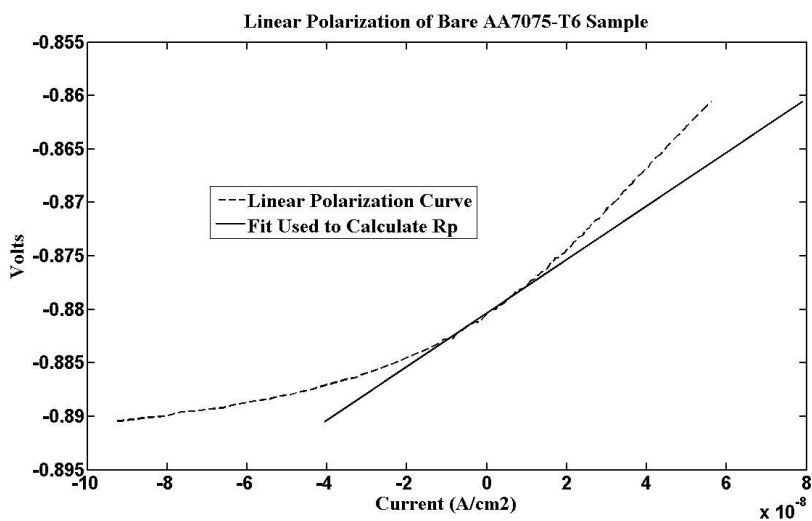
Figure 3-9. Linear polarization curve and slope line used to calculate  $R_p$  of Bare AA7075-T6 sample

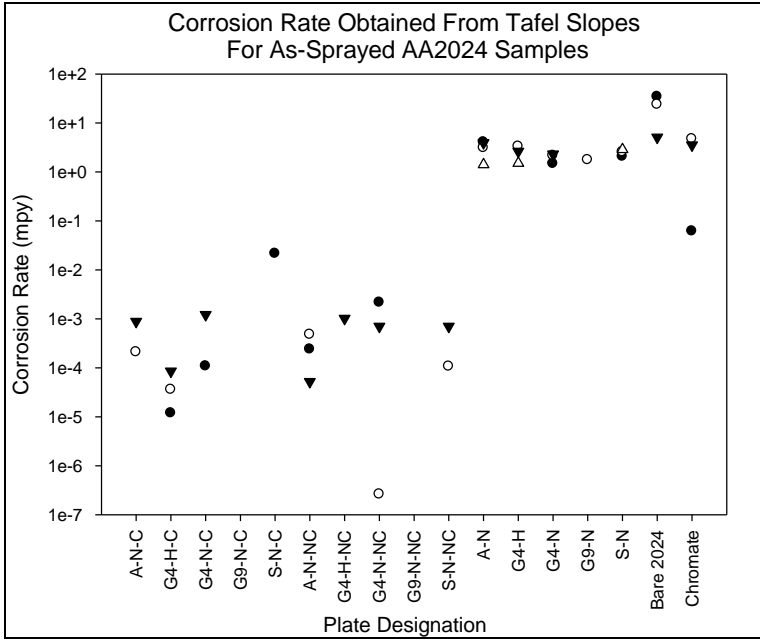
Figure 3-10. Corrosion Rates obtained from potentiodynamic polarization tests for AA2024-T3 samples.

Figure 3-10 shows the corrosion rates calculated for the CP-AL coatings on AA2024-T3. The bare AA2024 yielded corrosion rates which varied over a very wide range, from about 5 mpy to about 34 mpy. The as-sprayed samples, however, all resulted in consistent corrosion rates, obtained by Tafel slopes and Equation (2), of less than 5 mpy. The data shows that the as-sprayed samples performed much better in this test than the bare AA2024 substrate. The as-sprayed samples also had corrosion rates comparable to the chromate coated AA2024 sample. An example a potentiodynamic polarization curve for an as-sprayed sample and the corresponding fit used to find tafel slopes and the corrosion current is included as Figure 3-11. Obtaining consistent data for sealed specimens from the potentiodynamic polarization experiment was extremely difficult as data yielded graphs that were erratic and difficult to analyze. The data that was accurate and consistent showed corrosion rates an order of magnitude lower than those of the as-sprayed samples. Appendix 1: Table 3-4 shows the corrosion rates obtained from the potentiodynamic polarization experiment on all samples.

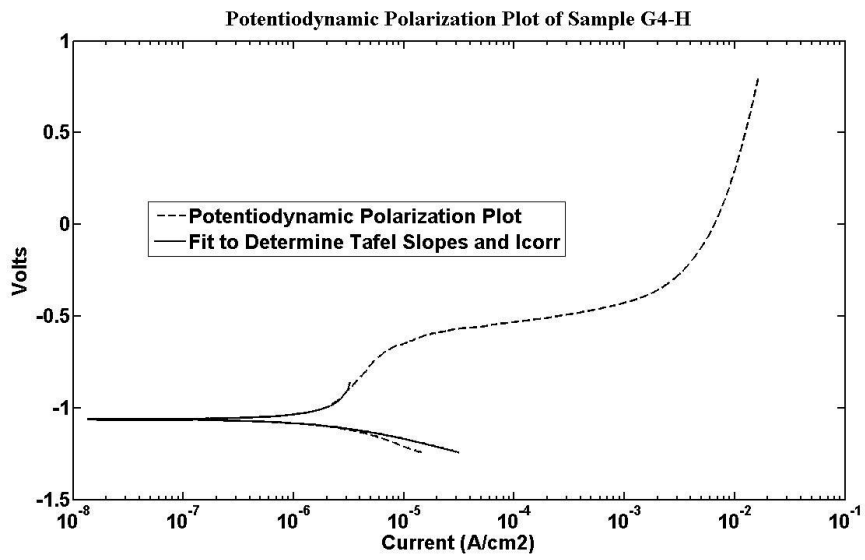
Figure 3-11. Potentiodynamic polarization plot and corresponding tafel slope fit of sample G4-H.

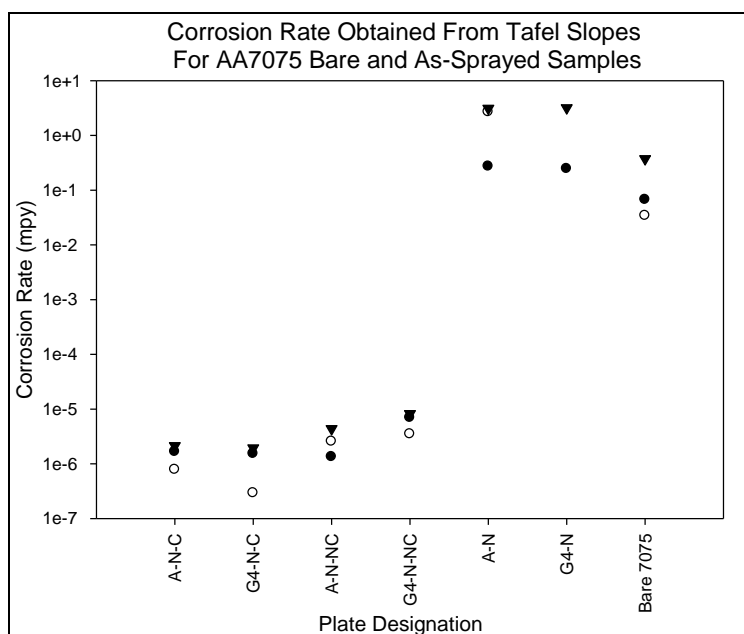
**Figure 3-12. Corrosion Rates obtained from potentiodynamic polarization tests for AA7075-T6 samples.**

substrate had a range of corrosion rates that varied from 0.05 to 0.3 mpy. The bare AA7075 therefore performed much better in this experiment than the as-sprayed coatings. The sealed samples had corrosion rates on the order of  $10^{-6}$  mpy, six orders of magnitude lower than the as-sprayed samples and five orders of magnitude below the bare AA7075 sample. The non chromate sealed samples had slightly higher corrosion rates than the chromate sealed samples. Appendix 1: Table 3-4 provides the raw data obtained from each replicate.

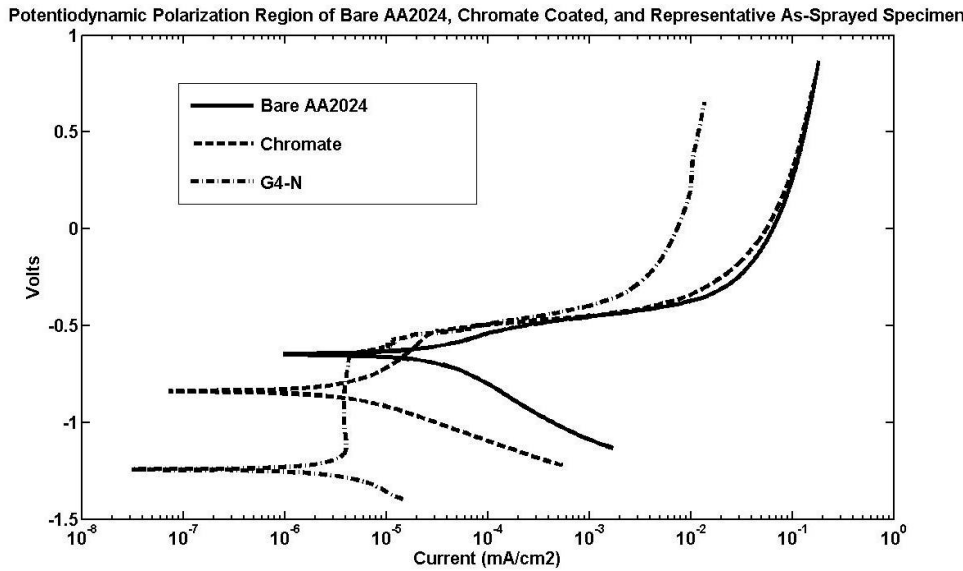
Figure 3-13. The potentiodynamic polarization region of bare AA2024, chromate coated, and a representative as sprayed specimens.

The sealed samples yielded data which varied significantly and was difficult to analyze with confidence. Some passivation potentials were lower than the as-sprayed samples, and some were as high as 1400 mV.

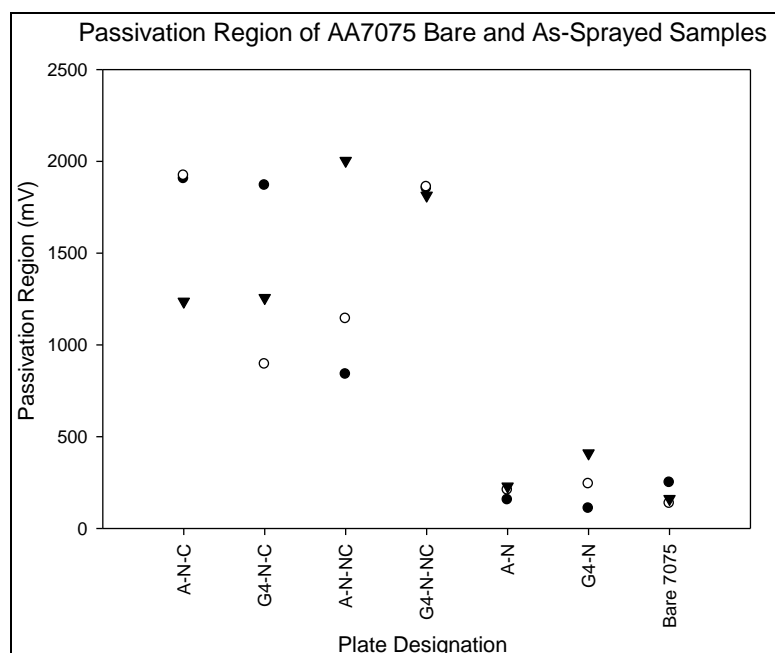
**Figure 3-15. Potentiodynamic polarization tests which indicate the passivation regions for the AA7075-T6 samples.**

The passivation ranges of the sealed AA7075 samples were extremely difficult to analyze due to the fact that the pitting potential was never reached in most tests. In general, the passivation ranges seem to be an order of magnitude higher than either the as-sprayed or bare samples. There is no difference in passivation regions between the chromate and non-chromate coated sealed samples. The average values from three replicates are presented in Table 3-5 of Appendix I.

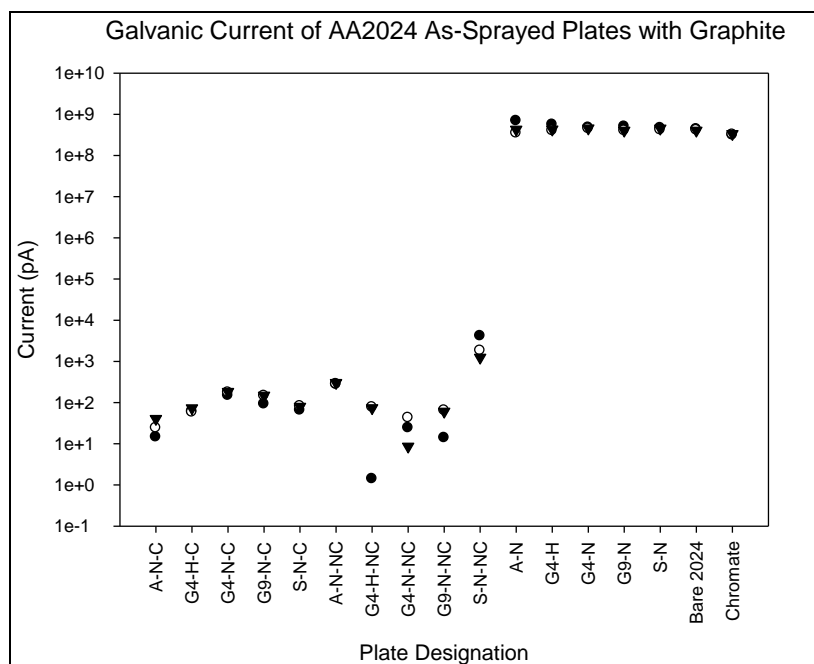
**Figure 3-16. Galvanic corrosion data showing the current obtained for AA2024-T3 samples vs graphite.**

The sealed samples had galvanic currents five to seven orders of magnitude lower than that of the bare and as-sprayed AA2024. This means that sealed specimens have a much lower tendency to corrode when coupled with graphite than bare or chromate coated AA2024 samples. Non-chromate sealed coatings yielded a wider range of currents, but all sealed samples acted similarly. The S-N-NC sample had currents an order of magnitude higher than all other sealed samples. Table 3-6 of Appendix I shows the average data for all samples.

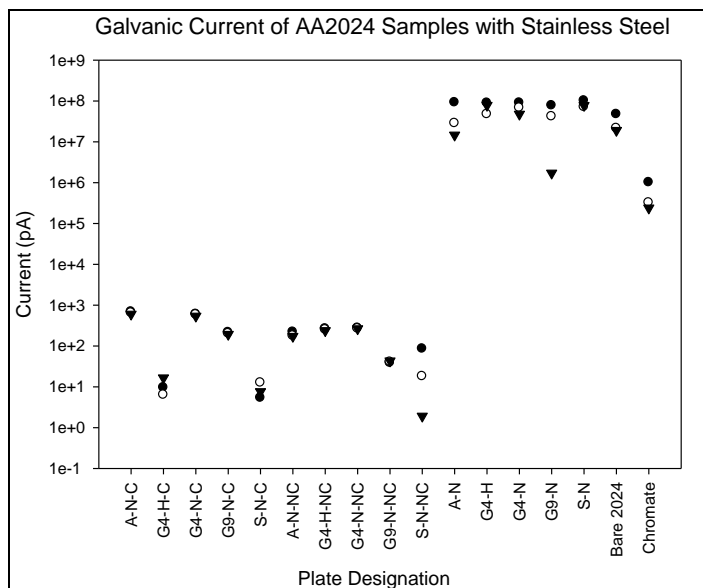
**Figure 3-17. Galvanic corrosion data showing the current obtained for AA2024-T3 samples vs stainless steel.**

The sealed specimens had currents three to five orders of magnitude lower than bare or chromate coated substrates when coupled to stainless steel. There were no appreciable differences between the chromate and non-chromate coated sealed samples. Appendix I: Table 3-6 shows the average data for all samples.

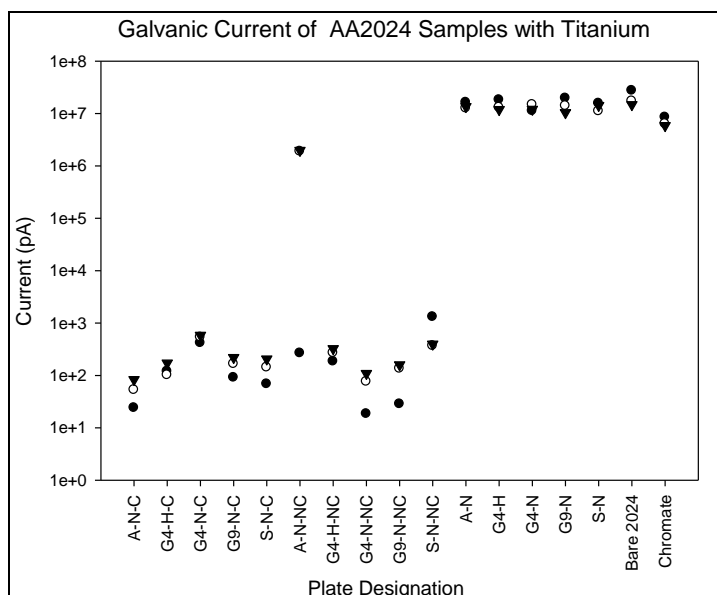
**Figure 3-18. Galvanic corrosion data showing the current obtained for AA2024-T3 samples vs titanium.**

were more comparable to those of the underlying AA2024 specimen. Table 3-6 of Appendix I shows the average data for all samples.

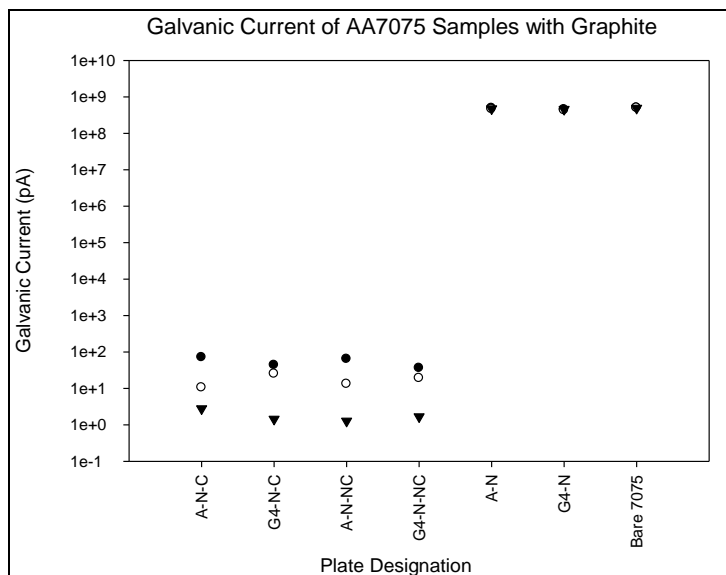
**Figure 3-19. Galvanic corrosion data showing the current obtained for AA7075 samples vs graphite.**

The sealed plates yielded currents eight orders of magnitude lower than the bare substrate. This means the sealed coatings have a much lower tendency to corrode than bare AA7075 when coupled with graphite. Table 3-6 of Appendix I shows the average data for all samples.

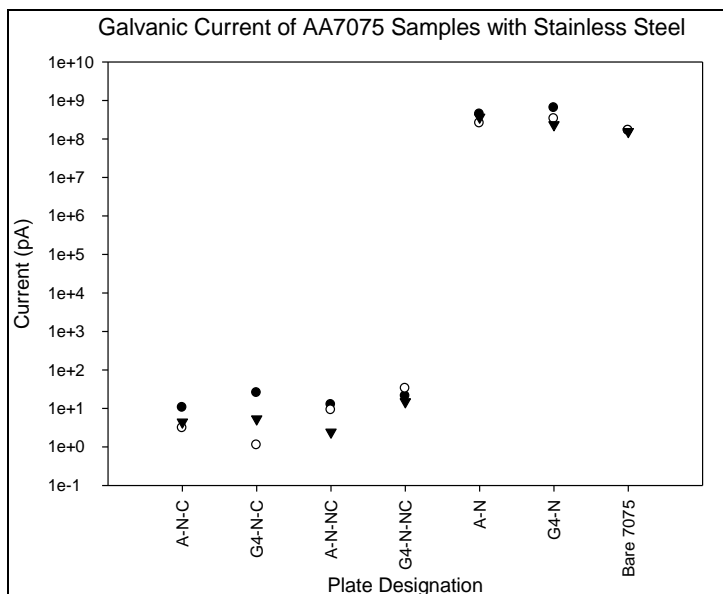
**Figure 3-20. Galvanic corrosion data showing the current obtained for AA7075 samples vs stainless steel.**

The sealed specimens had currents seven to eight orders of magnitude lower than the bare substrate when coupled to stainless steel. One sample, G4-N-NC, had the most consistent data yet the highest average current. Both sealed samples prepared by alumina grit blast had the lower currents when coupled against stainless steel than the samples with glass bead grit blast. Table 3-6 of Appendix I shows the average data for all samples.

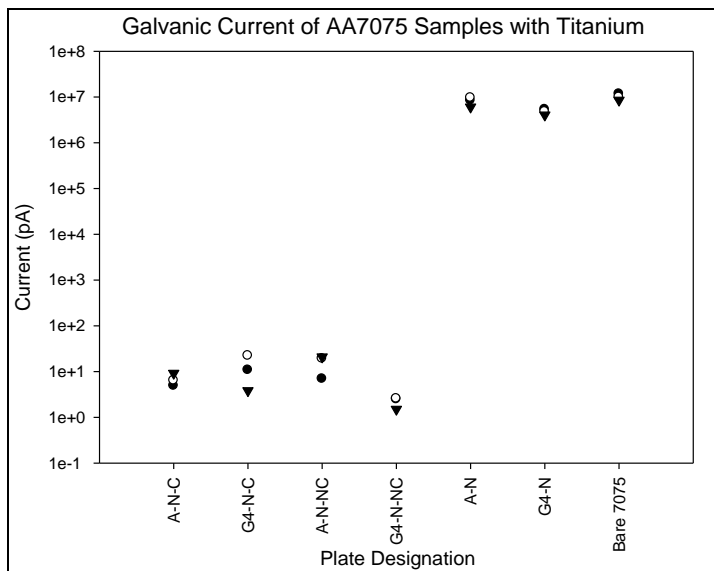
Figure 3-21. Galvanic corrosion data showing the current obtained for AA7075 samples vs titanium

The sealed samples displayed currents six to seven orders of magnitude lower than the bare substrate. There was not a significant difference between the chromate and non-chromate coated specimens. The glass bead sealed non-chromate sample (G4-N-NC) had the lowest galvanic current against titanium. Table 3-6 of Appendix I shows the average data for all samples.

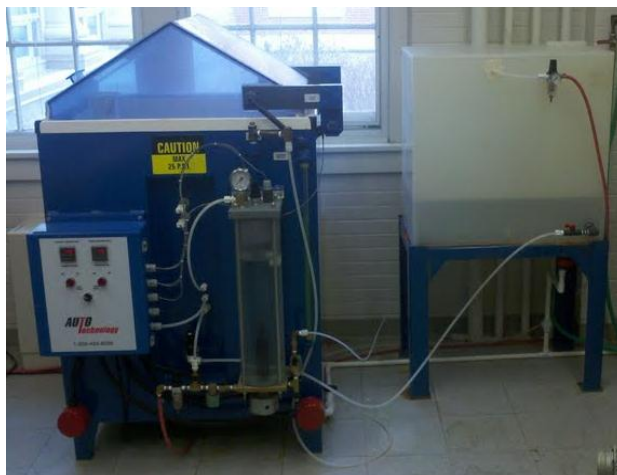
**Figure 4-1. The salt spray cabinet (left) and solution chamber (right).**

In an attempt to emulate field exposure results in a shortened time frame, accelerated salt spray cabinet tests have become a popular means of imitating atmospheric testing. This test involves a cabinet, in which samples to be tested are placed, connected to a chamber containing artificial seawater. The salt spray cabinet and solution chamber is shown in Figure 4-1.

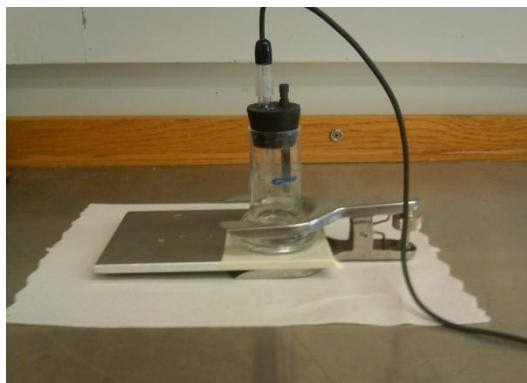
**Figure 4-2. An example of an electrochemical cell used to measure corrosion characteristics**

Each EIS test was performed by creating an electrochemical cell with the substrate to be tested. This was accomplished by first masking an area of the test specimen, and then clamping an O-ring and glass cylinder over the masked area. This cylinder was then filled with 40 mL of electrolyte consisting of 3.5% NaCl artificial seawater conforming to ASTM standard D-1141-52. A rubber stopper containing a graphite rod counter electrode and saturated calomel reference electrode was then placed on top of the glass cylinder, with the counter and reference electrode resting in the electrolyte. An example of a test cell can be viewed in Figure 4-2. All electrochemical measurements were made using a Gamry Reference600 Potentiostat, with multiple EIS measurements being run through a Gamry Electrochemical Multiplexer.

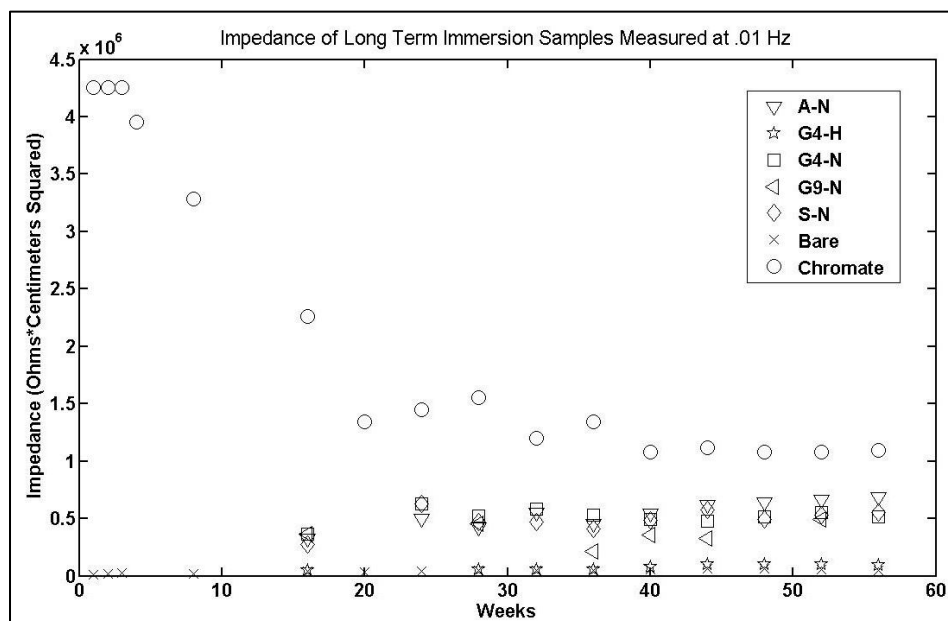
**Figure 4-3. Impedance values of long term immersion specimen measured at 0.01 hz.**

sample can likely be attributed to the low density of the helium carrier gas compared with nitrogen. The lower density, in general, allows for higher accelerating velocities. This has been shown to cause higher stresses in the helium sprayed particles, higher particle deformation, and therefore more sites for corrosion to occur [10]. These corrosion sites would lead to the lower impedances observed in these EIS measurements.

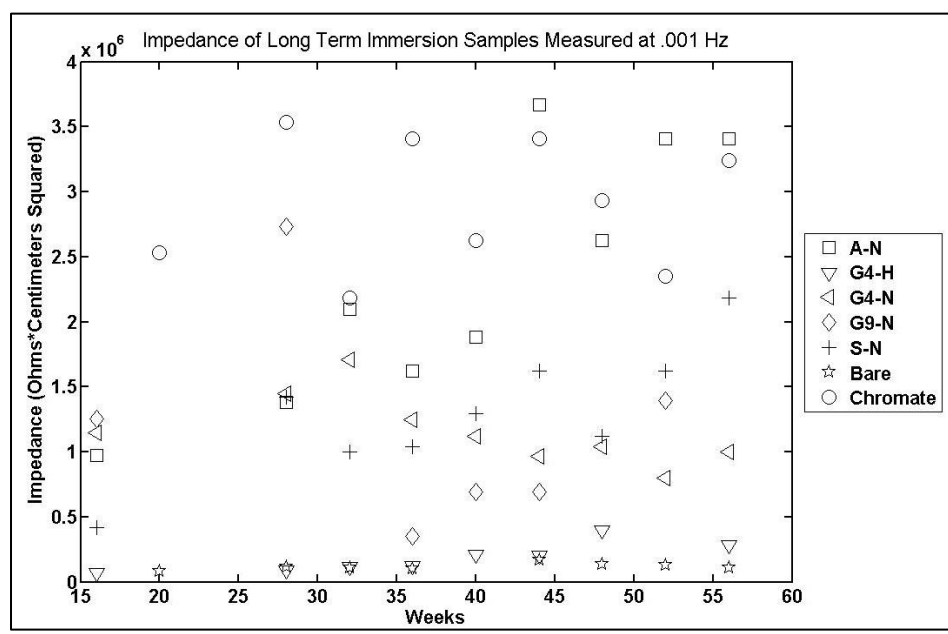
Figure 4-4. Impedance values of long term immersion samples measured at 0.001hz.

and G4-H samples had the lowest impedance, as was seen at 0.01 hz. The as sprayed coating prepared with alumina grit blast at 45° with nitrogen carrier gas (A-N) performed the best out of all the as-sprayed coatings. The impedance was comparable to the chromate coated plate; this was also observed in the test run at 0.01hz frequency. All as-sprayed coatings and the chromate coated AA2024 plate ended 12 to 14 months of testing with measured impedances on the same order of magnitude. The impedances were one order of magnitude above the bare substrate.

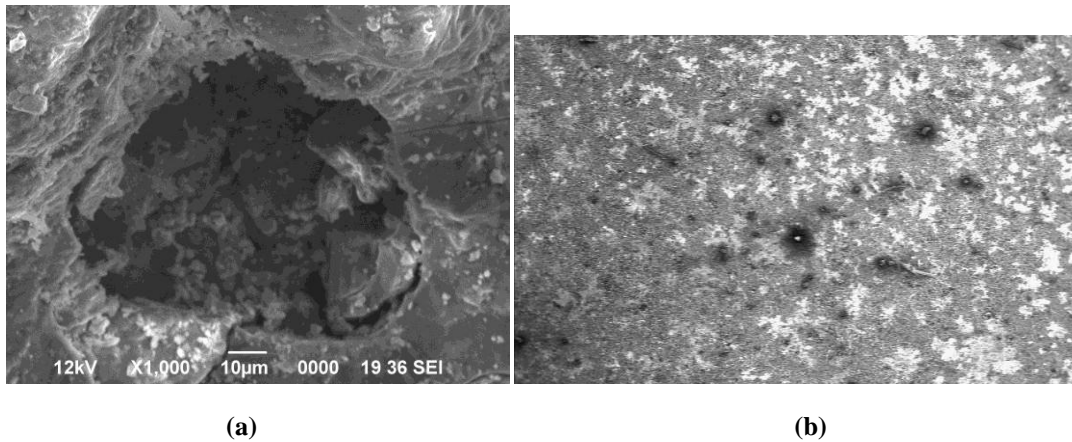
**Figure 4-5. Typical pit on as-sprayed sample (a) and G9-N surface with large pit distribution (b).**

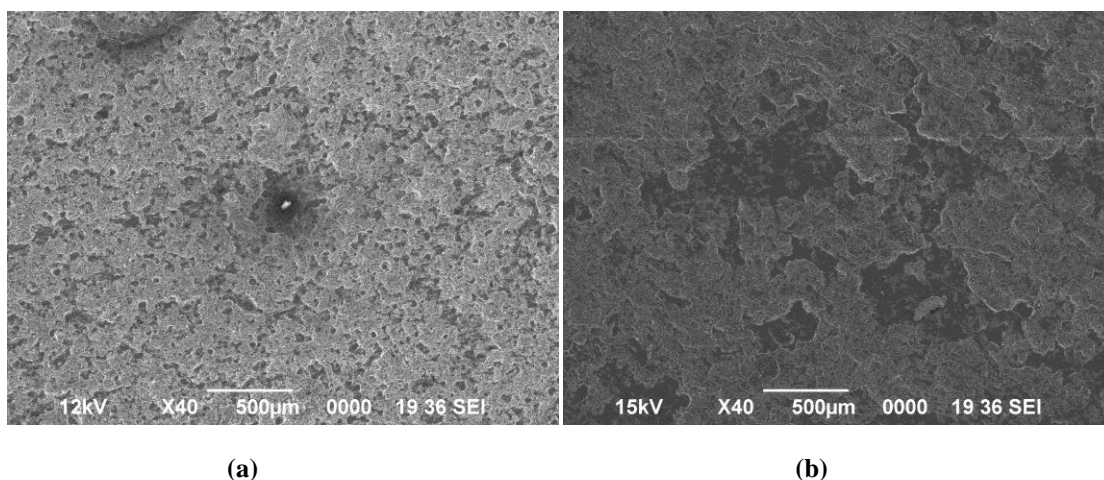
**Figure 4-6.** The porous surrounding surface of sample A-N (a) and the severely pitted bare surface (b).

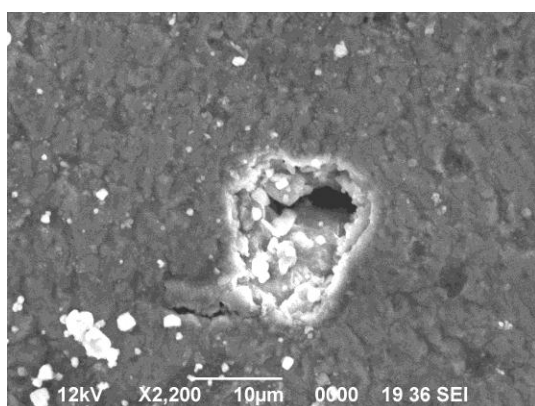
**Figure 4-7.** Pit found on chromate coated surface.

chromate coated sample performed extremely well with few pits that occurred in relatively small sizes. An example of a pit on a chromate coated sample is shown in Figure 4-7. It should be noted though that the pits of the chromate coated samples appeared to be much deeper than the pits of the as-sprayed samples. This is undesirable because deep pits remove material from within a substrate and lead to a larger reduction in mechanical properties than shallow pits.

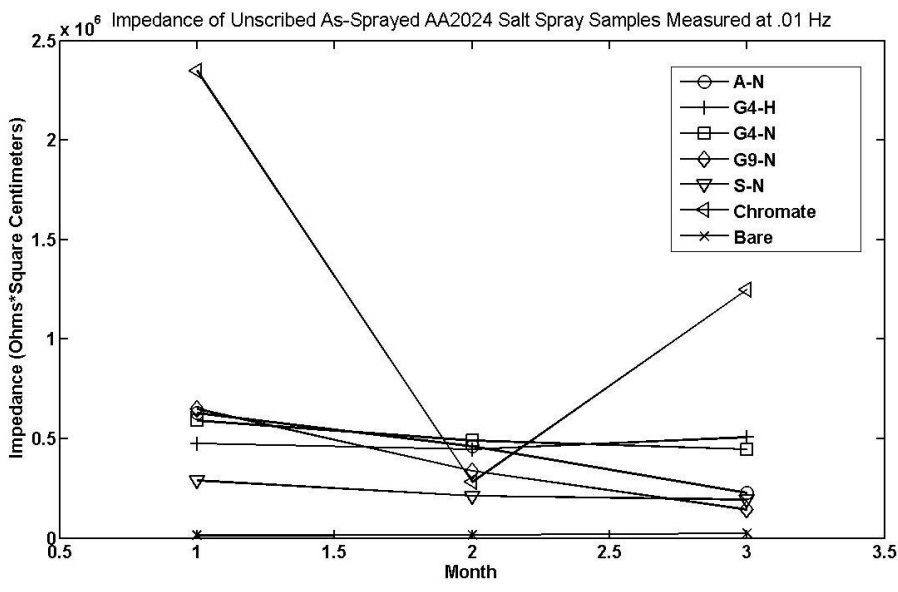
Figure 4-8. Impedance values of unscribed as-sprayed AA2024-T3 specimen.

the scribed test, the glass bead at 45° samples had impedances twice as high as the glass bead at 90° sample. This is likely due to the fact that the 45° angle reduced the impact velocity of the glass bead media and therefore reduced the resulting embedded grit from the application process. A reduction in embedded grit would lead to higher coating adhesion, greater corrosion protection, and the high impedance values that resulted from the EIS experiment. The chromate sample, which is not included in Figure 9 in order to show each as-sprayed condition more clearly, regularly showed impedances an order of magnitude higher than as-sprayed samples throughout these tests.

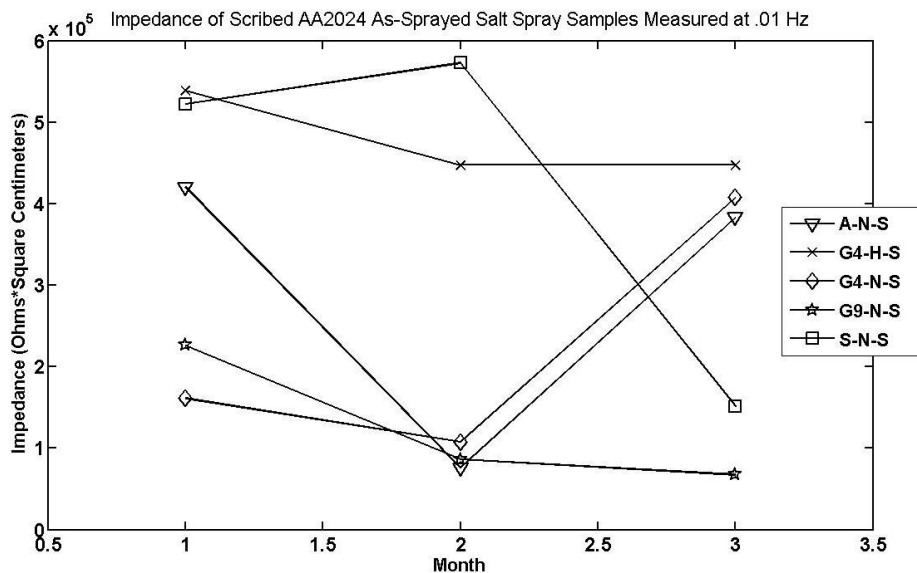
**Figure 4-9. Impedance values of scribed as-sprayed AA2024-T3 specimen**

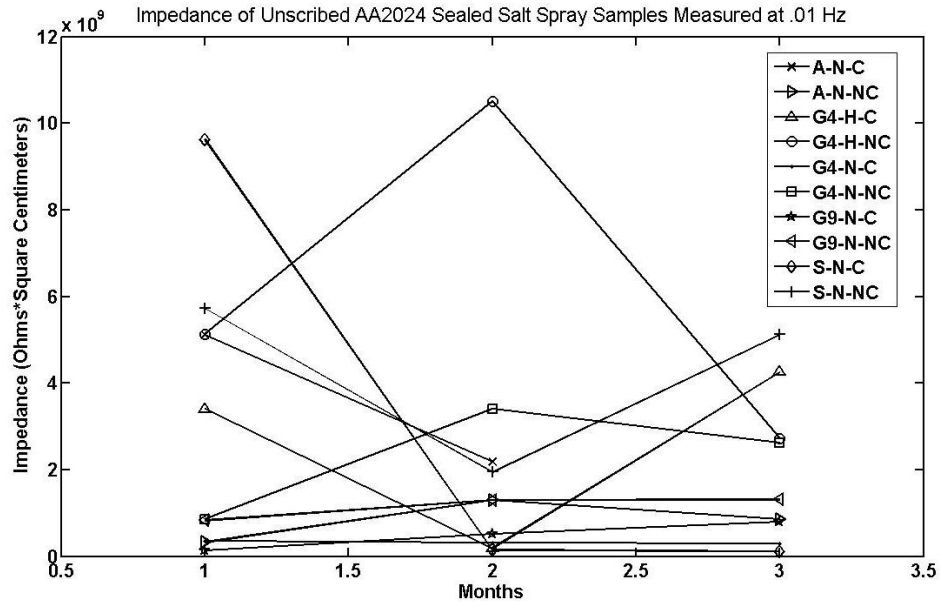
Figure 4-10. Maximum Impedance at lowest frequency of unscribed sealed AA2024 specimen

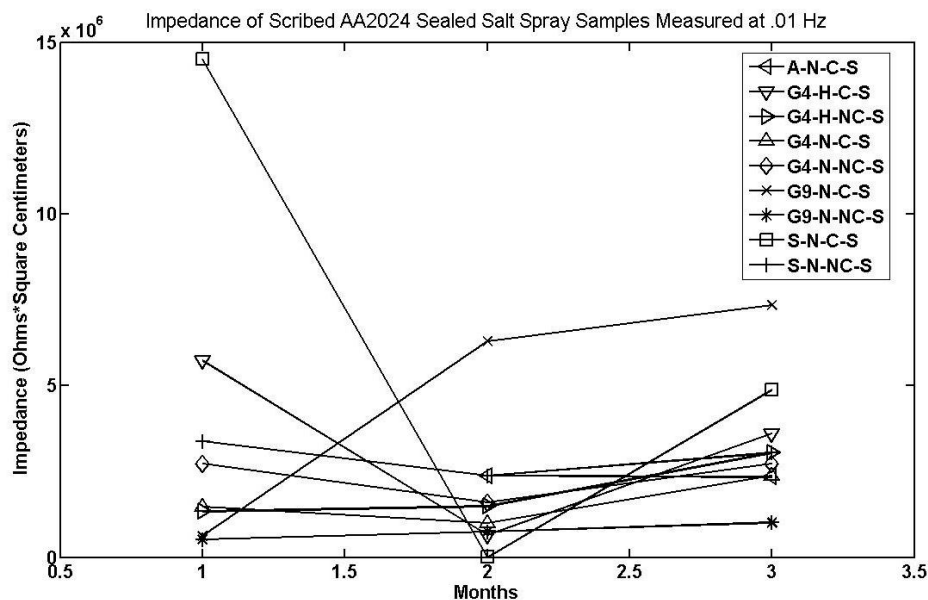
**Figure 4-11. Maximum impedance at lowest frequency of scribed sealed AA2024 specimen**

In the scribed condition shown in Figure 4-11, the A-N-NC and G4-N-NC samples performed better than the corresponding samples with a chromate coating. The A-N-NC plate produced impedances so much higher than any other sample, it was not included in the figure in order that data for the other samples could be discerned more clearly.

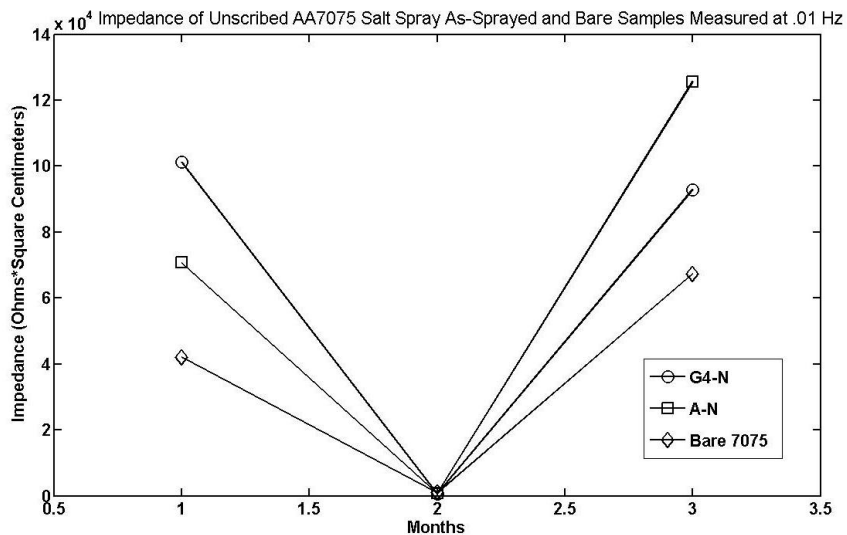
**Figure 4-12. Maximum impedance at lowest frequency of unscribed as-sprayed AA7075 specimen**

Figure 4-12 and 4-13 show the impedance values as a function of time for unscribed and scribed as-sprayed A7005 coatings on AA7075-T6. As-sprayed A7005 coatings had higher impedances than bare AA7075 samples in both scribed and unscribed conditions. The measured impedances were up to an order of magnitude higher than the bare substrate. In the unscribed conditions both surface preparations were comparable in performance. However, in the scribed condition, G4-N performed significantly better after three months of testing.

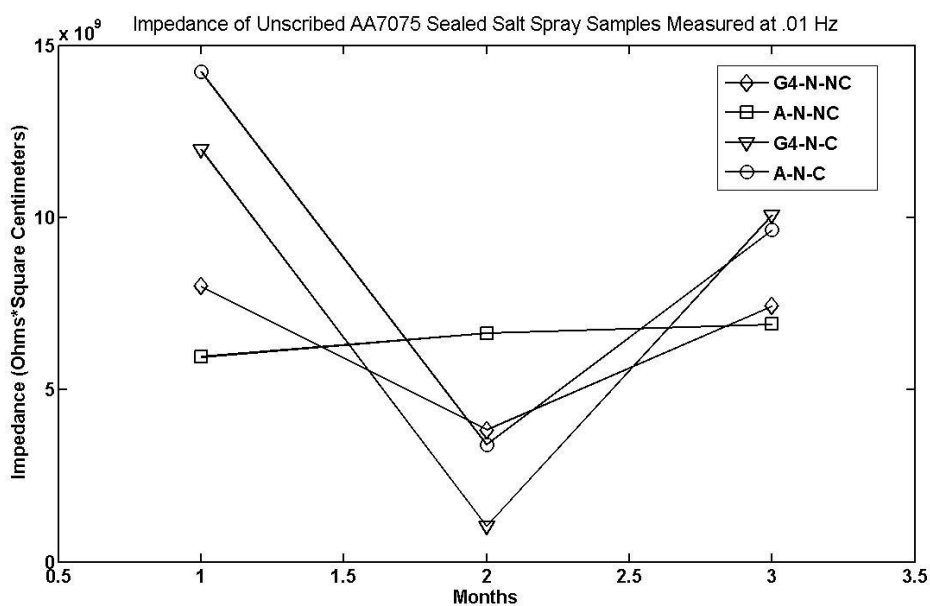
Figure 4-14. Maximum impedance at lowest frequency of unscribed sealed AA7075 specimen

month. These dips indicate a reduction in the corrosion resistance offered by the coating. The sealed samples with chromate coatings displayed significant drops in impedances in the second month, but recovered in the third month. In the scribed condition, both sealed samples with chromate had higher impedances than the non-chromate sealed samples during all three months of testing. All samples performed consistently from month to month.

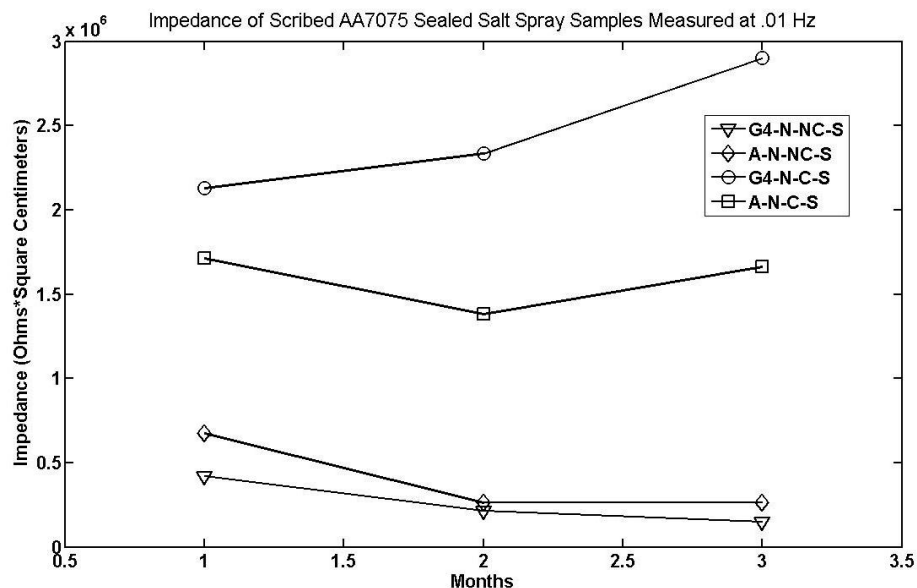
**Figure 4-15. Maximum impedance at lowest frequency of scribed sealed AA7075 specimen**

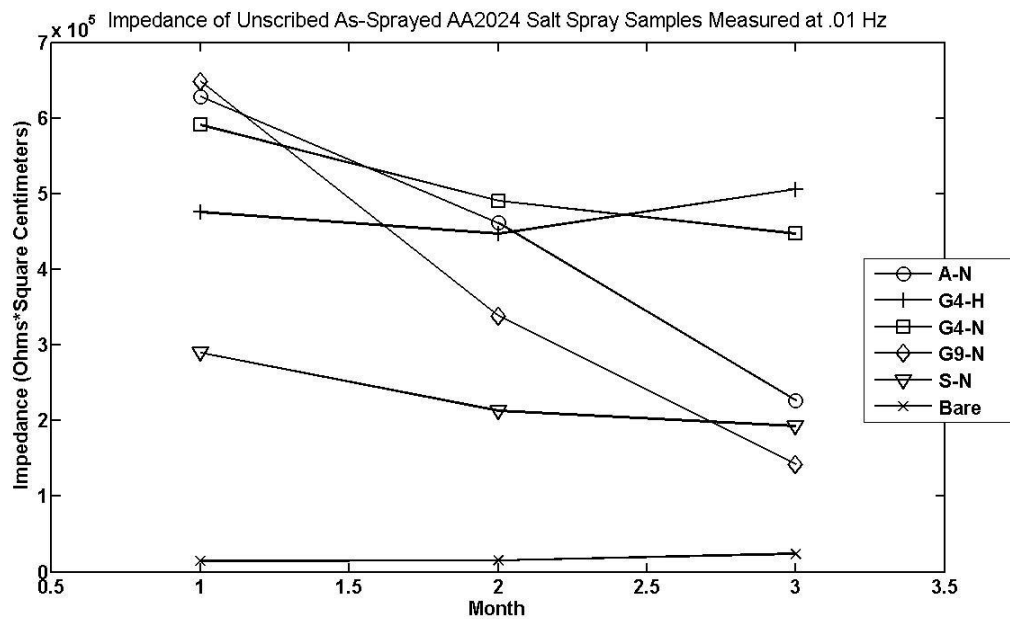
Figure 4-17. Impedance values of unscribed as sprayed AA2024-T3 specimen with chromate sample removed.

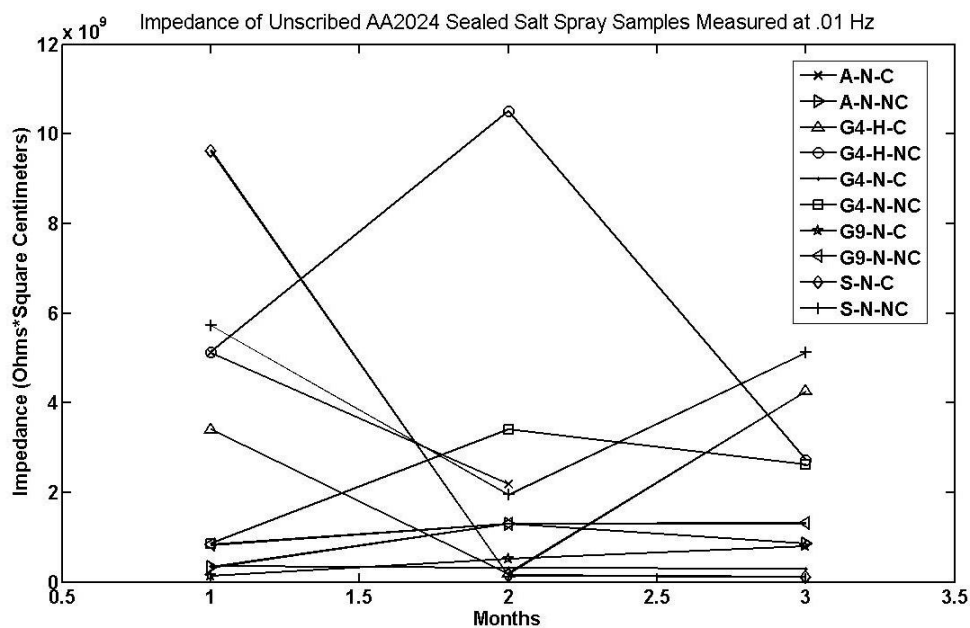
Figure 4-20. The maximum impedance at lowest frequency data for unscribed, sealed AA2024 specimens

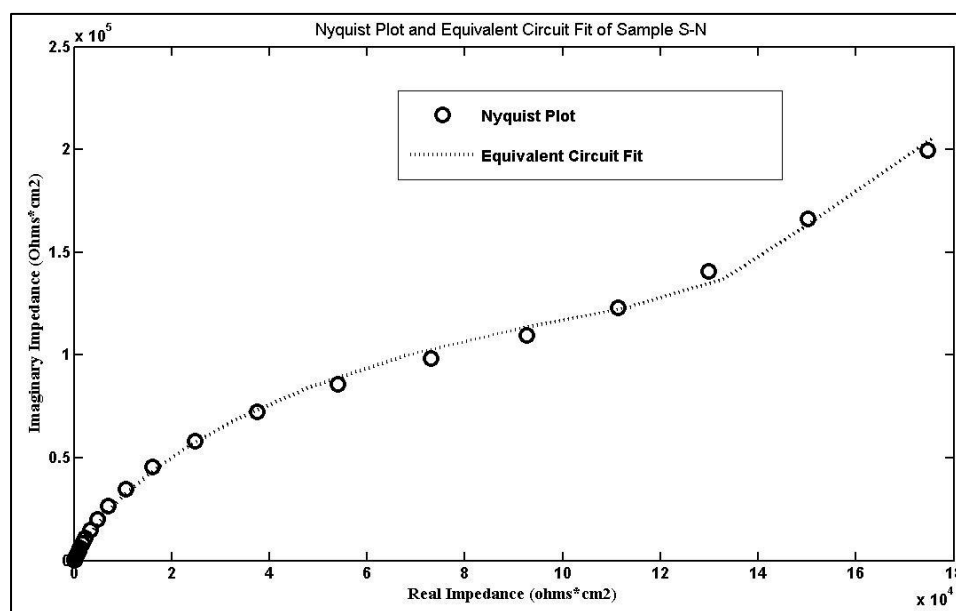
Figure 4-23. As-sprayed sample S-N modeled with equivalent circuit after 4 months of exposure.

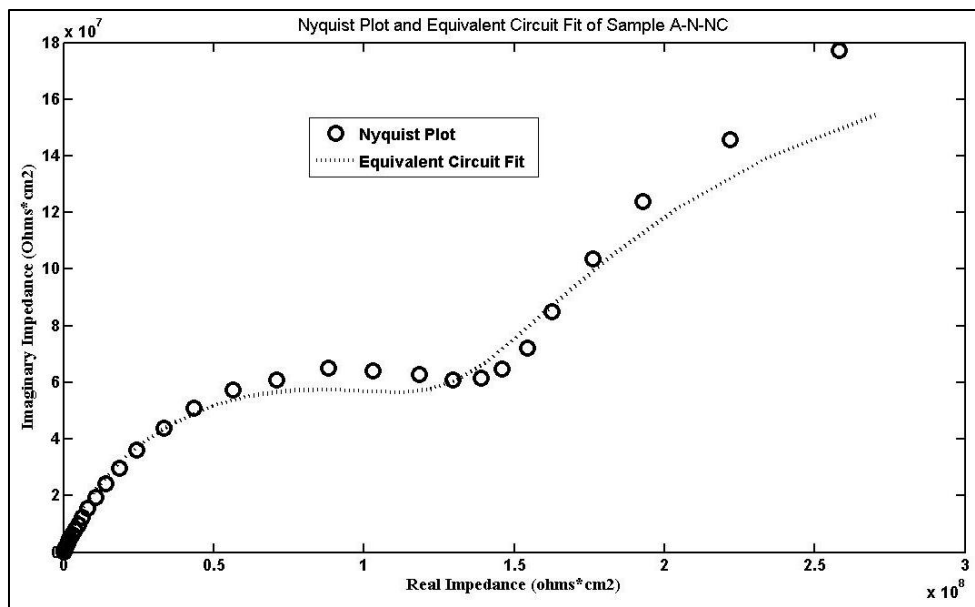
Figure 4-24. Sealed unscribed sample A-N-NC modeled after one month of exposure with the equivalent circuit.

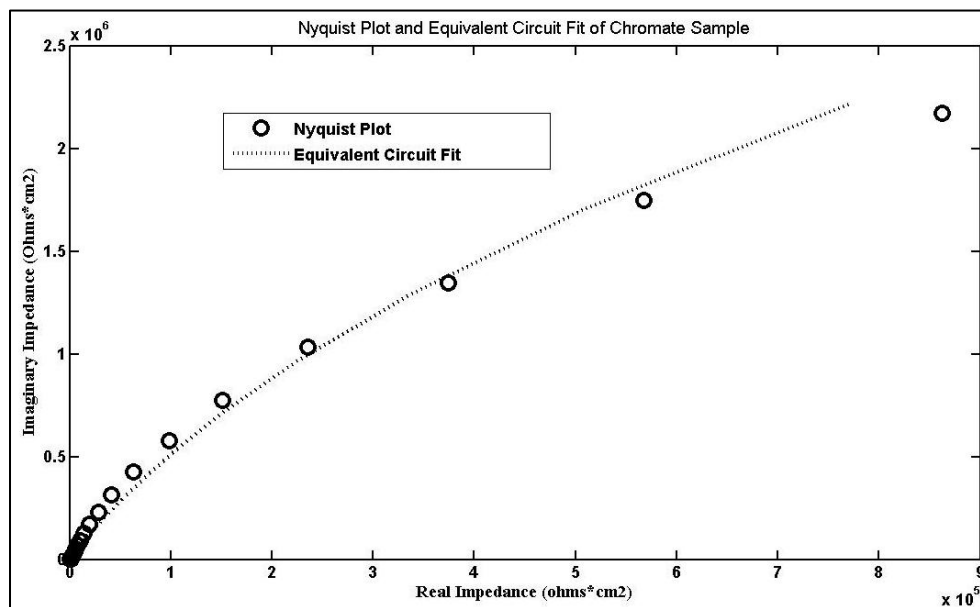
Figure 4-25. Unscribed chromate sample after 2 months of exposure modeled with equivalent circuit.

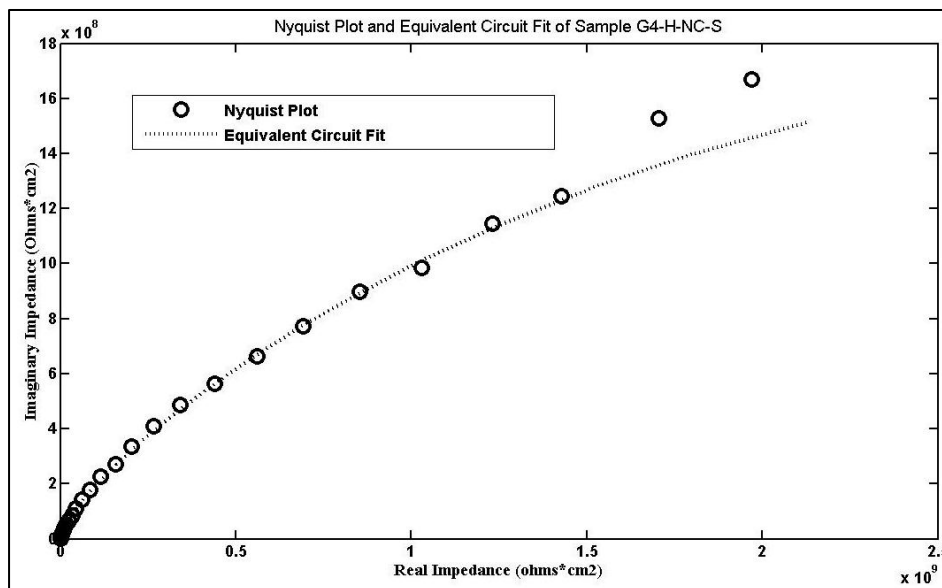
Figure 4-26. Scribed sealed sample G4-H-NC-S modeled after three months of exposure with equivalent circuit.

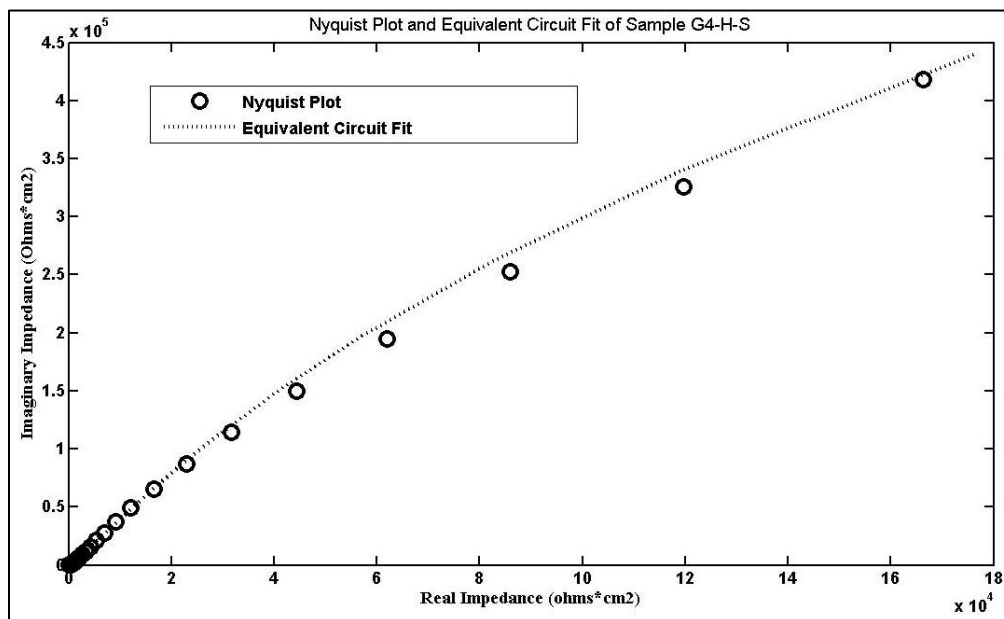
Figure 4-27. As-sprayed scribed sample G4-H-S modeled after 2 months of exposure with equivalent circuit.
