# Corrosion Characteristics And Mechanical Properties Of Aluminum Coatings Applied By The Cold Spray Process

Ben Bouffard  
*Bucknell University*

Presented to the Faculty of  
Bucknell University  
In Partial Fulfillment of the Requirements for the Degree of  
Master of Science in Mechanical Engineering

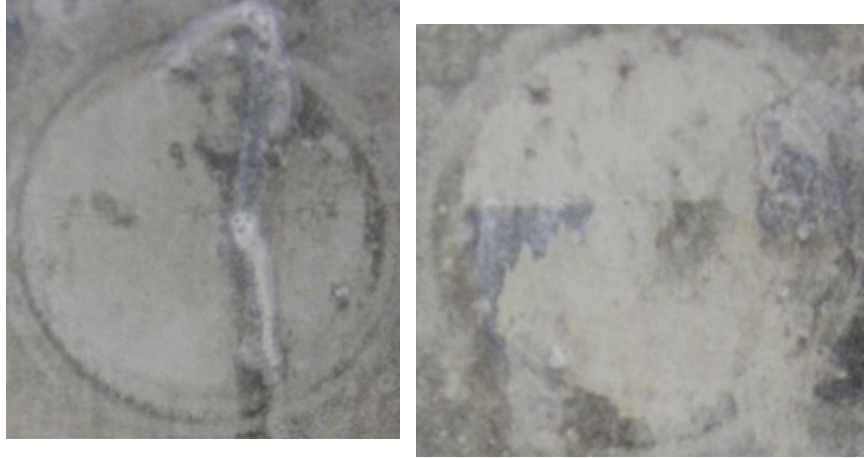
**Figure 4-28. Sample A-N-S (left) and S-N-S (right) that showed significant material loss along the scribe.**

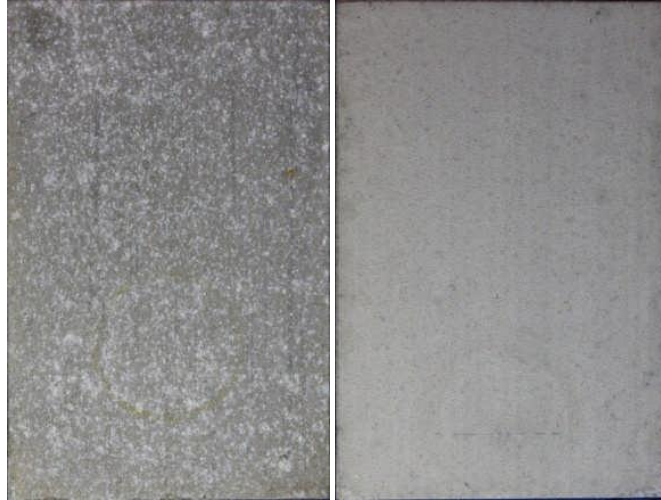
**Figure 4-29. A comparison of a bare specimen with significant corrosion (left) and an as-sprayed sample with no corrosion damage (right).**

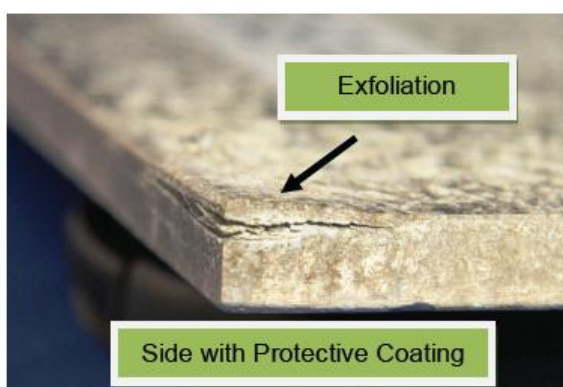
**Figure 4-30. An example of exfoliation on the back of an as-sprayed sample**

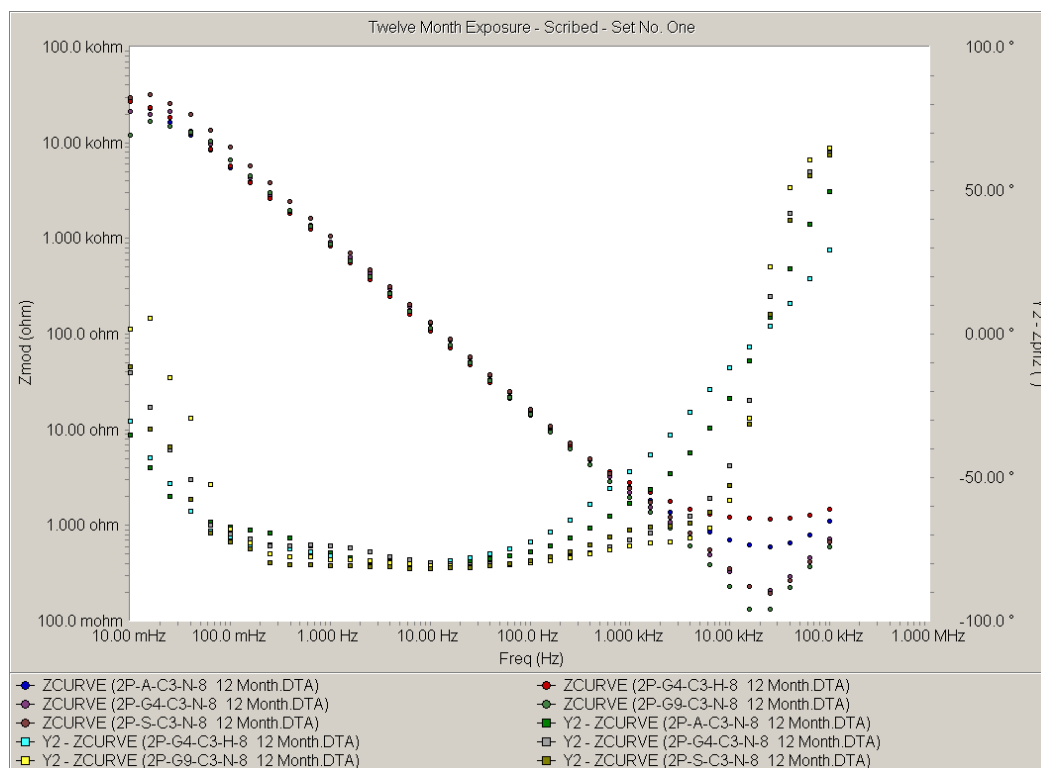
**Figure 4-32. EIS of as-sprayed scribed samples after 12 months of exposure**

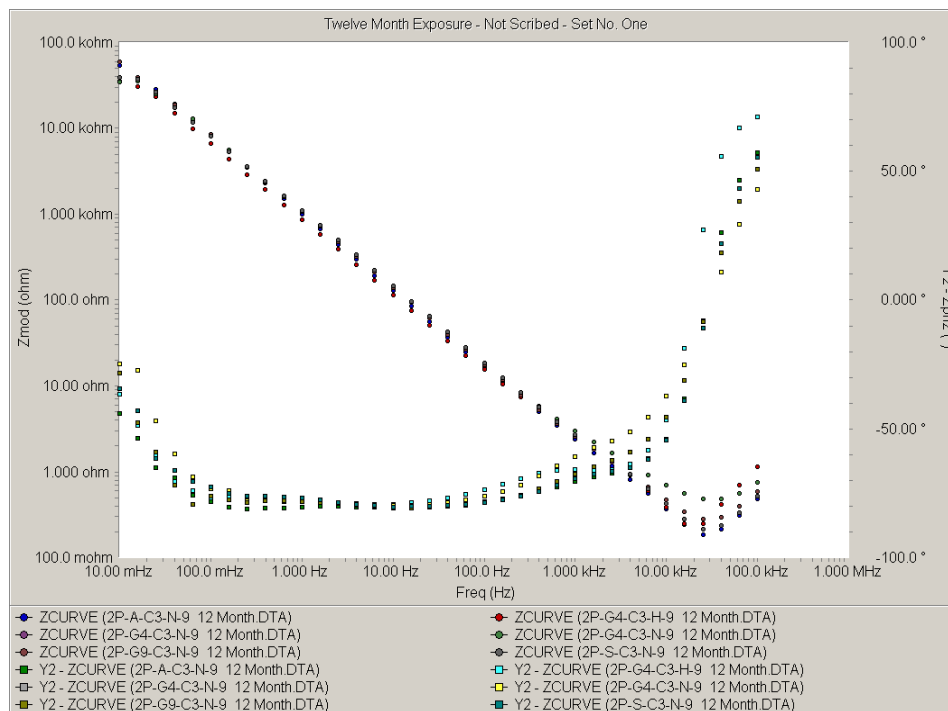
**Figure 4-33. EIS of as-sprayed samples (un-scribed) after 12 months of exposure.**

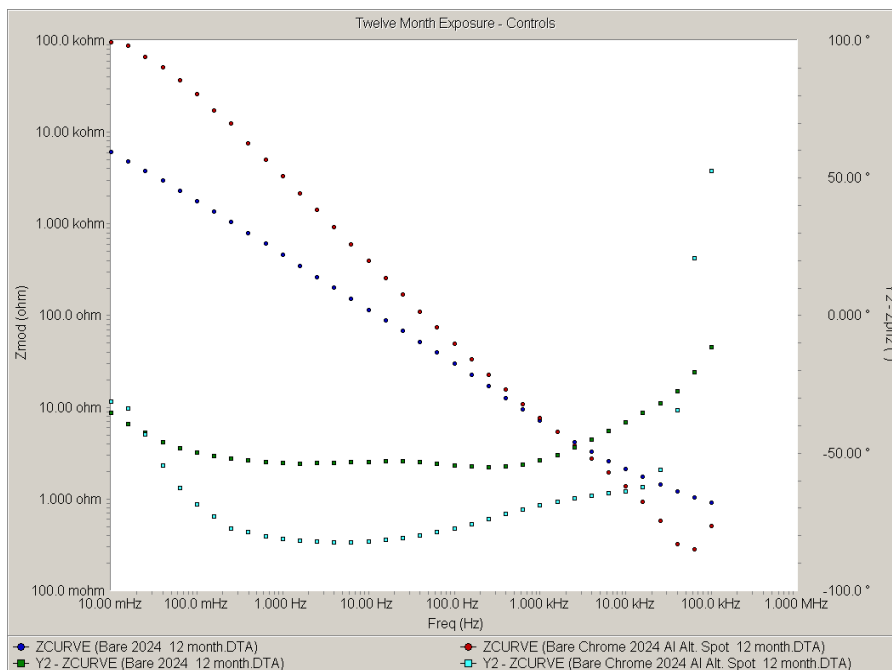
**Figure 4-34. EIS of non-scribed bare and chromate coated AA2024 samples after 12 months of exposure.**

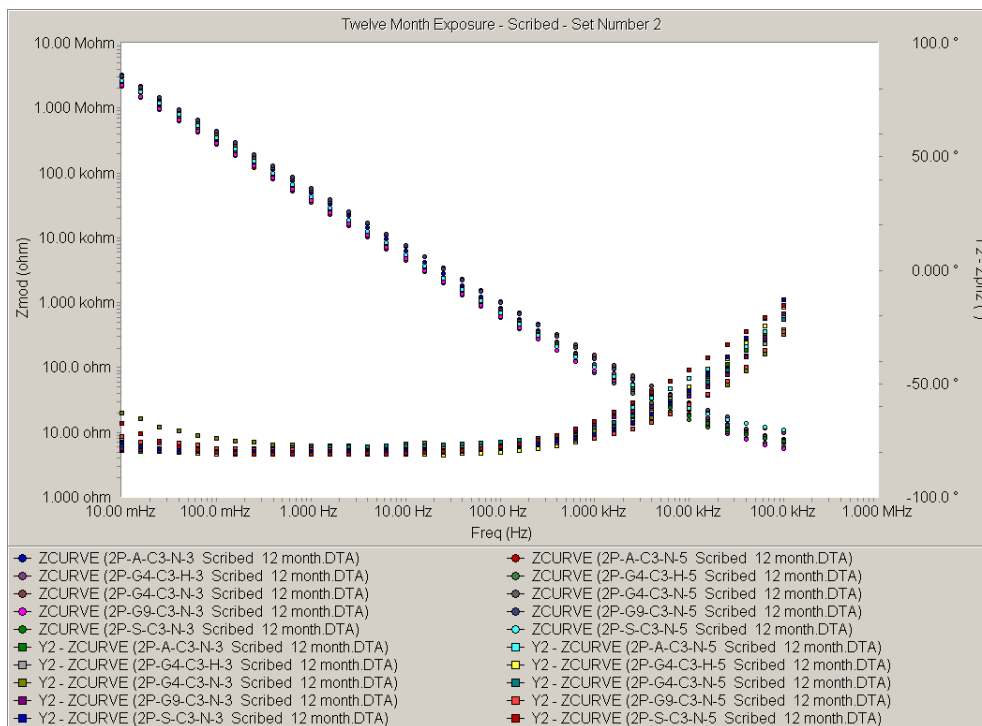
**Figure 4-35. EIS of sealed samples (scribed) after 12 months of exposure.**

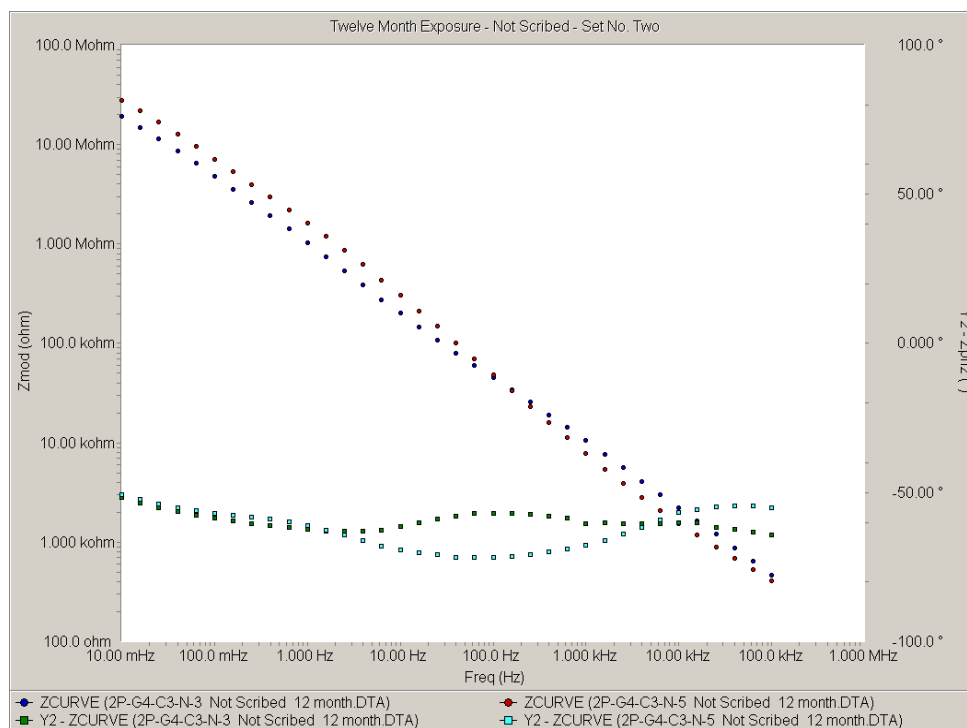
**Figure 4-36. EIS of sealed non-scribed samples after 12 months of exposure.**

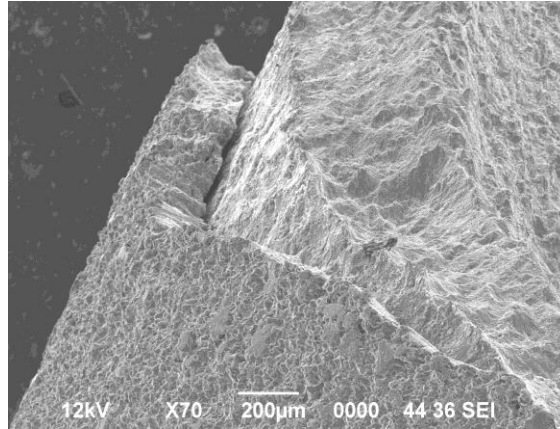
**Figure 5-3.** An example of the coating and substrate on a fractured grit blast and coated specimen.

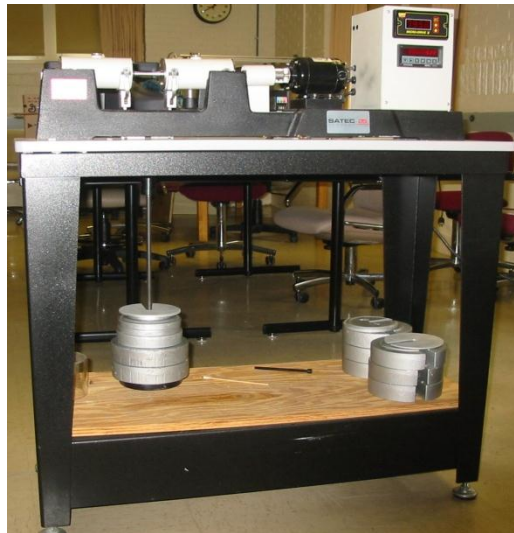
**Figure 5-4.** The Instron RR Moore rotating fatigue testing apparatus used in this study.

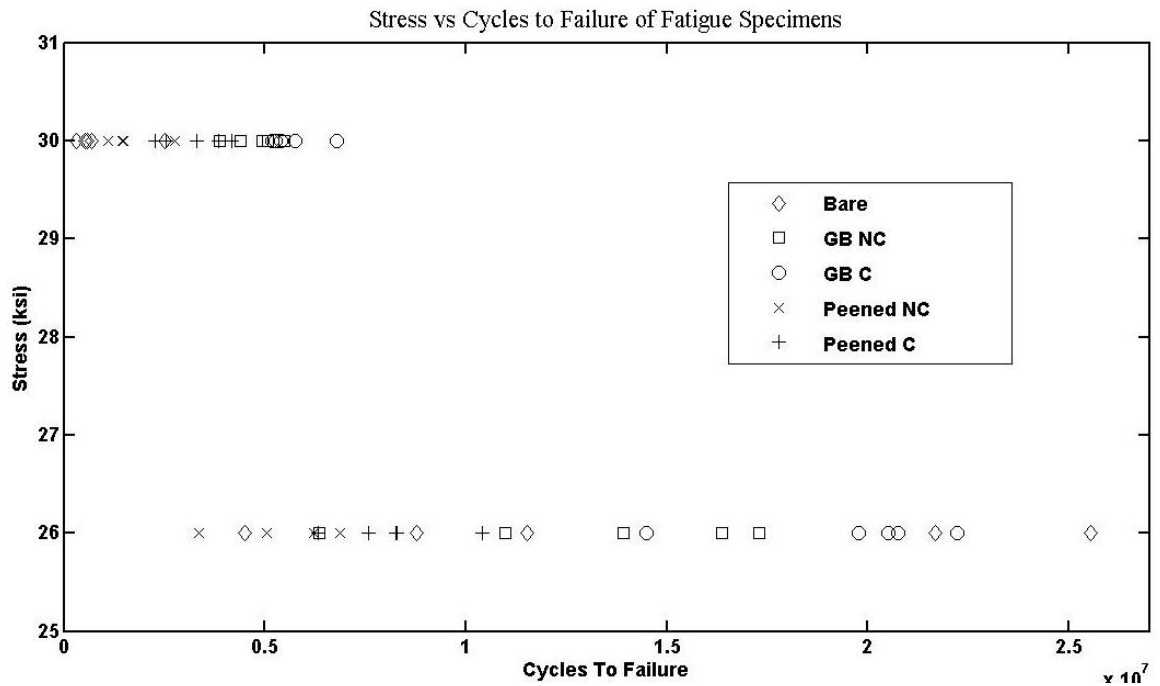
Figure 5-5. An S-N curve of the resulting data

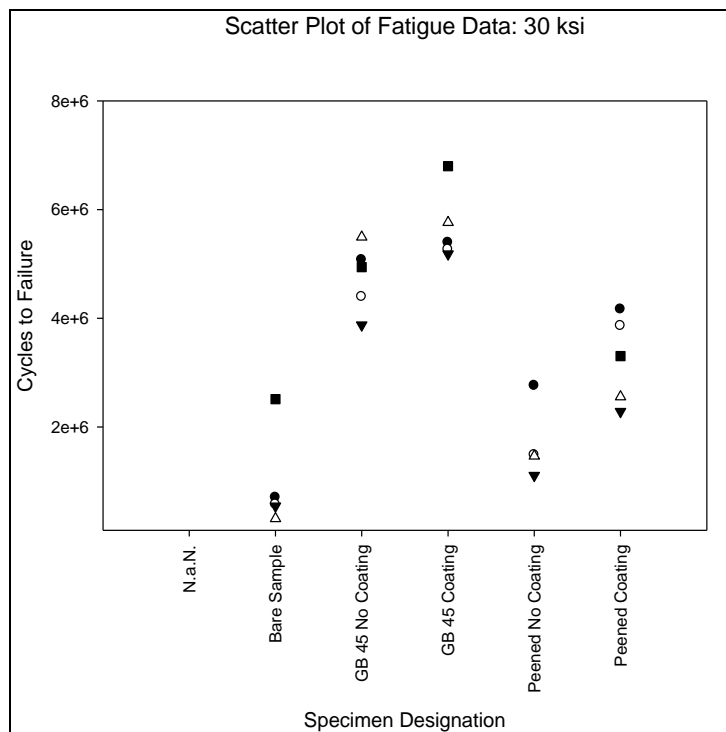
Figure 5-6. A Scatter plot of the cycles to failure of samples tested at a stress of 30 ksi.

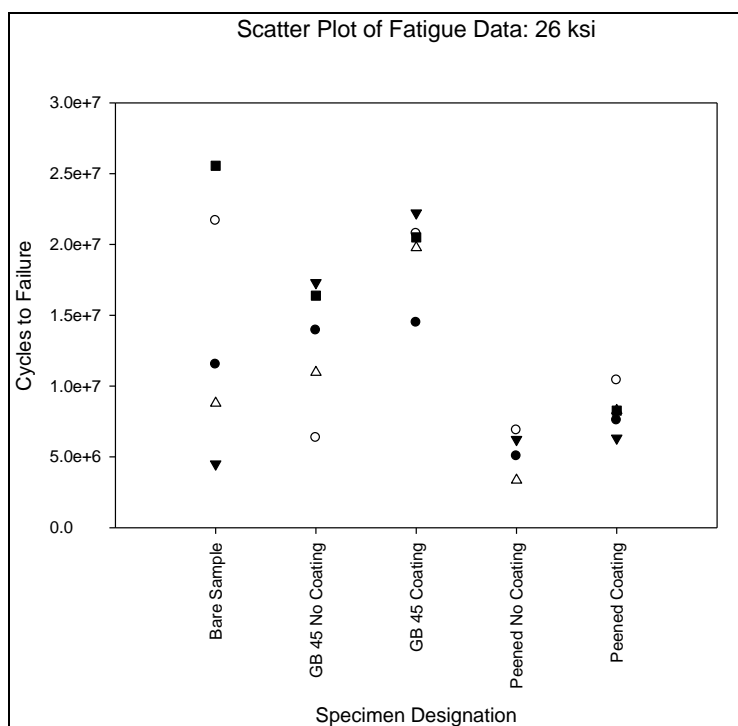
Figure 5-7. A Scatter plot of the cycles to failure of samples tested at a stress of 26 ksi.

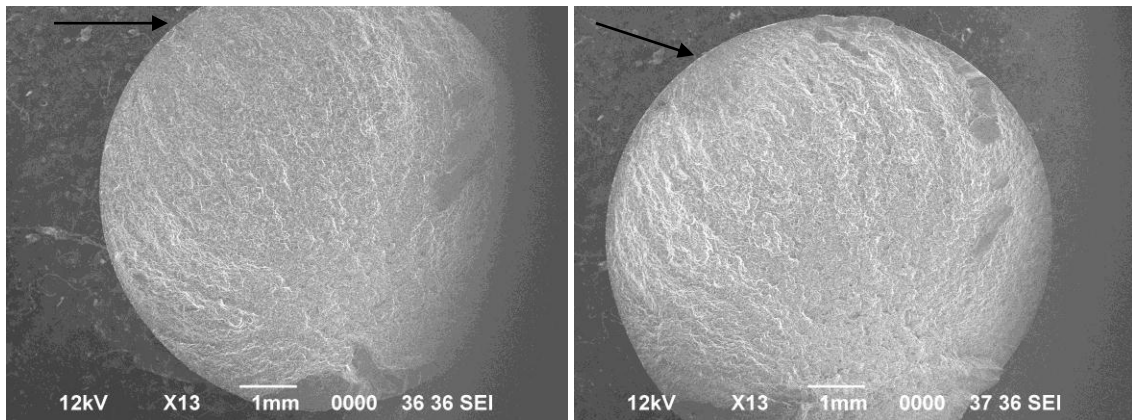
**Figure 5-8. The crack initiation points of bare specimens at 26 ksi (left) and 30 ksi (right).**

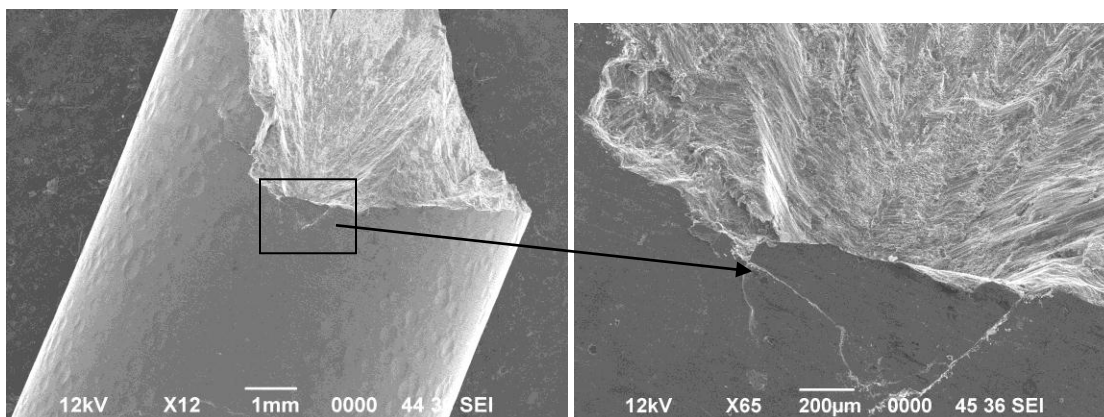
**Figure 5-9. The crack initiation site for an uncoated shot peened sample.**

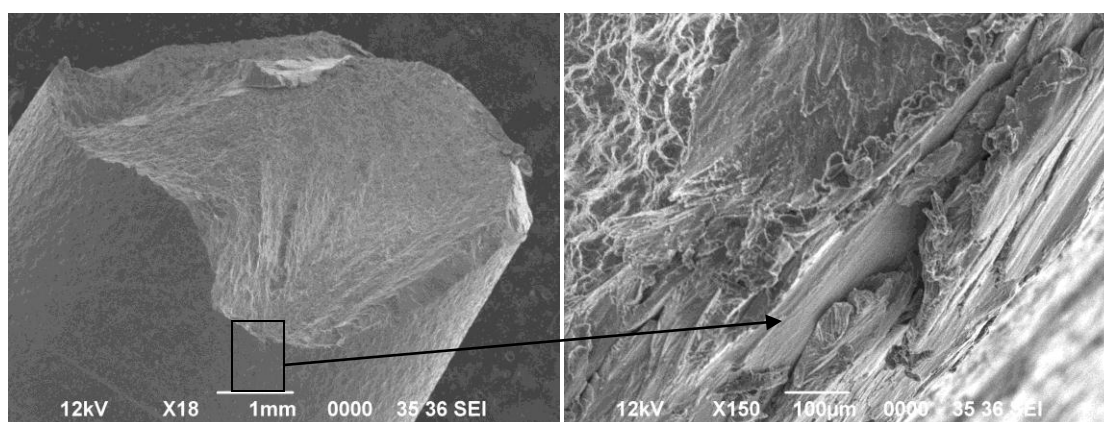
**Figure 5-10. The typical crack initiation site for non coated grit blast specimens.**

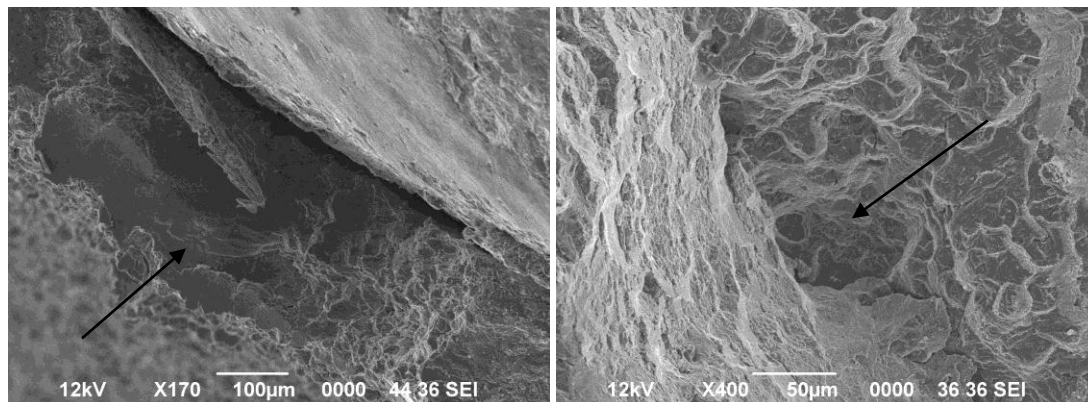
**Figure 5-11. Pores on the substrate/coating interface that led to the failure of both types of coated samples at 30 ksi.**

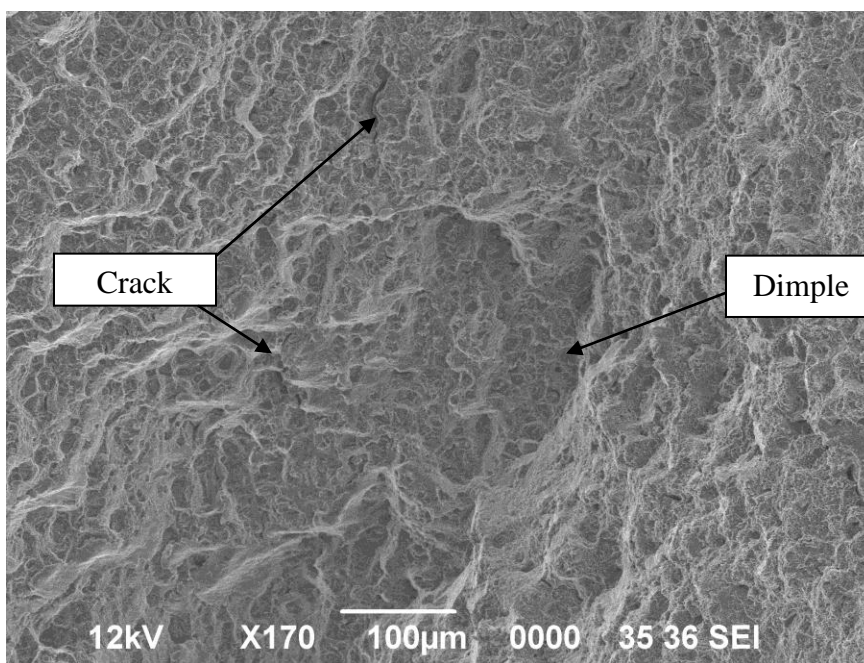
**Figure 5-12. The dimple and resulting cracks of a grit blast and coated sample tested at 26 ksi.**

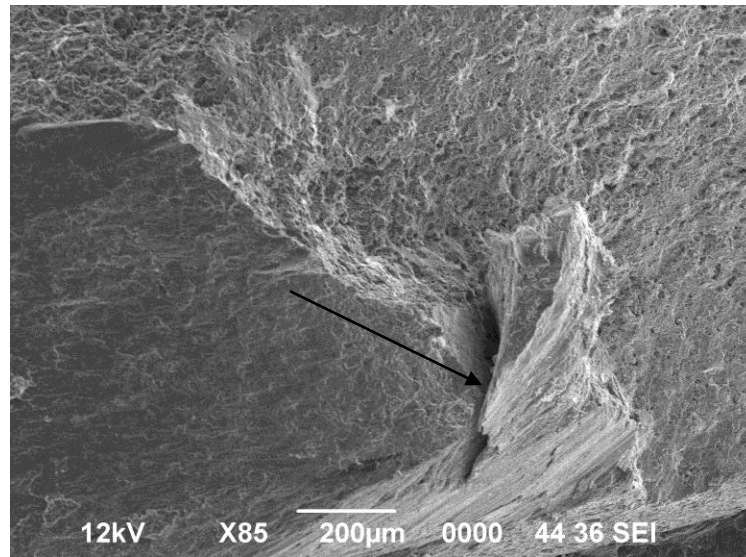
**Figure 5-13. The failure initiation site occurring on the substrate/coating interface of a typical shot peened and coated specimen tested at 26 ksi.**
