# Fatigue Behavior of FRP-Reinforced Douglas-Fir Glued Laminated Bridge Girders

**FATIGUE BEHAVIOR OF FRP-REINFORCED DOUGLAS-FIR GLUED  
LAMINATED BRIDGE GIRDERS**

A THESIS

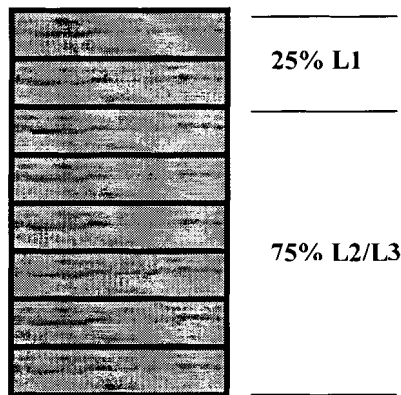
**Figure 3.1** Typical cross section of an unreinforced glulam beam specimen.

The L1 and L2/L3 laminations are grades of visually inspected wood reserved for use in glulam applications. According to the Wood Handbook (1999) published by the Forest Products Laboratory, the specific grade given to the individual lamination is characterized by maximum allowable knot size, grain slope and wane. An L1 lamination cannot have knots larger than one-quarter the width of the lamination, an L2 lamination has knots no larger than one-third the lamination width, and an L3 lamination has a maximum allowable knot size of one-half the width of the lamination. Since the multiple laminations in a glulam reduce the effects of edge knots, the locations of the knots within the lamination have no bearing on the grade.

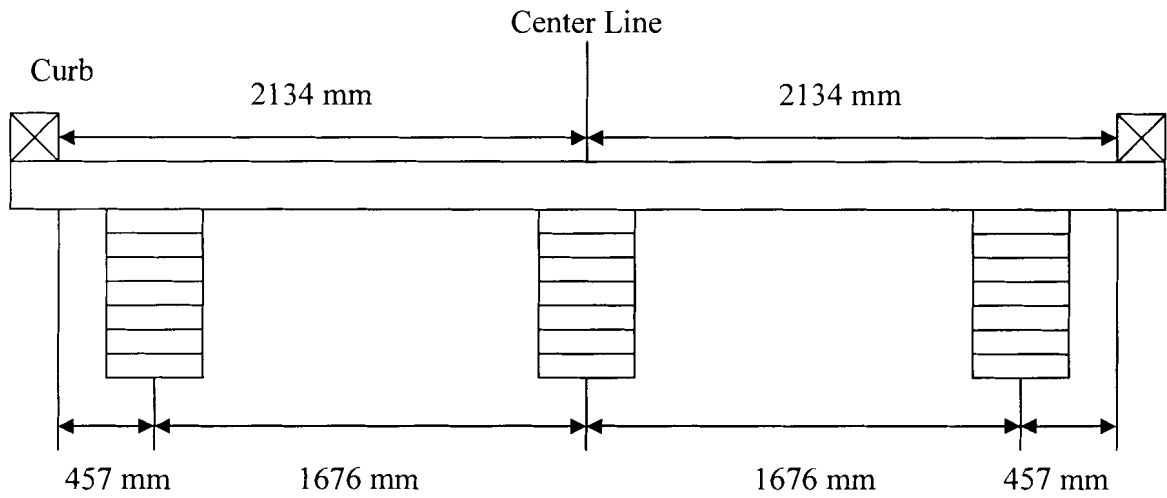
**Figure 3.2** Cross section of the timber bridge used in the design example.

a fixed width of 130 mm and subjecting it to loading from an AASHTO HS-20-44 design truck.

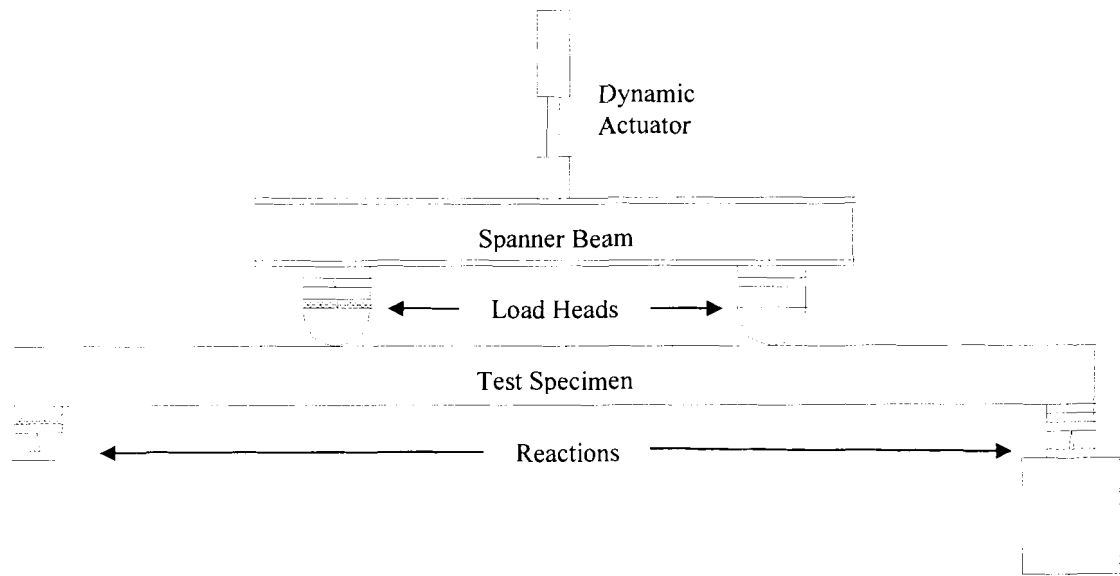
**Figure 3.3** A typical test specimen in the testing frame.

The specimens were simply supported at each end, with a pinned connection at one support and roller connection at the other. These connections were mounted on concrete pedestals and the centerline of the reaction was located 152 mm from the end of the beam. Figure 3.4 shows a typical beam with boundary conditions in the testing set-up.

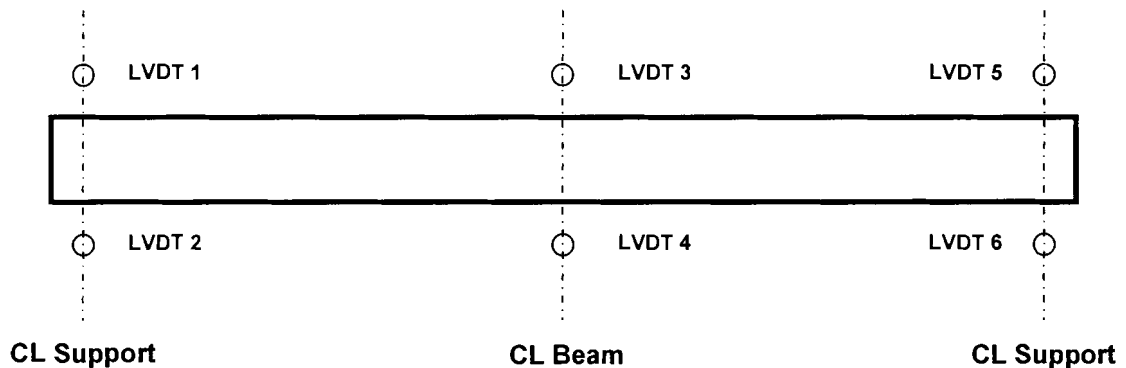
**Figure 3.4** Top view of beam showing the instrumentation scheme of a typical specimen.

The instrumentation scheme for the static tests is shown in Figure 3.4. A total of six Linear Variable Differential Transformers (LVDTs) measured displacement on the specimen. Two LVDTs were located at center span to measure maximum deflection while two LVDTs located at the centerline of the reactions at each end of the beam measured uplift. The LVDTs at center span (LVDT 3 and 4 in Figure 3.3) had a range of  $\pm 125$  mm for a total range of 250 mm and the four LVDTs at the ends of the beam (LVDT 1, 2, 5, and 6) had a range of  $\pm 12$  mm for a total range of 25 mm. All six LVDTs recorded displacement from the specimens at the neutral axis.

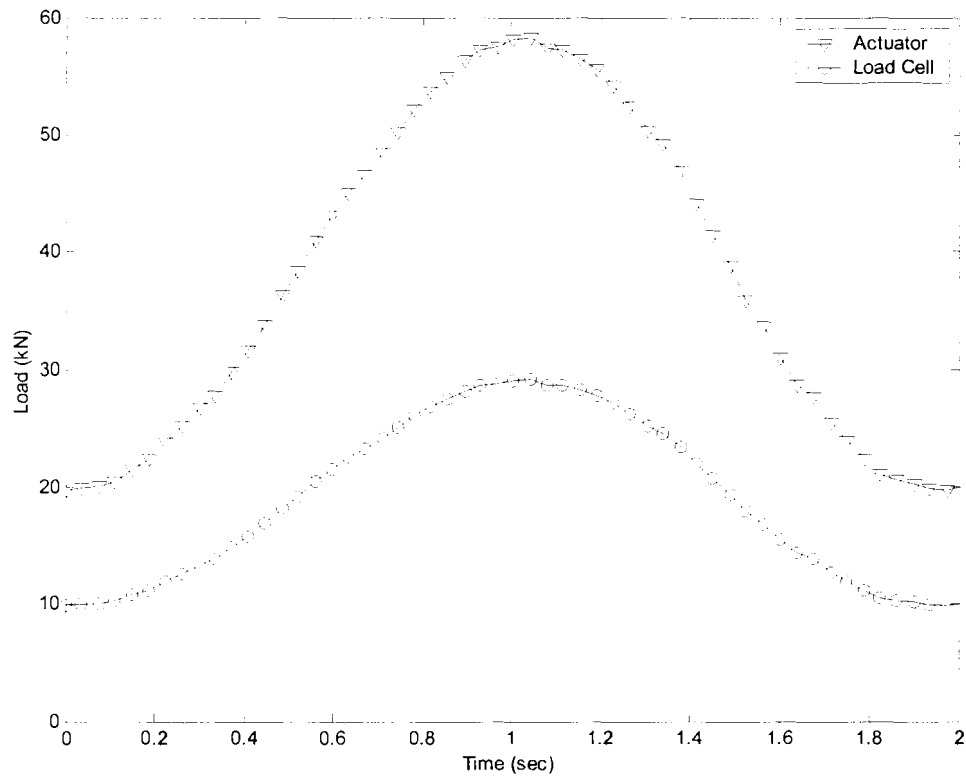
**Figure 3.5** Load cell and actuator load versus time for a frequency of 2.0 Hz.

reached. The maximum rate at which the tests could be run without sacrificing accuracy was 2.0 Hz. The actuator and the load cell loads are plotted against time in Figure 3.5 for a frequency of 2.0 Hz. The maximum and minimum loads were being met with reliable accuracy and therefore the slight distortion in the peak of the actuator loads was acceptable. As can be seen, the plot from the load cell is in phase and half that of the actuator load. All of the 6,700 mm beams were fatigued at a frequency of 2.0 Hz in the 244 kN actuator. Testing was run 24-hours per day constantly and each test took approximately 13 days to complete.

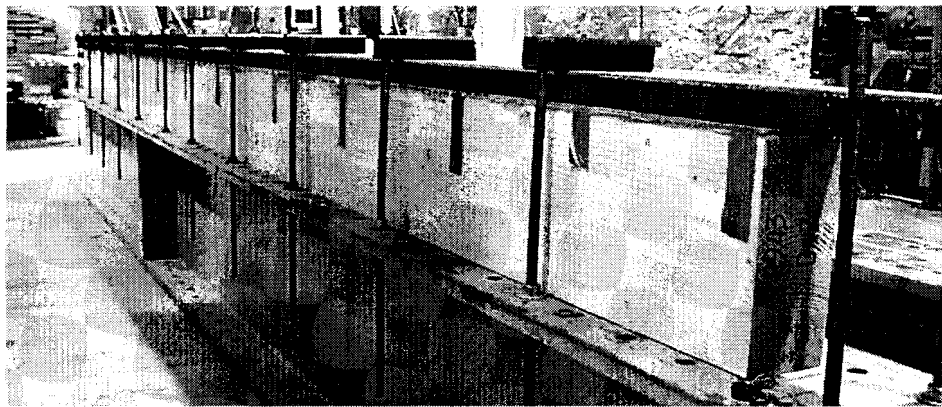
**Figure 4.1** A 6700 mm Beam in cold press.

The last step in reinforcing the beams was to clamp the FRP and glulam together to apply pressure to the bond line. The cold press used to clamp the FRP to the glulam was a large I-beam with threaded rods spaced evenly through the top flanges of the beam. The glulam beam was then placed between the threaded rods and clamped to a pressure of 0.345 MPa. Figure 4.1 shows a reinforced beam in the cold press. The threaded rods were calibrated using a load cell and torque wrench to obtain a tension value based on applied torque. This was done for a number of rods and the average value was used to calculate the appropriate torque needed in each rod given the number of rods, the rod spacing and the required bond line pressure. The appropriate torque for each rod was determined by the total number of rods used to clamp the specimen.

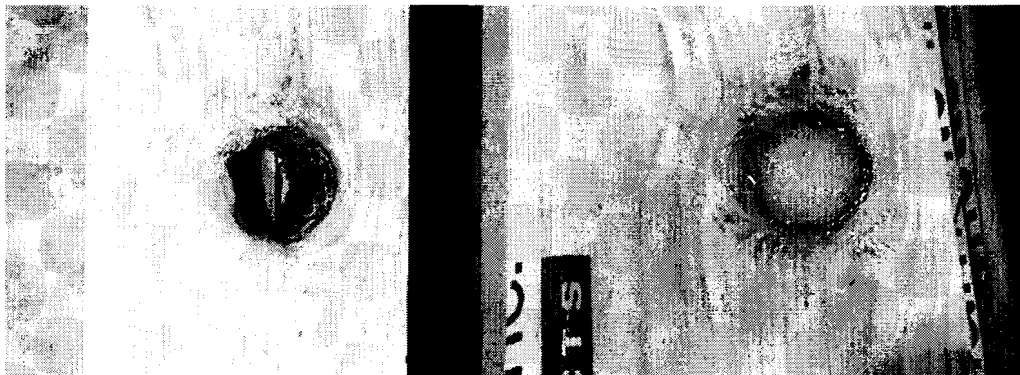
**Figure 4.2** The left side of the picture shows a knot, right side shows the same knot filled with epoxy.

Several of the beams came from the Willamette plant with knotholes that had not been plugged. Many of the unplugged knots were on the tension side of the beams where the FRP was applied. Before the beams were reinforced, these holes were plugged with an epoxy resin, the same FPL-1 epoxy used to bond the FRP to the glulam. This ensured that there would be at least some bond between the wood and FRP at these knotholes. The pictures in Figure 4.2 show one such knothole, before and after it had been filled with epoxy resin. Defects such as cracks and checking in the beams were not treated. Beams not suitable for partial length reinforcing (as discussed later in this chapter) were used for full-length reinforced tests.

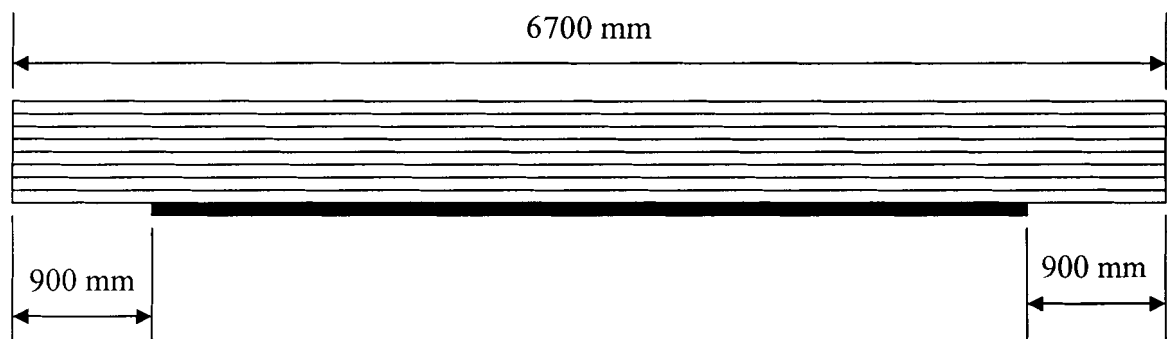
**Figure 4.3** Typical partially reinforced beam.

in Chapter 3. This gave the maximum possible savings in reinforcing material, 26.8% for the 6700 mm specimens, without sacrificing the specimen's flexural strength. However, this also created the most critical situation for evaluating durability of partial length reinforcing. Typically, as in the case of reinforced concrete, tensile reinforcing is extended a certain distance beyond the point where it is theoretically no longer required (American Concrete Institute 1999). This is done to help minimize the effect of stress concentrations at the transition point. Terminating the FRP reinforcing at the TCOP would magnify any problems that might exist at the unconfined terminations and provide a better insight into the behavior of the FRP at unrestrained terminations.

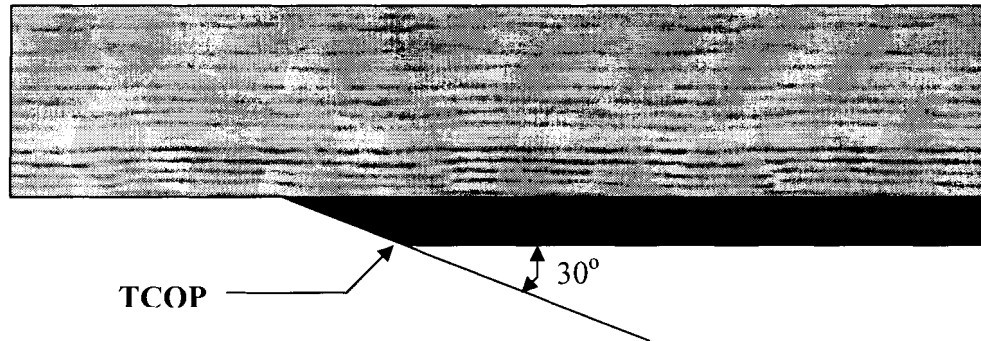
**Figure 4.4** Beveled end detail for partial length reinforcing.

steel beams must be beveled at an angle no more than 30 degrees with the horizontal at their terminations. The beveled portion of the FRP was beyond the TCOP as shown in Figure 4.4.

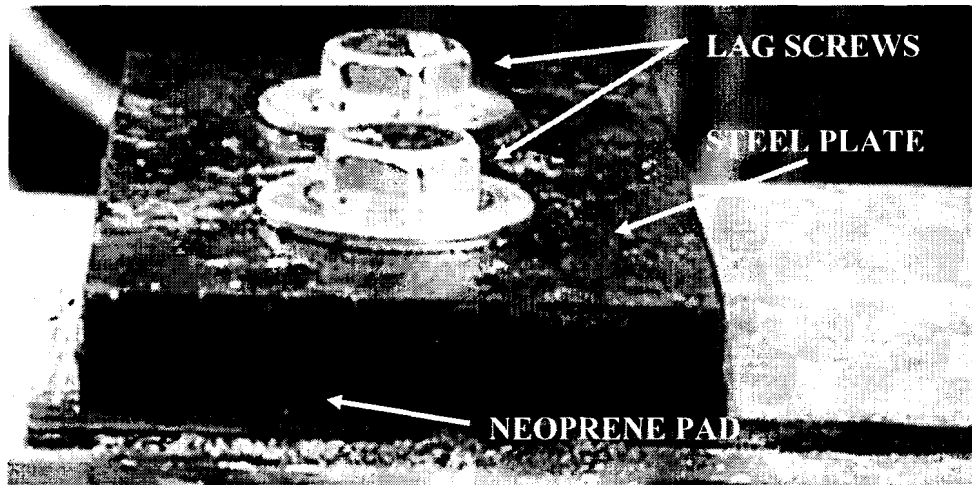
**Figure 4.5** Mechanical restraint used to confine the FRP terminations of partial length reinforcing, shown here on an inverted beam.

The restraints used to confine the FRP terminations, shown in Figure 4.5, were fabricated from A36 steel plates measuring 130 mm x 75 mm x 9.5 mm, a neoprene pad of the same dimensions to provide better surface contact, and two 152 mm x 12.7 mm lag screws. This was an inexpensive and easily constructed detail that could be applied with common tools and no special experience.

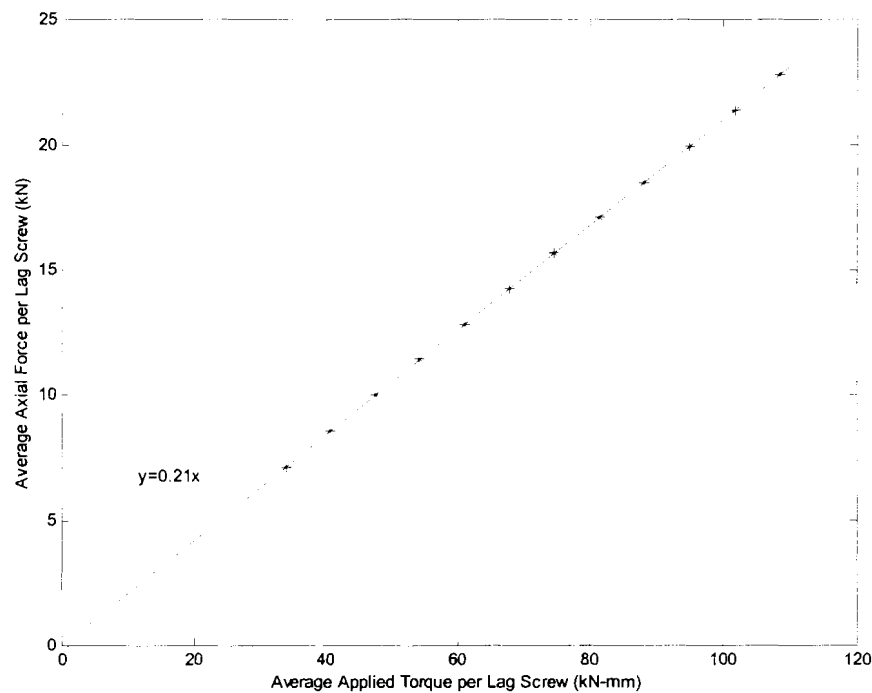
**Figure 4.6** Relationship between averaged torque and pressure for ten lag screws.

the FRP termination was approximately 18.1 kN. The thickness of the steel plate was designed so that at the applied clamping force, the stress in the cantilever portion of the plate (the portion from the center of the lag screw to the outer edge of the plate) would be half of the yield stress of the steel. While the specimens were being fatigued, the torque in the lag screws was checked during the periodic static tests, and re-torqued to 86.4 kN-mm if necessary as discussed in Chapter 5.

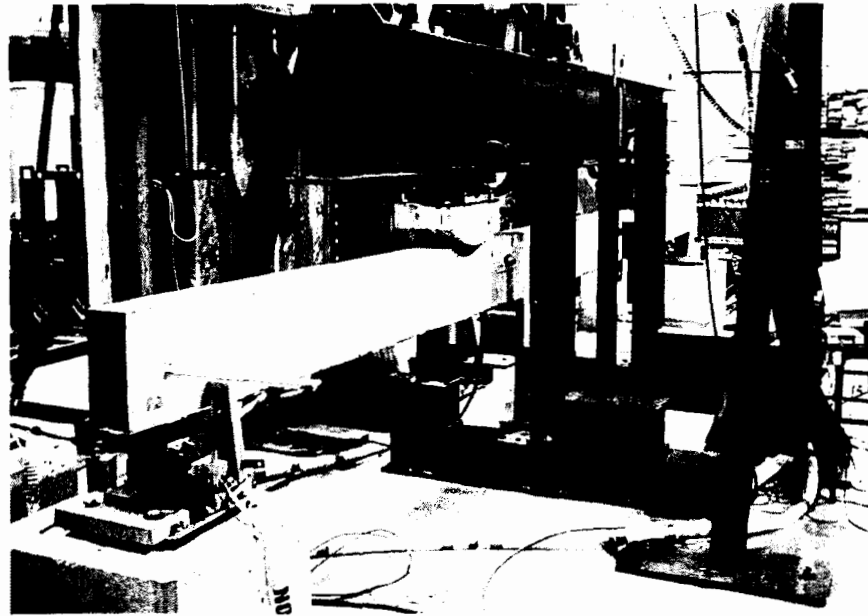
**Figure 5.1** Picture shows a 6,700 mm specimen in the testing apparatus.

All fatigue tests were run for  $2 \times 10^6$  cycles, or until failure, and then broken in static bending. The fatigue testing program was a modified ASTM D198 (ASTM 2000) four-point bending setup that cycled the beams between an appropriate minimum load and maximum load. The support length was 300 mm and lateral bracing was placed at the beam's third points. A picture of a 6,700 mm specimen in the testing apparatus can be seen in Figure 5.1. The dead load to live load ratios were calculated using typical unreinforced timber bridge design values, but substituting the flexural strengths of the reinforced beams. These FRP-reinforced design values were obtained from ReLam (Lindyberg, 2001), a computer program which returns glulam strengths based on lamstock data and probabilistic moment-curvature analysis.

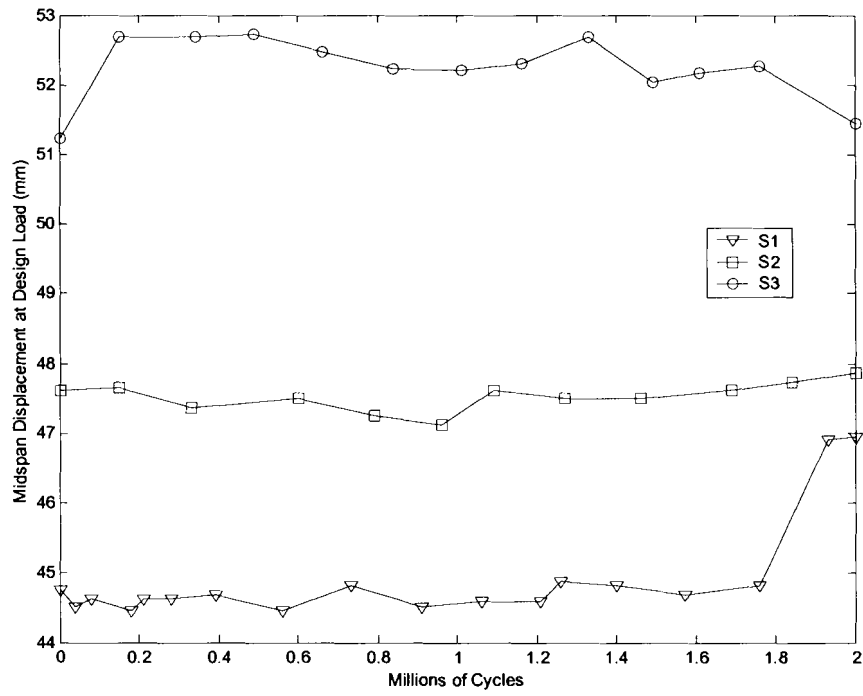
**Figure 5.2** Stiffness vs Time plot for specimens S1, S2 and S3.

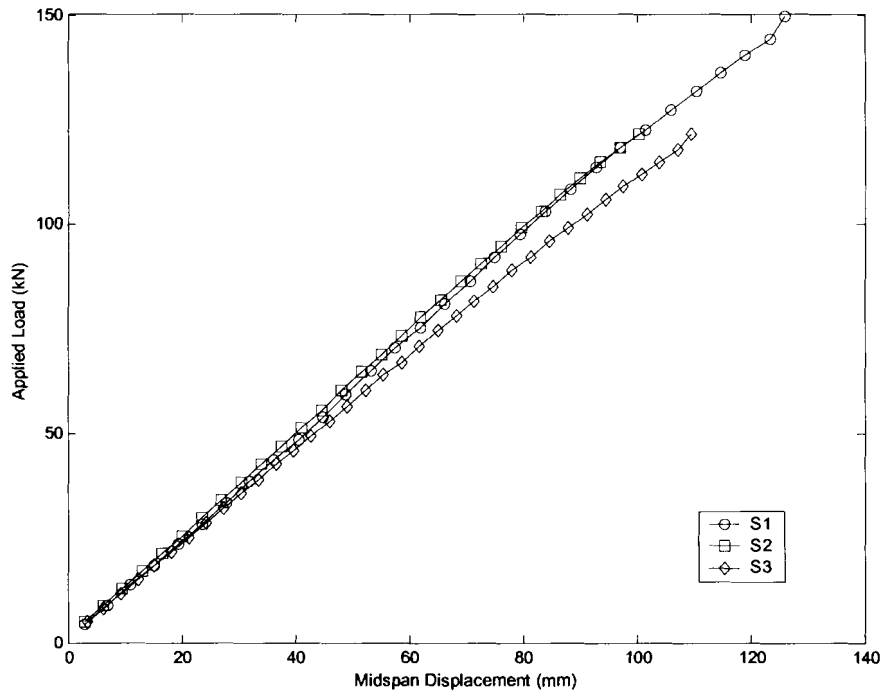
**Figure 5.3** Load vs Displacement plot for specimens S1, S2 and S3.

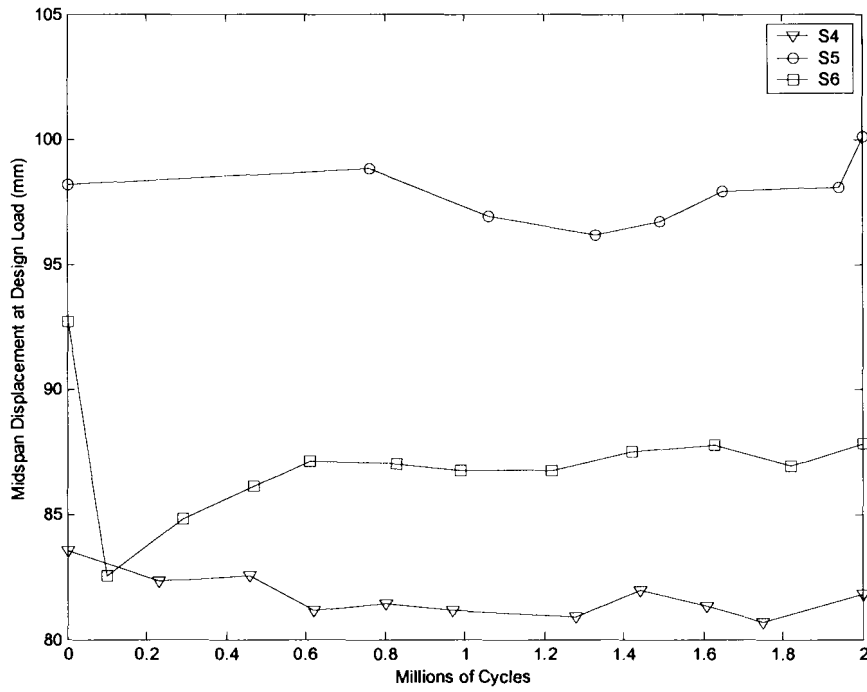
**Figure 5.5** Stiffness vs Time plot for specimens S4, S5 and S6.

Specimens S4, S5 and S6 measured 130 mm x 533 mm x 11,278 mm with full-length reinforcing. The behavior during fatigue and also the ultimate failure mode of this group of specimens were very similar to the smaller S1, S2 and S3 specimens. None of the three specimens in this group showed significant stiffness degradation (see Figure 5.5). However, a horizontal shrinkage crack at one end of specimen S5 was noted to be 610 mm long at the start of testing and had propagated to 1,470 mm by the end of the fatigue test. The crack, located in the third lamination from the top, did not have any significant effects on stiffness. No other significant failures or damage were noted during cycling in this or any of the other beams. An interesting phenomenon with specimen S6 was that the initial static test inexplicably showed the beam to be less stiff than all subsequent static tests. No definitive explanation for this is known. For all specimens S4-S6, failure occurred at either a finger joint or knot near midspan and, as seen in Figure 5.6, the load-deformation curves remained linear until failure. The load deformation plot for specimen S6 shows a slight nonlinearity in the second to last point plotted. This was due to the tensile lamination failing just prior to the FRP being torn from the beam. The beam loses load (second to last point in plot for specimen S6) when the lamination fails and then begins to hold load again as displacement increases. This phenomenon was largely due to the fact that the tests were run in position control and can be seen in several other specimen load-deformation plots.

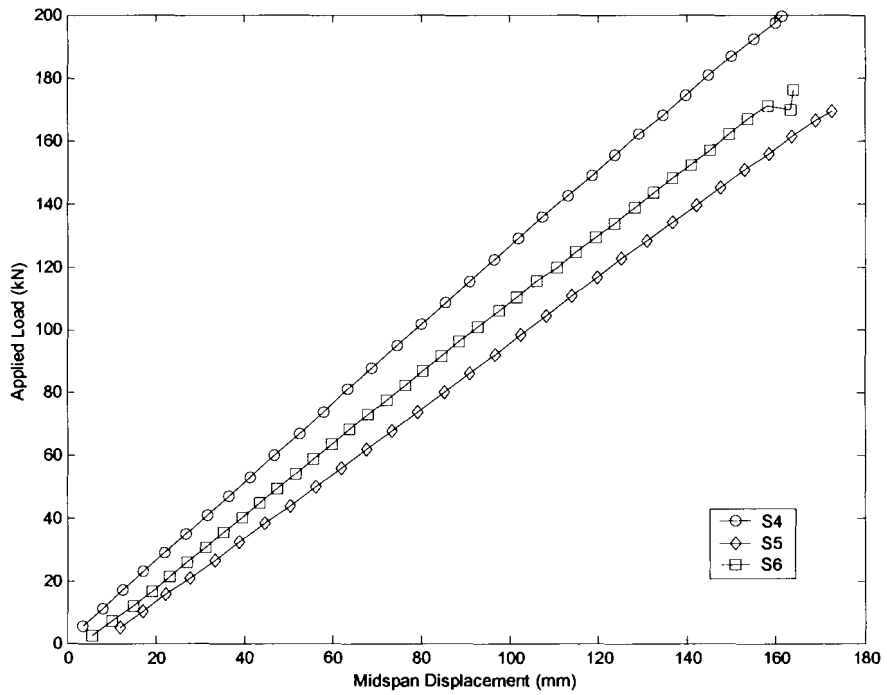
**Figure 5.6** Load vs Displacement plot for specimens S4, S5 and S6.

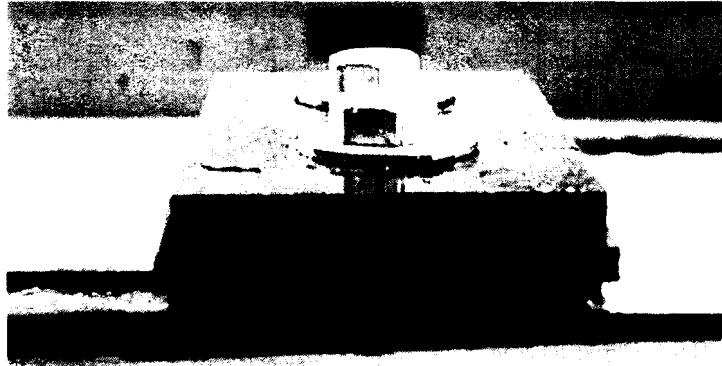
**Figure 5.7** View shows typical end restraint for partially-reinforced specimens. Beam is inverted for better perspective.

periodic static test performed. Torque losses were between 4 and 7 kN-m per static test. Refer to Chapter 4 for more details on the construction of the partially-reinforced beams.

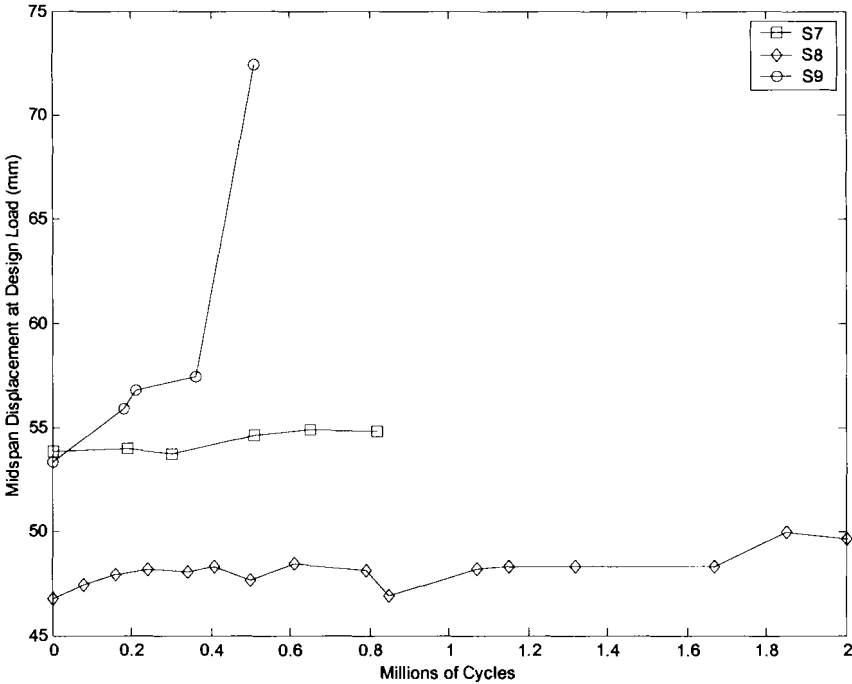
**Figure 5.8** Stiffness vs Time plot for specimens S7, S8 and S9.

Specimen S8 lasted only 592,000 cycles and had the most significant stiffness loss of all beams tested. The relative stiffness loss was almost 38%, which can be seen in Figure 5.8. There were no outwardly visible signs of damage occurring in the beam, leading to the conclusion that the significant stiffness loss was due to internal damage that occurred somewhere after 30,000 cycles. The source of failure in specimen S8 was identical to that of S7 and S9, with a loss of bond at the FRP termination leading to a tension failure in the wood.

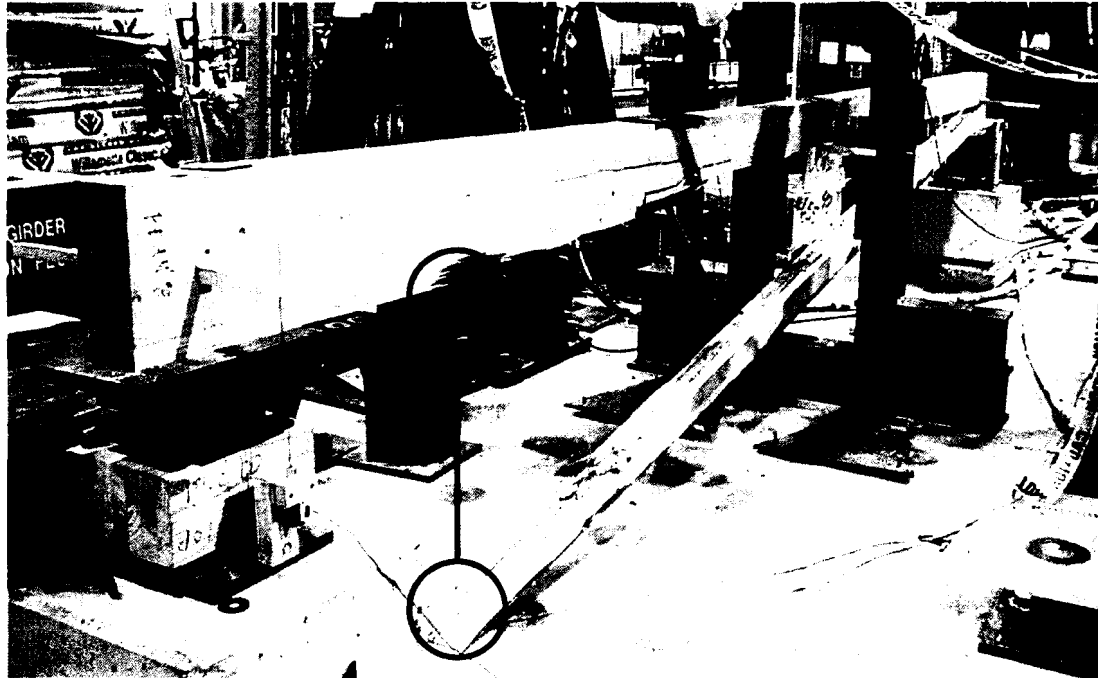
**Figure 5.9** Debonding failure of Specimen S7 during fatigue. Circles shows the FRP termination on the floor and the location of the termination before failure. This failure mode was typical of specimen S7, S8 and S9.

5.9 with the beam still in the testing apparatus. The portion of the beam seen lying on the floor is the FRP termination where the failure initiated.

of the specimen. Although the beam did not fail during fatigue, the failure was similar to specimen S7 in that the failure initiated as a loss of bond at the FRP termination and ultimately led to a tension failure in the wood. Failure looked very similar to that of specimen S7 seen in Figure 5.9.

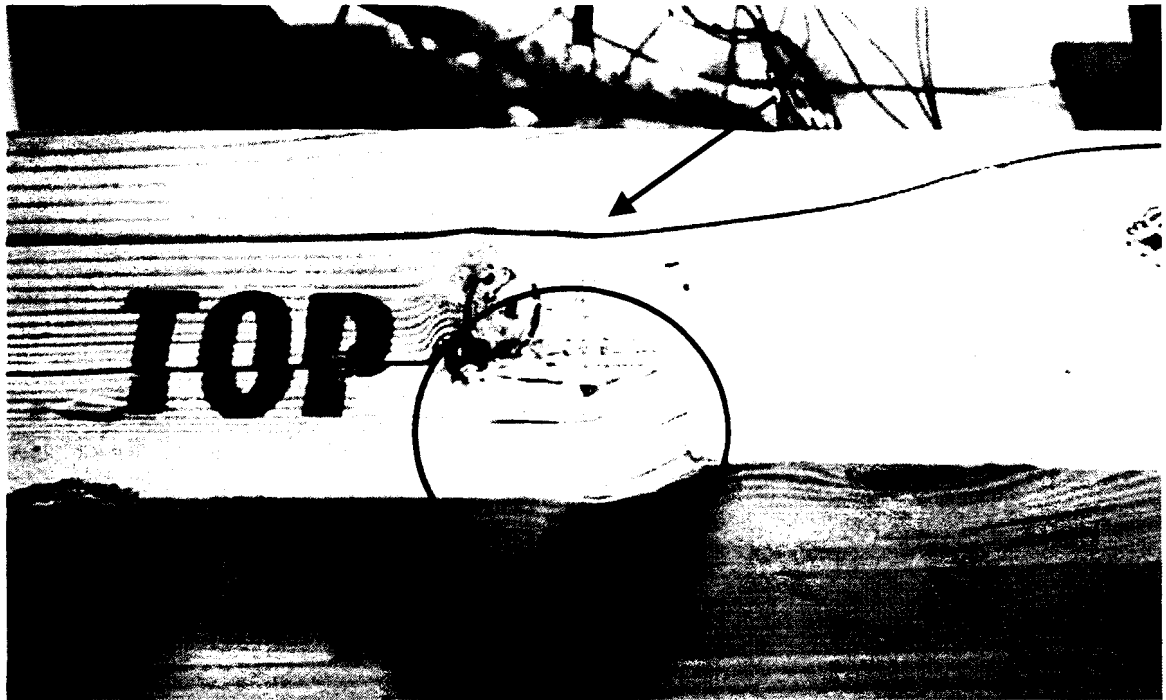
**Figure 5.10** Compression failure in specimen S9.

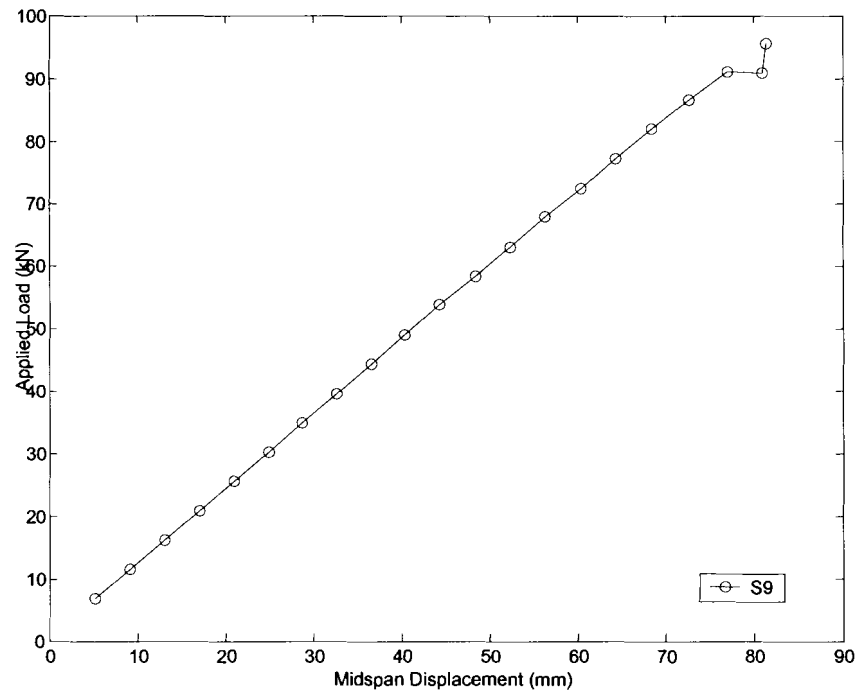
**Figure 5.11** Load vs Displacement plot for specimen S9.

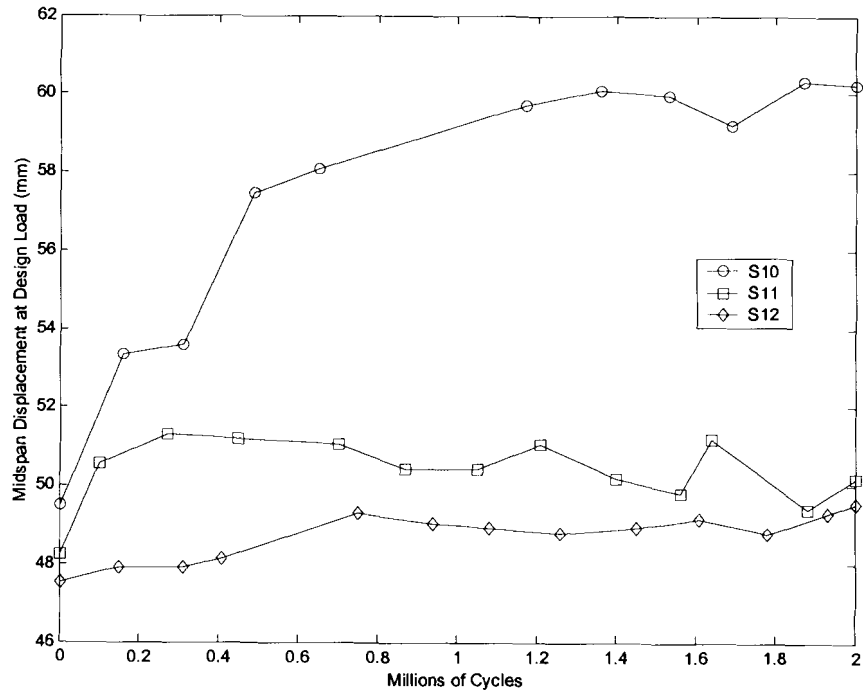
Figure 5.12 Stiffness vs Time plot for specimens S10, S11 and S12.

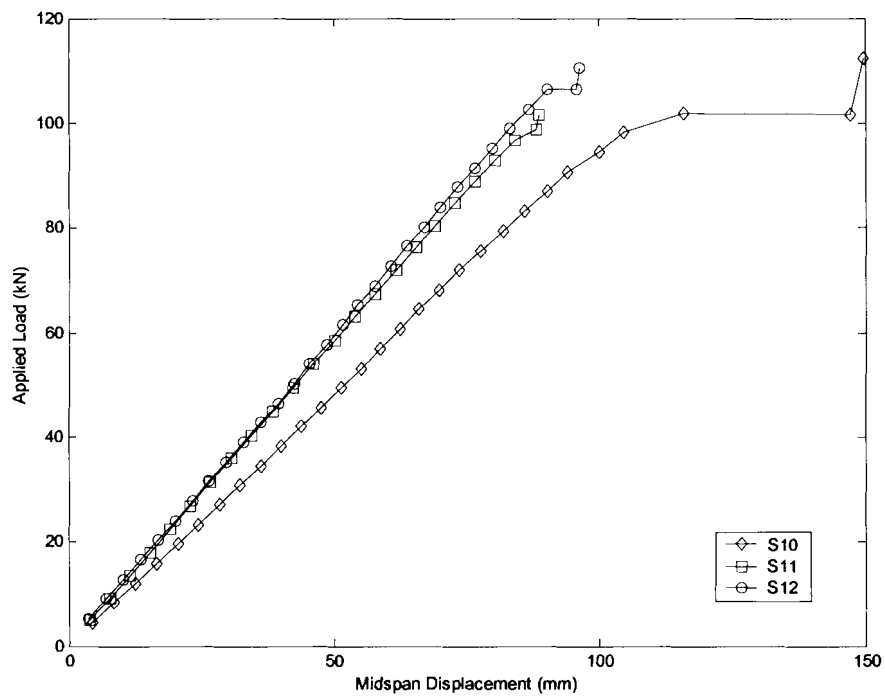
**Figure 5.14** Load vs Displacement plot for specimens S10, S11 and S12.

The beam was loaded to failure in static bending after the fatigue testing was completed. Figure 5.14 shows the load-deflection curve for specimen S11. At failure, the beam developed a horizontal shear failure that ran the entire length of the beam (see Figure 5.15). The shear cracks initiated under the load heads near the neutral axis and propagated down the length of the beam toward the supports. This was the only beam to fail in shear while being broken in static bending.

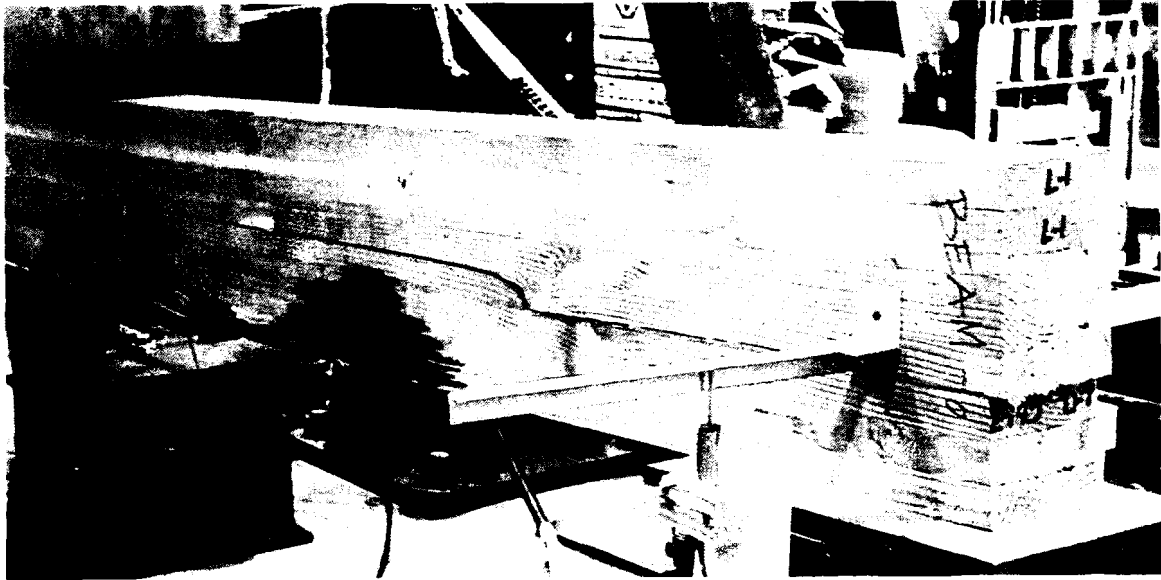
**Figure 5.15** Shear failure in specimen S11.

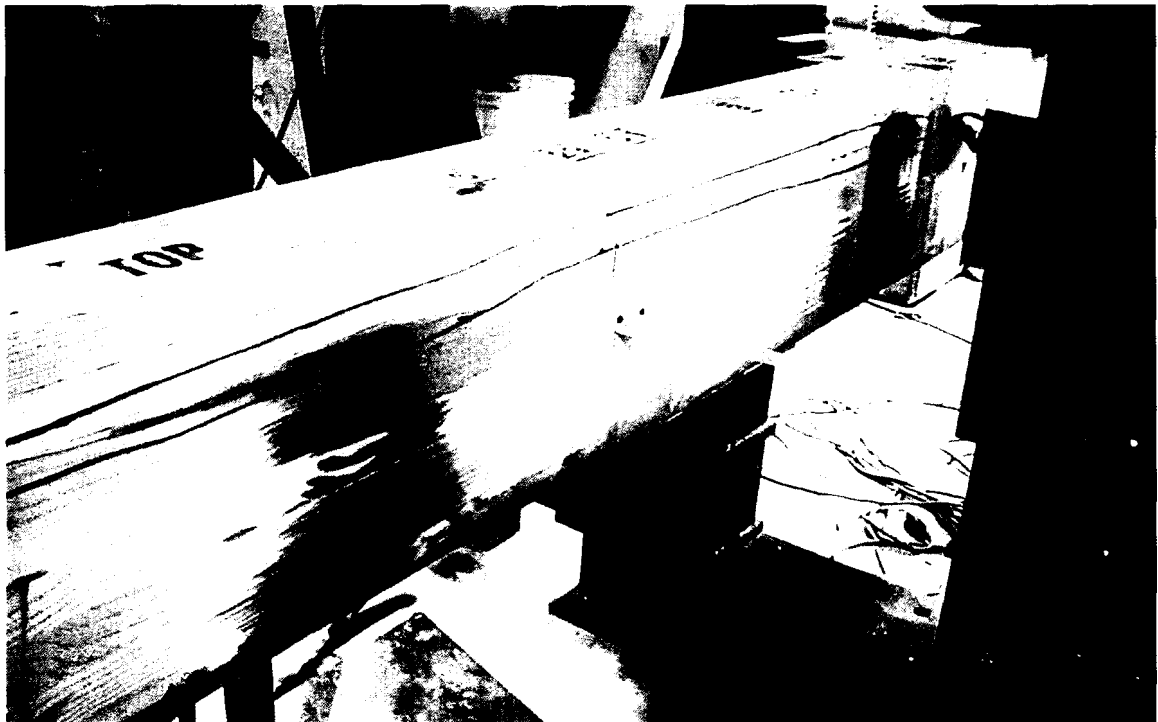
**Figure 5.16** Shear failure in specimen S13 (shear crack highlighted by two horizontal marker lines).

wood and was mostly along the wood-wood bond line of the laminations indicating that it was not a bond line failure, but rather a wood failure. After examining the failed beam, a knot was found on one side of the beam, which had been completely blown out by the shear failure. This knot ran the full depth of the lamination and penetrated approximately 45 mm into the width of the cross section. Because of the very short duration of the fatigue cycling period, only an initial static test was run and therefore there is no record of stiffness change over time.

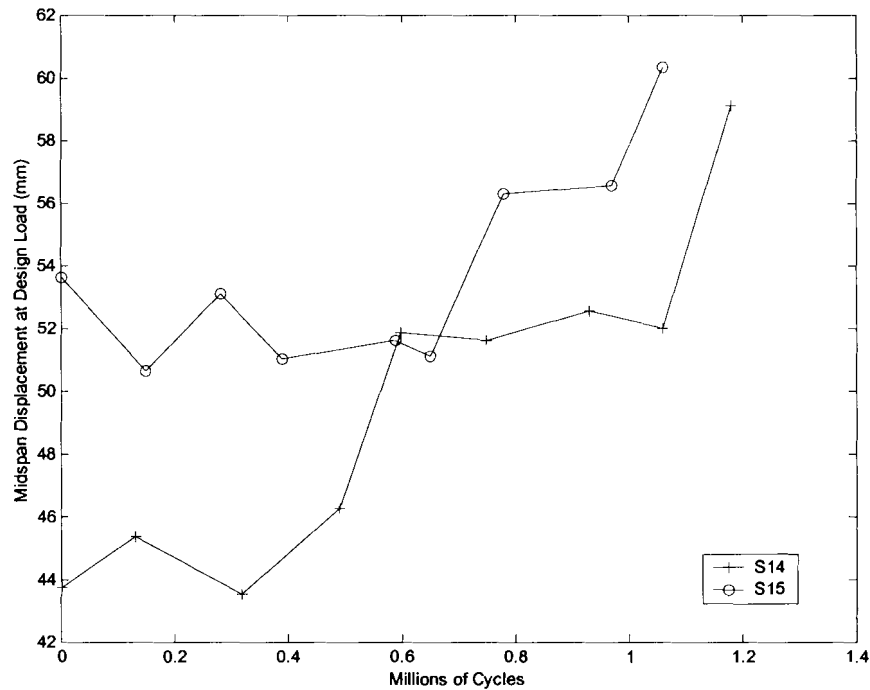
**Figure 5.17** Stiffness vs Time plot for specimens S14 and S15.

This compression failure corresponds well with what is seen in the plot of midspan deflection versus number of fatigue cycles in Figure 5.17. There is a definite trend of stiffness loss after 400,000 cycles, just before the failure was noticed and this stiffness loss continued as the crack propagated further.

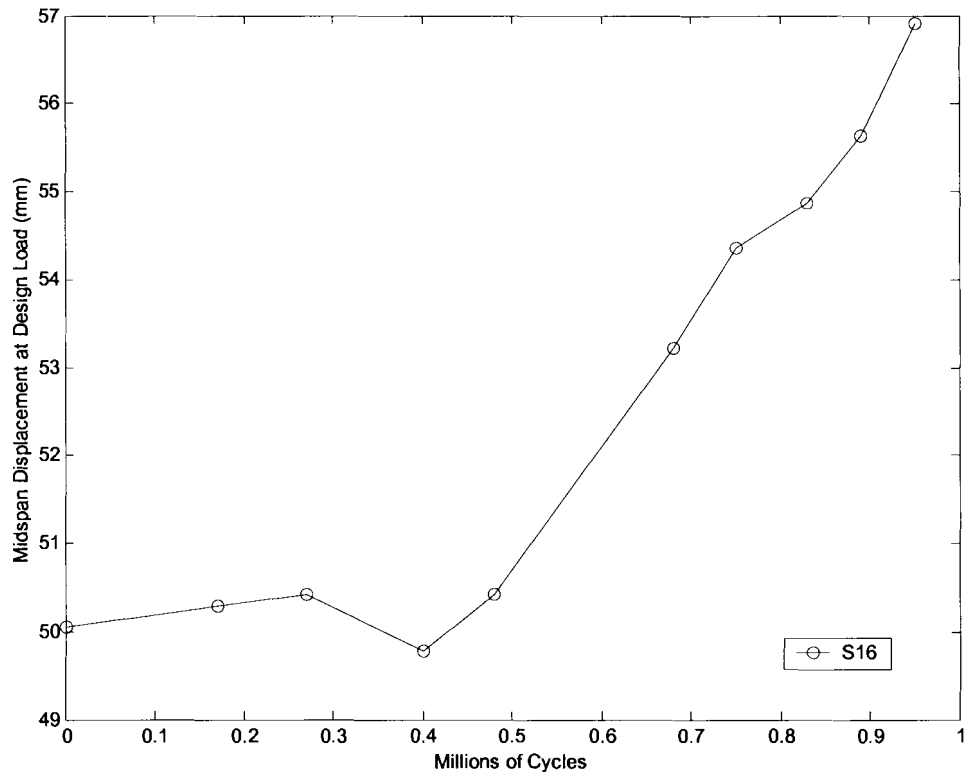
**Figure 5.19** Stiffness vs Time plot for specimen S16.

between the wood and the FRP. The beam continued to cycle until ultimately failing at 953,845 cycles due to the local tension failure at the knot. Figure 5.19 shows a significant stiffness loss of almost 14% between the periods when the tensile failure was first noted to when the beam ultimately failed. The same knot where the tensile failure formed was the ultimate source of failure in the beam.

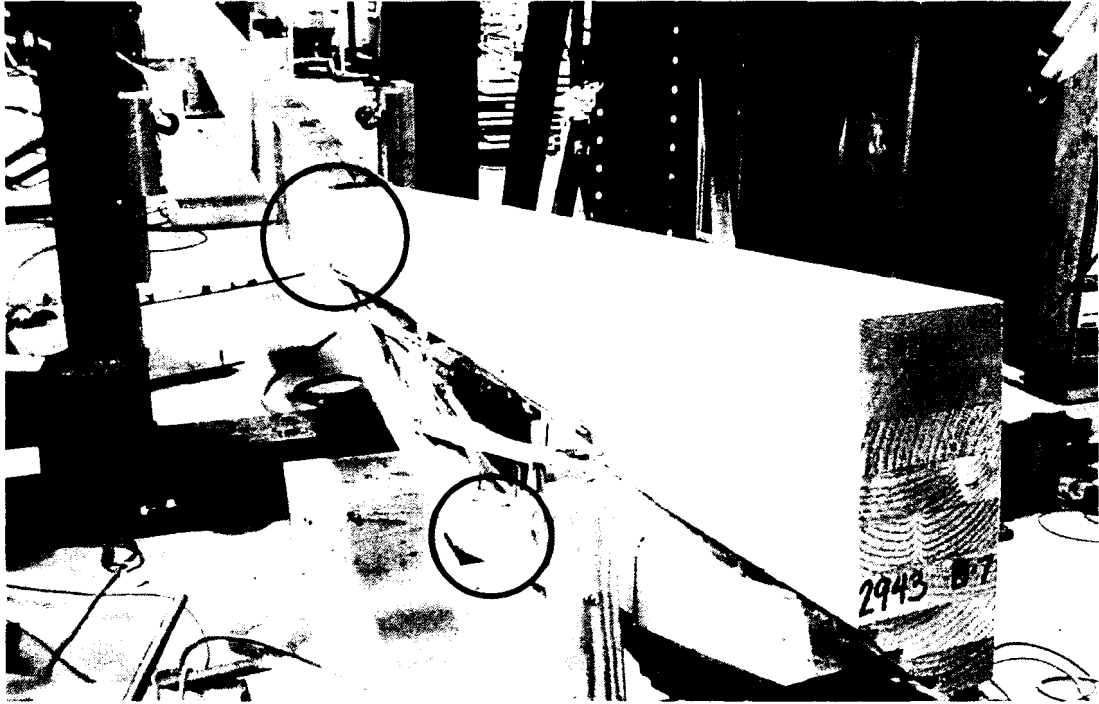
**Figure 5.20** Specimen S17, post-failure. Top circle highlights point of initial shear failure and subsequent tensile failure. Bottom circle shows the lag screws.

Specimen S17 cycled for 101,000 cycles and failed in fatigue. No one was present to witness the failure, however, the conclusions drawn from examining the broken beam was that the failure initiated as a shear crack under the load head and propagating to the end of the beam. Figure 5.20 shows the beam post-failure, still in the testing apparatus. The cracked section of the beam between the end of the beam and the load head then failed in tension, pulling the lags screws out and cracking the beam in the compression region. Because of the short life span of the beam only an initial static test was performed and therefore there is no plot of stiffness degradation over time.

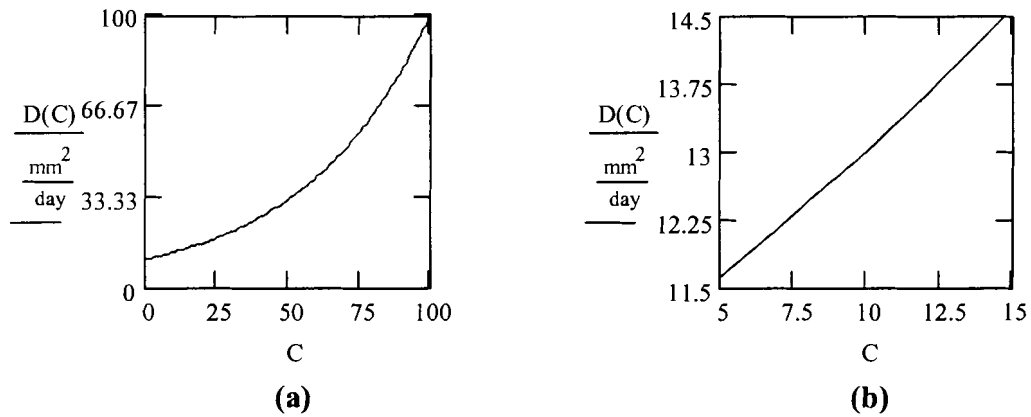
**Figure 6.1** (a) Plot of Diffusion Coefficient for Moisture Content range of 0-100%  
 (b) Plot of Diffusion Coefficient for Moisture Content range of 5-15%.

of the diffusion coefficient for moisture contents of 0% to 100% and Figure 6.1b shows the linearity of  $D$  between 5% and 15%. For these reasons, a diffusion coefficient of  $12.903 \text{ mm}^2/\text{day}$ , which corresponds to a moisture content of 10%, was used for all simulations.

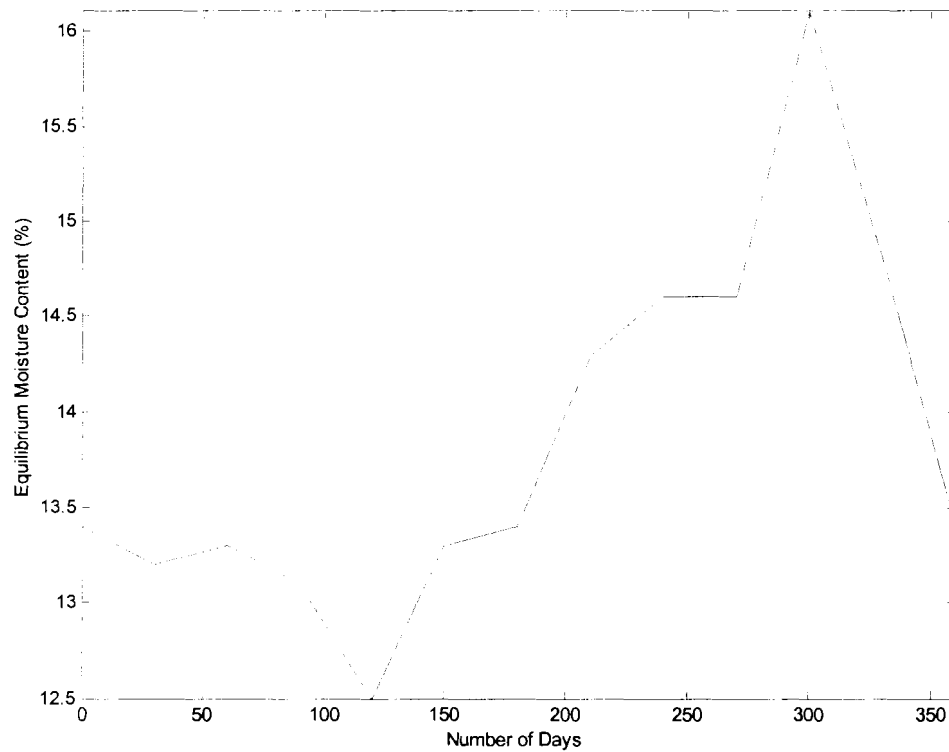
**Figure 6.2** Plot of annual EMC fluctuation.

Annual fluctuations of this data fit roughly to a sinusoidal function. Figure 6.2 is a plot of the change in equilibrium moisture content over the year. The lowest annual equilibrium moisture content occurs around day 120 while the annual high occurs around day 300.

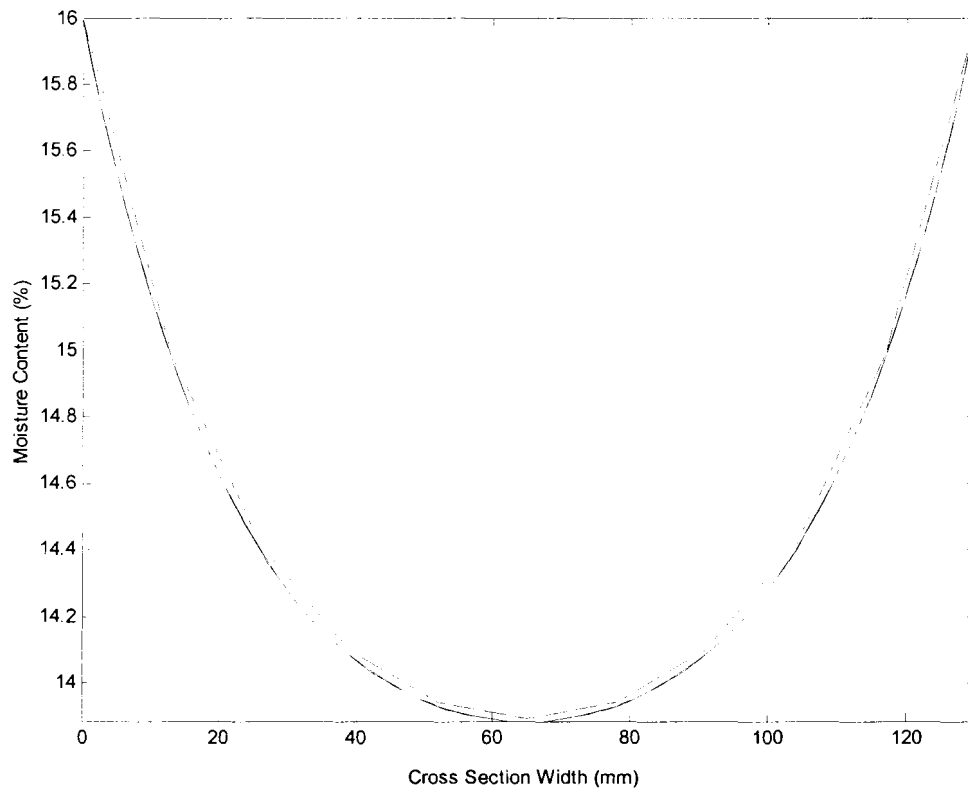
**Figure 6.3** Convergence of cross-sectional divisions,  $\Delta x$ .

several incrementally small values until there was little evidence of change between iterations. A plot of the solutions to the model as  $\Delta x$  varied with changes in the number of cross sectional division can be seen below in Figure 6.3 below. The model was tested with 15, 50, 75 and 100 divisions of the cross section, and convergence was achieved after 50 divisions in the cross section. The dashed line in the plot below represents 15 divisions of the cross section. The segmented nature of the line indicates that more divisions are necessary to fill in the values between segments and smooth out the line. A smoother function is desired to give a more accurate representation of the moisture profile. The plots for 50, 75, and 100 divisions are almost coincident and therefore anything over 50 divisions was deemed acceptable for use as input for the model. These plots all show much smoother functions than the plot of 15 divisions and the difference in the shape of the plots is negligible.
