# Fatigue Behavior of FRP-Reinforced Douglas-Fir Glued Laminated Bridge Girders

**FATIGUE BEHAVIOR OF FRP-REINFORCED DOUGLAS-FIR GLUED  
LAMINATED BRIDGE GIRDERS**

A THESIS

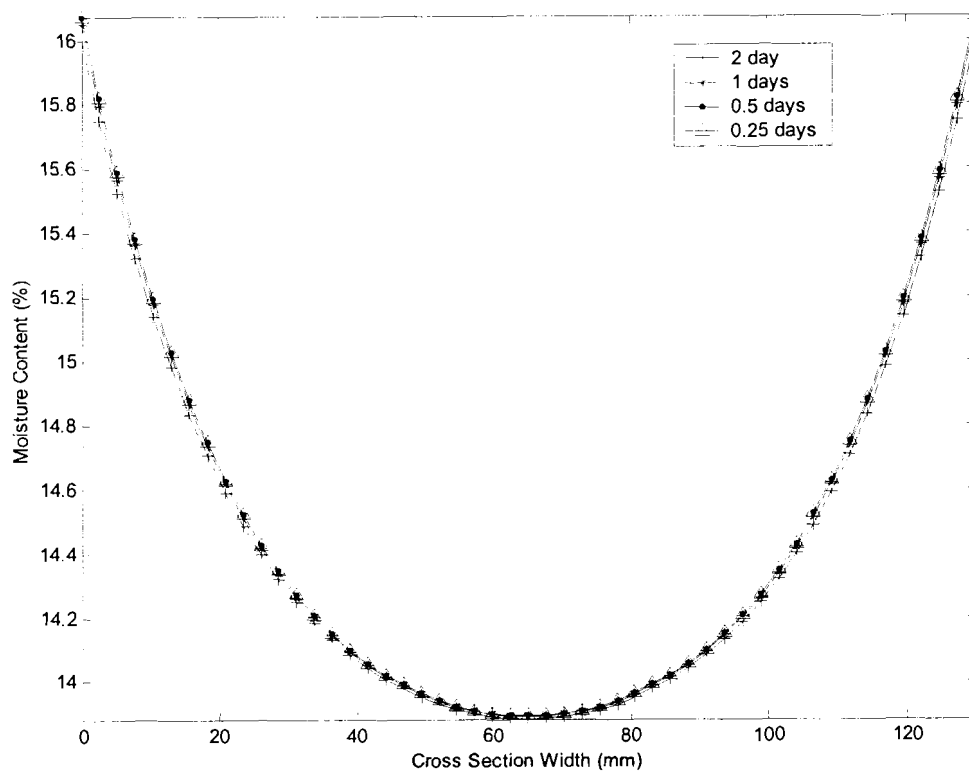
**Figure 6.4** Convergence of time step value, time\_step.

Once a reliable value for the number of divisions in the width of the cross section was established, another convergence study was done for the size of the individual time steps. Holding the number of divisions constant at 50, the time step was varied and the solutions plotted. Time step values of 2 day, 1 day,  $\frac{1}{2}$  day, and  $\frac{1}{4}$  day were used and their plots can be seen in Figure 6.4 below. As can be seen the plots of all 4 time step values are almost coincident. A time step of 1 day was convenient to work with in terms of calculation time and was found to be sufficiently small, and was thus selected.

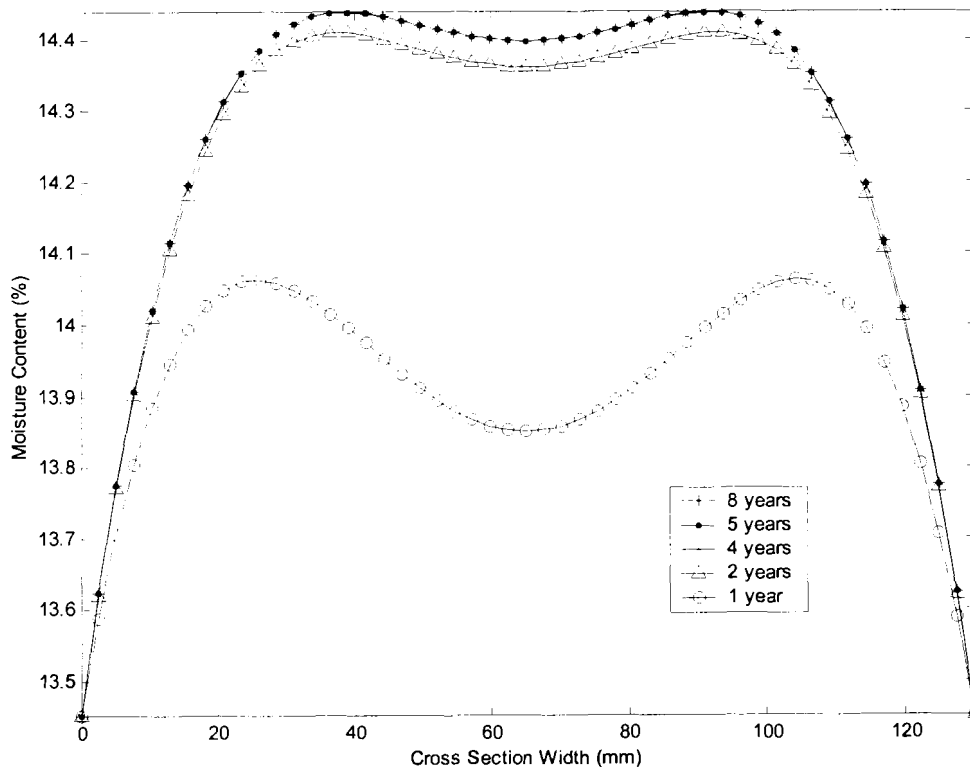
**Figure 6.5** Moisture Profile for month of January after 1, 2, 4, 5, and 8 years.

annual cycles and examining the results to see when the core seemed to no longer be affected by the moisture fluctuations. The input variables discussed earlier were used in this analysis and the plots can be seen in Figure 6.5 below. Plots were generated for the January moisture profile in the cross section for a period of one year, two years, four years, five years and eight years. After a period of four years, the moisture content of the core is stable and any changes are due to the monthly changes of the boundary conditions. The line denoted by circles and the line denoted with triangles are the profiles after one annual cycle and two annual cycles, respectively. The line marked with x's at the top of the plot represents the profile after four years and is coincident with the plotted lines for five years and for eight years.

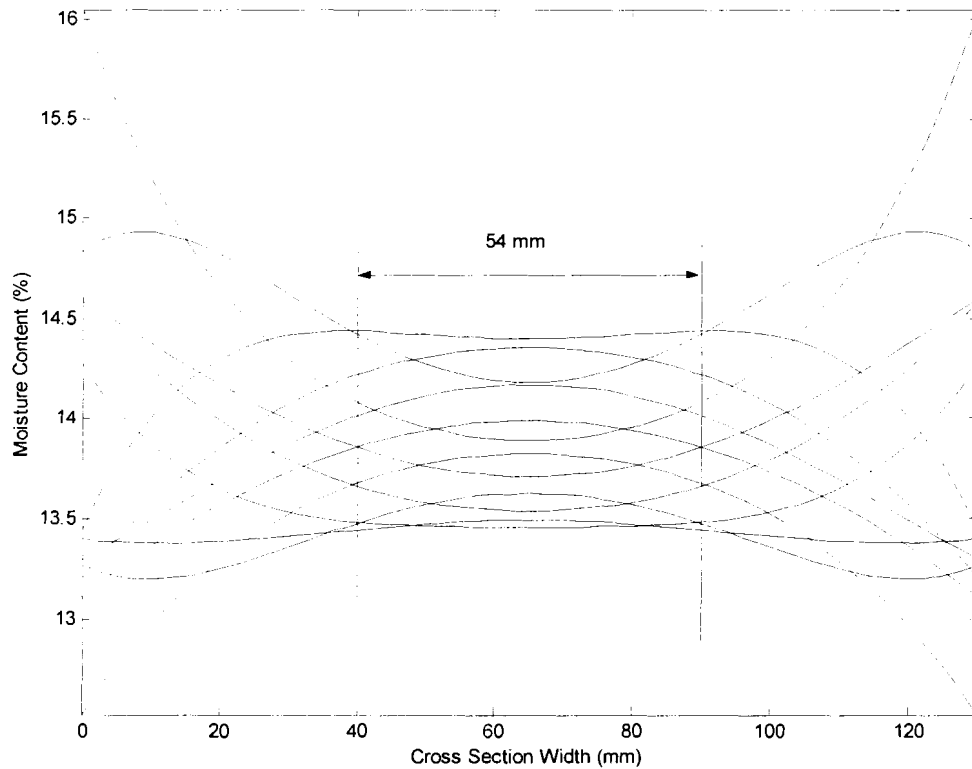
**Figure 6.6** Plot of moisture profile for 12 months data after initial 4 years.

Determining when the core of the beam would reach equilibrium was needed in order to determine where to start running the model for the hygrothermal stress analysis. Although initial shrinkage and swelling may cause the highest stress concentrations in the bond line of the reinforced beam, the period of time that the specimen is exposed to this higher stress level is relatively insignificant compared to the entire service life of the beam. Therefore, it was decided that the best way to model the cycling in the beam would be to try to reproduce the monthly changes a beam would see when exposed to these exterior conditions.

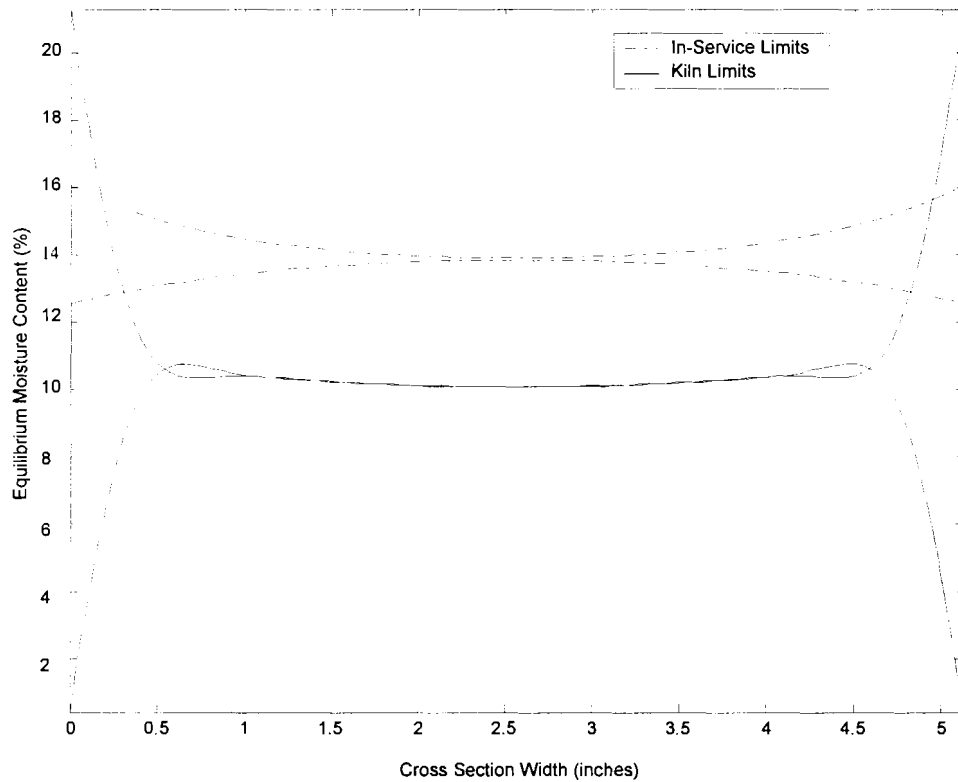
**Figure 6.7** Extreme kiln limits overlaid on in-service high and low conditions

Using moisture profiles from the kiln conditioning and in-service simulations, changes in moisture content were determined and finite element models using the ANSYS program were required to evaluate the stresses that develop due to the moisture changes over the year. The changes in moisture content were found in the same manner as described previously for the environmental conditions.

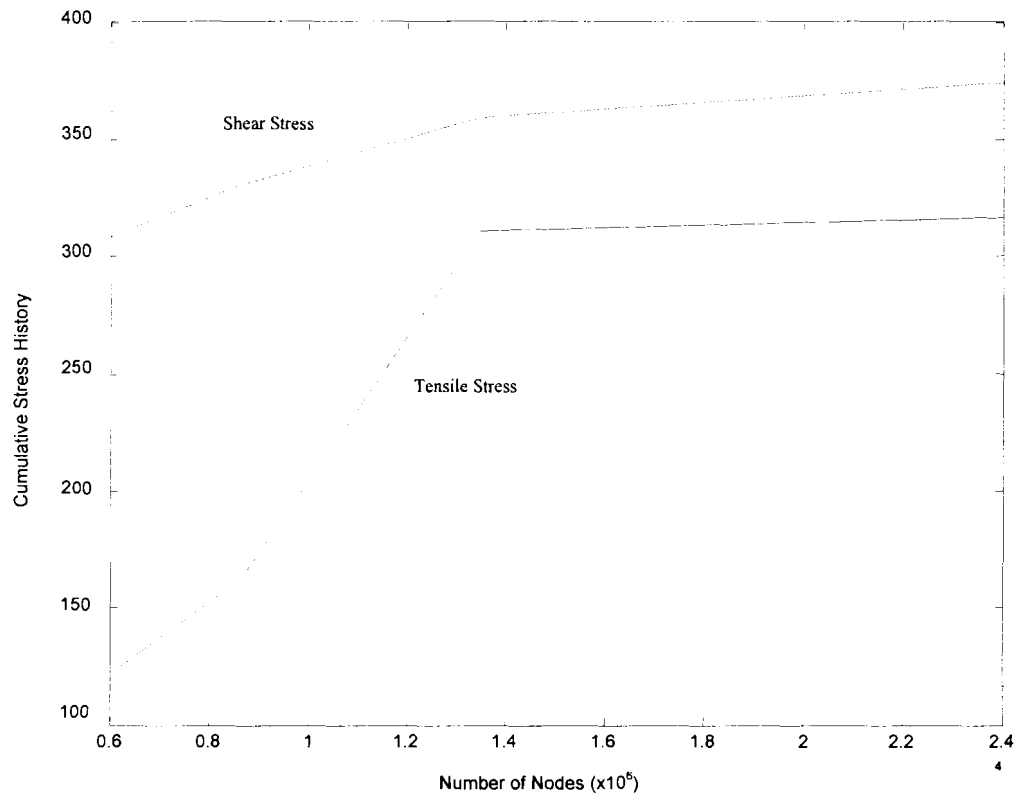
**Figure 6.8** Mesh Convergence for Hygrothermal Finite Element Model

Several models were built using different mesh densities in order to check for stress convergence in the model. Models were built with mesh sizes corresponding to 50, 60, 75 and 100 divisions along the width of the cross section. These divisions corresponded to a mesh density of approximately 6000, 8600, 13500 and 23900 nodes per model, respectively. Figure 6.8 shows the convergence of the model for both the tensile and shear stresses. Convergence was based on a cumulative stress history calculation, explained in more detail later, and the mesh density.

As can be seen from the above figure, the stress history is convergent with about 13500 nodes, or 75 divisions of the cross section for both tensile and shear stresses. For the purpose of evaluating the stresses that occurs at the wood-FRP interface, a mesh consisting of approximately 24000 nodes, or 100 divisions of the cross section was used in the models. This made each element a square with sides of a length of 1.3 mm. A screen image of this mesh can be seen in Figure 6.9.

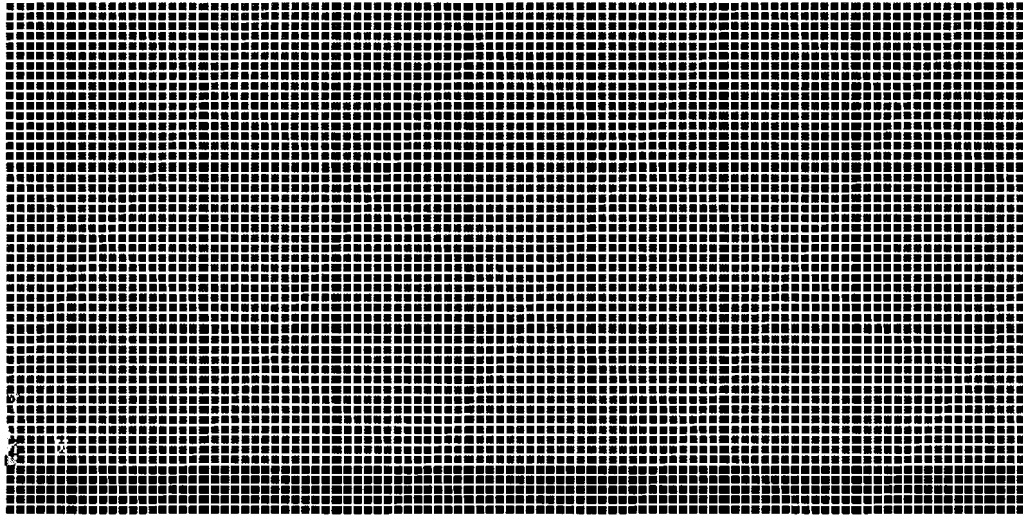
**Figure 6.9** Mesh used for finite element model. The darker color on the bottom represents FRP, the lighter color represents the wood. Close-up of bottom quarter of cross section.

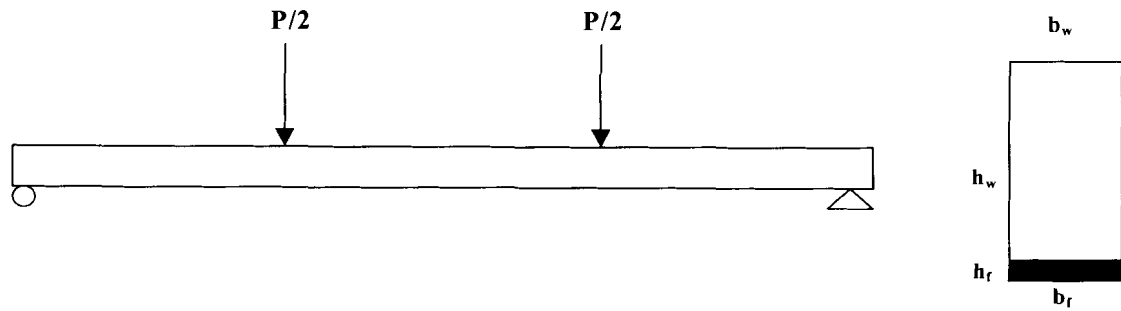
**Figure B.1** Specimen with boundary conditions

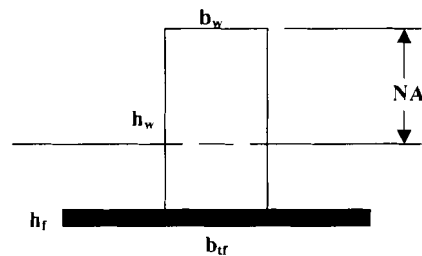
**Figure B.2** Transformed section

$$b_{tf} = 451\text{mm}$$
