State of Maine's Beaches in 2013

Open-File No. 13-18

The 2013 State of Maine's Beaches Report is the 4th report in a consecutive series of reports coinciding with the Maine Beaches Conference from 2007, 2009, and 2011. The purpose of the report is to summarize major observed morphologic characteristics and changes of Maine beaches that are monitored as part of the State of Maine Beach Profiling Project (SMBPP, Maine Sea Grant Extension, 2003). The SMBPP utilizes trained volunteers to collect monthly beach profiles which start at a known point or benchmark (usually in the frontal dune or in a seawall) and continue shore-perpendicular to roughly the low water line. Fixed starting locations are used with the Emery Method of beach profiling (Emery, 1961). Data collected is entered by volunteers into an online database, where it is accessible for outside researchers (Maine Shore Stewards, 2007). The SMBPP is funded and managed by combined efforts of the Maine Geological Survey, University of Maine, Maine Sea Grant, and Maine Coastal Program.

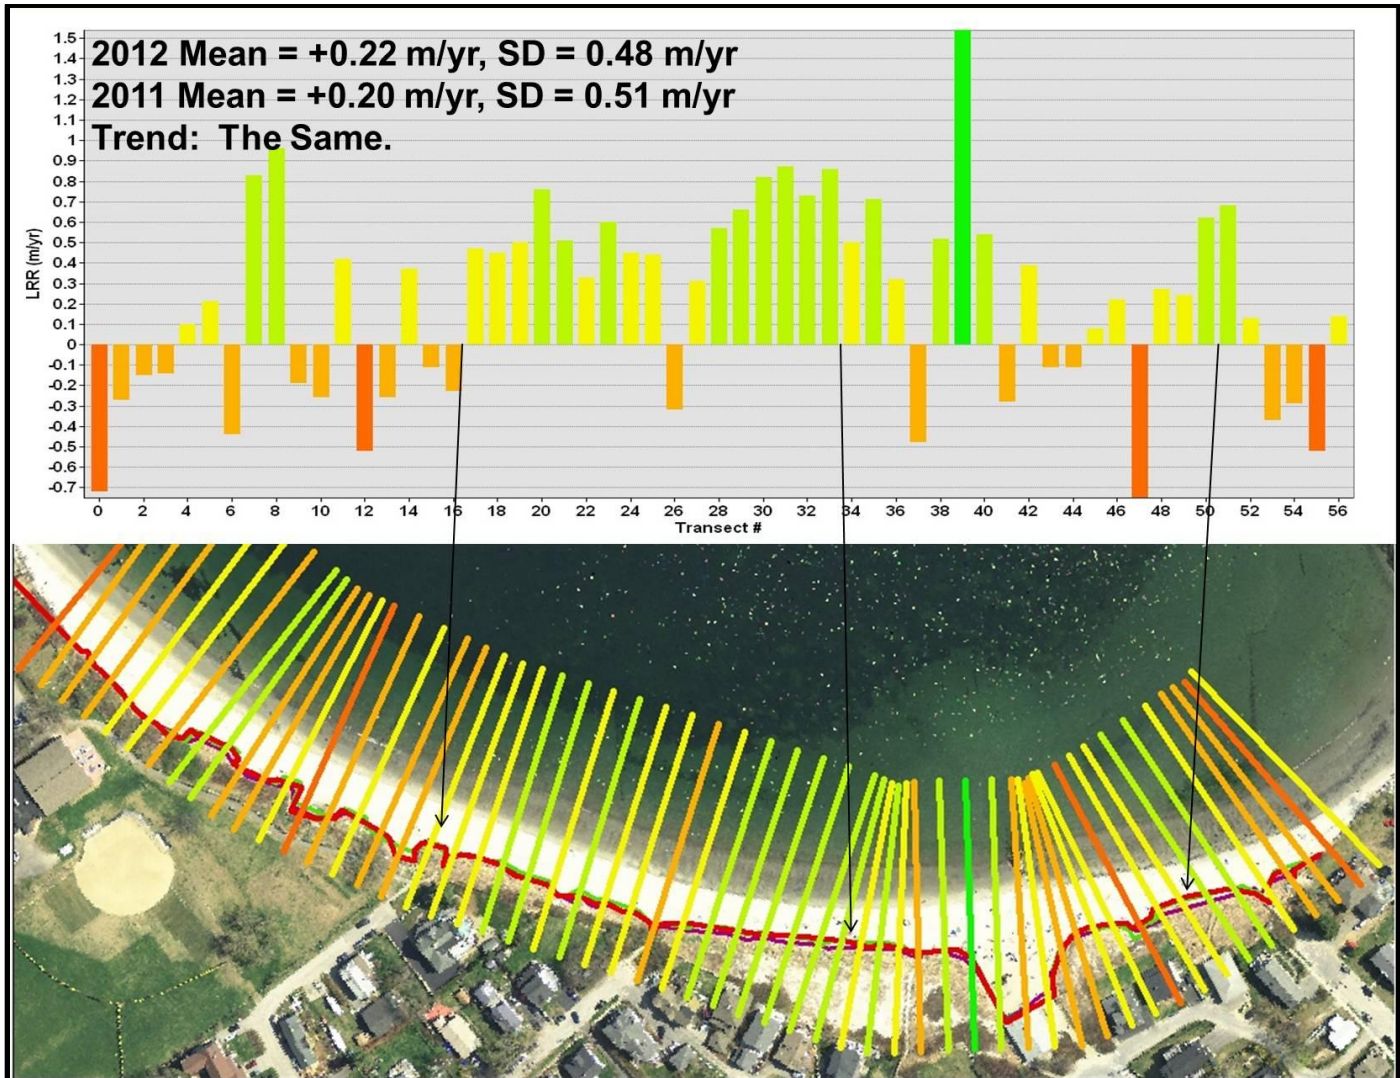
to the north of the beach restrooms and snack shack. The remainder of the dune system to the north had relatively good dune growth, with several pockets of increased erosion at the northernmost end of the beach. The dunes along the central portion of the beach appear to be most stable, with increased erosion at the southern and northern ends of the beach. **Willard Beach is proving to have one of the most stable dune systems, and much of this has to do with the restoration and management efforts undertaken by the community.**

Figure 6. MBMAP data showing shoreline changes along Willard Beach, South Portland. 2012 base imagery from Maine OGIS.

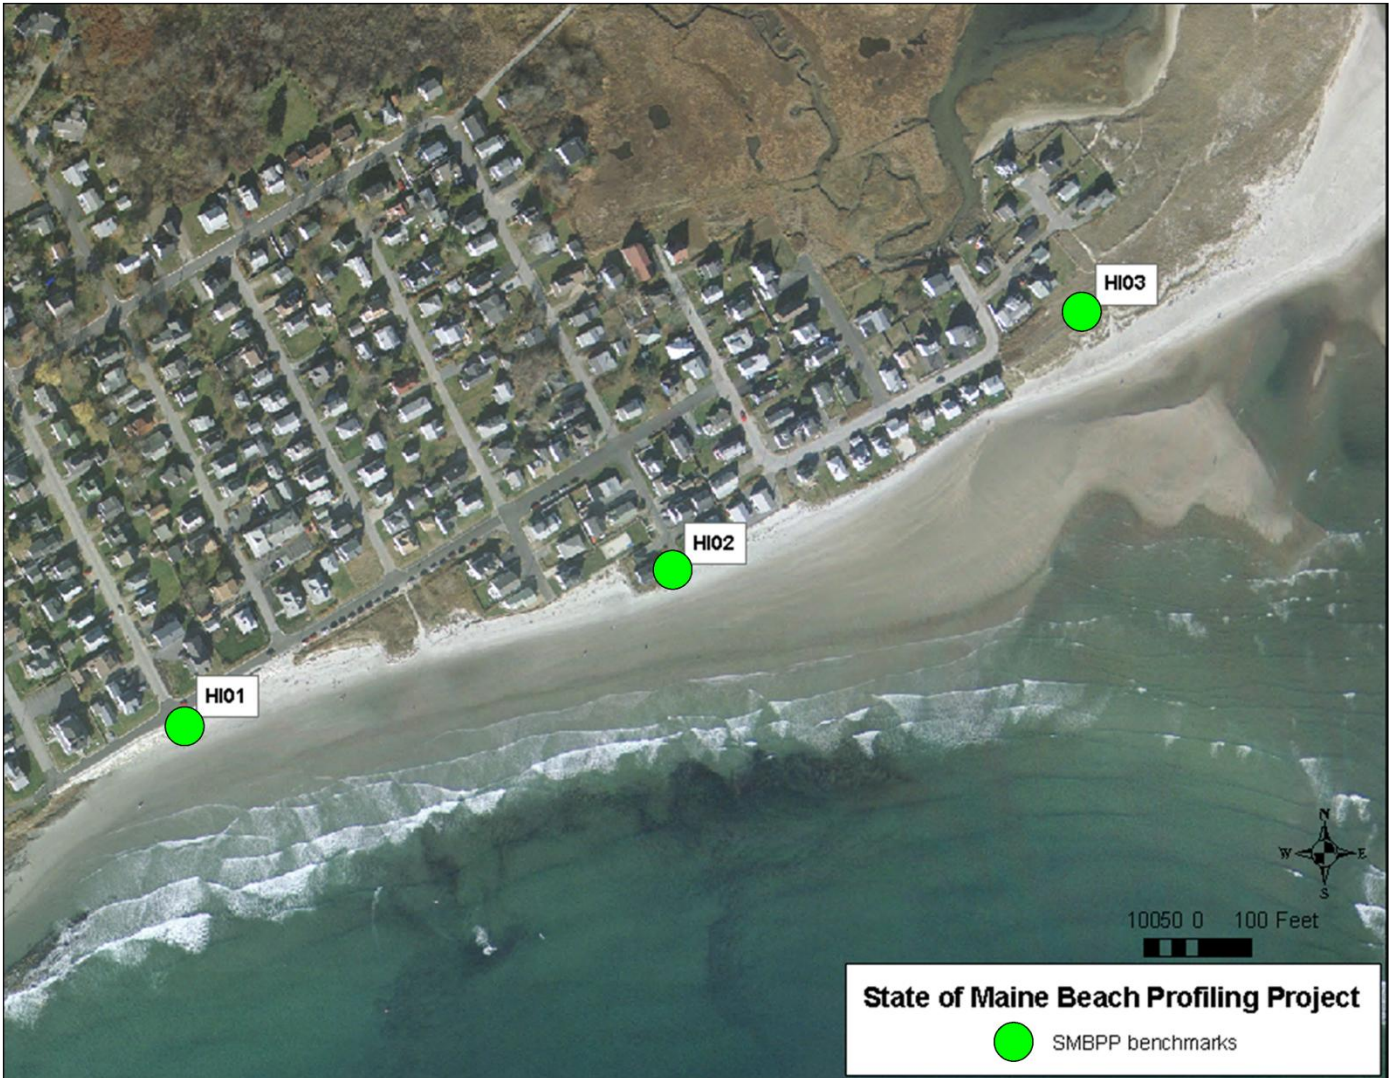
Figure 7. Higgins Beach, Scarborough profiling locations.

Overall Summary: Unfortunately, it appears that overall, the beach continued to undergo erosion. Winter erosion hampers HI01, but it showed some ability to recover in terms of its summer shapes. It appears that seawall reflectivity during series of winter storms may be the cause of continued winter erosion at HI01. HI02 showed some stability over the past few years. Changes in inlet dynamics at the Spurwink

River have eroded large sections of beach and dune in the vicinity of HI03; however, a large, emergent bar is now present. We do expect that bar to hopefully move onto the beach in the summer months, bringing back a pattern of accretion at HI03. **Higgins Beach Overall Grade: D+ (68). 2011 grade: C-. Trend: Slightly worse.**

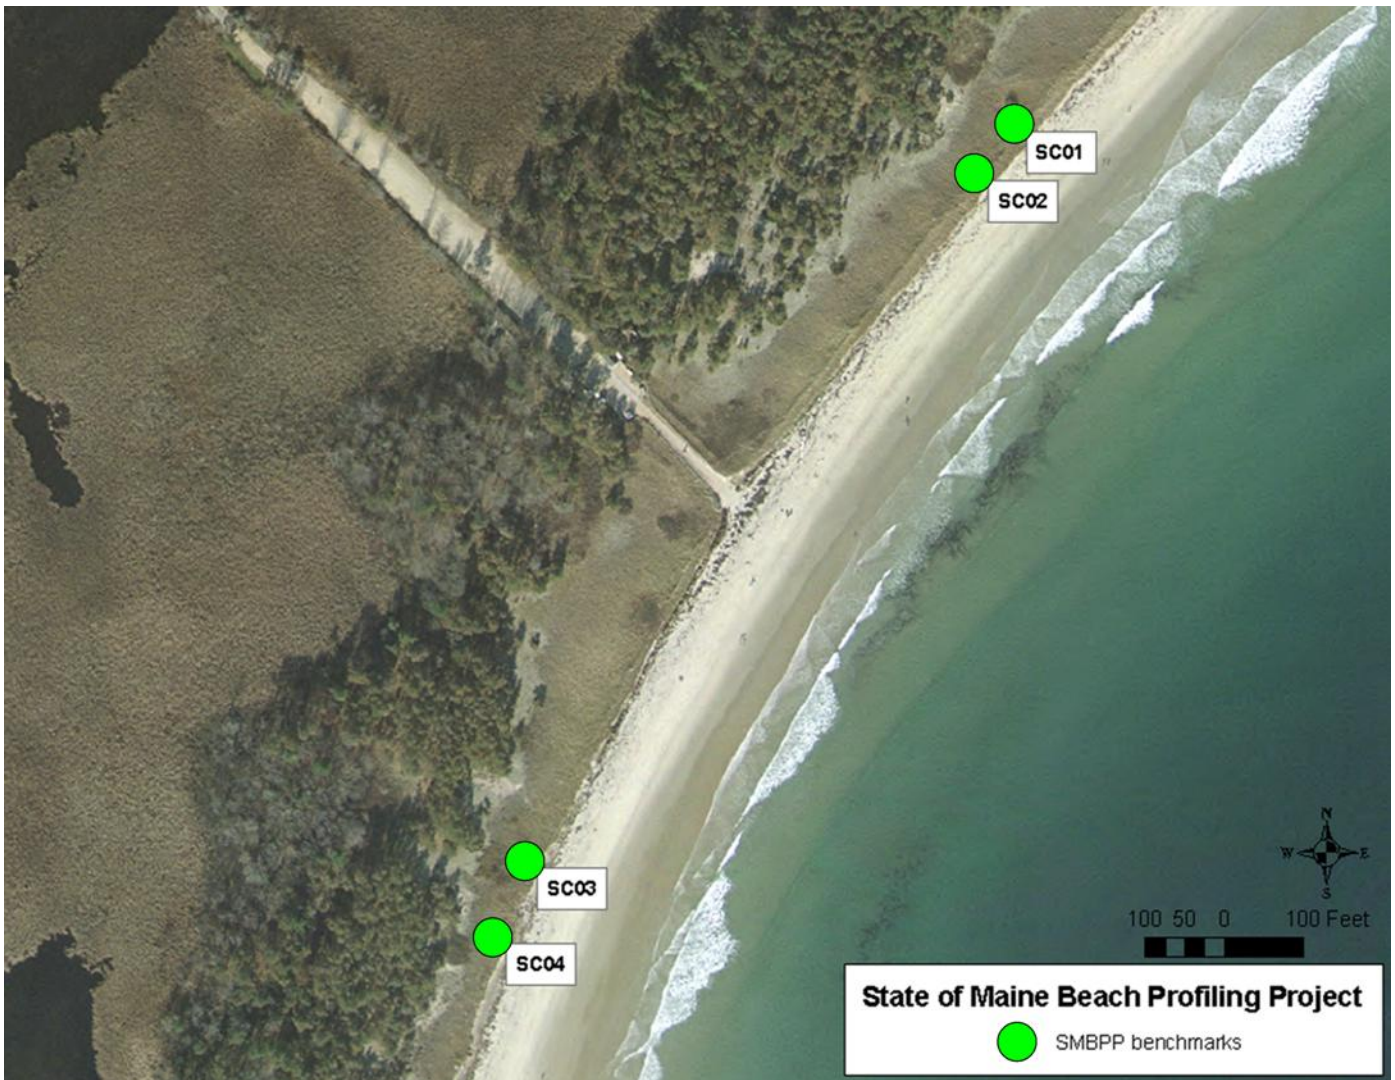
Figure 15. Locations of Scarborough Beach profiles. 2012 base imagery from Maine OGIS.

Overall Summary: Profiles were relatively stable to slightly erosive, with the largest erosion near SC04. This profile is furthest south, and impacted by cobble migration associated with a salient stretching offshore. SC01 had the most “winter” shape (concave), while the others had winter and summer berms. The beach maintained good summer shapes, with some seaward growth of the berms, especially north of the access path. **Overall Scarborough Beach Grade: B- (80). 2011 grade: C (76). Trend: Better.**

A total of four beach profiles (SC01 to SC04, Figure 15) were available for comparison.

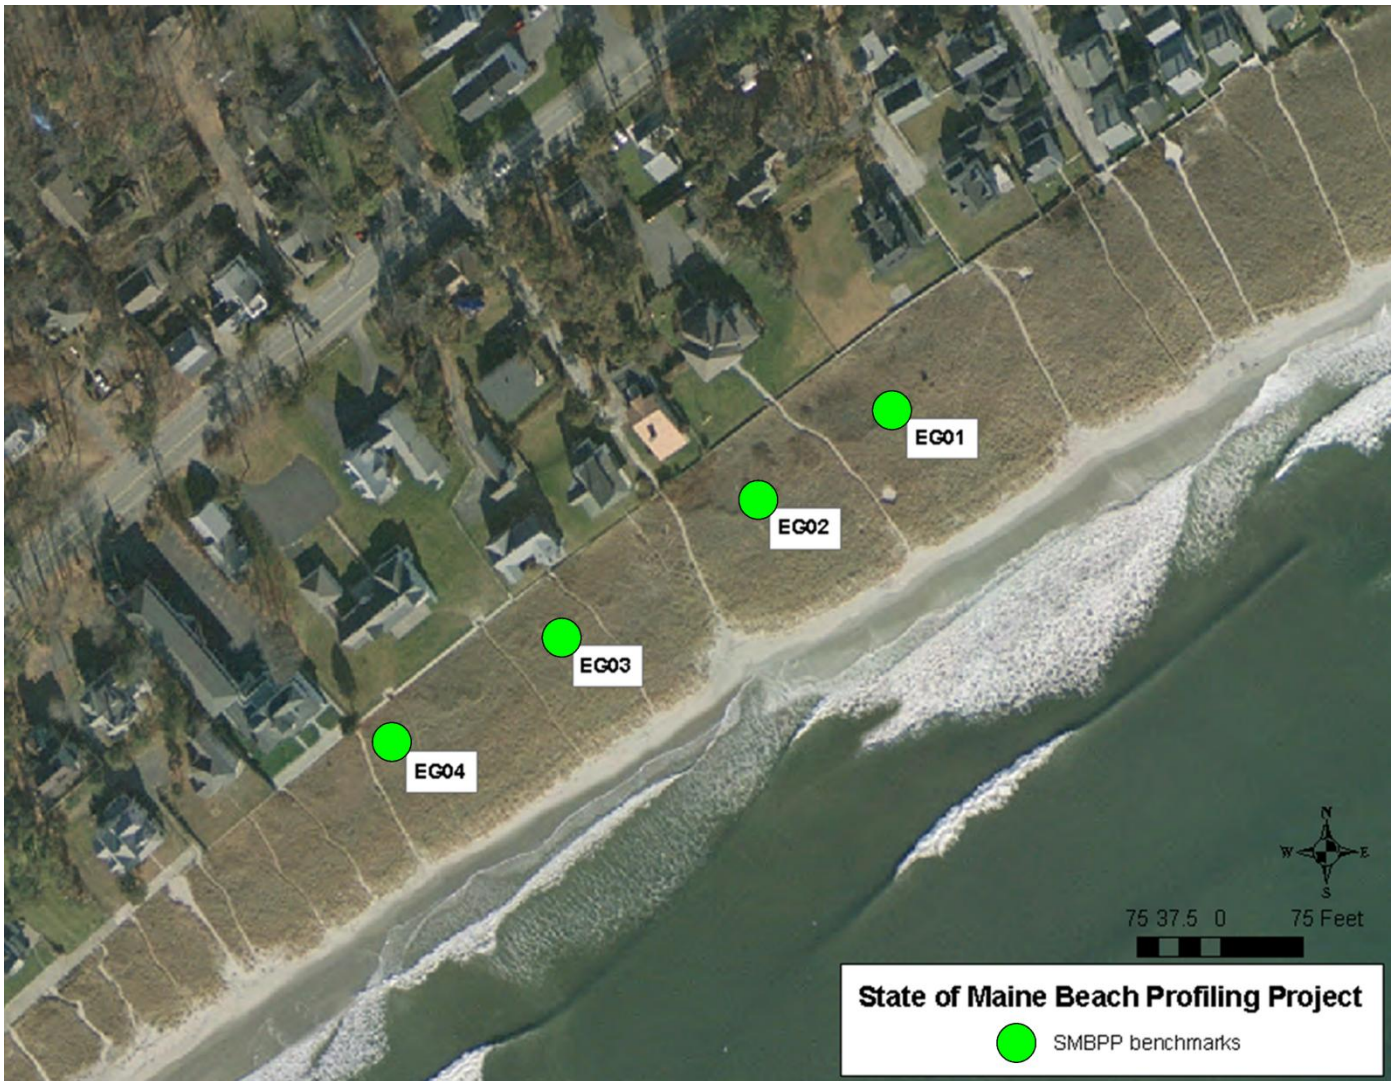
Figure 26. Locations of East Grand Beach volunteer monitoring profiles. Base imagery from Maine OGIS.

Overall Summary: East Grand Beach has reversed a long trend of marked seaward growth of the dune and berms from the previous assessments. The winter profiles –which include data through winter 2012 – all showed landward movement and dune erosion. The summer profiles – which only include data through summer 2011 – showed landward movement of dune crests, and berm losses. However, the profiles also showed vertical growth of the dunes, indicating an ample sediment supply to allow natural transgression to occur. **Overall Beach Grade: C (76). 2011 grade: A- (92). Trend: Worse.**

Four profiles (EG01-EG04, Figure 26) were available. No data was collected in summer 2012 or winter 2013.

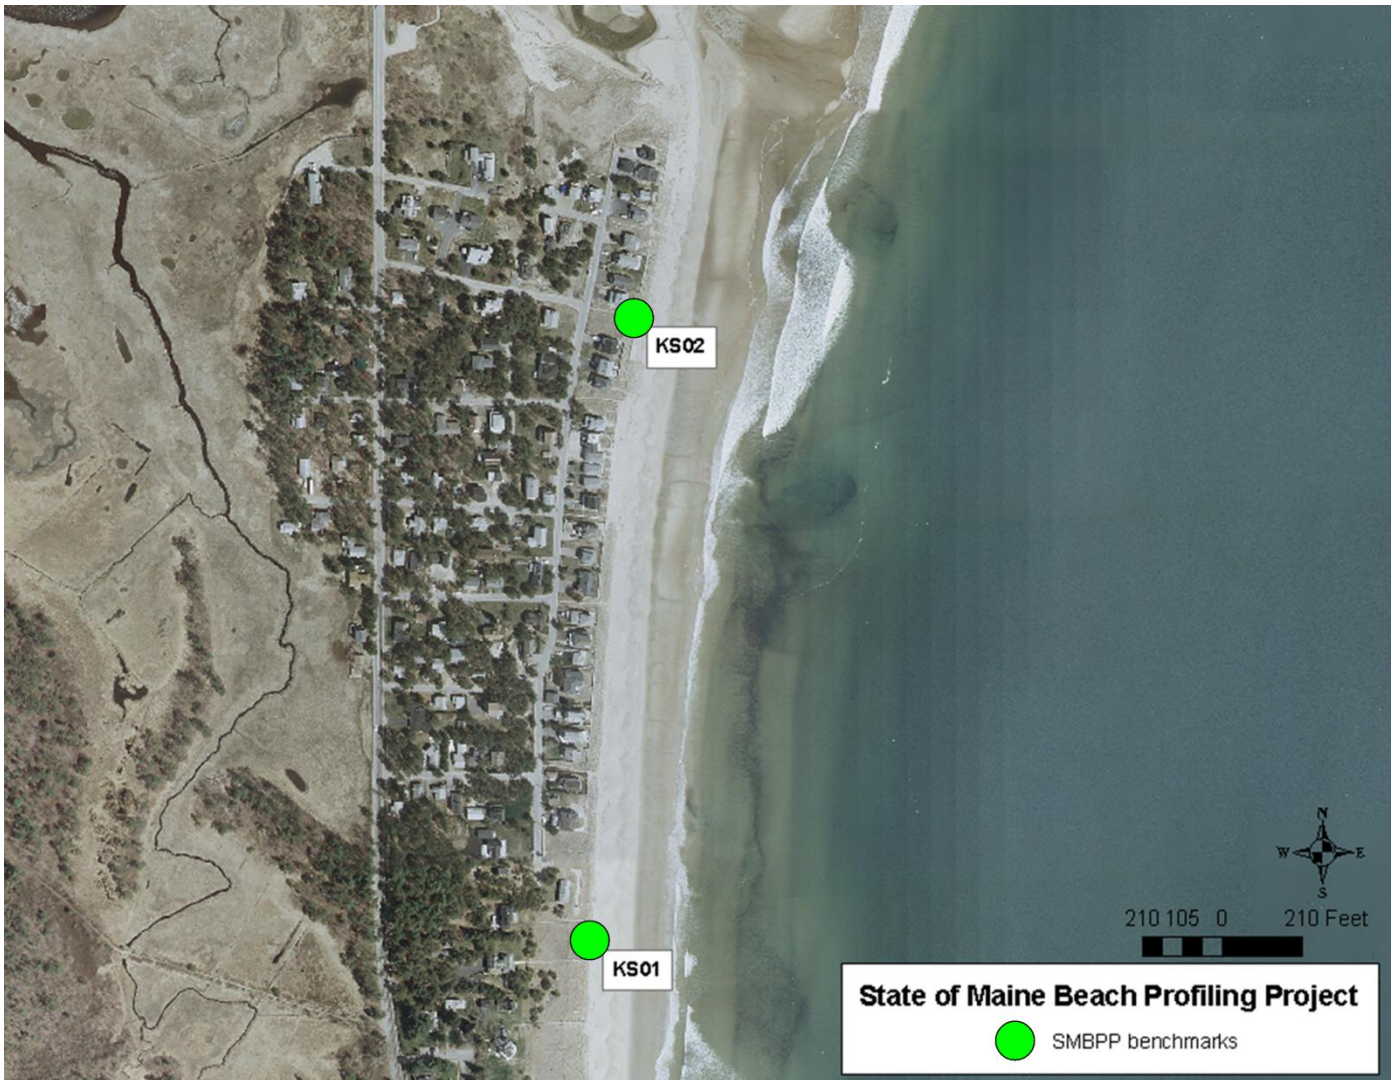
Figure 36. Locations of Kinney Shores volunteer beach profiling locations. Base imagery from Maine OGIS.

A total of two beach profiles (KS01, KS02, Figure 36) were available for comparison.

In the northern end of the bay, in the vicinity of the Kinney Shores Profiles, Figure 51 shows MBMAP results. The MBMAP data supports the trends observed at the profiles; that KS01 is undergoing a more erosive phase than KS02.

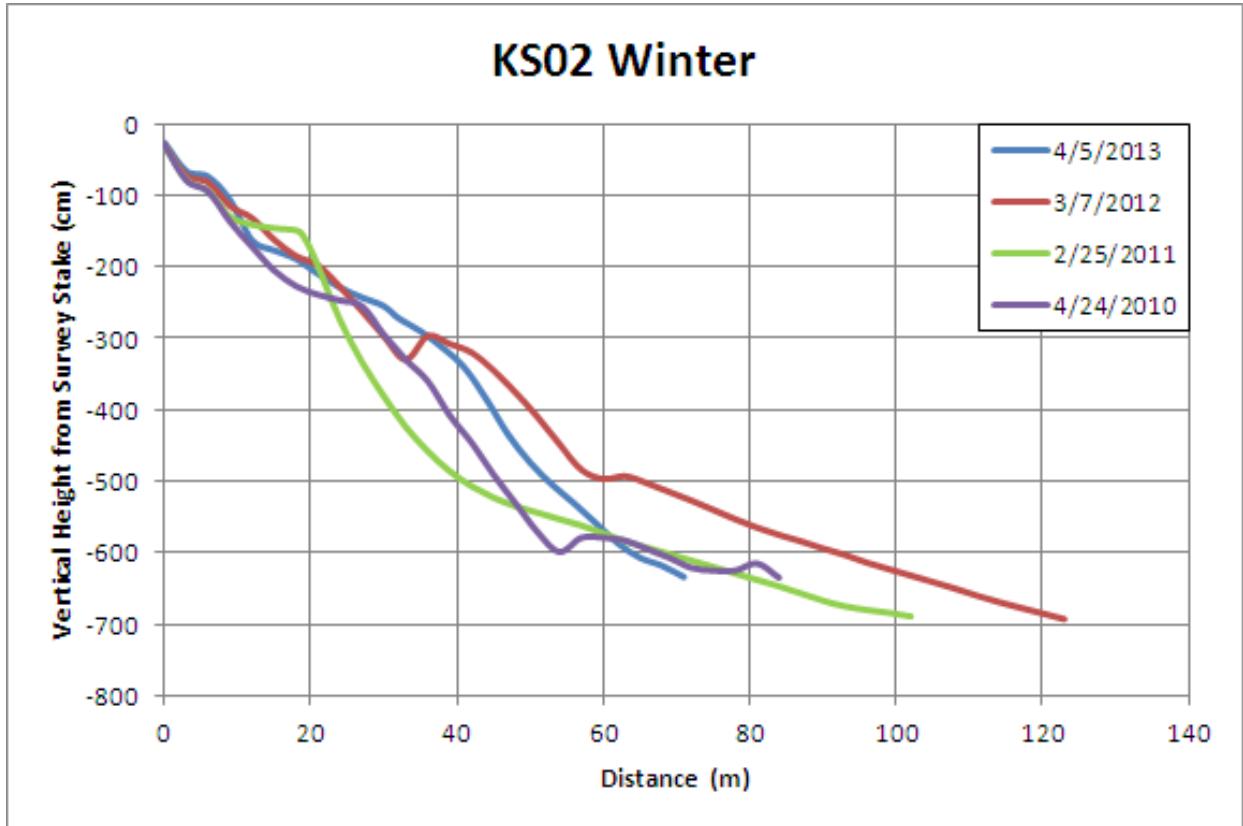
Figure 39. Winter beach profiles for KS02 from 2010, 2011, 2012, and 2013.

Winter KS02 = C (75). 2011 grade: C. Trend: Same. KS02, located at the northern end of Kinney Shores in a seawall with a dune, received an A- and C previously. The 2010 profile had a berm feature at around the 20-25 m (Figure 39). In 2011, the lower portion of the profile eroded, and although the berm gained in elevation, it migrated landward, indicating erosion of the beach and landward retreat. By March 2012, the profile showed good recovery, with a well-defined berm out at the 40 m mark, and elevation gains offshore. In 2013, the profile showed some stability out to 40 m, but lost some elevation offshore. This profile is showing stability to slight erosion, and remains with a cautious rating.

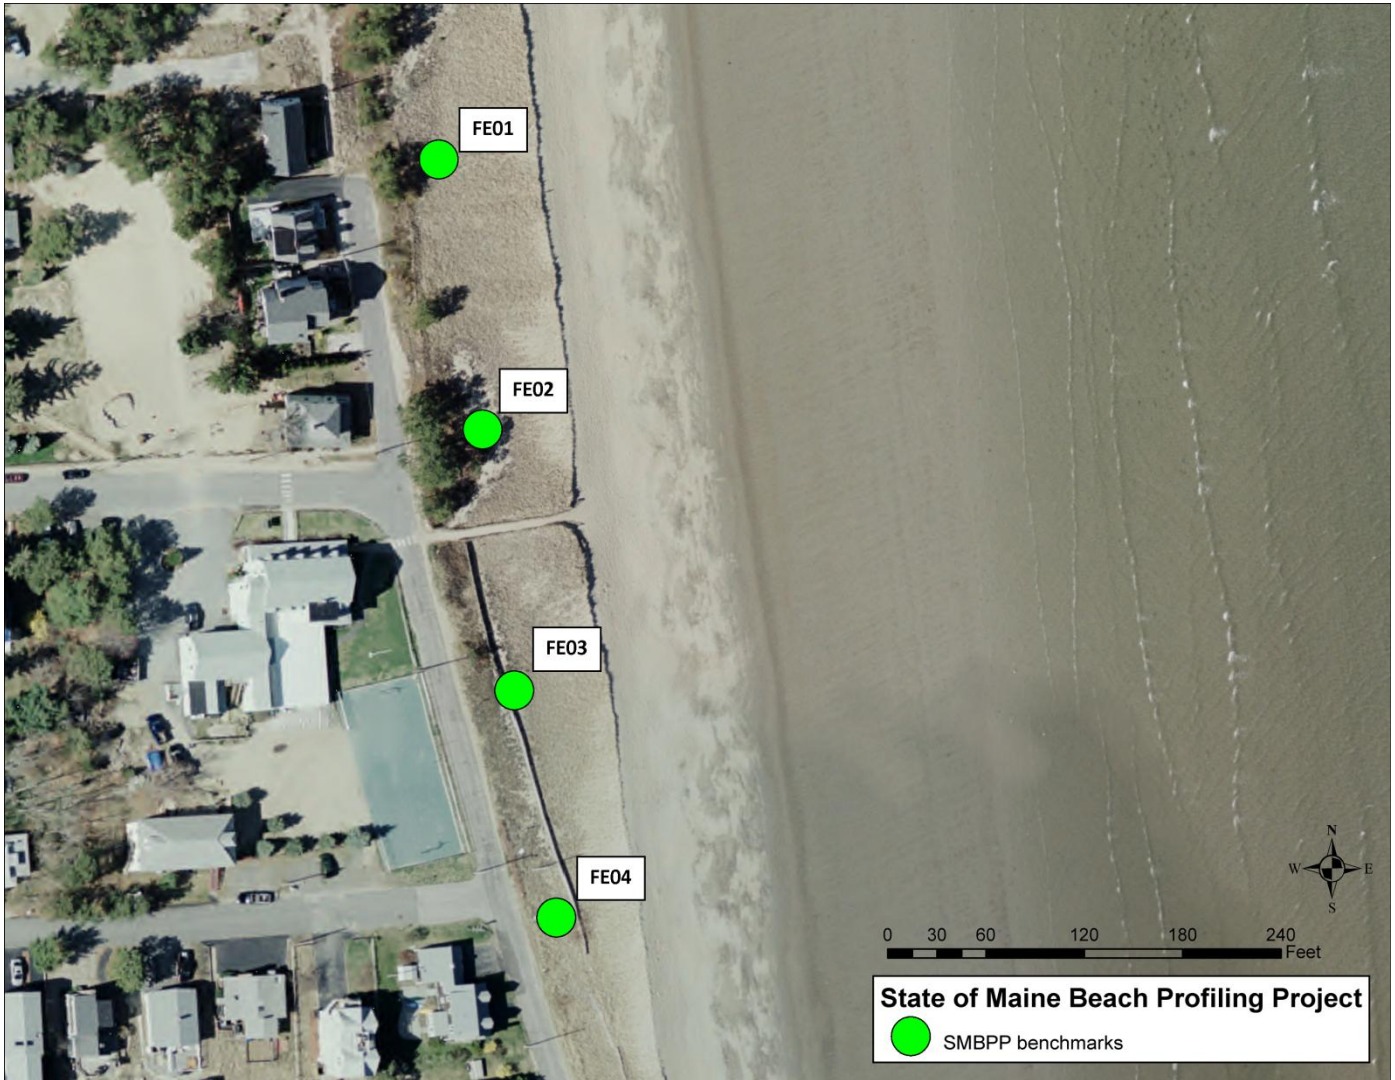
Figure 41. Locations of volunteer monitoring profiles at Ferry Beach, Saco. Base imagery from Maine OGIS.

Overall Ferry Beach Grade: D (67). 2011 grade: D+ (69). Trend: Worse.

A total of four beach profiles (FE01 to FE04, Figure 41) were available for comparison.

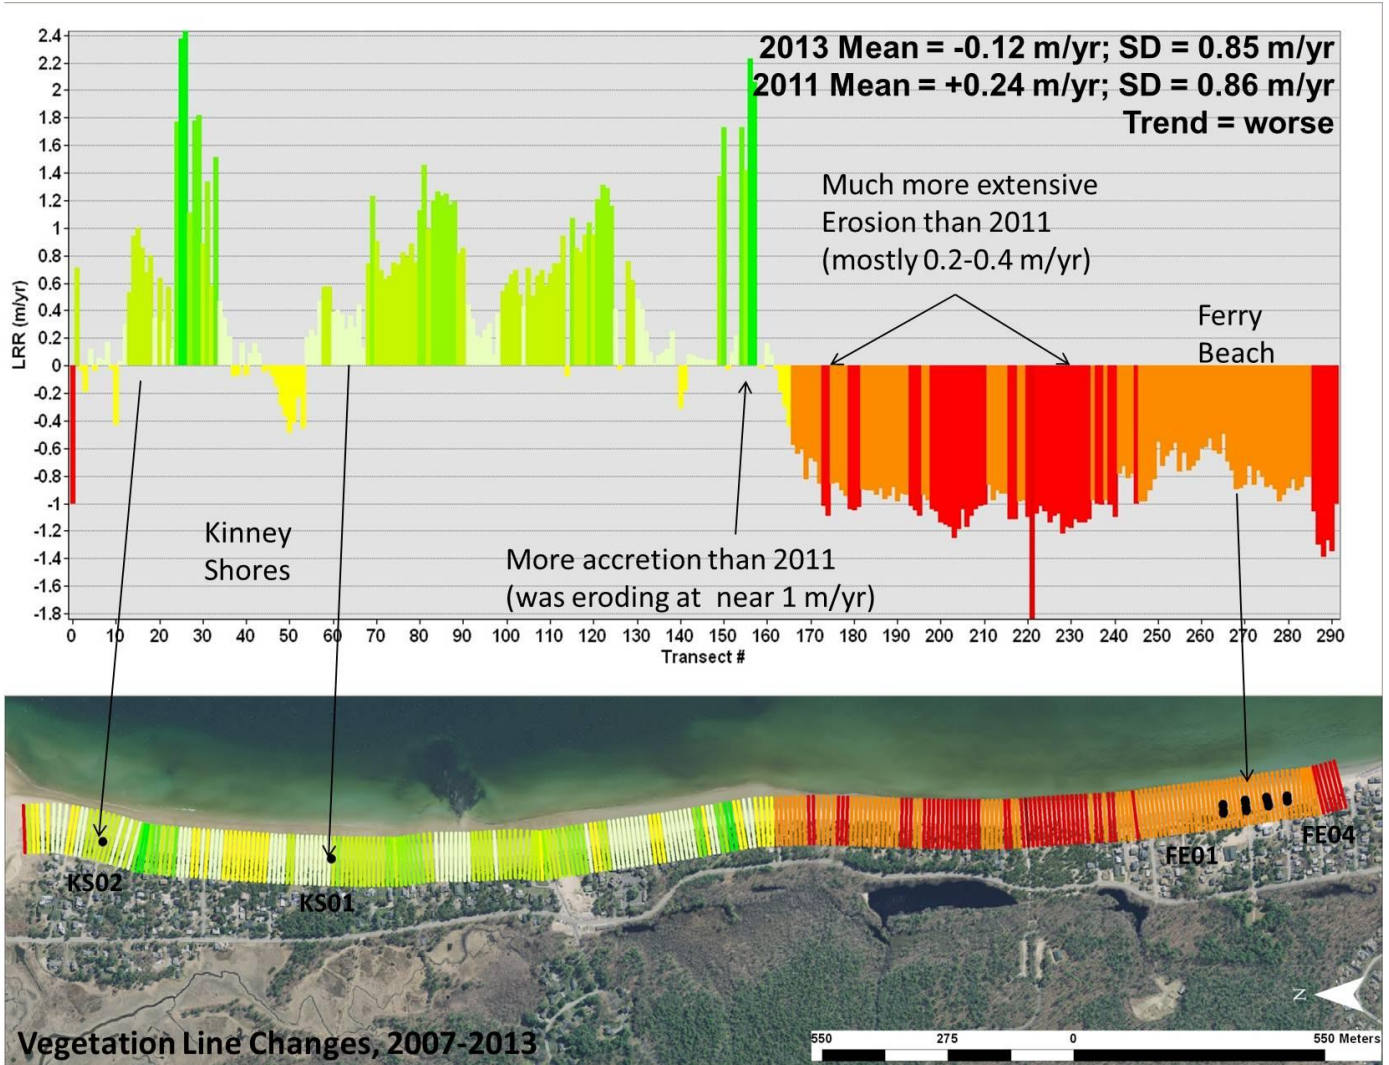
from near Ferry Beach State Park south to the Ecology School – averaged around -0.2 to -0.4 m/yr., with pockets around -0.6 to -1m/yr. **Erosion has clearly worsened in the area north of Ferry Beach Ecology School by the 2013 report.** However, an area of the shoreline just north of the Park that was eroding previously (marked on the image, above, underwent accretion, gaining sand dune.

Figure 50. MBMAP shoreline change results for Saco beaches. Base imagery from Maine OGIS.

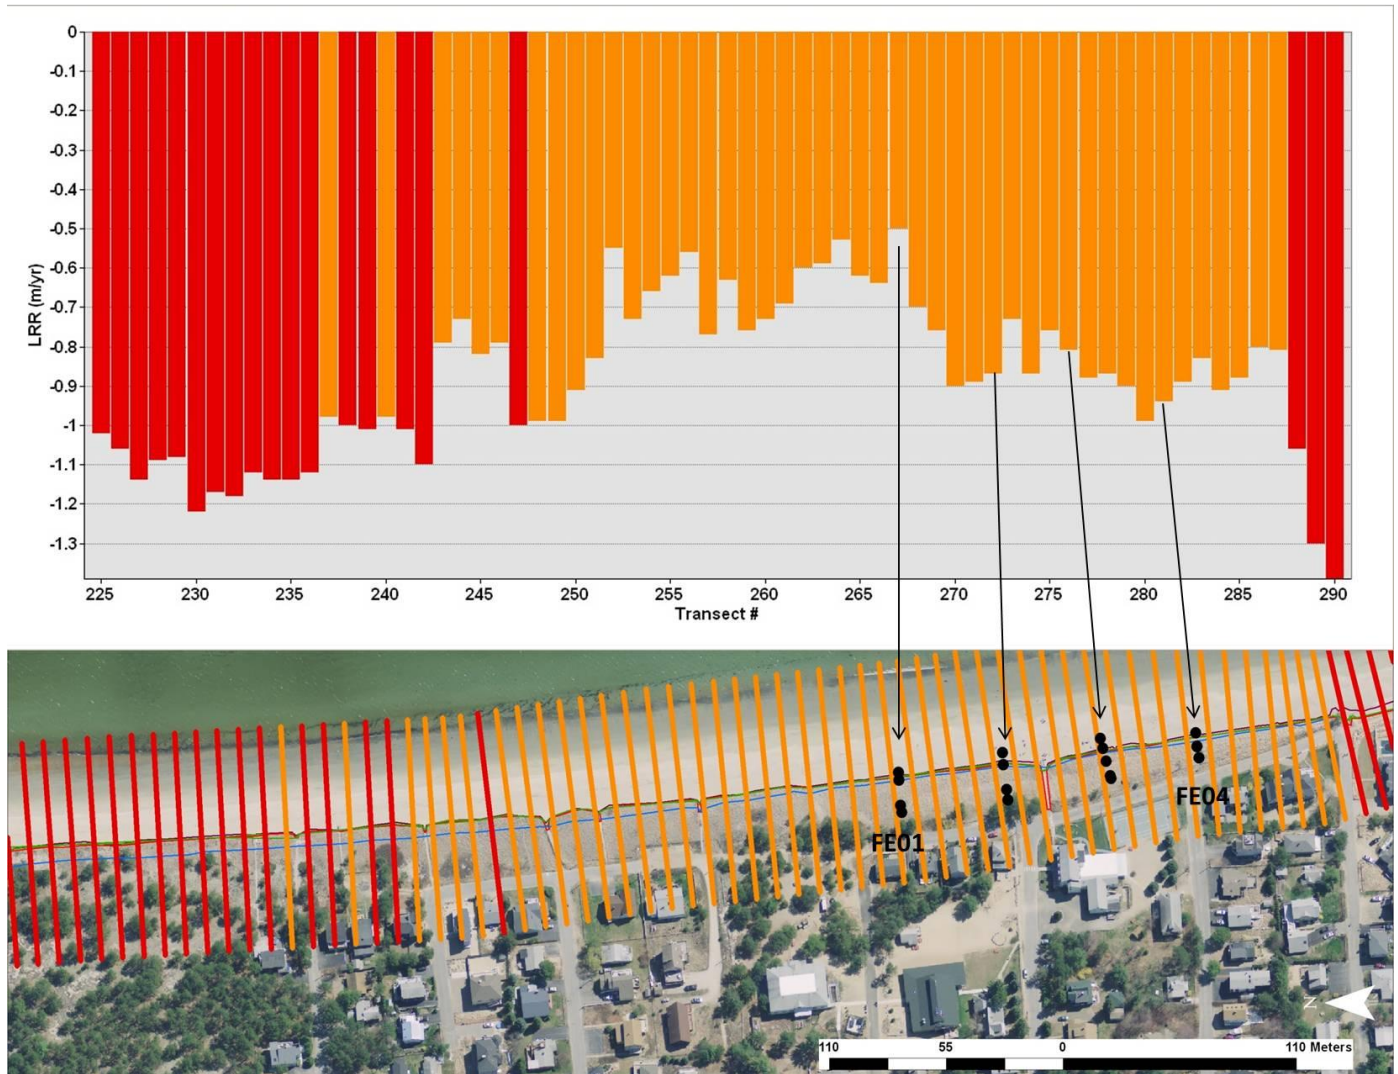
increased, as changes are over -1 m/yr., when in 2011, the shoreline changes in this area were much lower, between -0.2 m/yr. and -0.4 m/yr.

Figure 52. MBMAP shoreline change results for the Ferry Beach area of Saco beaches. Base imagery from Maine OGIS.

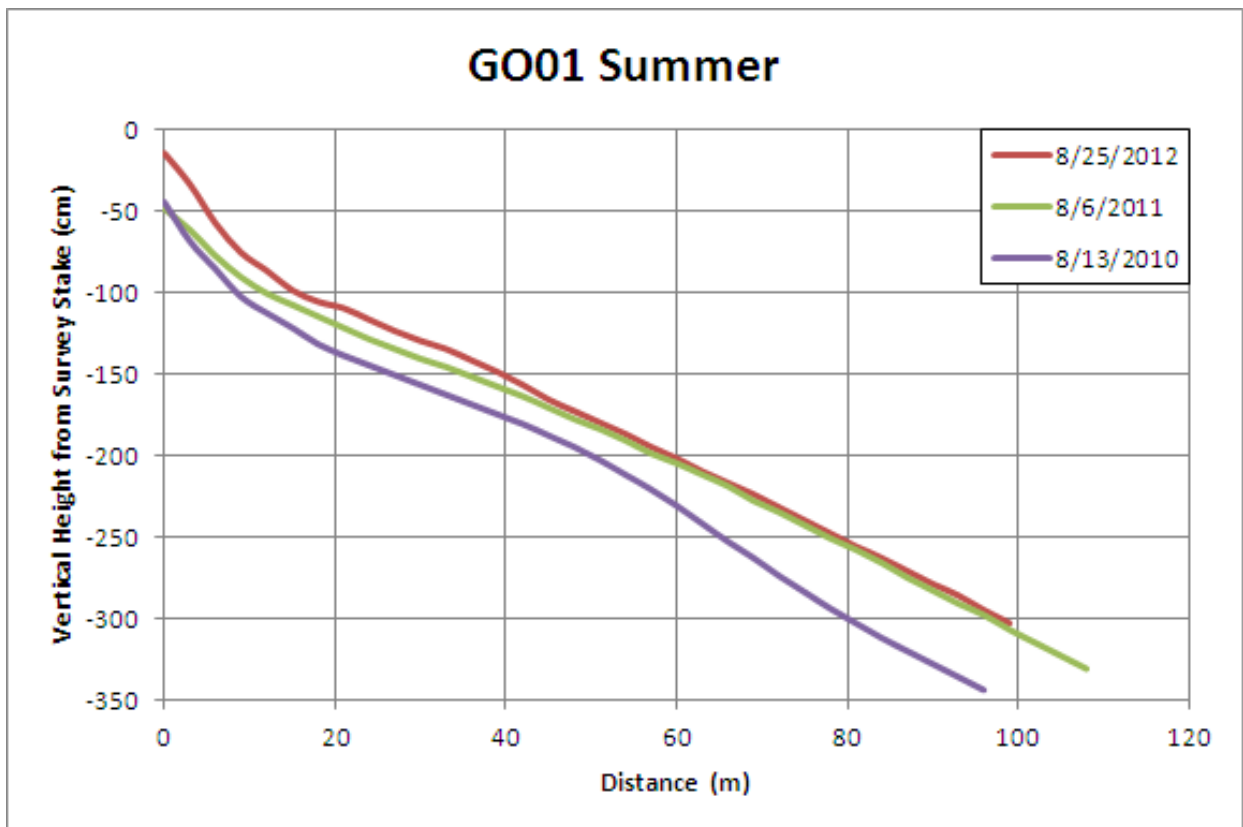
Figure 65. Summer beach profiles for GO01 from 2010, 2011, and 2012.

Summer GO01 = B+ (88). 2011 grade: D. Trend: Better. The profile received a D previously. 2010 had sand elevation at -50 cm at the starting point and a slightly convex shape (Figure 65). By 2011, it gained elevation, including at the berm. By summer 2012, it had gained sand within about 40 m of the seawall. The profile showed stability to growth over the past few years. The 2013 profile was about 30 cm – about 1 foot – higher in elevation than the summer 2010 shape.

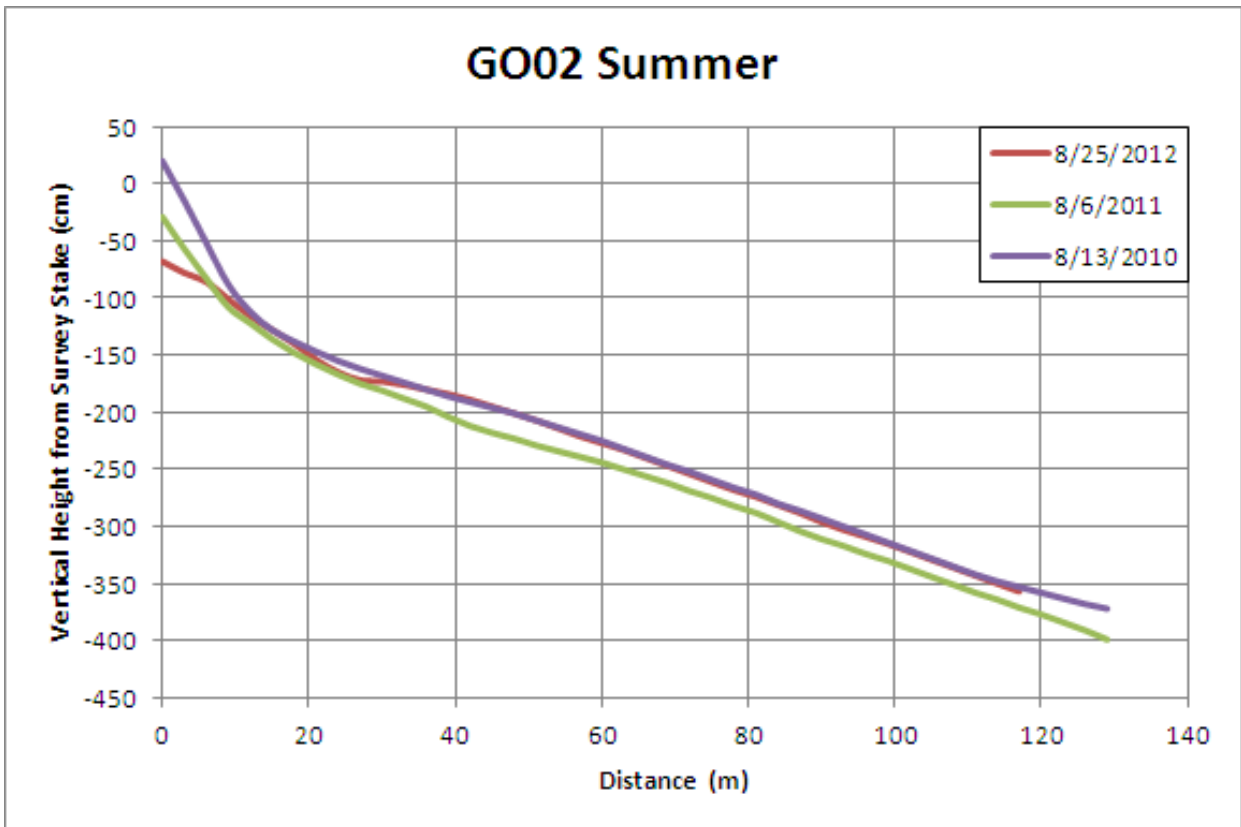
Figure 67. Summer beach profiles for GO02 from 2010, 2011, and 2012.

Summer GO02 = D (65). 2011 grade: A. Trend: Worse. The profile received an A previously. In 2010, it had a starting elevation of 20 cm, indicating sand was above the starting pin (Figure 67). It had a steep slope, which flattened seaward of 20 m. By 2011, it lost 50 cm at its starting point, and fell along its entire length, indicating erosion. In 2012, it lost more sand at the wall – down to -70 cm – indicating more erosion. Seaward of 30 m, it had the same shape as 2010. This profile showed stability along its lower portion (likely the historic erosion surface), but lost its summer berm at the seawall. We are concerned about the continuous berm loss.

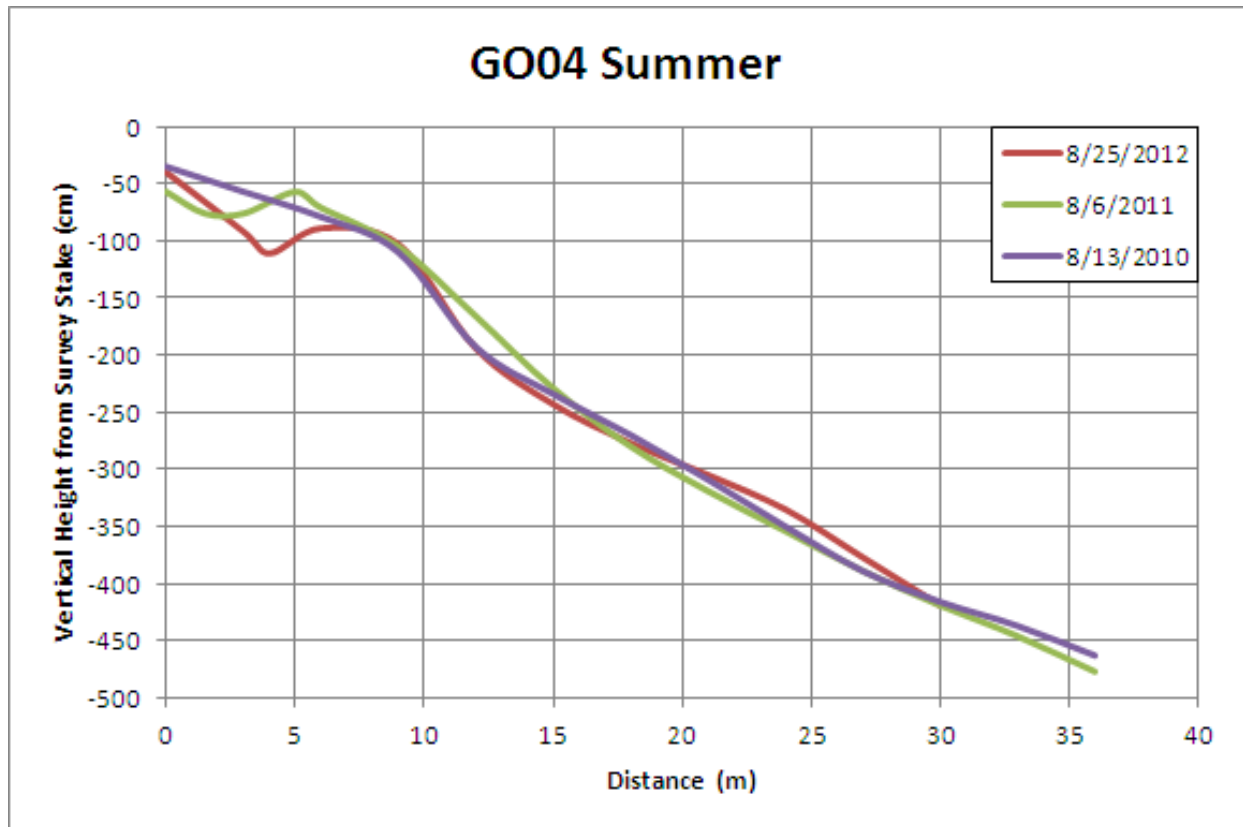
Figure 71. Summer beach profiles for GO04 from 2010, 2011, and 2012.

Summer GO04 = C+ (78). 2011 grade: B. Trend: Worse. 2010 had a starting point of -35 cm, and a well-defined berm. In 2011, it lost sand at the wall, and the berm migrated slightly landward (Figure 71). By 2012, the profile's starting point moved back up to the 2010 location, but a significant trough feature formed landward of the berm (at the 4 m mark). The berm is in the same location as the 2010 profile, and the rest of the profile is consistent with the 2010 shape. This profile showed general berm stability, but changes adjacent to the wall.

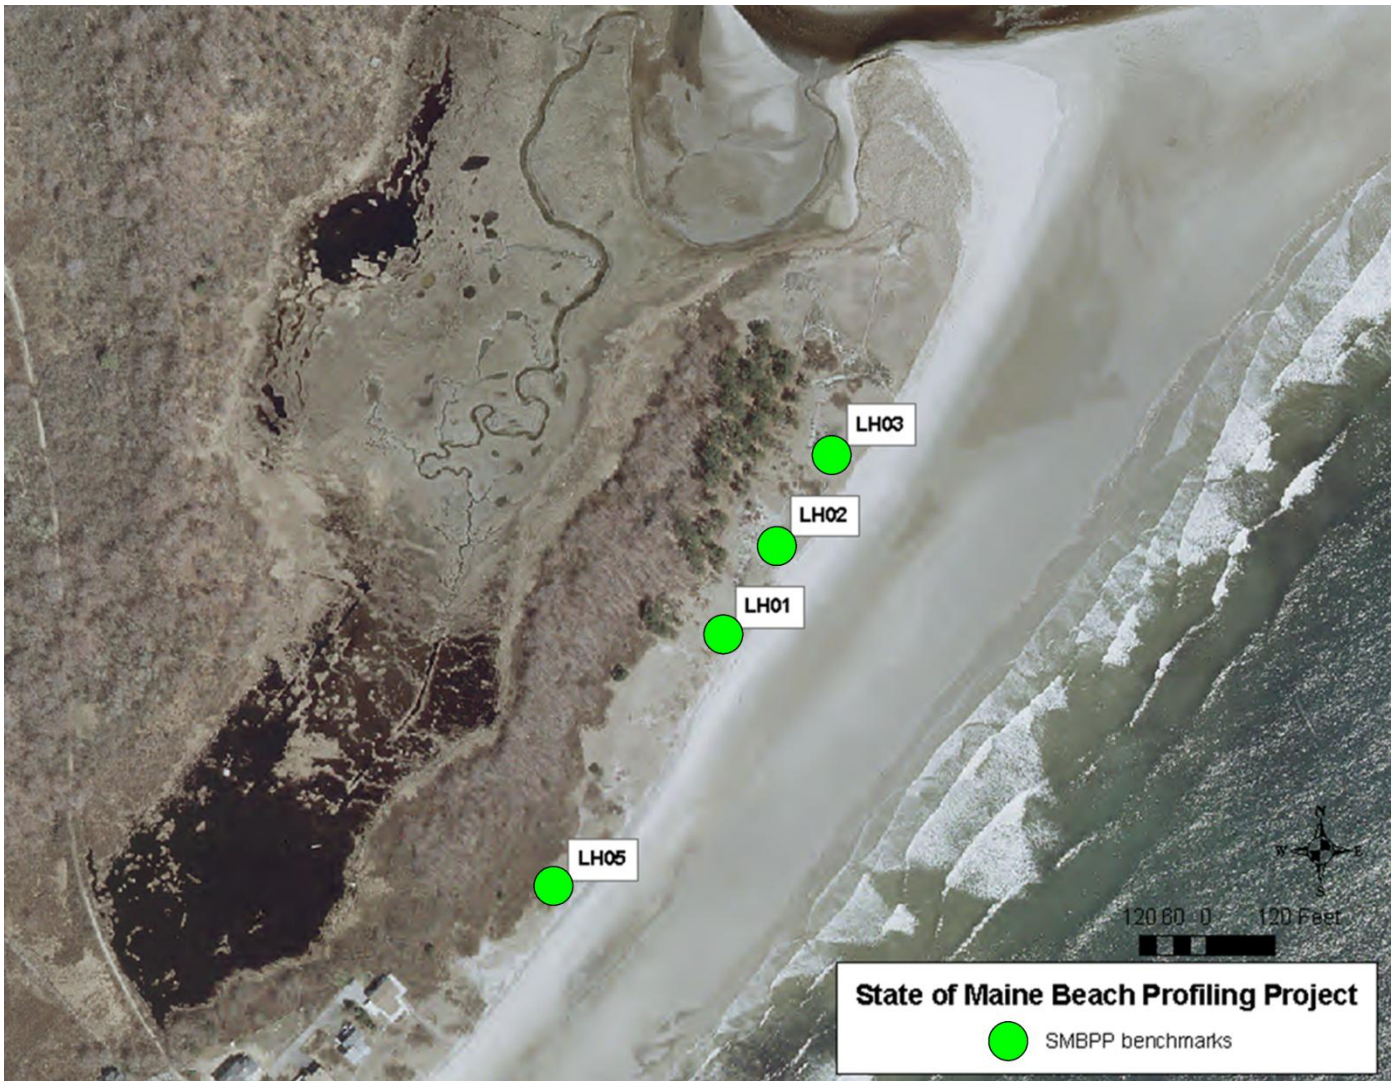
Figure 72. Volunteer beach profile locations along Laudholm Beach, Wells. Base imagery from Maine OGIS.

Overall Summary: Beach profiles showed worse winter trends, with exacerbated berm and dune erosion. The summer profiles fared slightly better, but showed evidence of continued erosion and landward migration. **Overall Laudholm Beach Grade: D+ (68). 2011 grade: C- (70). Trend: Worse.**

Four profiles (LH01-03, LH05, Figure 72) were available.

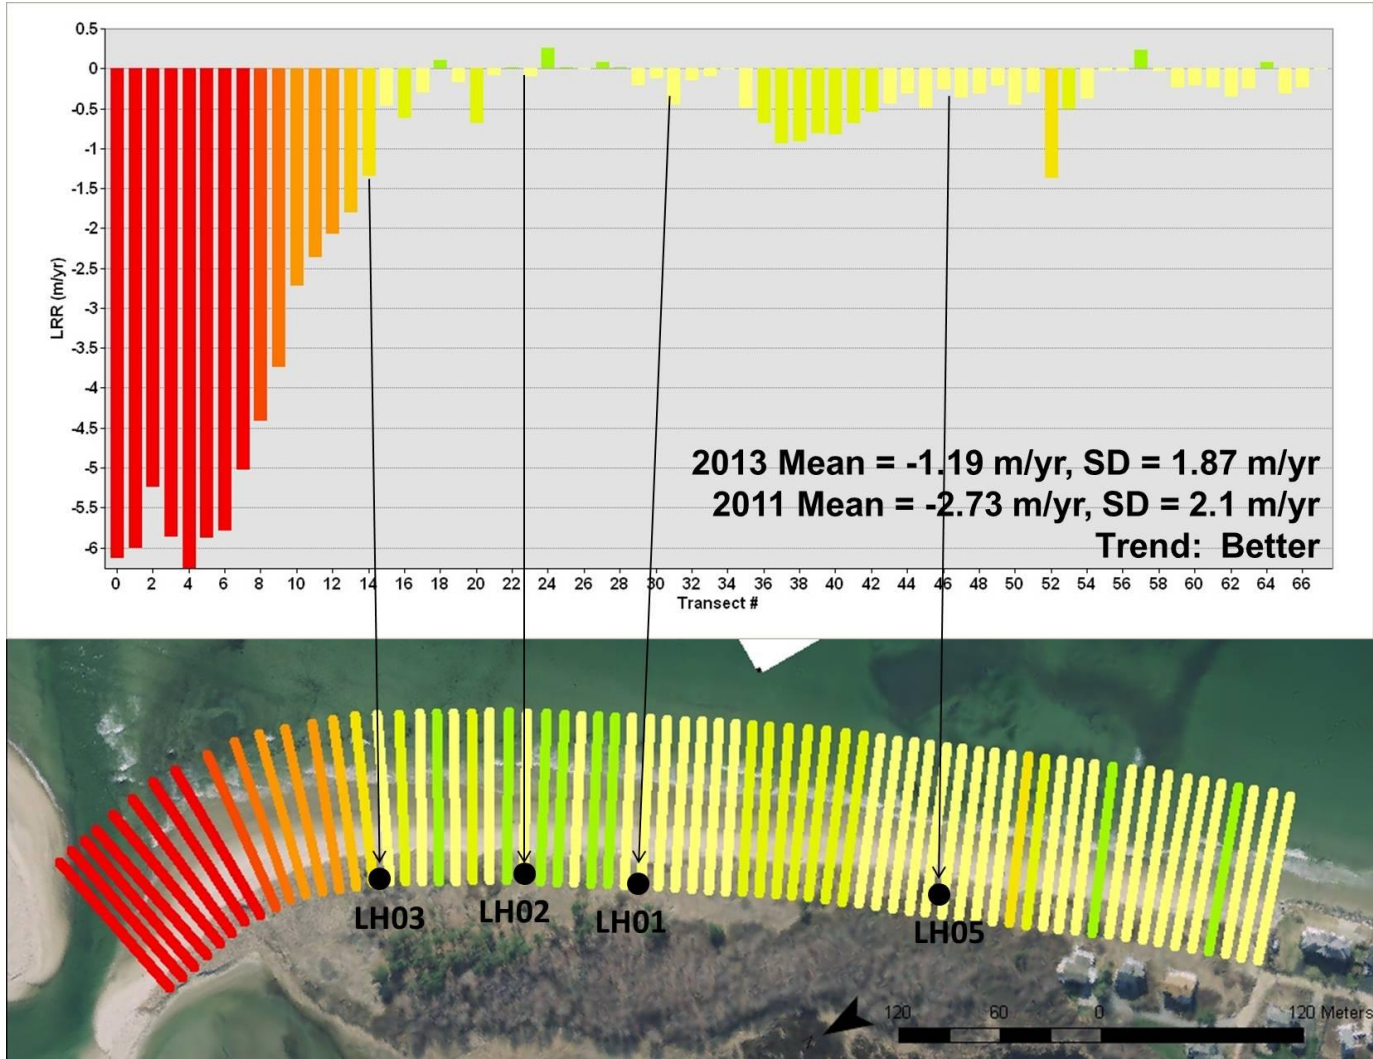
influenced the overall recession rates for the Laudholm Beach section of shoreline. The majority of the profile locations according to MBMAP data were slightly erosive, averaging around -0.5 m/yr. or less (aside from LH03). This trend appears to be reflected by the summer profile shapes at Laudholm Beach, which showed maintenance of the dune positions and not high erosion.

Figure 81. MBMAP shoreline change results for Laudholm Beach, Wells. Base imagery from Maine OGIS.
