State of Maine's Beaches in 2013

Open-File No. 13-18

The 2013 State of Maine's Beaches Report is the 4th report in a consecutive series of reports coinciding with the Maine Beaches Conference from 2007, 2009, and 2011. The purpose of the report is to summarize major observed morphologic characteristics and changes of Maine beaches that are monitored as part of the State of Maine Beach Profiling Project (SMBPP, Maine Sea Grant Extension, 2003). The SMBPP utilizes trained volunteers to collect monthly beach profiles which start at a known point or benchmark (usually in the frontal dune or in a seawall) and continue shore-perpendicular to roughly the low water line. Fixed starting locations are used with the Emery Method of beach profiling (Emery, 1961). Data collected is entered by volunteers into an online database, where it is accessible for outside researchers (Maine Shore Stewards, 2007). The SMBPP is funded and managed by combined efforts of the Maine Geological Survey, University of Maine, Maine Sea Grant, and Maine Coastal Program.

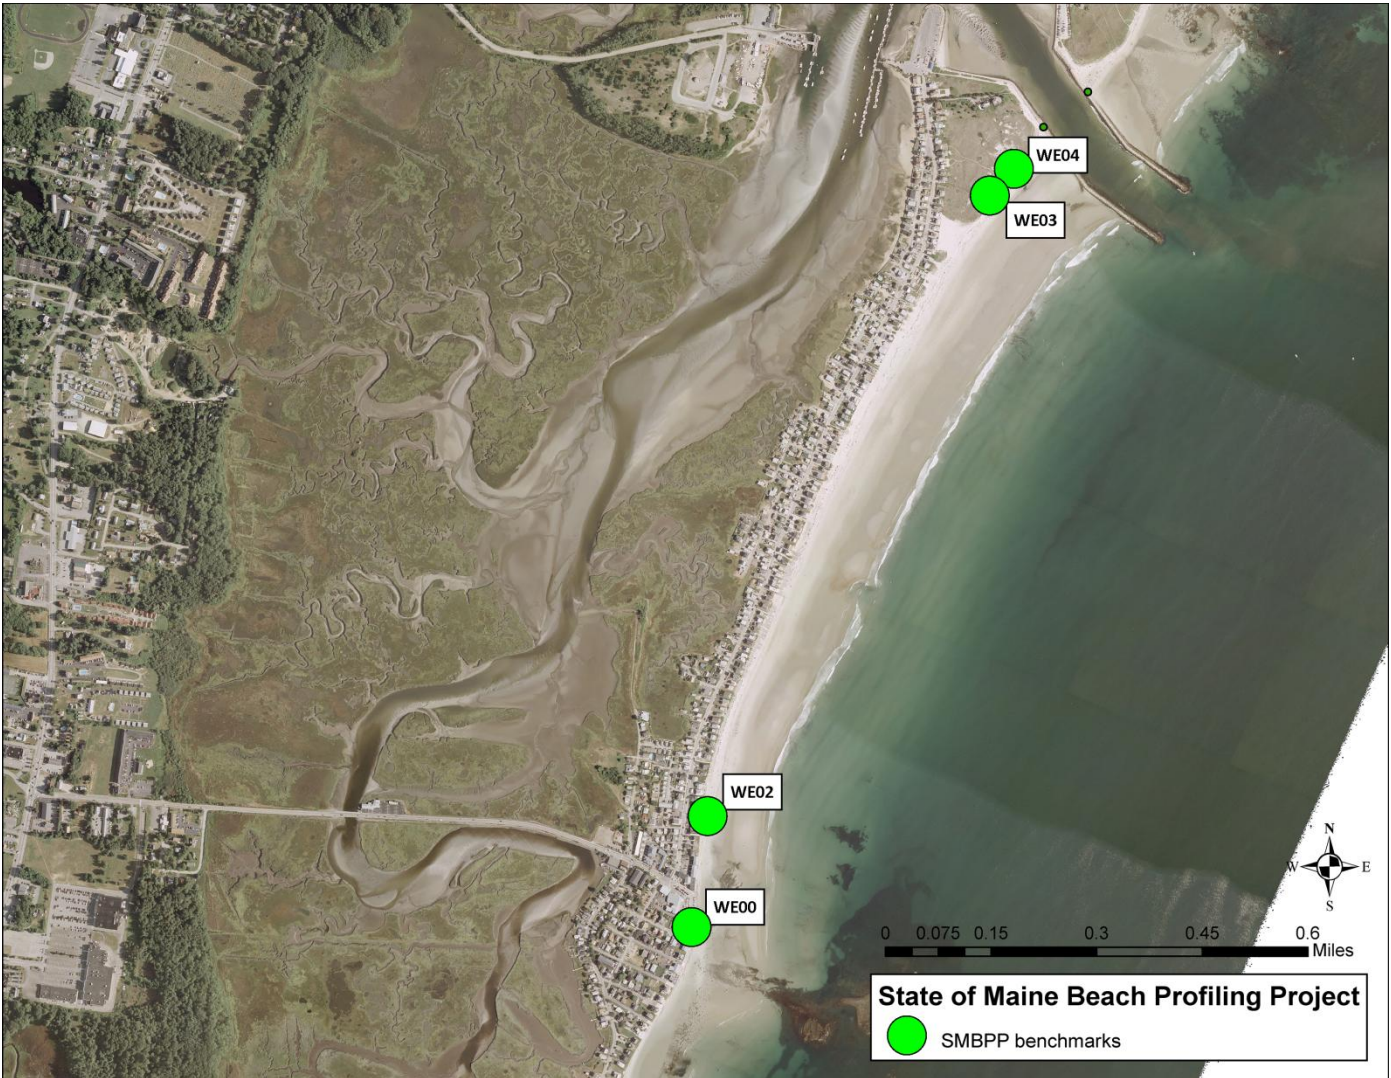
Figure 82. Locations of volunteer profiles along Wells Beach, Wells. Base imagery from Maine OGIS.

Overall Summary: Wells Beach appears to be undergoing erosion at the dune at its northern end – especially during winter. This appeared to have recovered by summer. Winter months were mostly erosive for all four profiles over the past few years. Luckily, the summer profile shapes at the northern end of the beach (WE03 and WE04) show seasonal recovery, while WE00 and WE02 struggled to maintain good summer shapes in this assessment. **Overall Wells Beach Grade: C- (71). 2011 grade: C+ (78). Trend: Worse.**

Four beach profiles (WE00, WE02-WE04, Figure 82) were available for analysis.

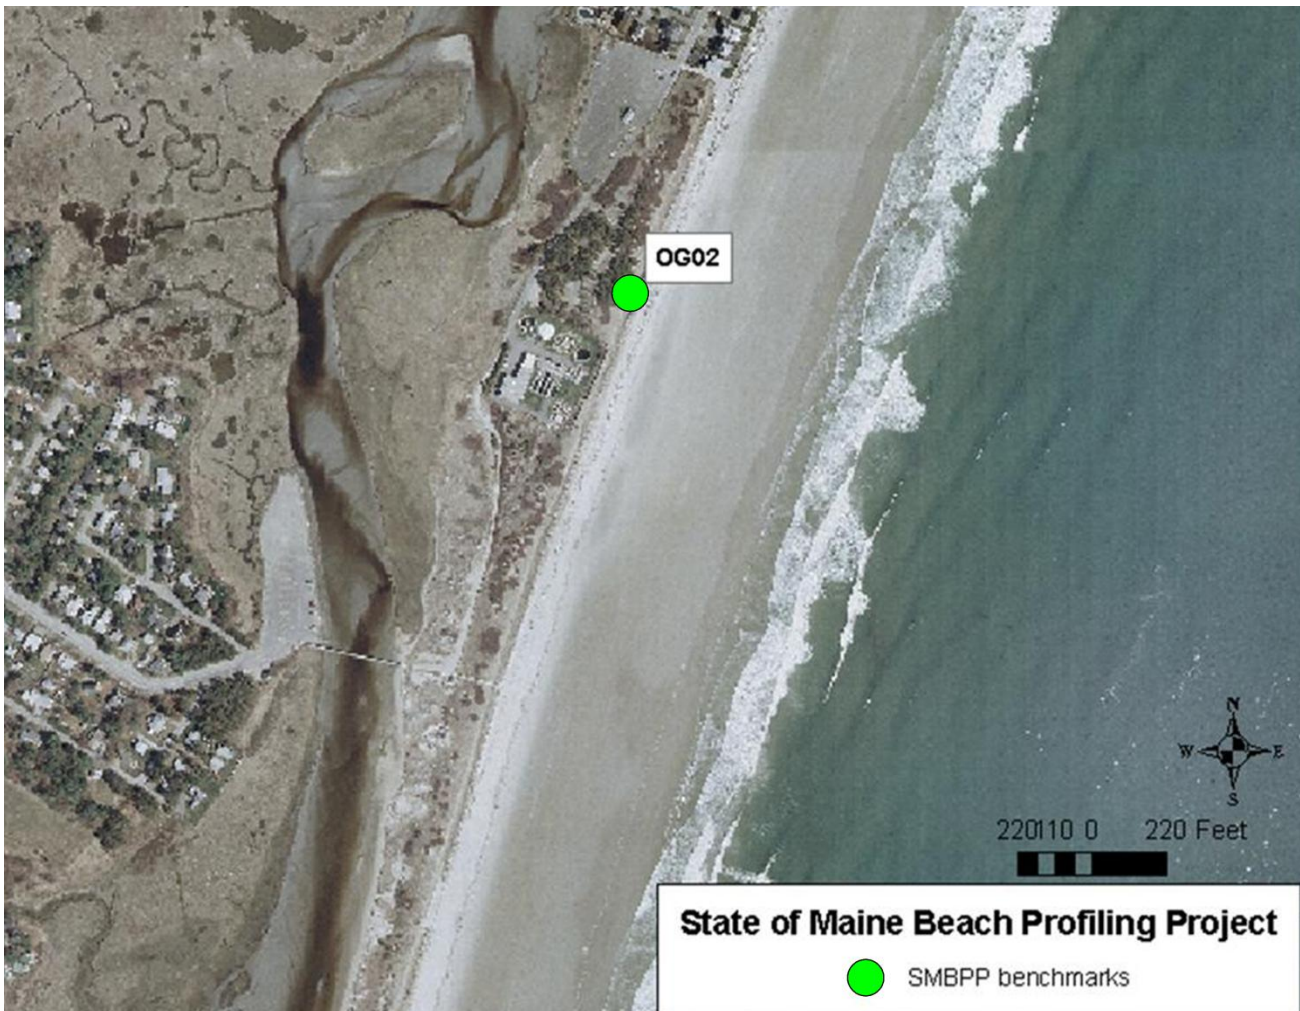
Figure 92. Location of volunteer monitoring profile at Ogunquit Beach, Ogunquit. Base imagery from Maine OGIS.

Overall Summary: At Ogunquit Beach, based on analysis of profile OG02, the previous trend of erosion has reversed, with good beach and berm stability and growth in the winter and summer beaches. Side-by-side comparison of the profile at this location shows the summer berm, which appeared each summer season, and the steeper, concave shape of the winter profile. *More profiling is required at the Ogunquit Beach area to understand spatial beach changes.* **Overall Ogunquit Beach Grade: B+ (88). 2011 grade: D (65). Trend: Better.**

At Ogunquit Beach, only one profile was available for comparison – OG02 (Figure 92). OG06 and OG07 do not have enough data for seasonal comparison. More profiling is required at this site to monitor changes.

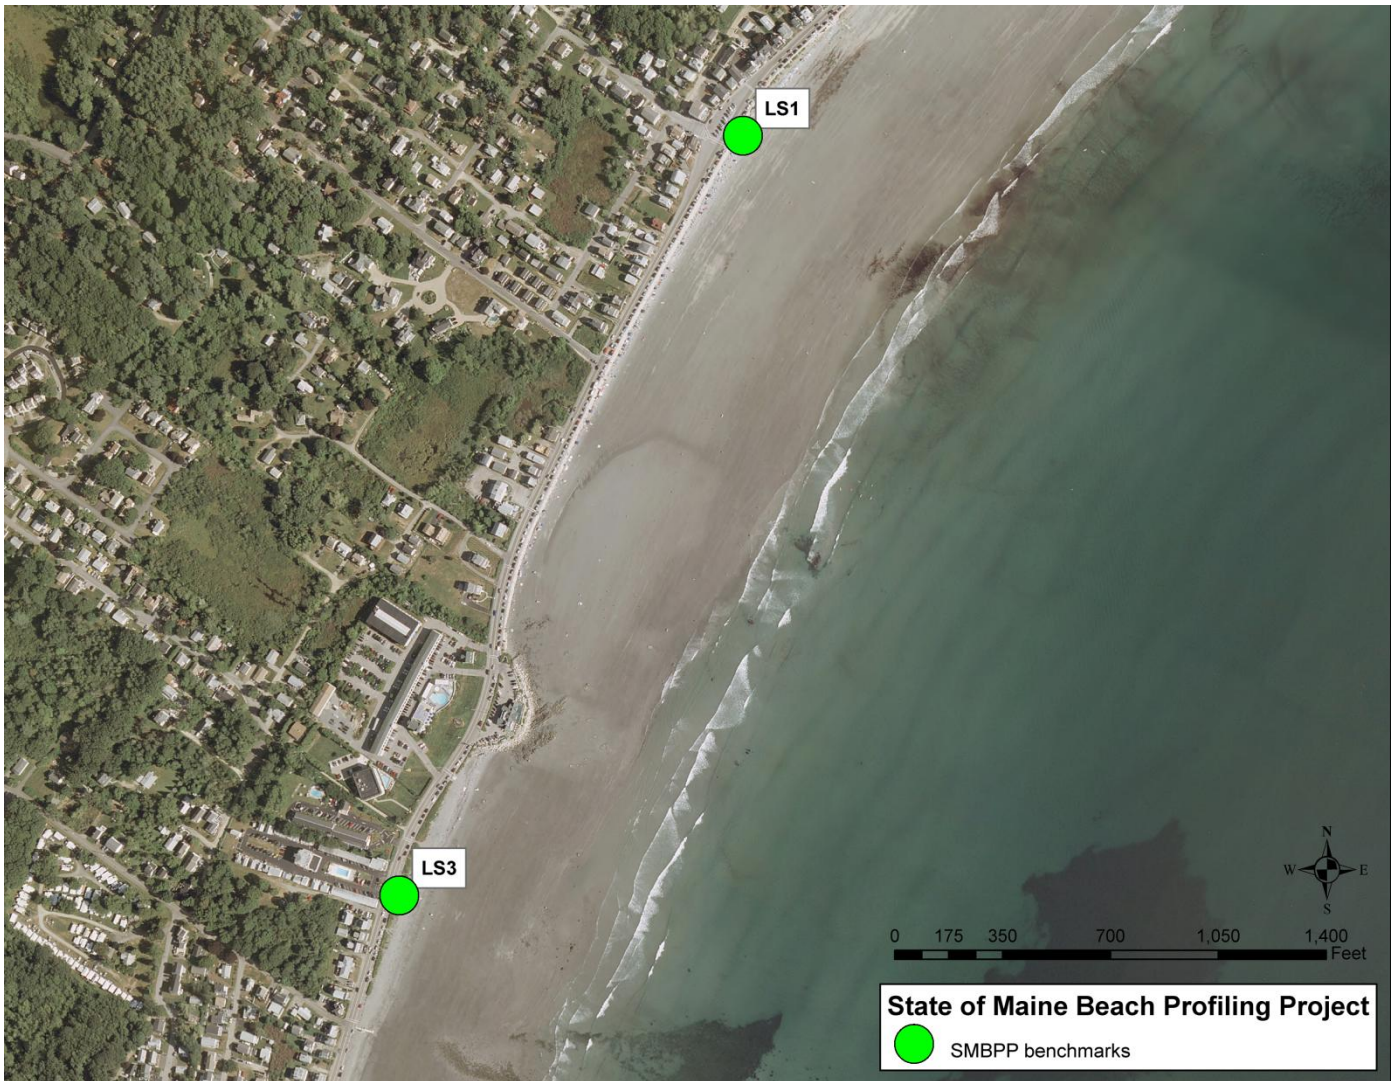
Figure 96. Locations of volunteer monitoring profiles along Long Sands Beach, York. Base imagery from Maine OGIS.

Two beach profiles (LS01 and LS03, Figure 96) were available for comparison.
