Annual ADFSL Conference on Digital Forensics, Security and Law

2019

A Forensic First Look at a POS Device: Searching For PCI DSS Data Storage Violations

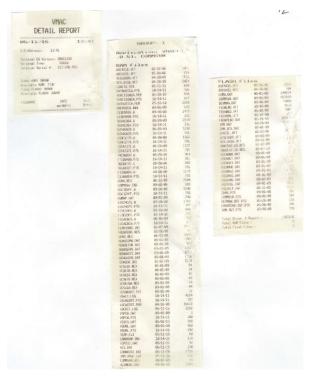
Figure 4. Partial VMAC Detail Report

We also printed a VMAC Detail Report, which included a VMAC Summary Report, followed by Group Details for each application group (see partial VMAC Detail Report in Figure 4).

and Ethernet ports, but the computer did not recognize that a device was connected. A wifi connection attempt also failed. This confirmed the entries on the VMAC detail report, which stated that Wifi and Ethernet were not supported on this terminal and the USB port was disabled.
