# Study of Separator Damage Effects on Lithium Ion Battery Cell's Performance

A Thesis Submitted in  
Partial Fulfillment of the  
Requirements for the Degree of

The University of Wisconsin-Milwaukee, 2018  
Under the Supervision of Dr. Ilya V. Avdeev

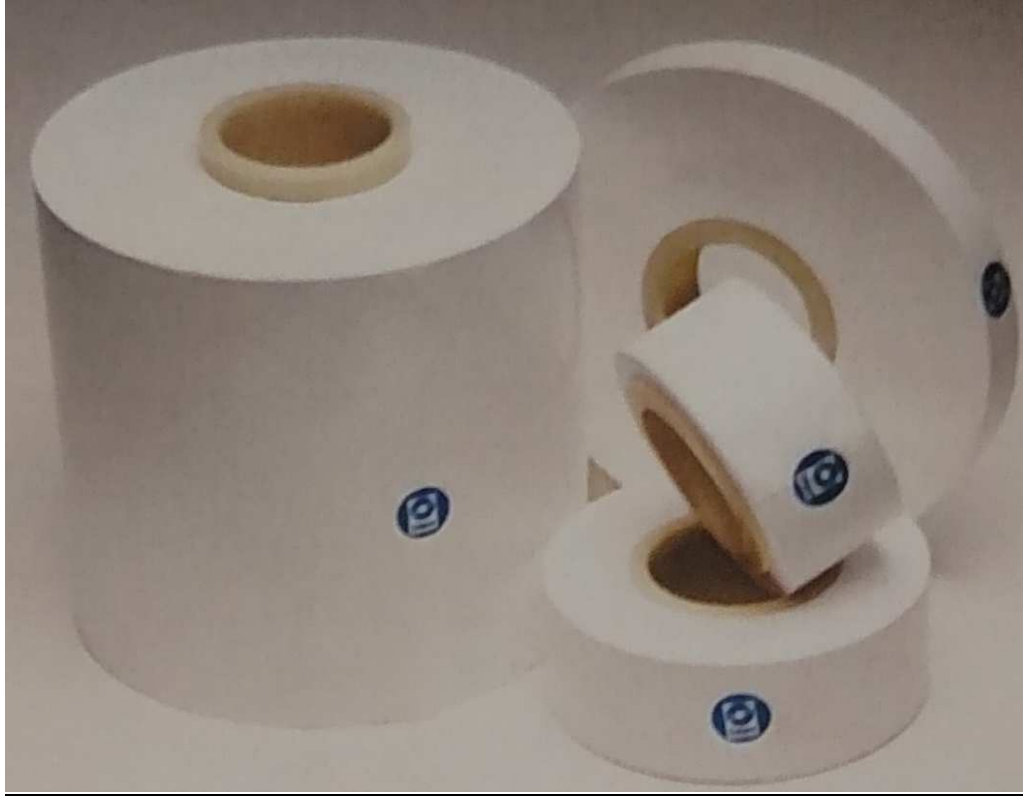
Figure 2: Rolls of Celgard 2325 Separator

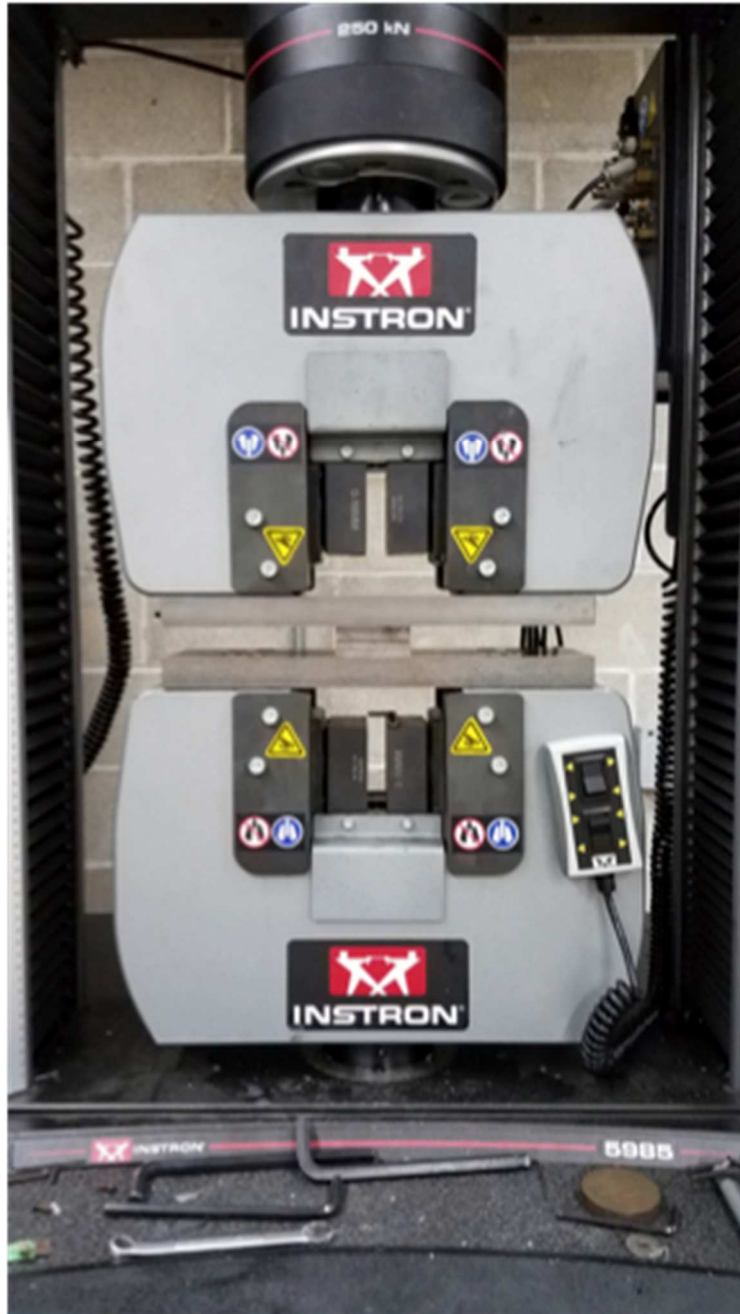
Figure 3: Separator Loading Setup Between Two Flat Plates Using Instron 5985

The Celgard 2325 tri-layer separator was used as the material studied in this research. An Instron 5985, shown in Figure 3, was used to compress the samples.

This ensured a controlled and uniform compression. A steel template was used to maintain a repeatable 19mm by 81mm area of compression. Samples were cut slightly larger than the template (21mm by 84mm) out of larger separator sheets using an XACTO knife. After the sample was cut to the correct size, and the steel template was set in place in the Instron, the separators were compressed to 33.71MPa, 67.42MPa, 101.13MPa and 134.84 MPa. These compressive stresses were chosen after analyzing data given from a Li-Ion Cell impact testing done by Gilaki et al [35]. In Gilaki's impact testing procedure, compressive forces on the cell reached 52.0kN with internal stresses reaching 67.42MPa. To ensure accuracy, at least 10 separator samples were compressed at each stress level.

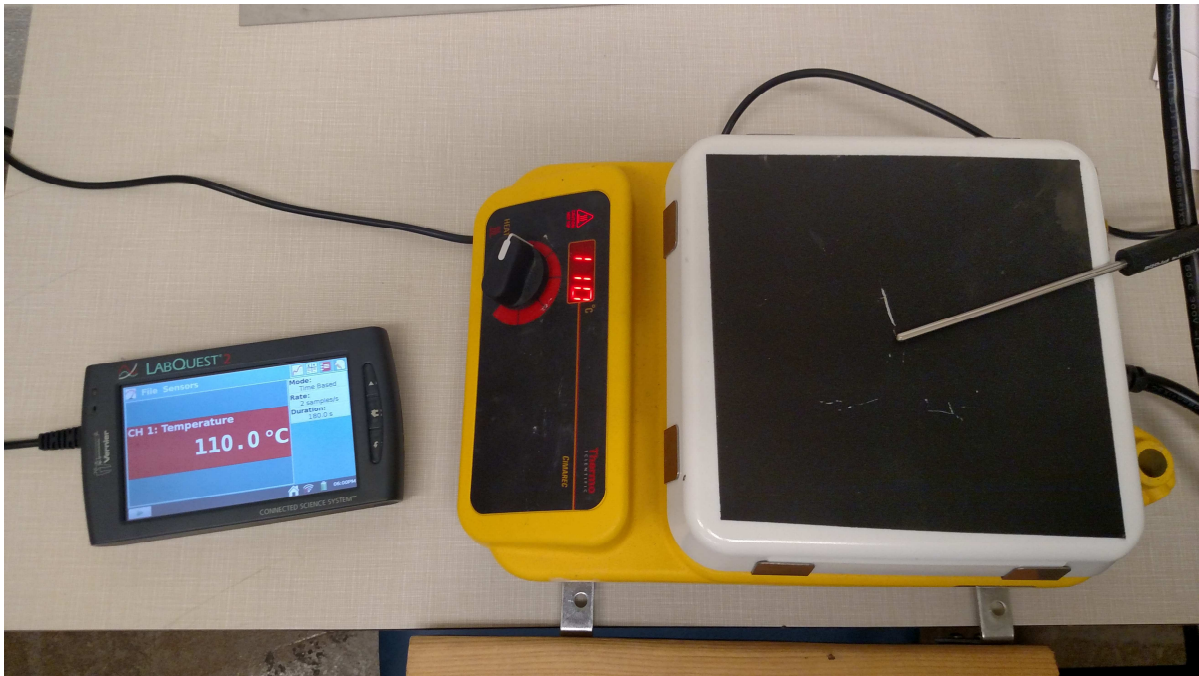
Figure 4: Hotplate with Thermal Couple

A hotplate was chosen to melt the separators, due to the uniformity of the temperature as well as the flatness of the surface. The surface of the hotplate temperature was checked for accuracy before each thermal test using a thermocouple as seen in Figure 4. Since the hotplate has a relatively flat surface, a stainless steel plate could be placed on top of the separator sheet being melted to assure a thermal abuse that could be observed in a tightly packed Lithium Ion battery cell like the cylindrical cell shown in Figure 5. Each separator was subject to the desired thermal abuse for 3 minutes to assure a uniform temperature. The separator was subjected to the thermal stresses in larger pieces and then cut to the correct size. Again, using a template and an XACTO knife.

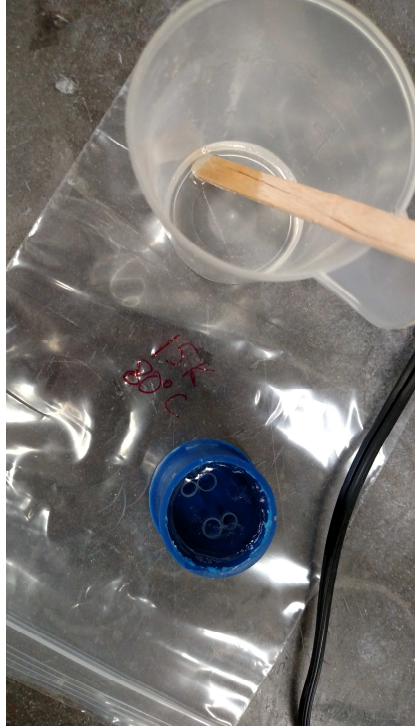
Figure 6: Epoxy Setup

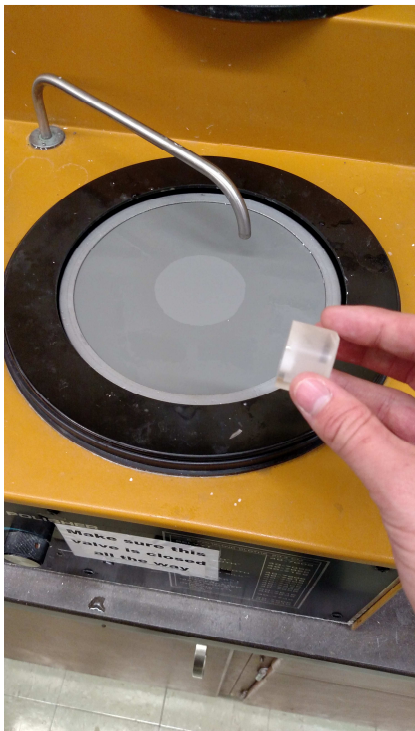
Figure 7: Grinding of Cylinder

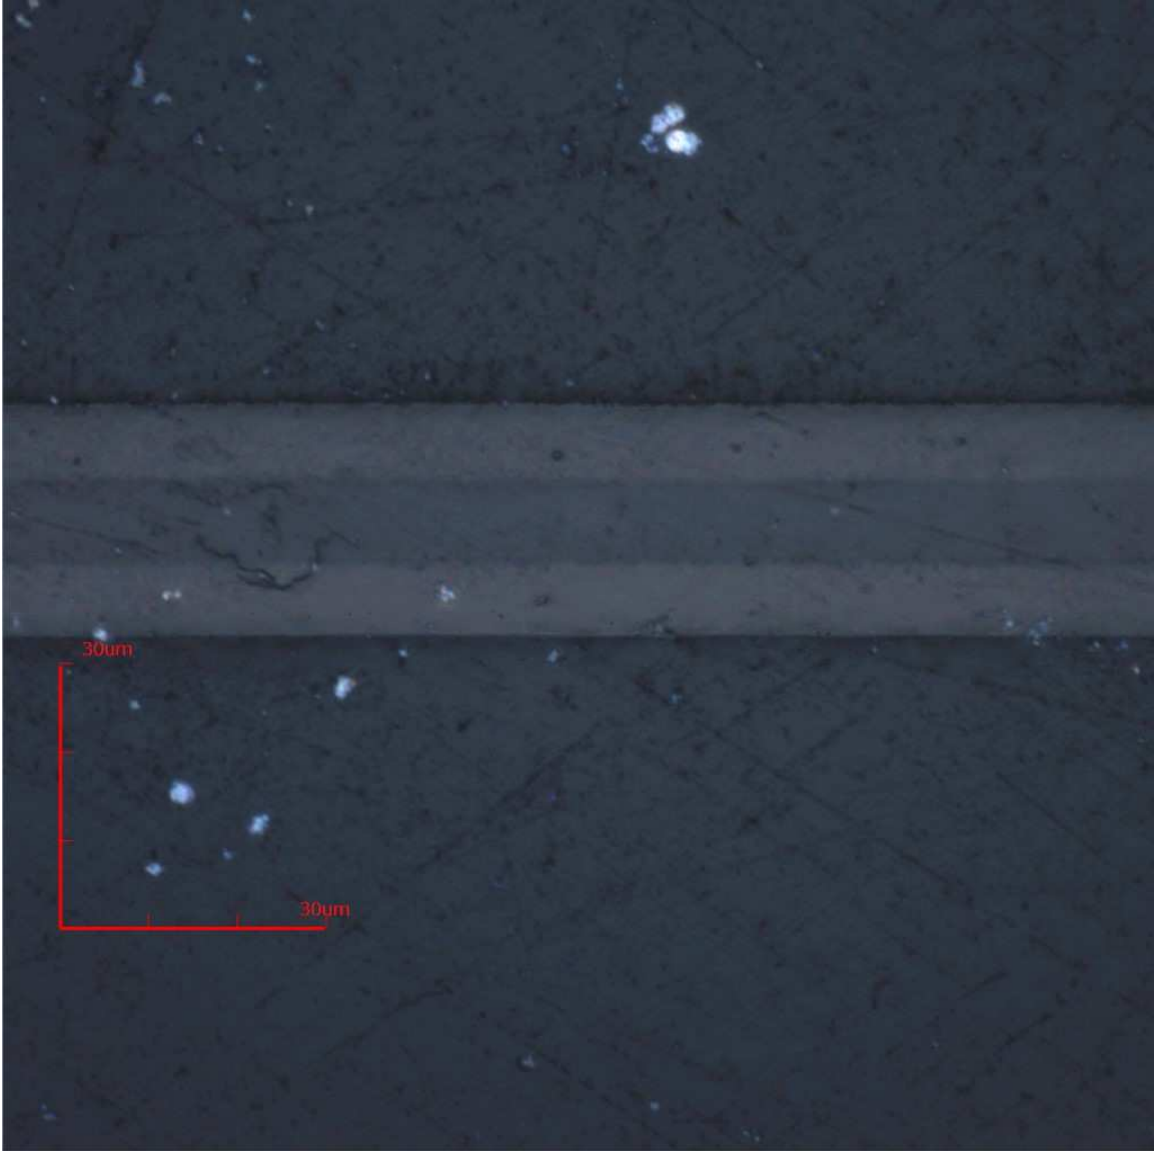
Figure 12: 3-D Microscopy Cross-Section of 110°C Separator

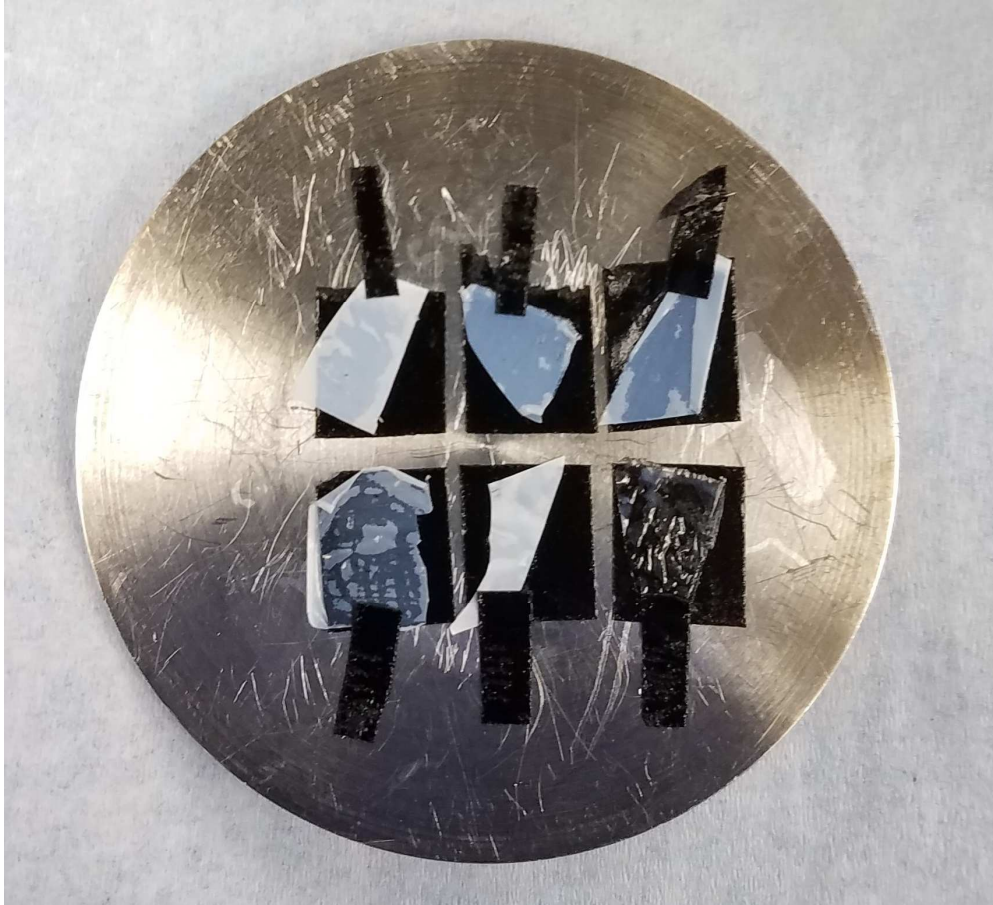
Figure 14: Mounted Samples for SEM Imaging

In this particular experiment, SEM imaging was used to determine the deformation of the separator pores after put under stress. After each separator was subject to a stress, segments small enough to fit inside the microscope were cut out using an XACTO knife. The separator pieces were then mounted to a steel cylinder using carbon tape as can be seen in Figure 14 and were coated with 1nm of Gold and

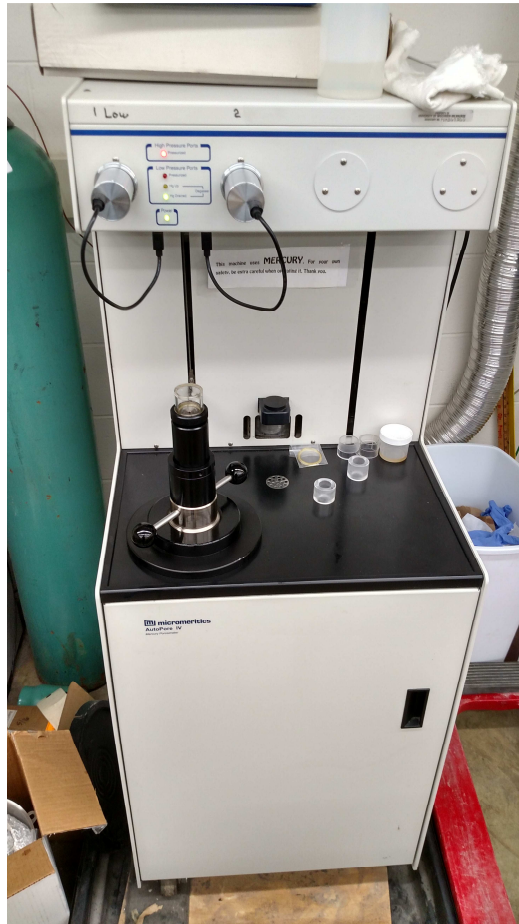
Figure 24: Hg Intrusion Machine

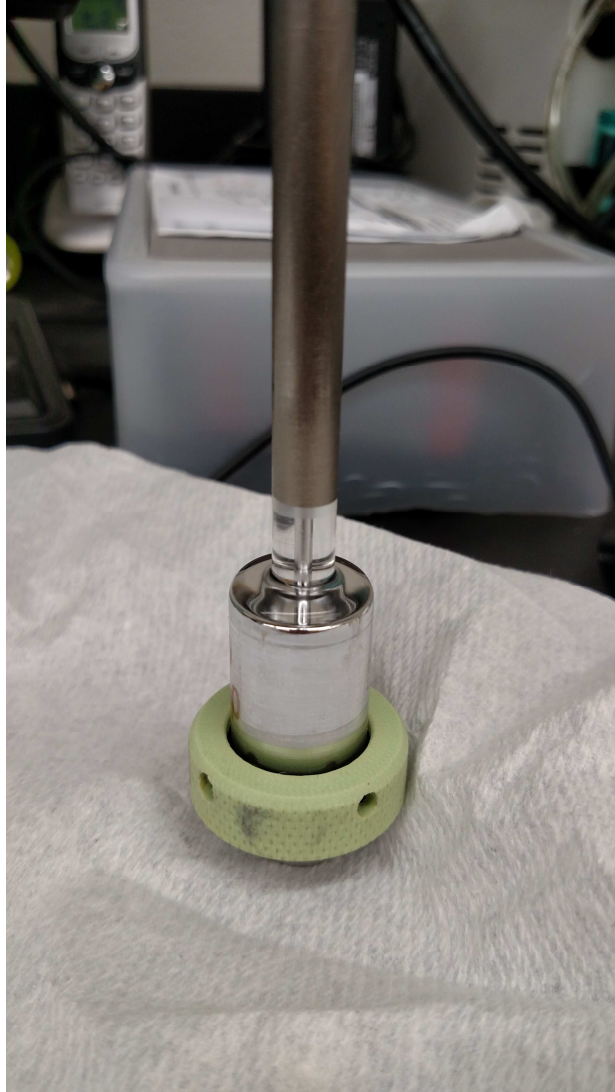
Figure 26: Penetrometer and Sample after Low Pressure Analysis

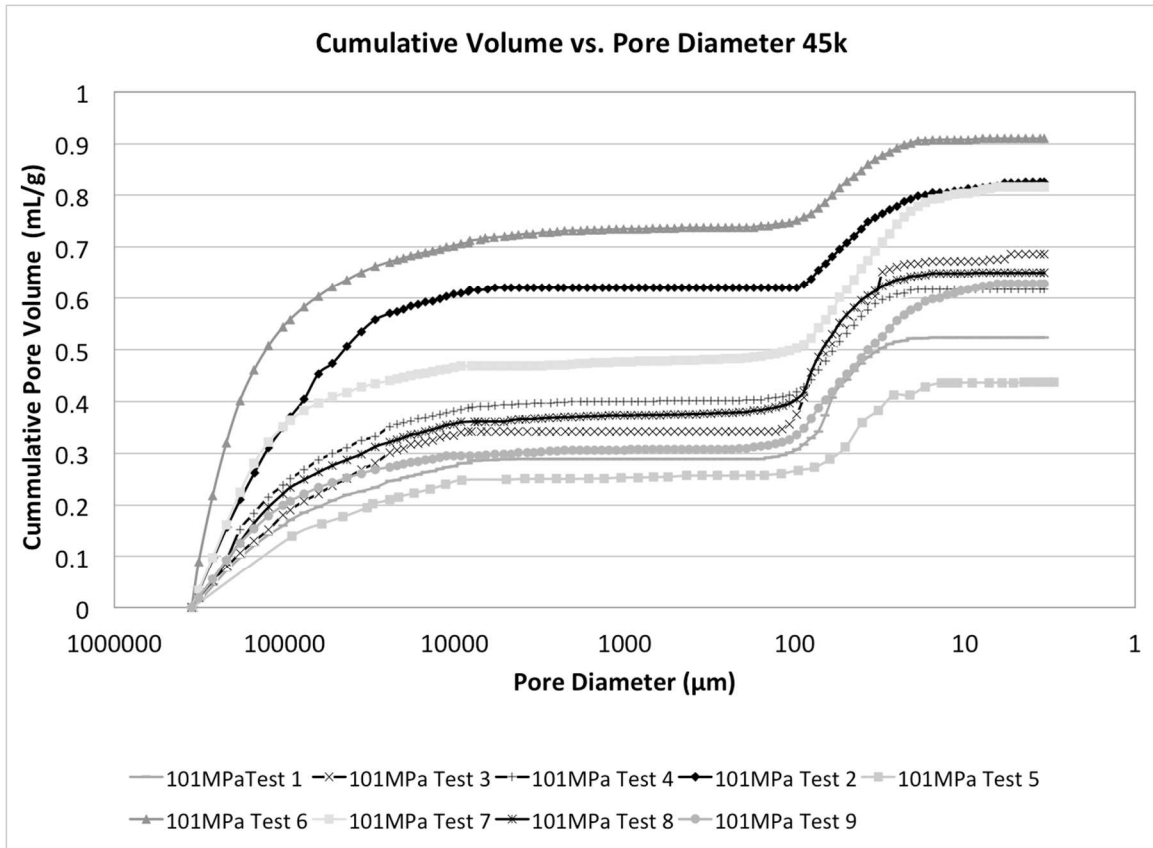
Figure 28: 101MPa Cumulative Volume vs. Pore Diameter

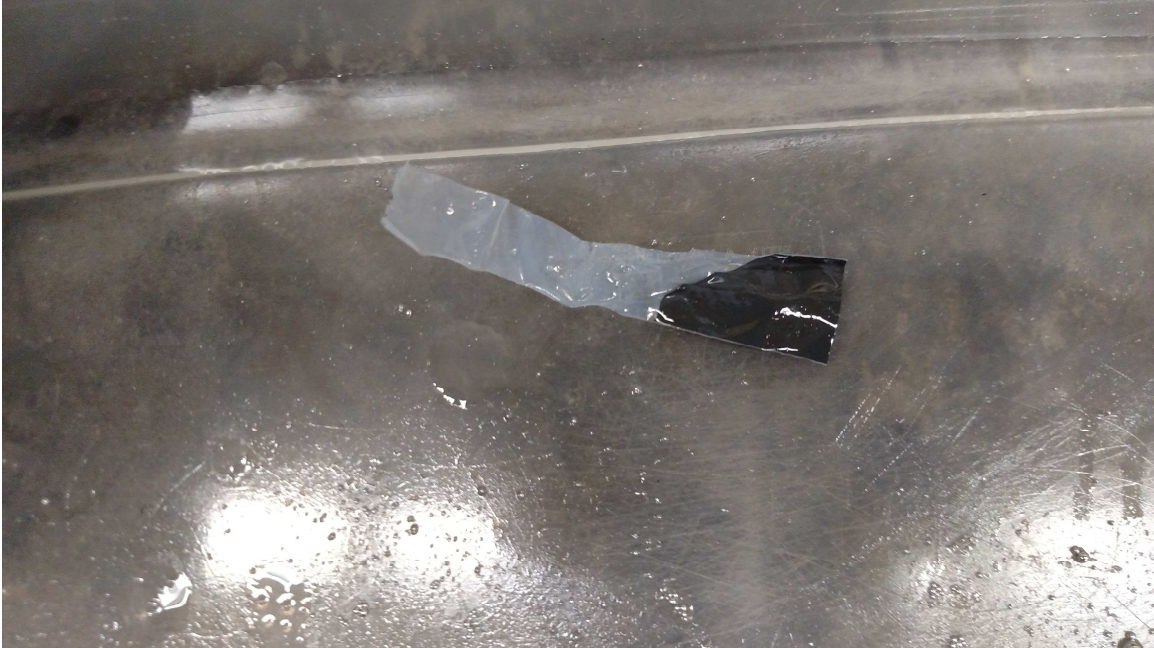
Figure 29: Dark Grey Patch on Separator Sample

In multiple samples that failed, a dark grey area on the separator formed during the test, as seen in Figure 29. There are a few possible reasons as to why some tests revealed this dark grey substance. The first possible reason is that the sample is going under a process called embrittlement. Embrittlement is a phenomenon when the structural integrity of an object (usually a metal) is changed by making it brittle due to a liquid metal (in this case mercury) [38]. Embrittlement is a form of corrosion and can occur under high pressures, although, embrittlement seems unlikely to influence a plastic separator. The second reason is that the mercury is getting trapped inside of the separator during the test. The third reason

is that the separator is going through a chemical reaction. Other reasons why samples failed include, a rip being in the separator, a contaminant got inside of the penetrometer, incorrect weight measurements, excessive vacuum grease, insufficient torque of penetrometer cap, etc.

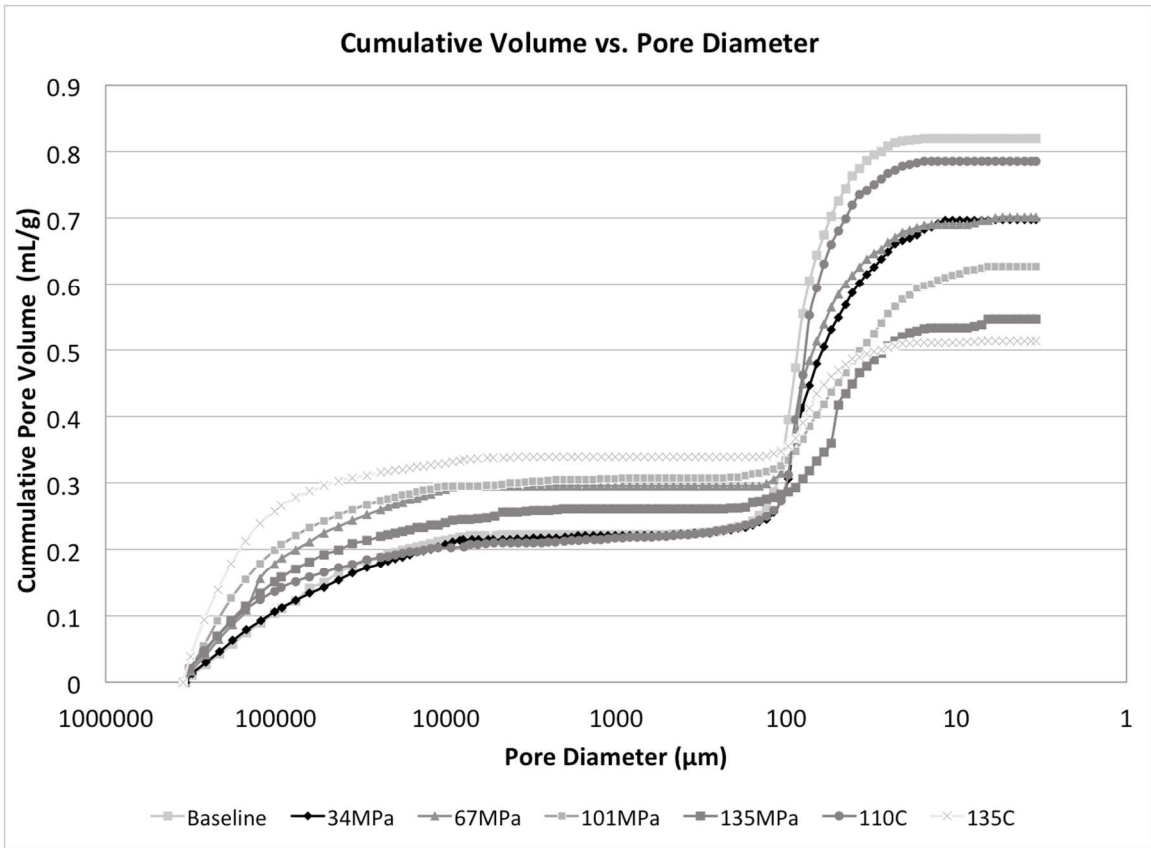
Figure 30: Cumulative Volume vs. Pore Diameter

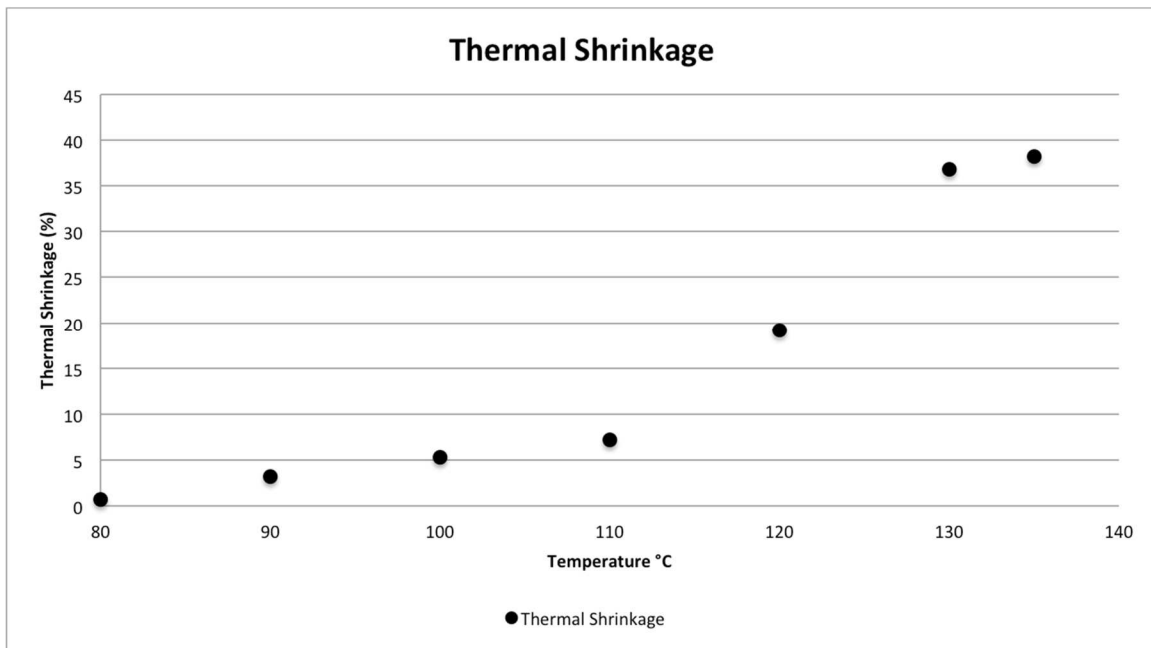
Figure 33: Thermal Shrinkage Graph

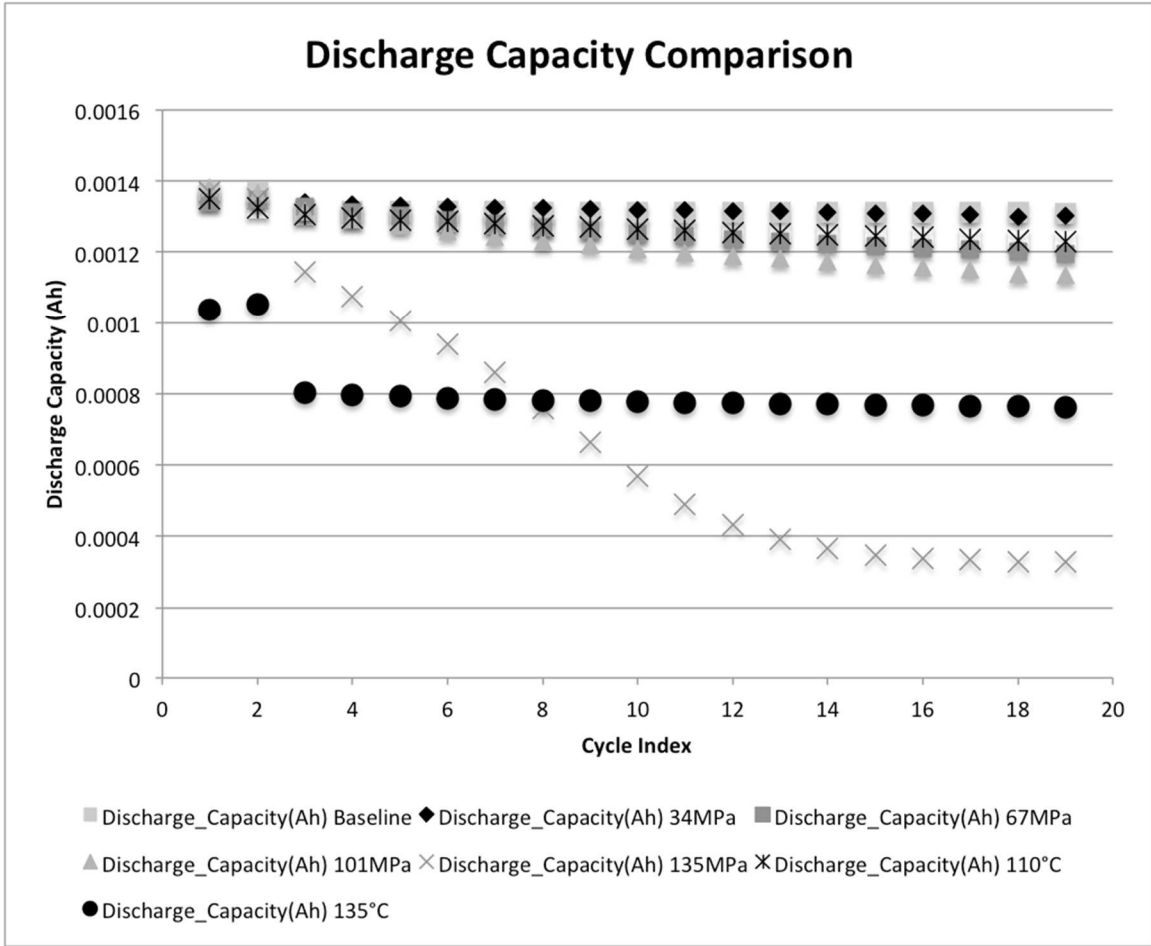
Figure 35: Discharge Capacity Comparison

The baseline or undamaged separator had a very similar discharge capacity throughout the first 20 cycles, as can be seen in Figure 35. However, investigated at a finer scale, such as in Figure 37, the discharge capacity curves are not the same. The baseline curve starts at 0.00137Ah for 2 cycles before quickly dropping to around 0.00131Ah where it levels out. The 34MPa on the other hand, starts at 0.00136Ah and begins a rather constant descent to 0.0013Ah by its 20<sup>th</sup> cycle. This seems to demonstrate what can be seen in the other damaged cells but on a much

smaller scale. The 34MPa curve looks similar to the 135MPa curve from Figure 35, just on a smaller scale. It seems, like the 135MPa, the 34MPa's discharge capacity will eventually fall to the point of being ineffective. However, it should be noted that the cycle life of the 34MPa will be relatively high.

Another observation that can be made from Figure 35 is the difference in discharge capacities from cycle 1 to cycle 20. As discussed earlier, after the 20<sup>th</sup> cycle, all of the damaged separator cells have a lower discharge capacity than the baseline. Perhaps the more interesting observation is during cycle 1, in which most of the cells (excluding 135°C) have a very similar discharge capacity. Each damaged separator has a lower porosity than the baseline separator. This explains why the cells with the damaged separator have lower discharge capacities in cycle 20 since the ions require the porous openings to transfer from electrodes.

The final anomaly as observed from Figure 35 is the difference in discharge capacity between the 67MPa and 110°C cells. The 110°C separator has a lower porosity than the 67MPa separator (27%±1% and 32%±1% respectively) as seen in Table 5. However, in Figure 38, the 110°C cell had a higher discharge capacity at the end of the 20<sup>th</sup> cycle. For the rest of the cells, the lower the porosity, the lower the discharge capacity at the 20<sup>th</sup> cycle. This could be due to the 110°C separator having more “large pores” than the 67MPa separator, as seen in Figure 31 from Chapter 2. The “large pore theory” is consistent with first theory from 3.2.3. However, looking at the SEM images from Chapter 2 (Figure 15 through 21), it can be seen that the two stresses deform the pores differently. The 67MPa compressive stress compresses the size the pores at a different orientation, forming long narrow

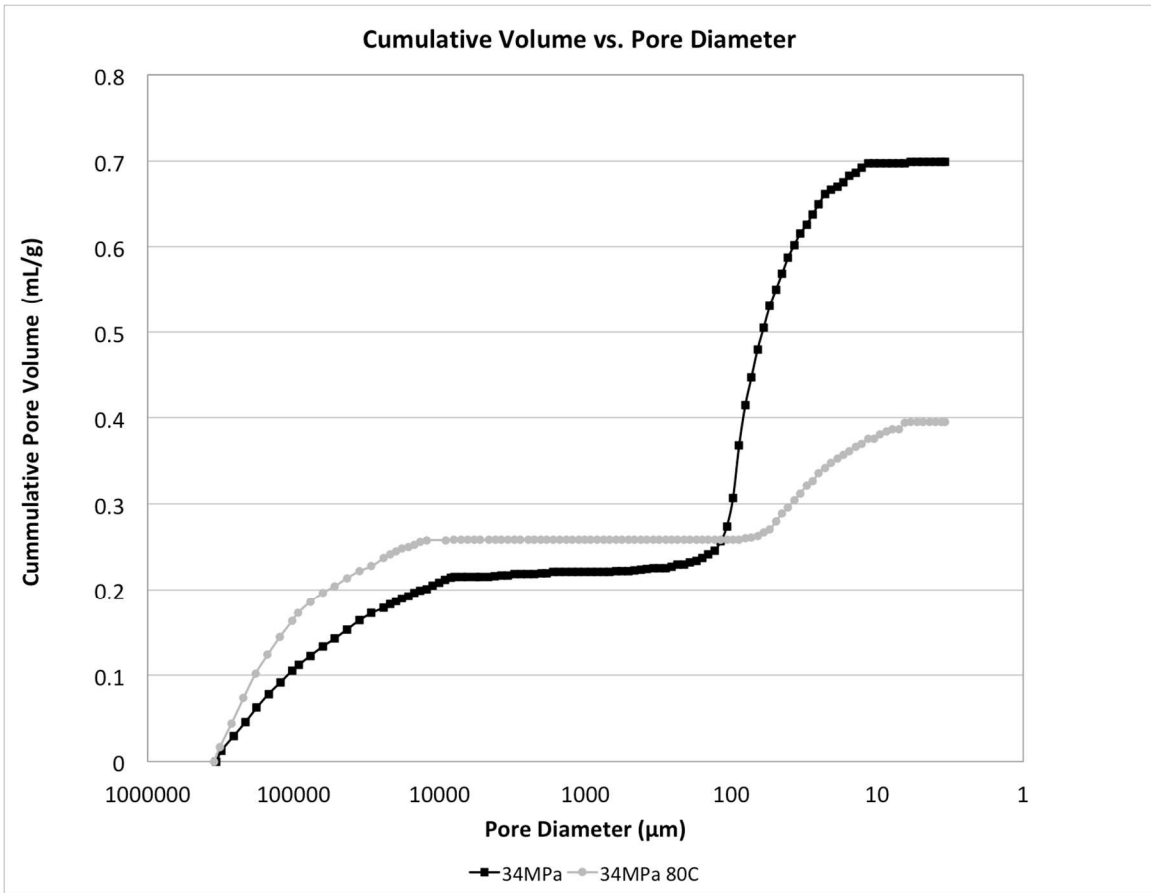
Figure 41: Hg Intrusion Compressed vs. Heated and Compressed

A separator crushed at 80°C showed differences when compared to a separator crushed at room temperature ( $\sim 21^\circ\text{C}$ ). The magnitude of the difference between the two crush temperatures, that were heated to 80°C while being crushed had a porosity of  $11\pm 1\%$  while separators being crushed with the same stress (34MPa) at room temperature had a porosity of  $35\pm 1\%$ . As seen in Figure 41, barely any mercury could be pushed into the pores of the 80°C crushed sample compared to the room temperature sample during their respective mercury intrusion tests. The lack of mercury being pushed into the combination sample compared to the 34MPa sample in Figure 41 offers a visual of the difference in porosity. Figure 42 demonstrates the distribution of pores sizes in the two samples. In Figure 42 the peak of the pore sizes completely shifts between the different stresses and also shows just how many pores have closed completely.

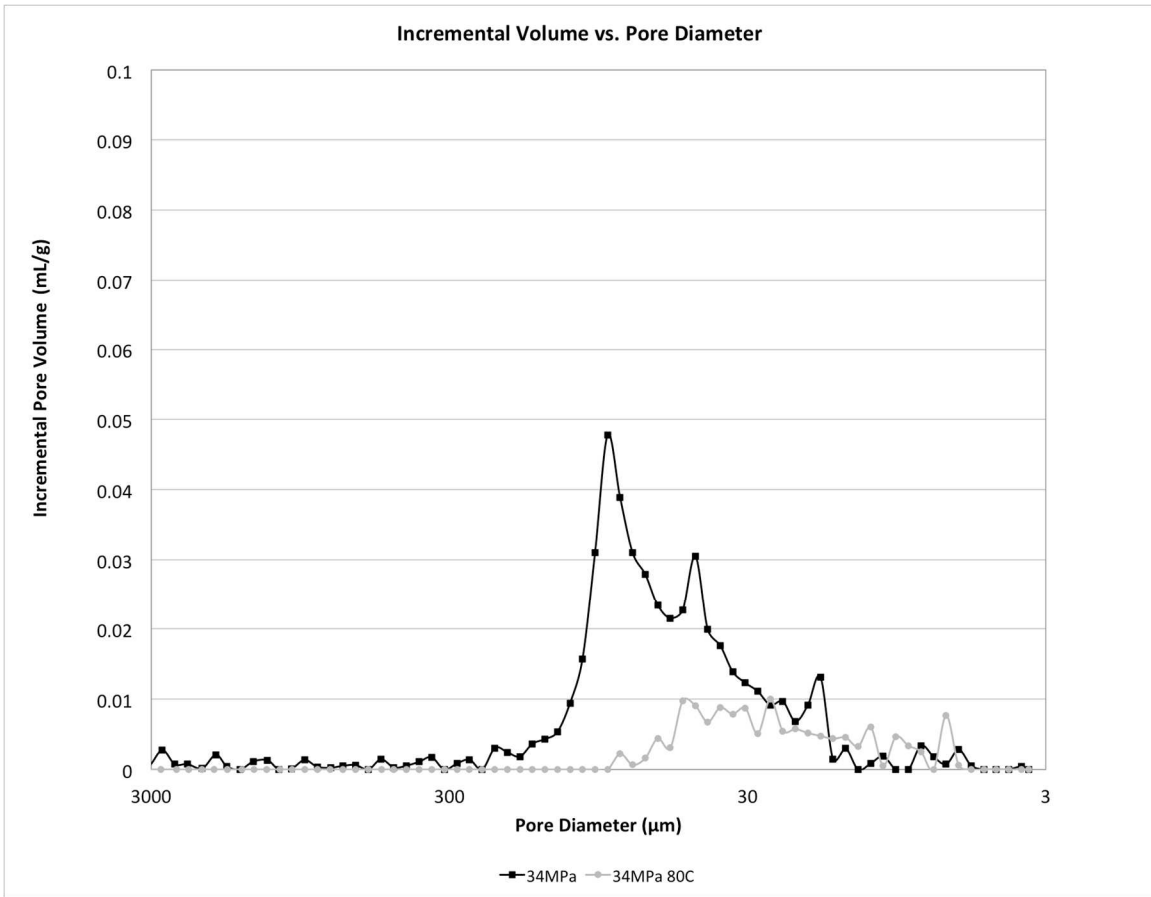
Figure 42: Incremental Pore Volume Compressed vs. Heated and Compressed
