GALVANIC CORROSION OF HIGH-TEMPERATURE LOW-SAG (HTLS) HIGH
VOLTAGE CONDUCTORS: NEW MATERIALS – NEW CHALLENGES

A Thesis

Eva Håkansson

June 2013

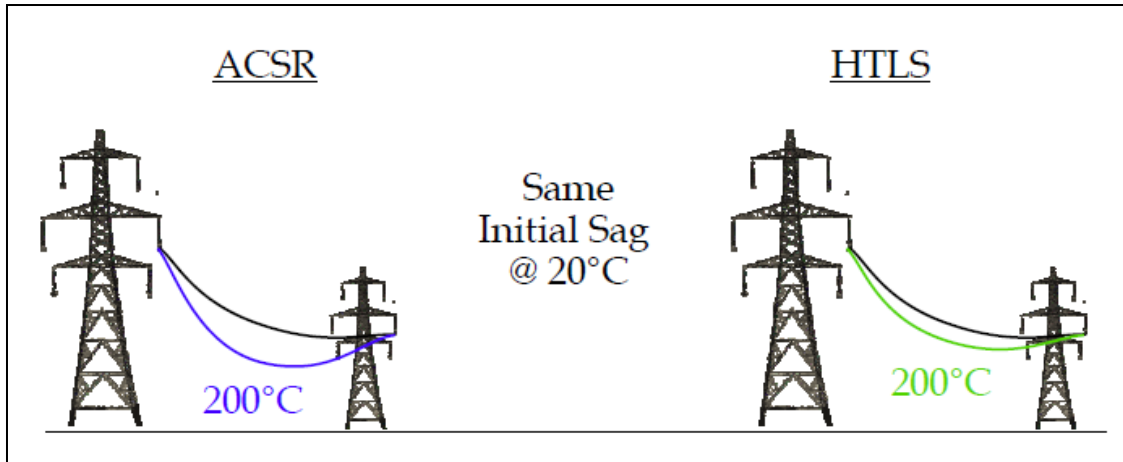
Figure 1: Thermal response of ACSR versus HTLS.
Source: (Lancaster, 2011)

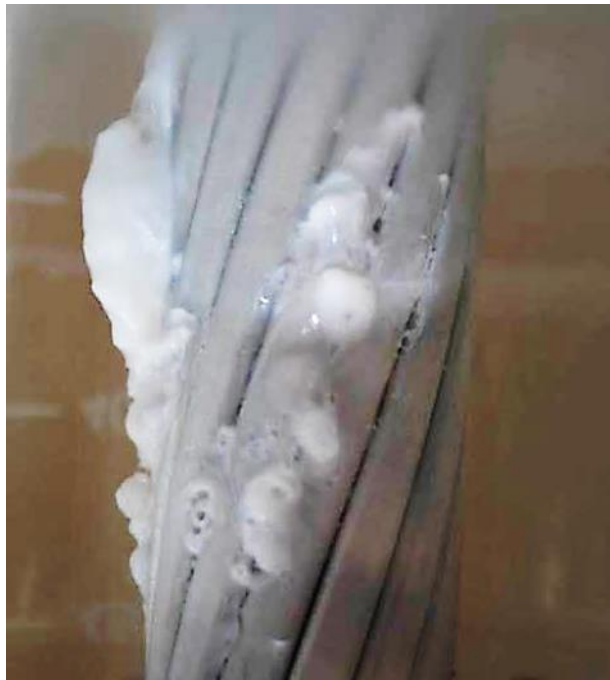
Figure 6: Formation of $\text{Al}(\text{OH})_3$ on the ACCC sample.

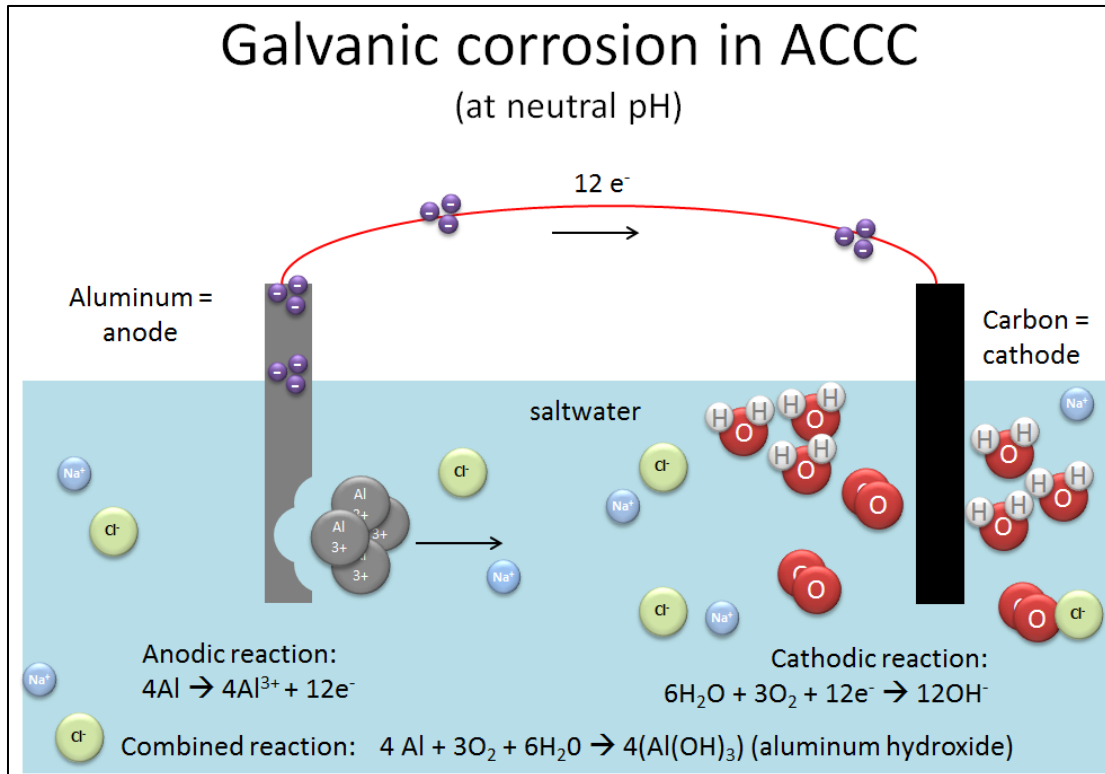
Figure 7: Principle of galvanic corrosion between aluminum and graphite in saltwater.

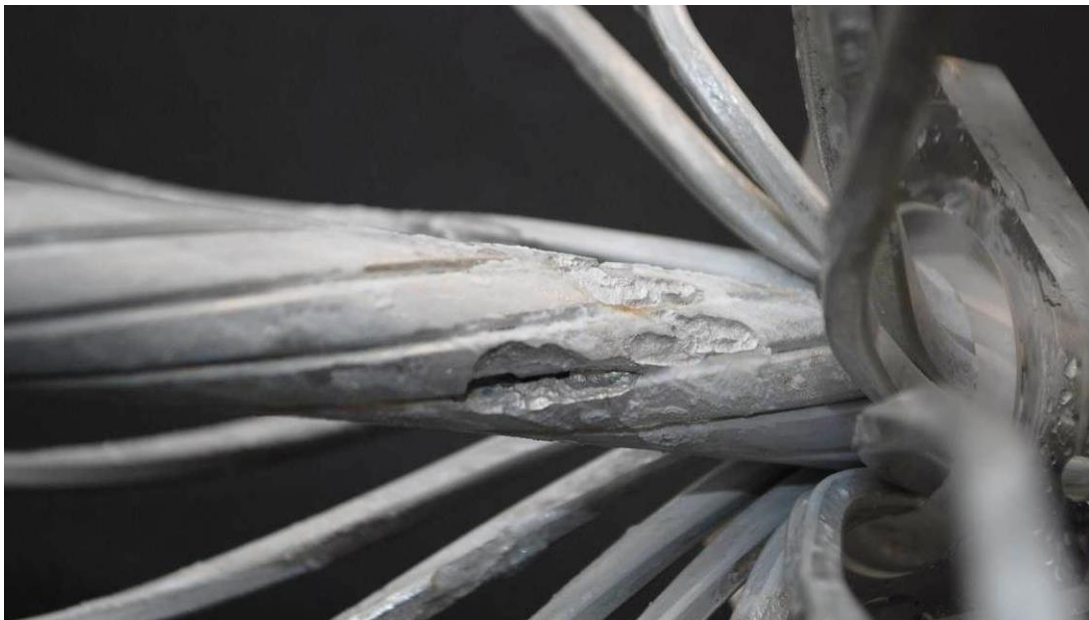
Figure 9: Typical pitting corrosion of aluminum.
The strands of an ACCC conductor after 3 months submersion in 85°C, 3 wt. % seasalt aqueous solution.

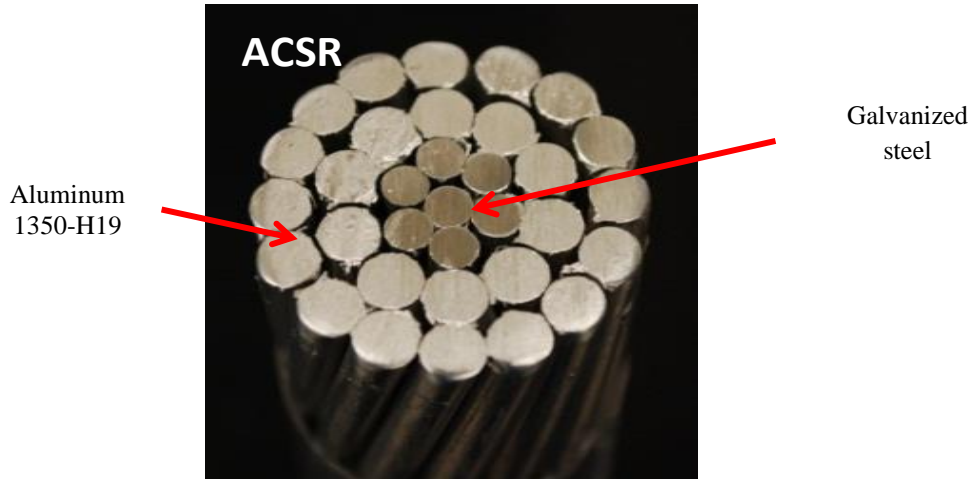
Figure 11: The components of ACSR.

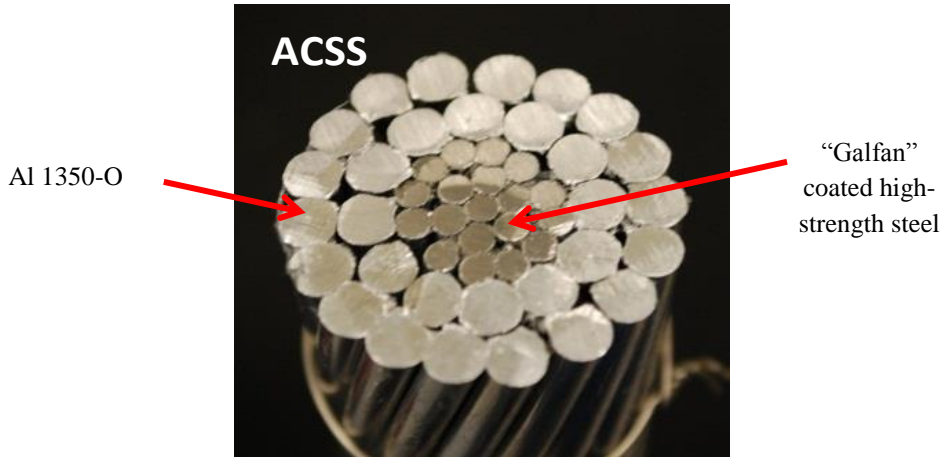
Figure 12: The components of ACSS.

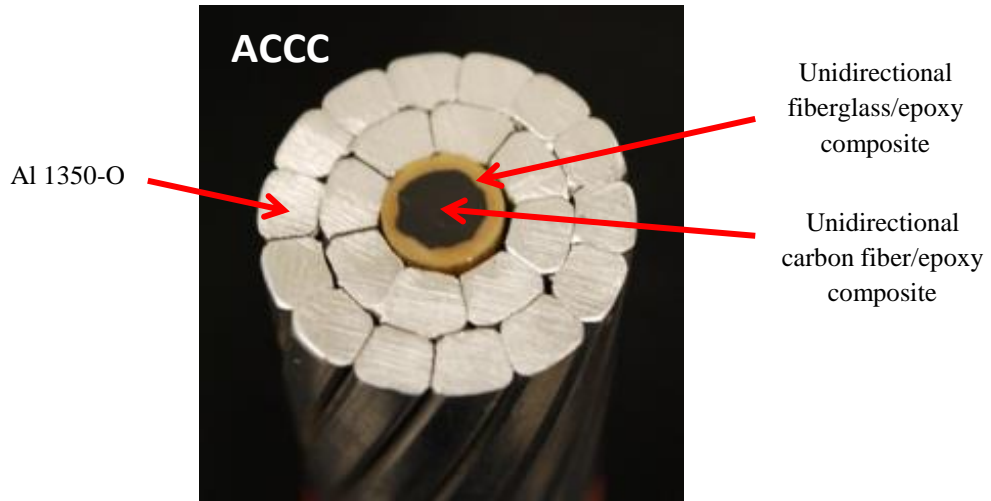
Figure 13: The components of ACCC.

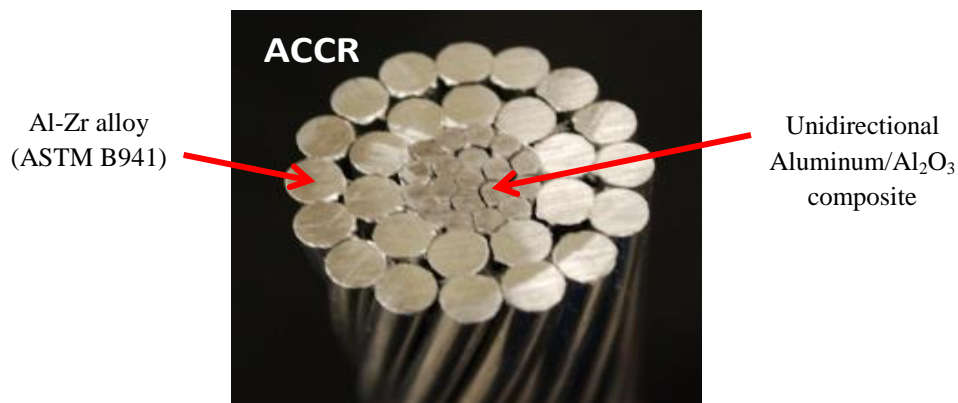
Figure 14: The components of ACCR.

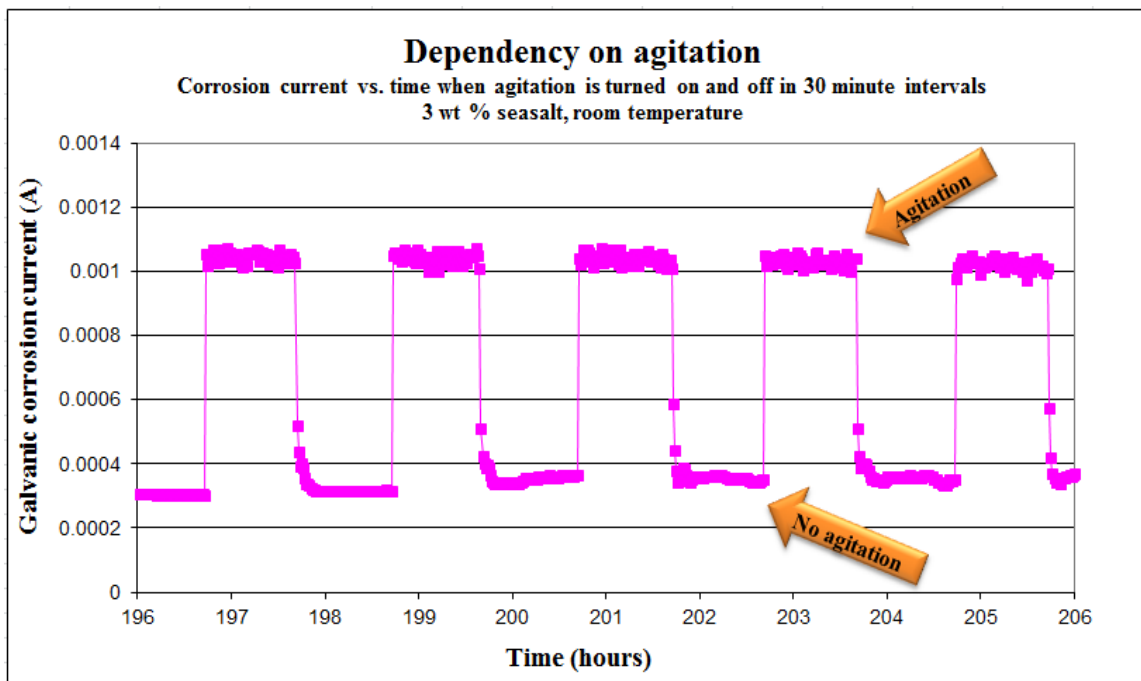
Figure 15: Dependency on agitation.
Initial galvanic corrosion tests showed a strong dependency on agitation of the electrolyte.
The electrodes in the experiment were aluminum and carbon fiber composite.

The cycling on and off gives additional information about the corrosion process since it shows if it is diffusion limited or not. If the reaction rate is diffusion limited, the resulting plot of the galvanic corrosion current as a function of time will have the characteristic square wave form as in Figure 15.

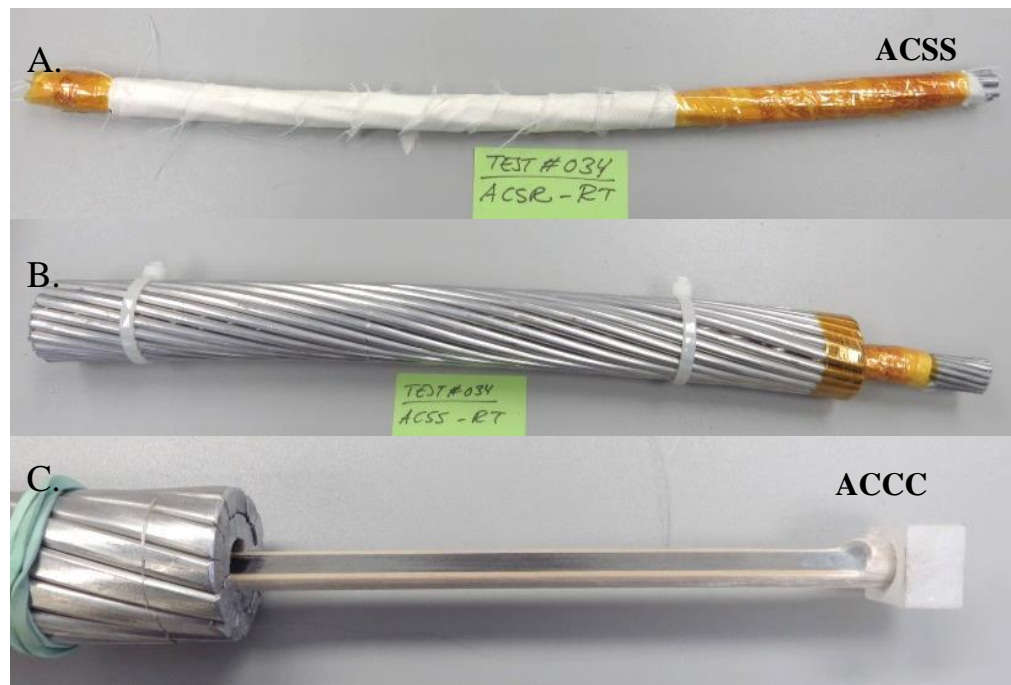
Figure 17: Samples for galvanic corrosion testing.

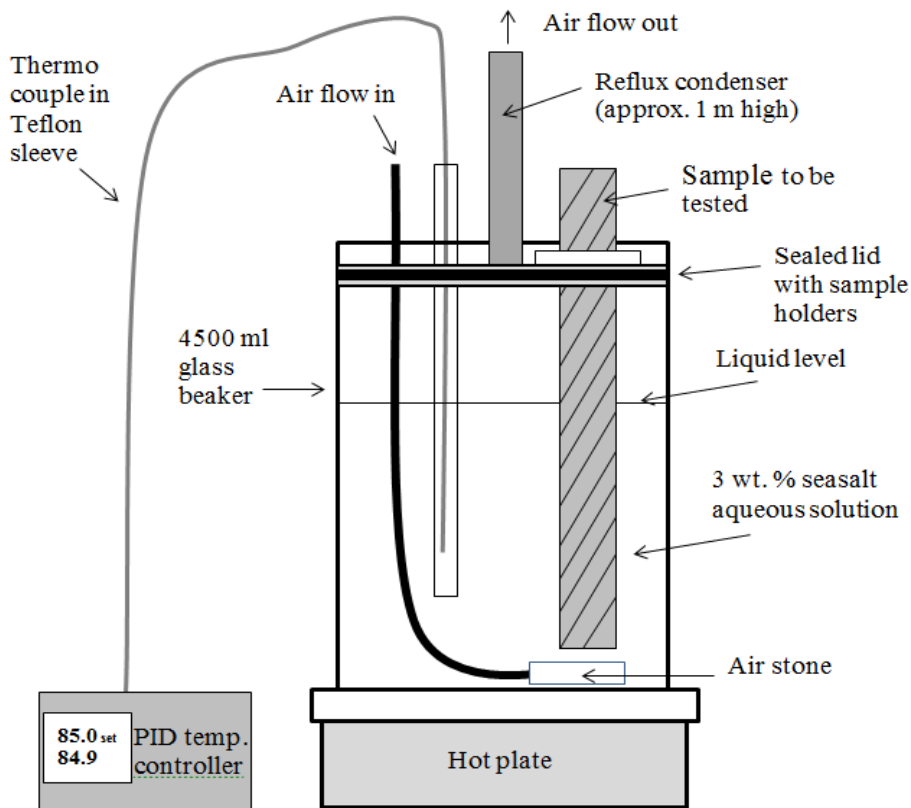
Figure 18: The C3LARC testing cell as used for test A.

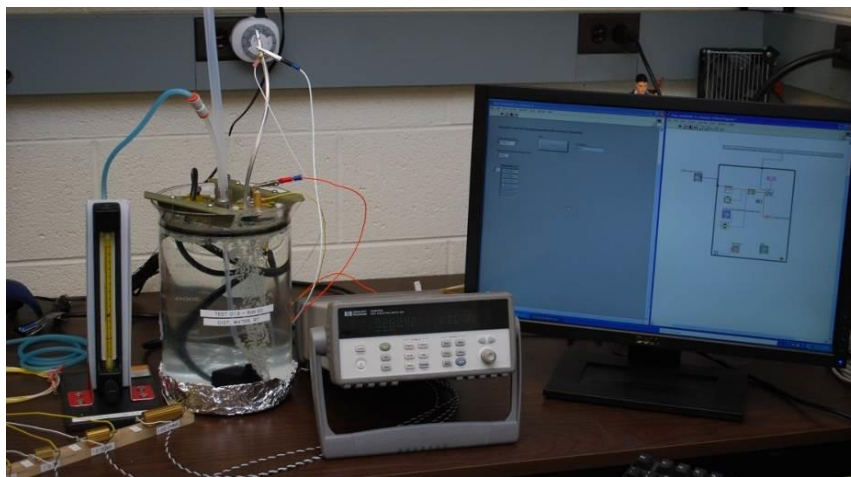
Figure 19: The C³LARC instrument.

The C³LARC instrument setup for partially submerged corrosion testing (Test A), fully submerged corrosion testing (Test B) and galvanic corrosion testing (initial testing).

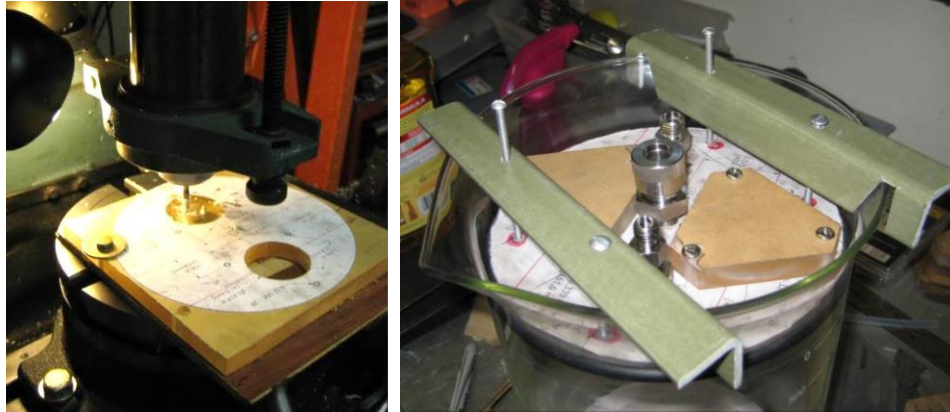
Figure 20: Manufacturing of the C³LARC testing cell.
 The C³LARC instrument can be built with simple manufacturing methods.
 Drawings are found in Appendix A.

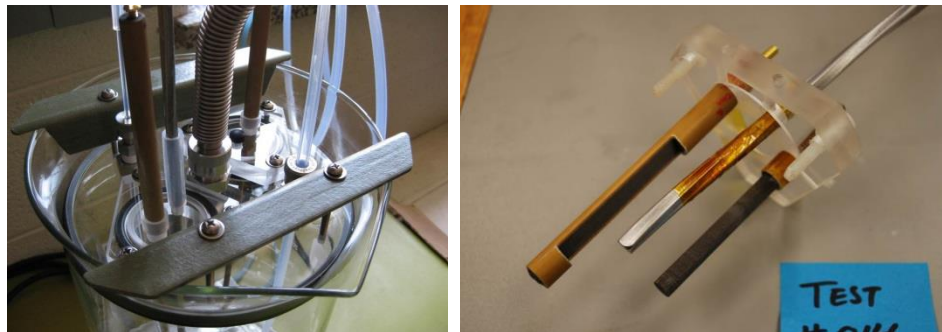
Figure 21: C³LARC sample holders.
 The sample holders are based on the KF-40 vacuum flange system which provides a standardized system for the easily modifiable sample holders.

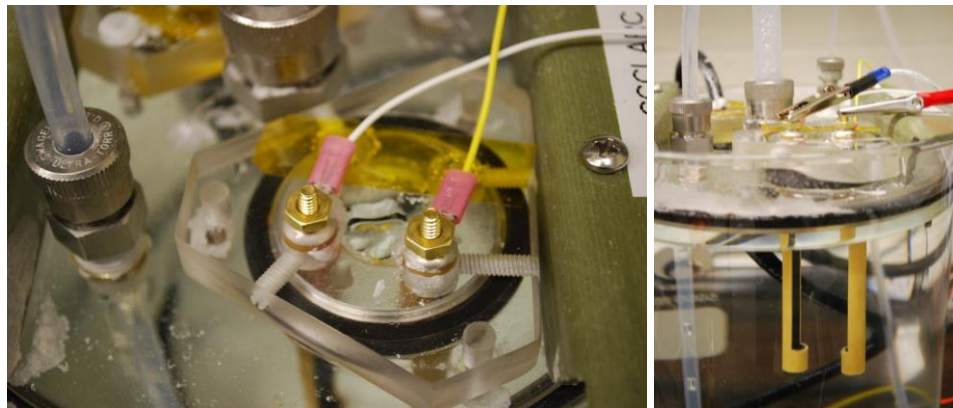
Figure 22: Electrical connections.
 The electrical connections to the samples are made outside the testing cell, making careful insulation of the connections unnecessary.

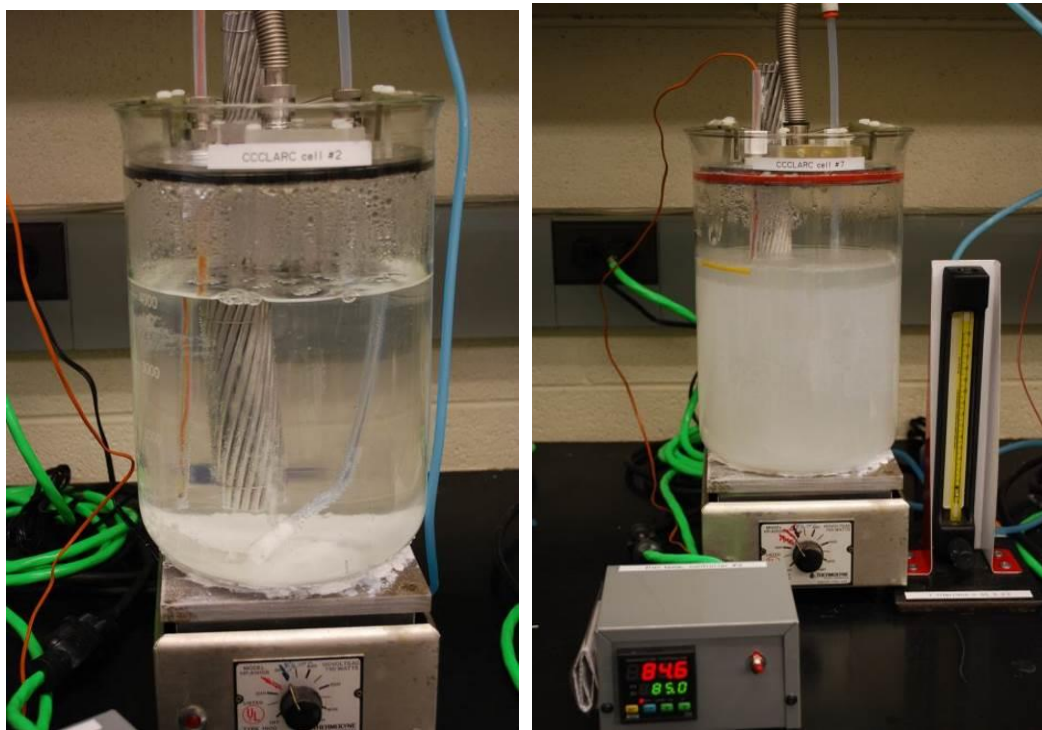
Figure 23: The C³LARC testing cell used for Test A.
Left: Start of the test. Right: About halfway through the test.
(Note: the two pictures are from two different tests).

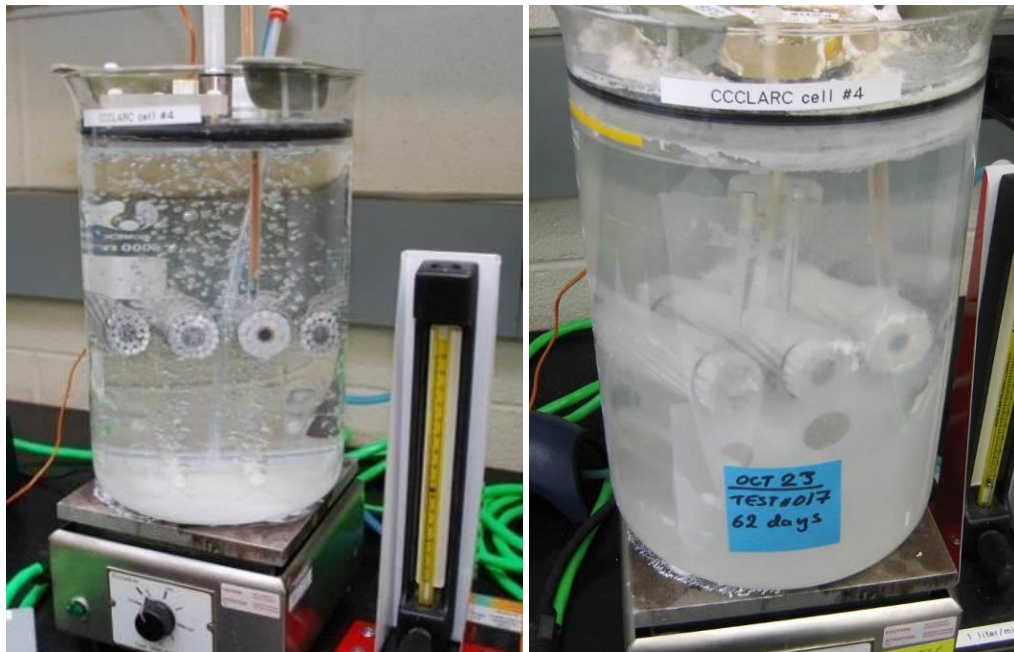
Figure 25: Test B – fully submerged.
Left: Start of test. Right: End of test (after 62 days).

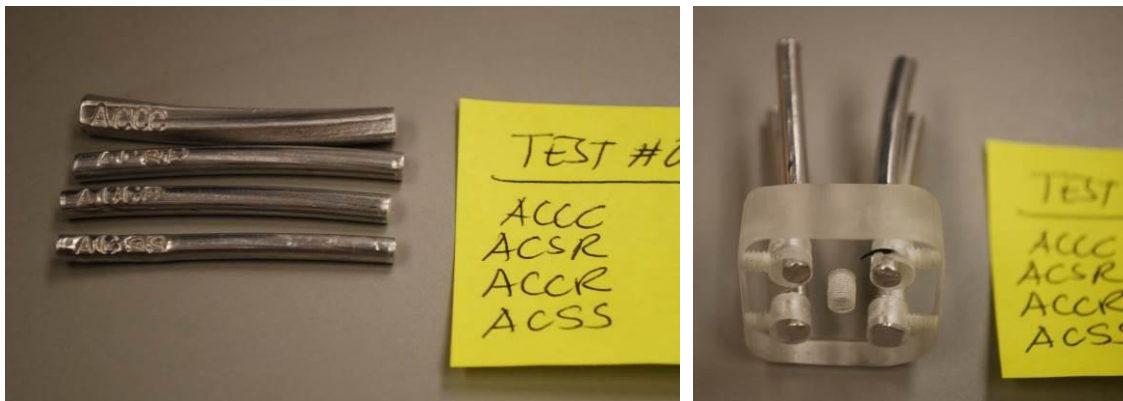
Figure 26: Samples for Test C.

The single strand aluminum samples (left) and the samples mounted in the holder (right). (ACCR composite strand sample not in picture)

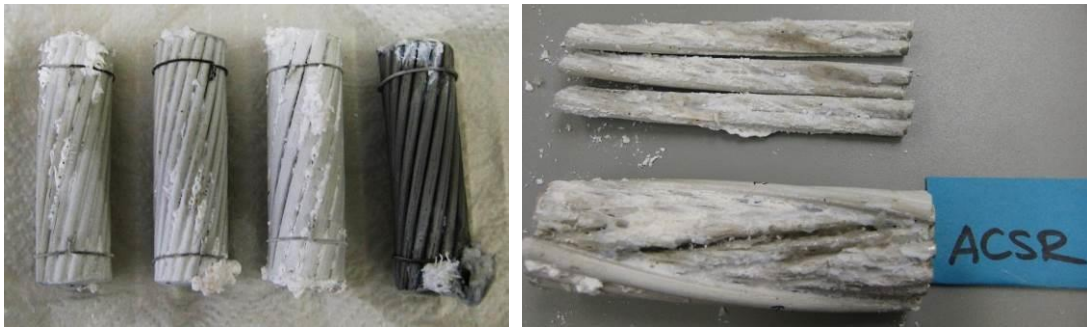
Figure 28: Samples from Test B.
Samples just taken out from Test B (left), and typical sample before cleaning (right).

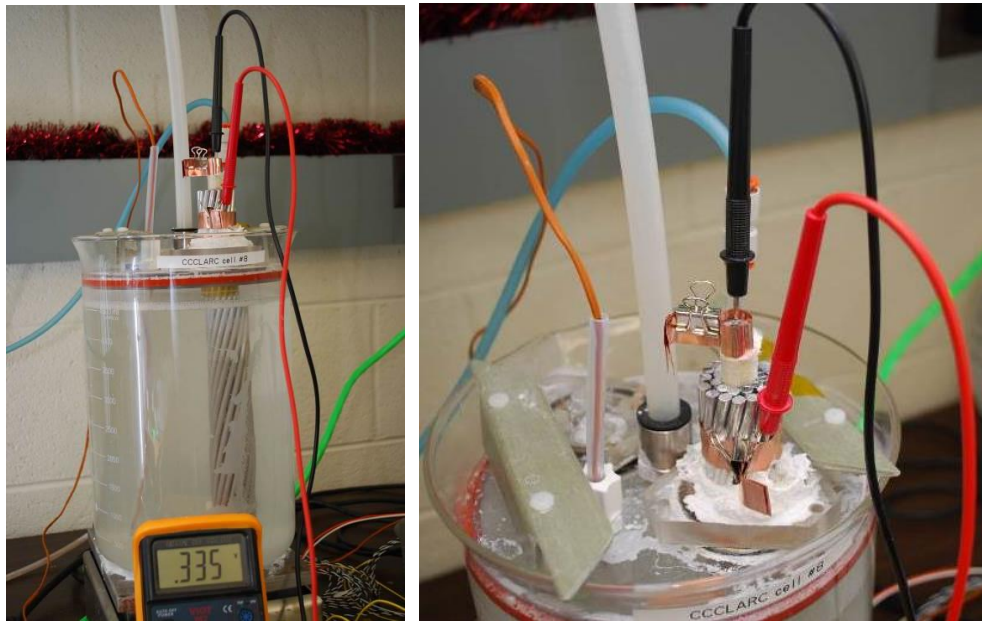
Figure 29: Open circuit potential measurement.
Measurement of the open circuit potential of the ACCC sample at 85°C during Test D.

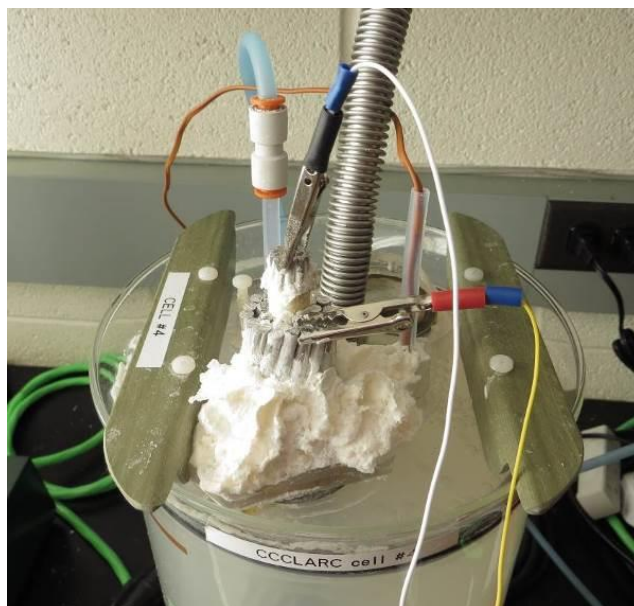
Figure 30: The ACCR sample at room temperature during Test E. Salt and corrosion products had crept up between the strands and crystallized on top of the sample holder.

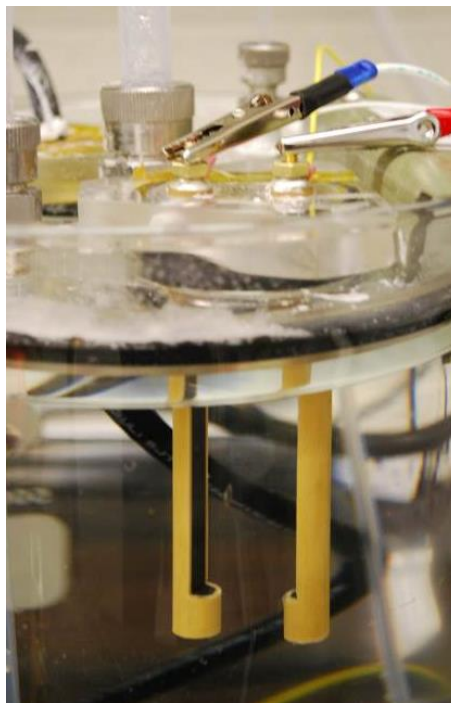
Figure 31: Zero calibration of the galvanic current measurement circuit.

To ensure that the recorded galvanic current really was galvanic current and not background noise, a zero calibration test was performed. Two identical samples of carbon composite (see Figure 31) were connected to the measurement circuit and partially submerged into the electrolyte. The identical samples should give no measurable galvanic corrosion current. The zero test showed zero current. One of the samples was then replaced with an aluminum sample, and a galvanic corrosion current could instantly be measured. The test was repeated with the same results and it was concluded that the measured current was really galvanic current and not electrical noise.

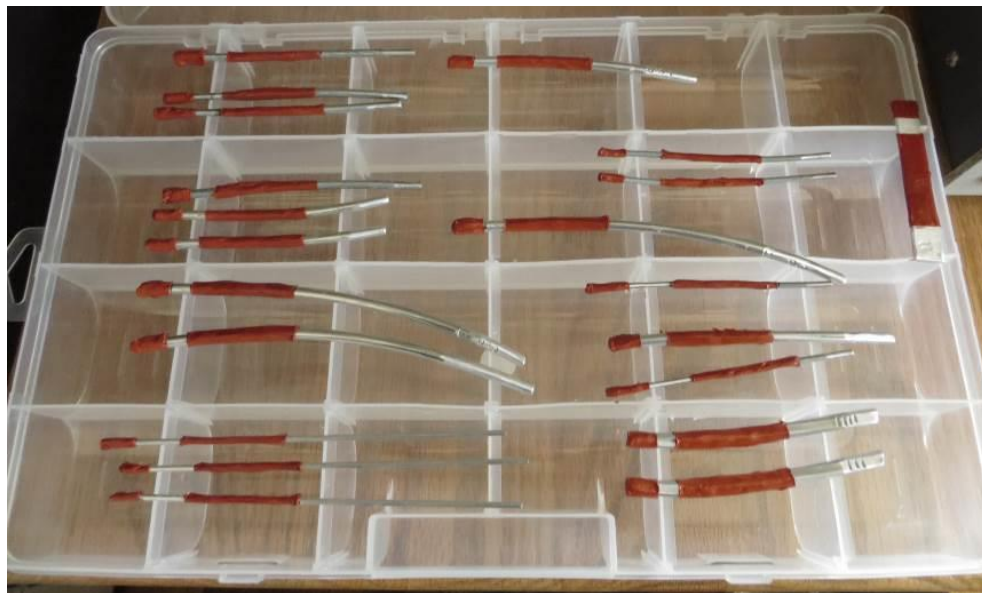
The samples for Test F were masked with RTV (silicone rubber) to give an exposed area of approximately 100 mm^2 for all samples. The only surface preparation was degreasing with alcohol.

1. Samples with an exposed area of approximately 100 mm^2 were prepared from individual conductor strands by masking with RTV (room temperature curing silicone rubber). The only surface treatment was degreasing with isopropyl alcohol, with the expectation samples of the steel core strands from ACSR and ACSS that had the coatings removed to allow measurements of E_{corr} for the steel. (See Figure 34: Samples for Test F. for sample design)

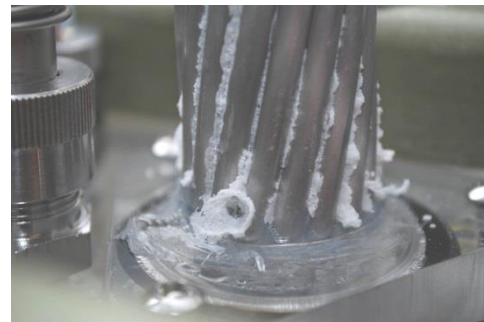
Highly localized corrosion of aluminum strands

The corrosion of the current-carrying aluminum strands was highly localized at the end of the sample and at the liquid surface level. This made it a bit difficult to accurately evaluate the mass loss. This method gave, however, very interesting information regarding corrosion patterns. To eliminate the liquid level effect, Test B was performed with fully submerged samples (see next section).

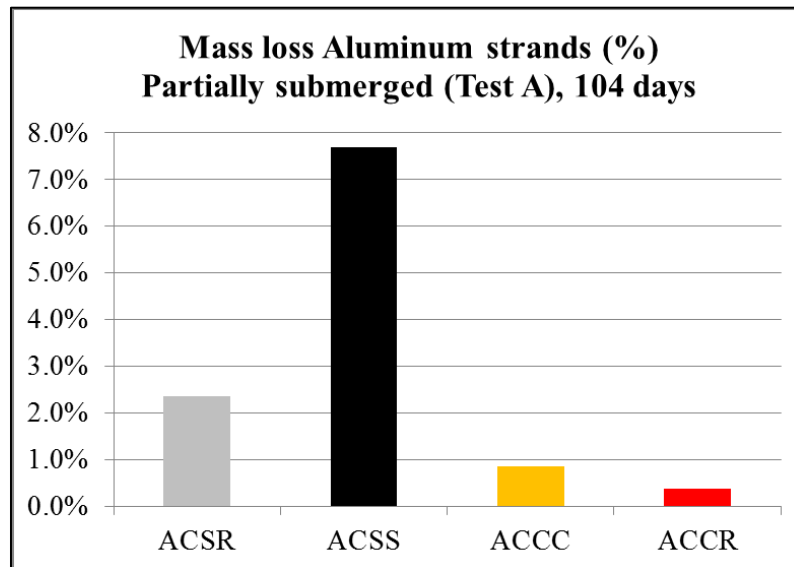
Figure 36: Mass loss aluminum strands (Test A).

ACCR exhibited significantly less mass loss (0.38%) than any of the other three conductors.

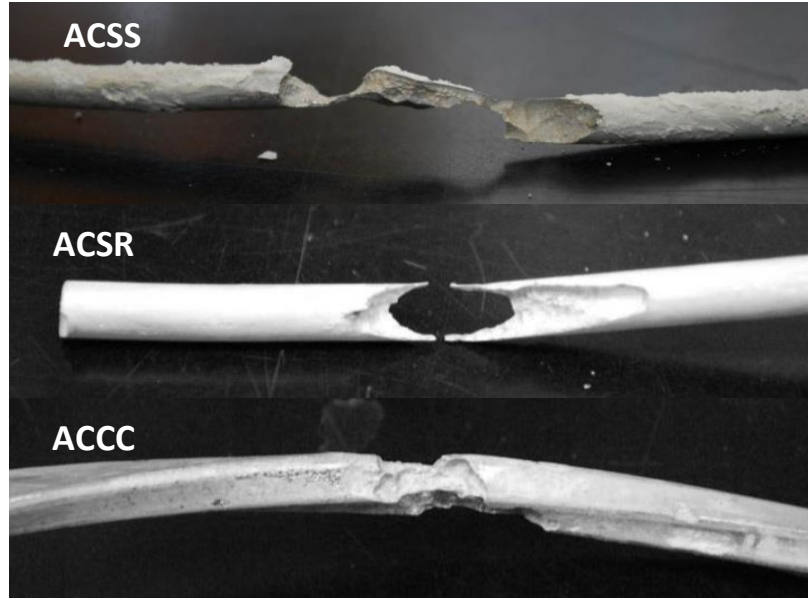
Figure 37: Localized corrosion on ACSS, ACSR and ACCC.
(Picture of ACSS taken before cleaning, ACSR and ACCC taken after cleaning).

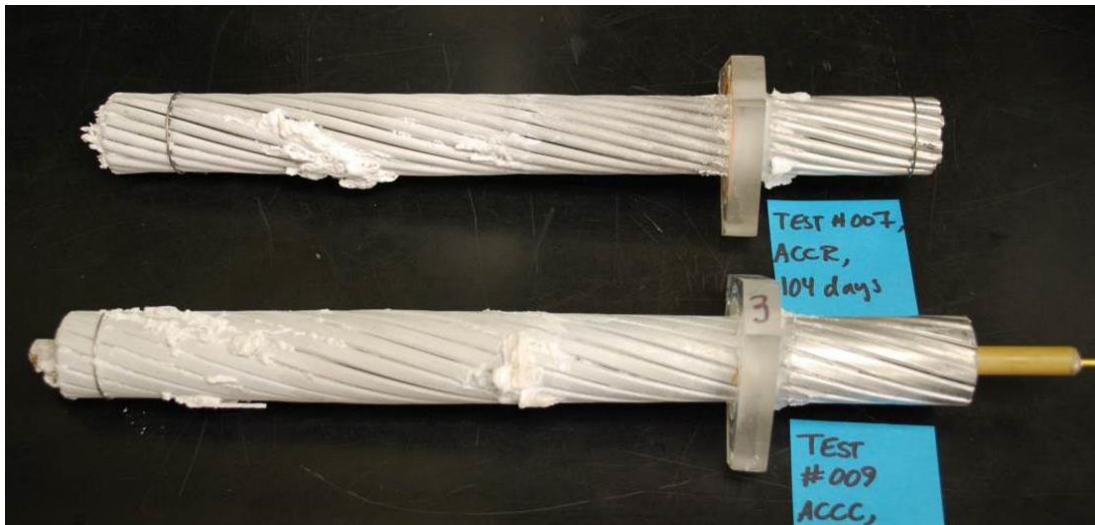
Figure 38: ACCR and ACCC after Test A.
ACCR (top) and ACCC (bottom) had very little visual damage before cleaning.

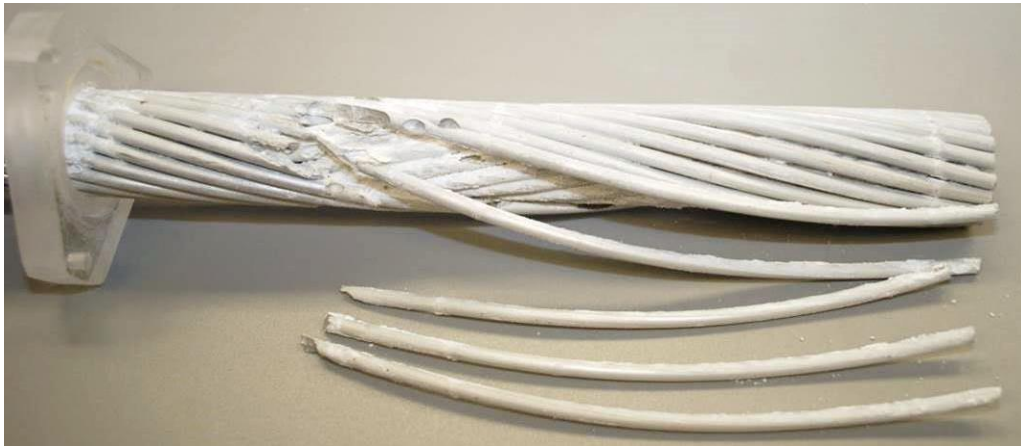
Figure 39: ACSS after Test A.

The corrosion of ACSS was so severe that several strands were completely corroded off. The conductor sample fell apart when the stainless steel wire holding it together was removed.

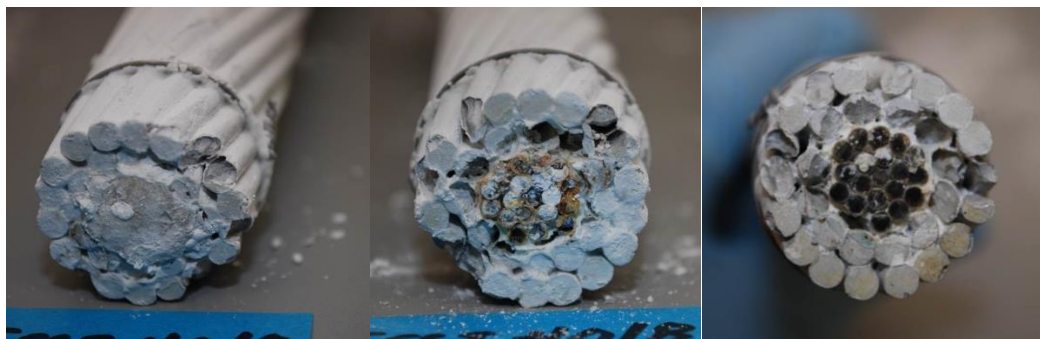
Figure 40: Localized corrosion at the end of the ACSS sample.

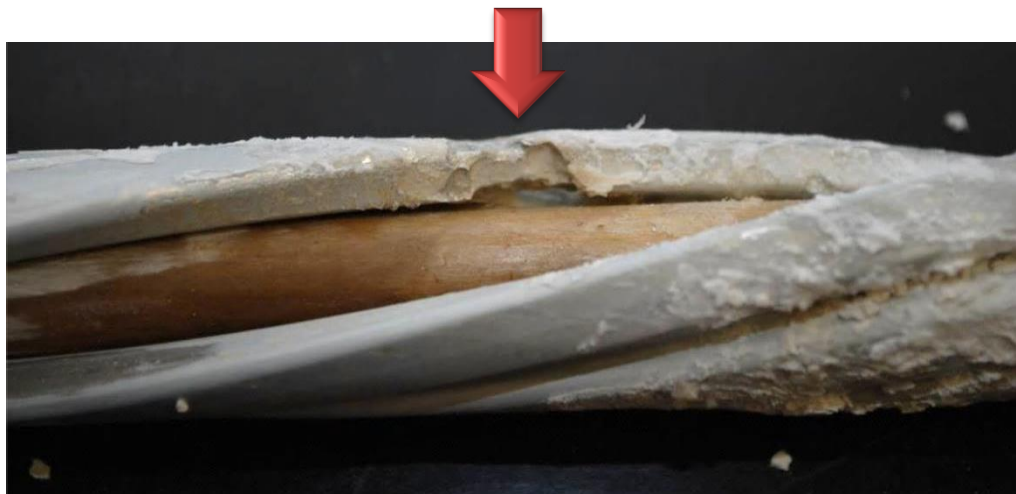
Figure 43: The core in the ACCC before removal.

Note that there is barely any noticeable damage to the polymer composite core next to the large corrosion pit.

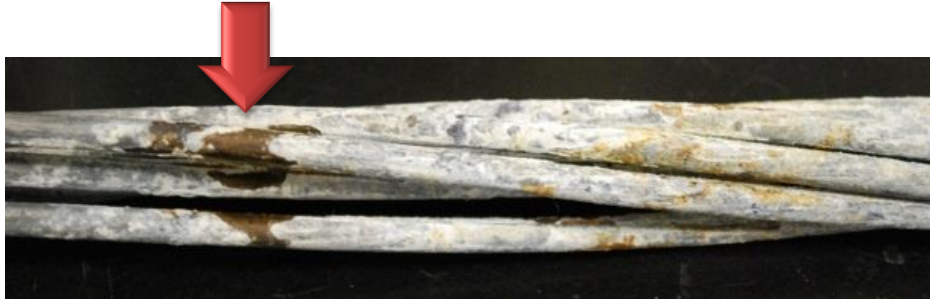
Figure 44: The loading bearing steel core in ACSR after being partially submerged in 85^oC, 3 wt. % seasalt for 104 days. The red arrow shows spots where the galvanization is lost.

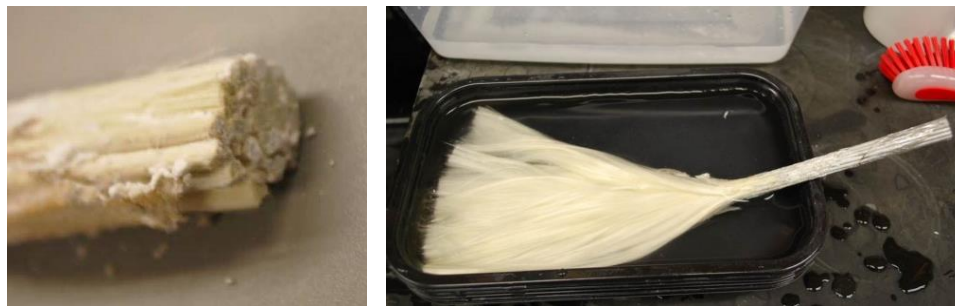
Figure 47: Damage to the ACCR core.

The yellowish appearance of the core (left) indicated that there were an abundance of disengaged aluminum oxide fibers, but the extent of the damage was not revealed until the sample was washed to remove the corrosion products (right).

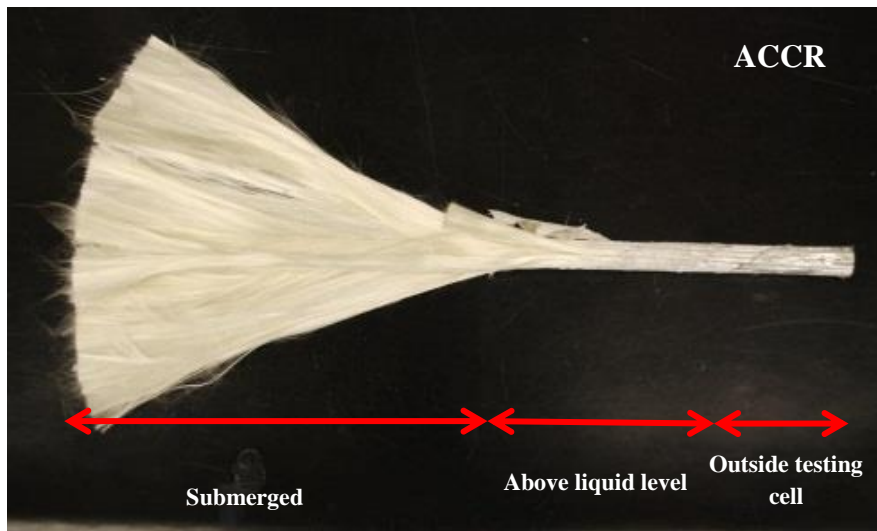
Figure 48: The metal matrix composite core of the ACCR after Test A (104 days in 85°C, 3 wt. % seasalt aqueous solution). Only the aluminum oxide fiber are left in the submerged section.

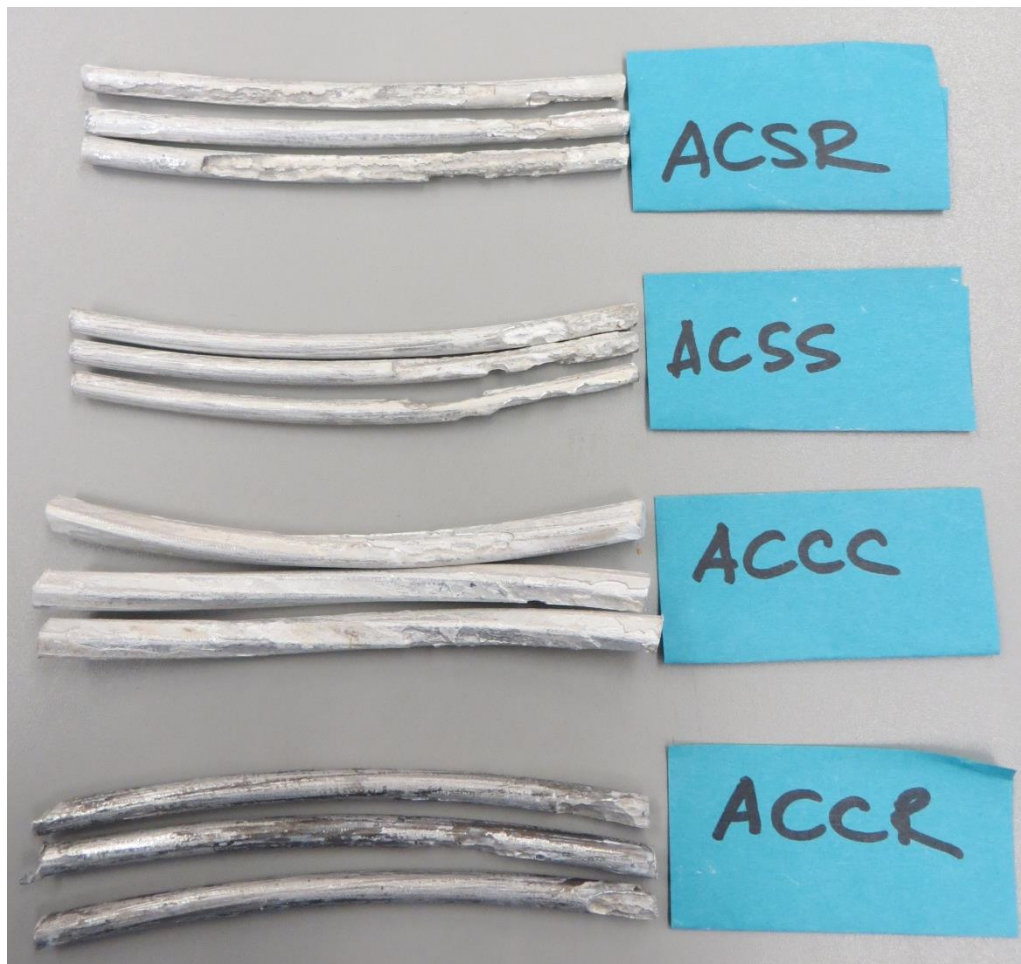
Figure 50: More uniform corrosion of aluminum strands in Test B. The three most corroded strands from each sample. No strand was fully corroded off.

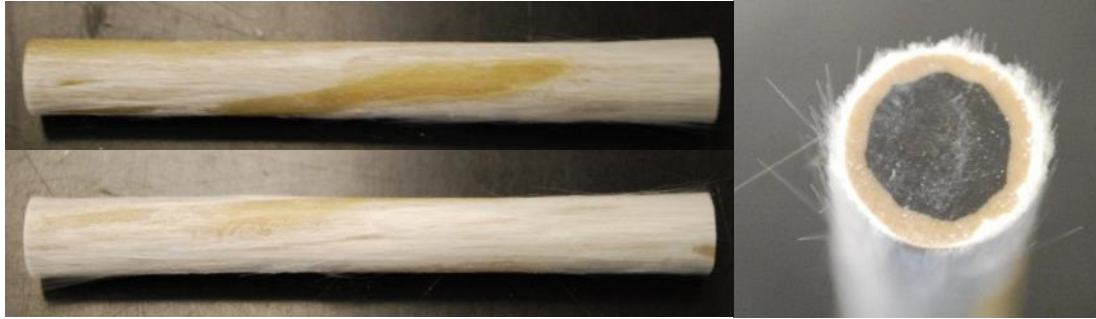
Figure 55: Three views of the same ACCC sample (Test B).
The minor surface damage is similar to that seen in Test A.

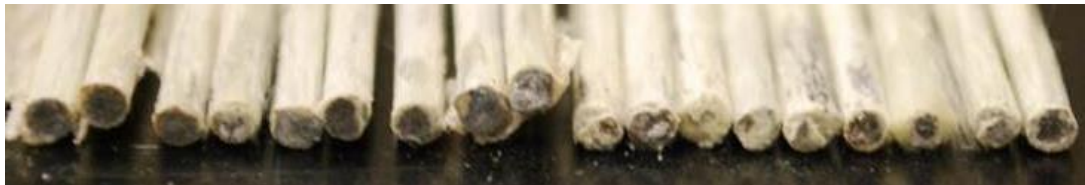
Figure 57: End view of the ACCR core strands (Test B).

The loss of matrix was calculated by cutting all the strands exactly in half. One set of the half strands was kept in the condition as above for reference. The other set of halves were cleaned with a plastic brush to remove all disengaged fibers and corrosion products. The matrix loss was calculated from the mass of the remaining composite compared to the original mass.

material was lost in 62 days (see figure 57). At the same time, the mass loss of the current carrying Al-Zr strands was only 0.38 % and 1.4 % respectively (see Figures 36 and 49).

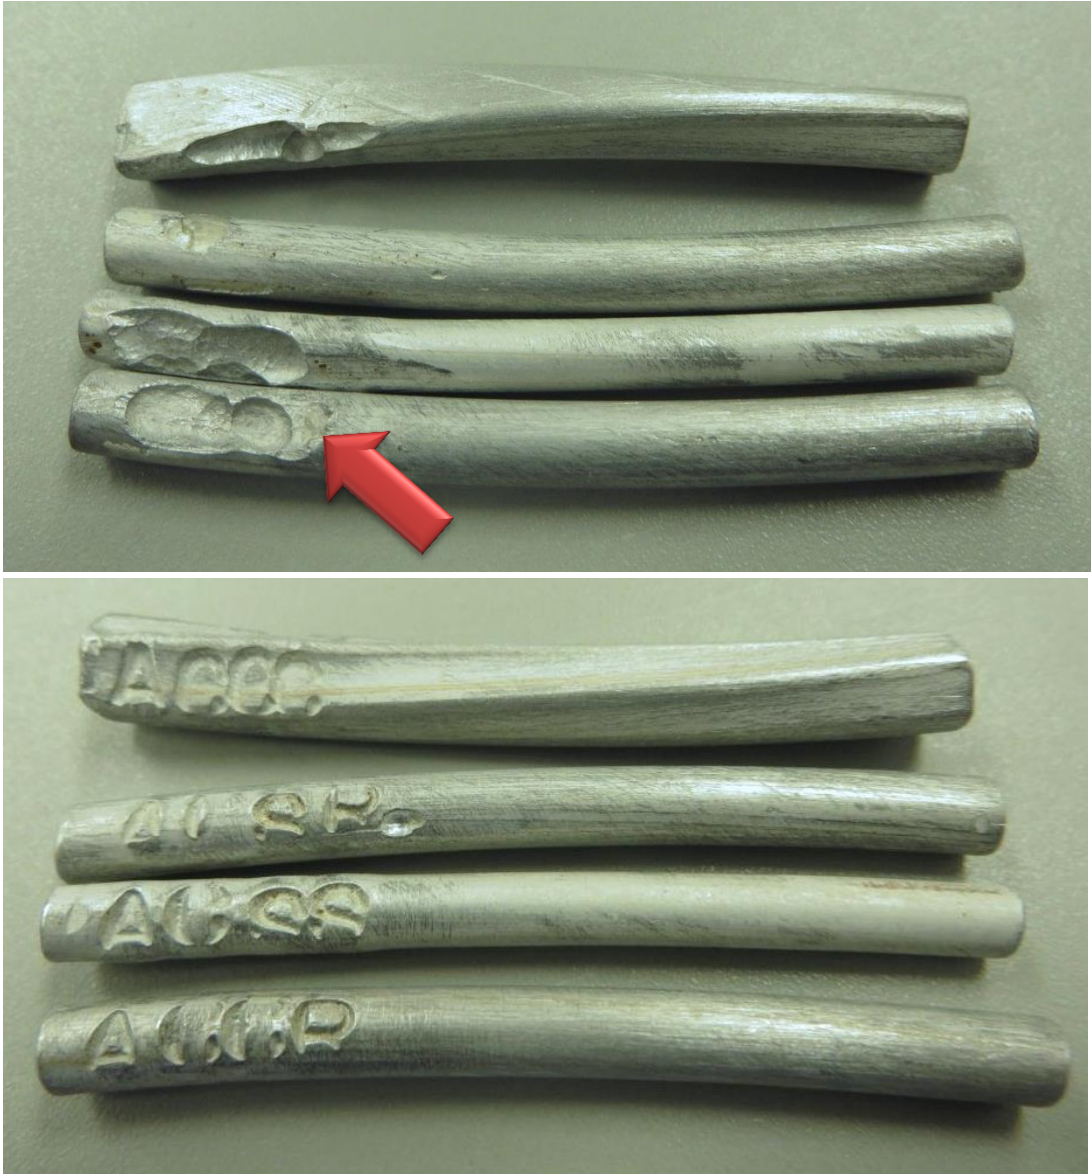
Figure 59: Samples after Test C.

Note the large corrosion pits to the left in the top picture. These were all created under the sample holder.

The result from Test C has large uncertainty due the development of large corrosion pits under the holder for all four aluminum strands (see Figure 59). The chemical composition of the aluminum strands from ACSR, ACSS and ACCC is identical (1350 alloy). The strands from ACSS and ACCC also have the same heat treatment (fully annealed). Similar corrosion performance would therefore be expected. The large spread in mass loss from 1.57 % for ACCC to 4.71 % for ACSS should therefore be interpreted with caution.

The ACCR core strand did not develop large corrosion pits under the holder.

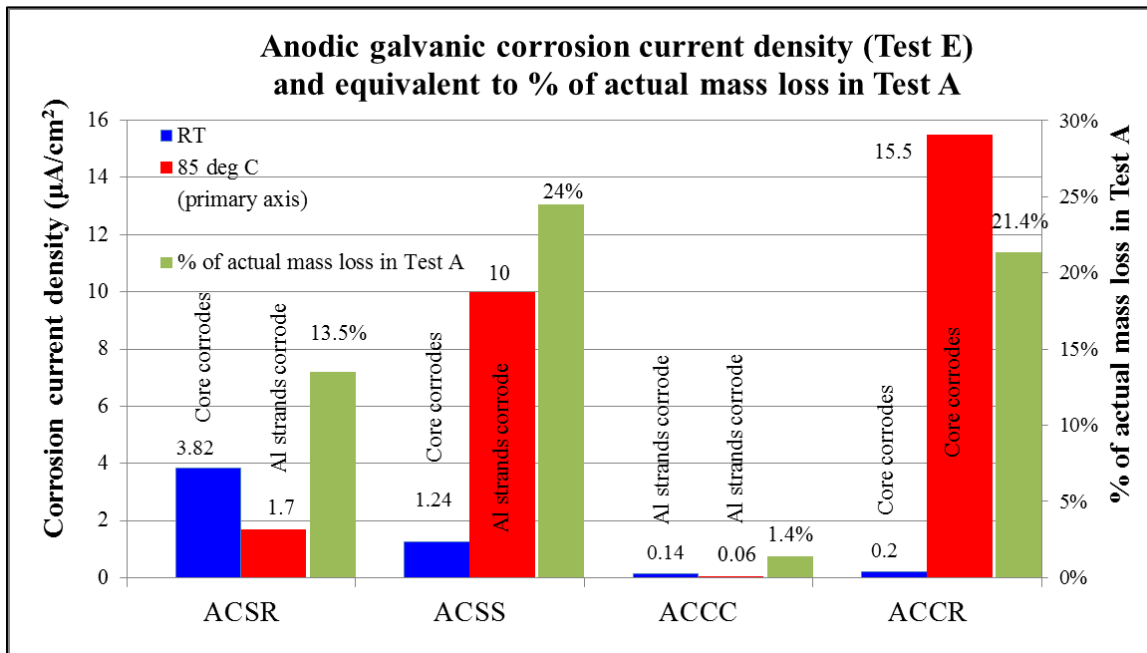
Figure 62: Anodic galvanic corrosion current density (Test E) and equivalent to % of actual mass loss in Test A

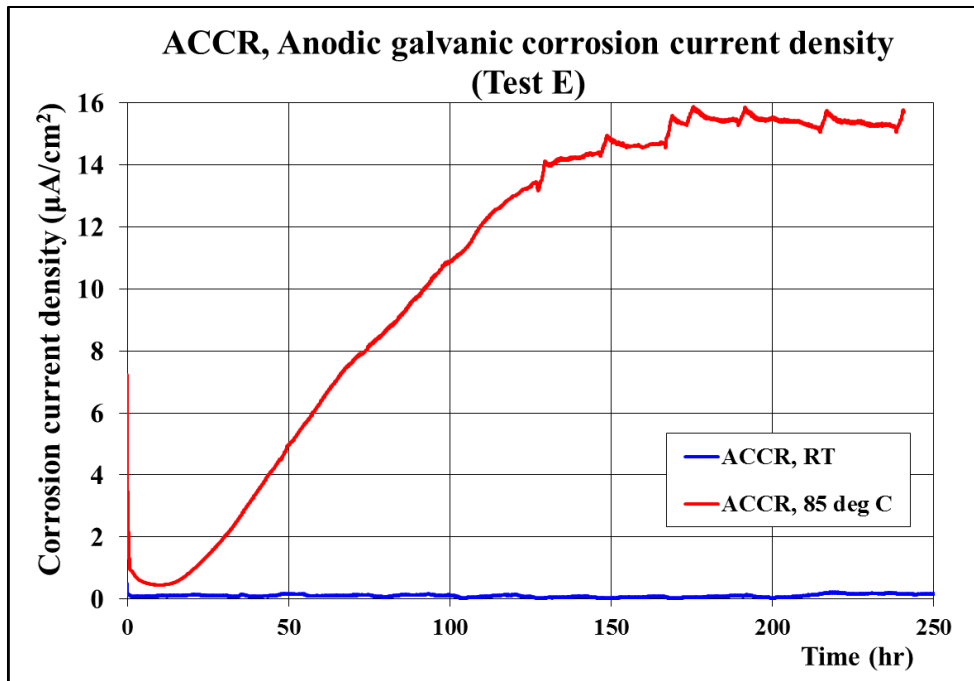
Figure 64: Galvanic corrosion current density for ACCR.
This plot is discussed extensively in chapter four.

Figure 64 (repeated). The sharp peaks are caused by refilling of water in the testing cell.
