GALVANIC CORROSION OF HIGH-TEMPERATURE LOW-SAG (HTLS) HIGH
VOLTAGE CONDUCTORS: NEW MATERIALS – NEW CHALLENGES

A Thesis

Eva Håkansson

June 2013

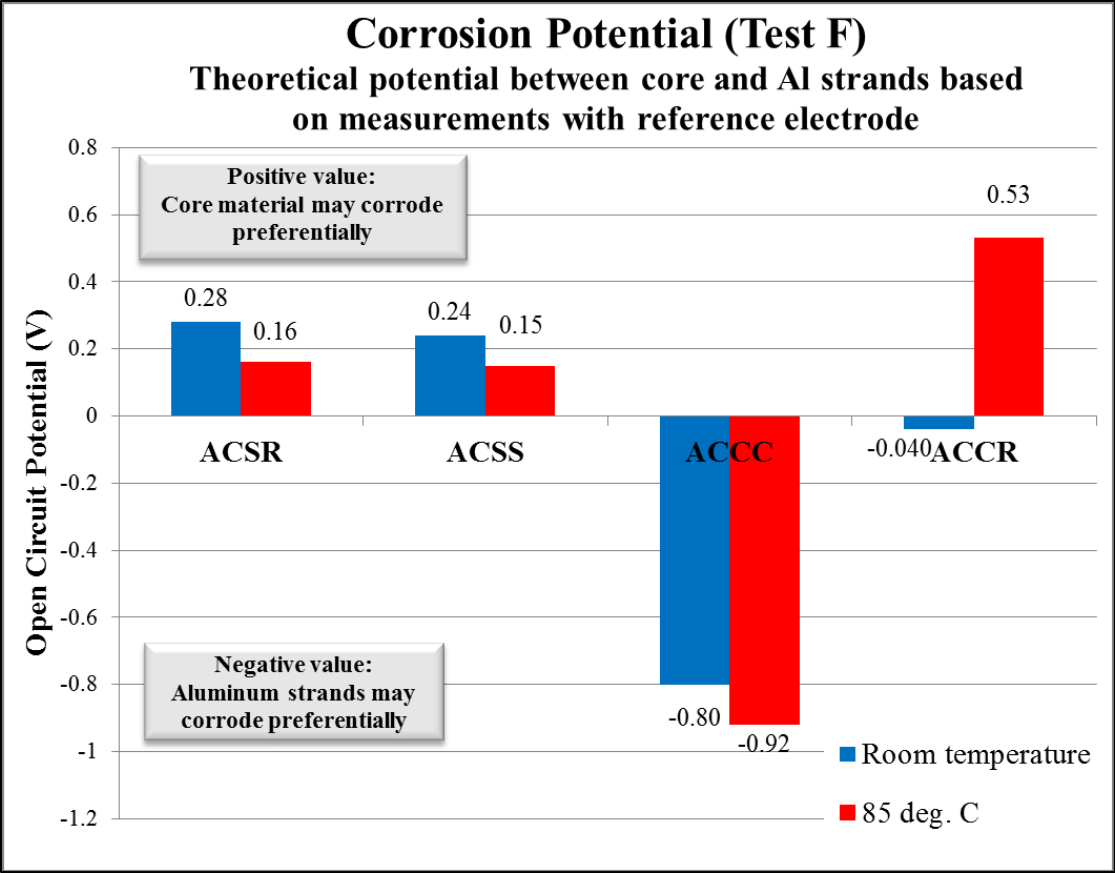
Figure 65: Theoretical open circuit potential in the conductor based on the measurements of the individual components. Note that the polarity is flipped compared to Table 18 to make the numbers comparable to the results from Test D.

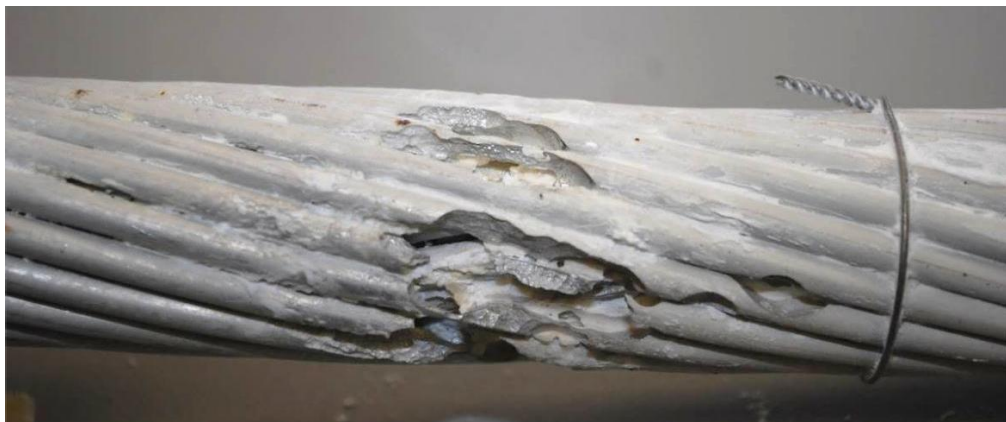
Figure 66: Severe localized corrosion on the ACSS sample after Test A.

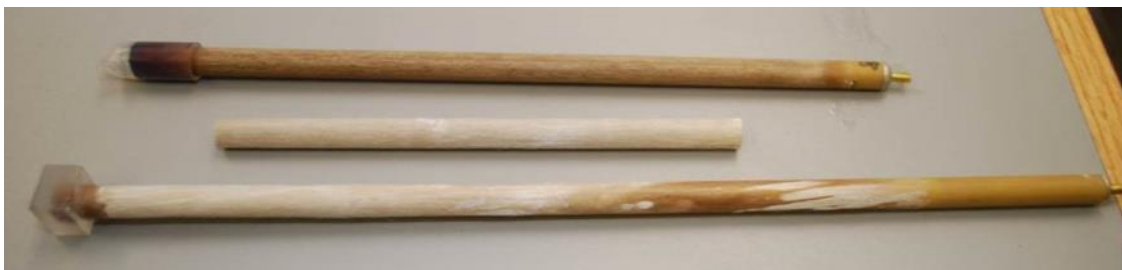
Figure 67: Three samples of ACCC core exposed to 85°C for approx. 100 days.
Top: Sample exposed to same electrolyte as used in this study, but without presence of aluminum hydroxide. Middle: sample placed in the “slurry” of aluminum hydroxide at the bottom of the testing cell during Test A. Bottom: Sample from Test A.

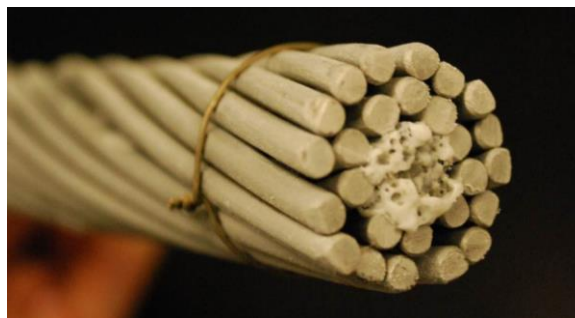
Figure 68: Build-up of corrosion products at the end of the ACCR core. Picture taken on day 7 of 104 in Test A.

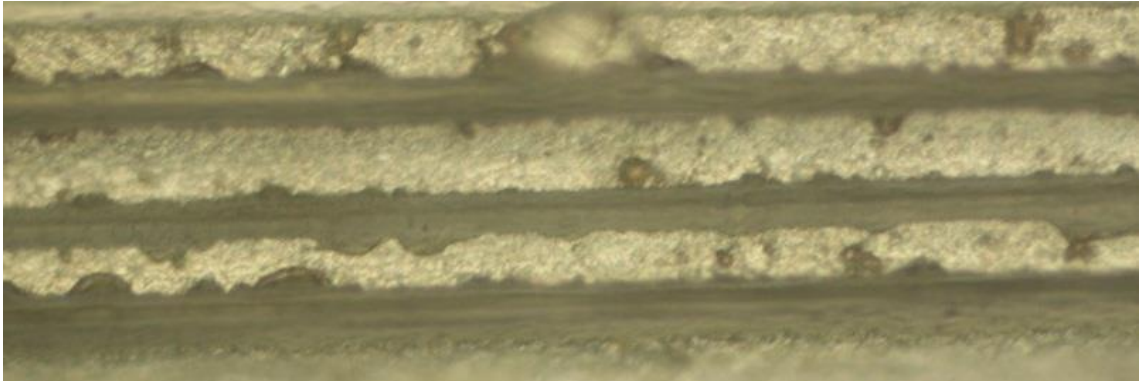
Figure 69: Initiation of corrosion pits along the fiber-matrix interface in the ACCR composite core. The light fields are the aluminum matrix, the dark stripes are the fibers. Optical microscopy, 500x magnification

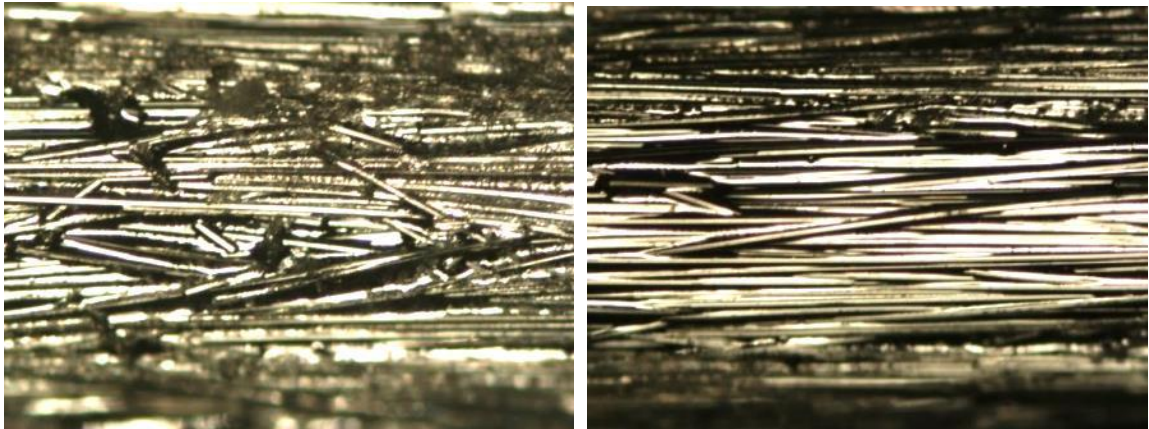
Figure 70: The surface of un-corroded ACCR. Optical microscopy, 100x magnification
