RECORDING EARTHEN ARCHITECTURE AT THE PERUVIAN ANDES: THE CASE OF KUÑO TAMBO CHURCH'S HISTORIC WALL PAINTINGS

CIPA Heritage Documentation

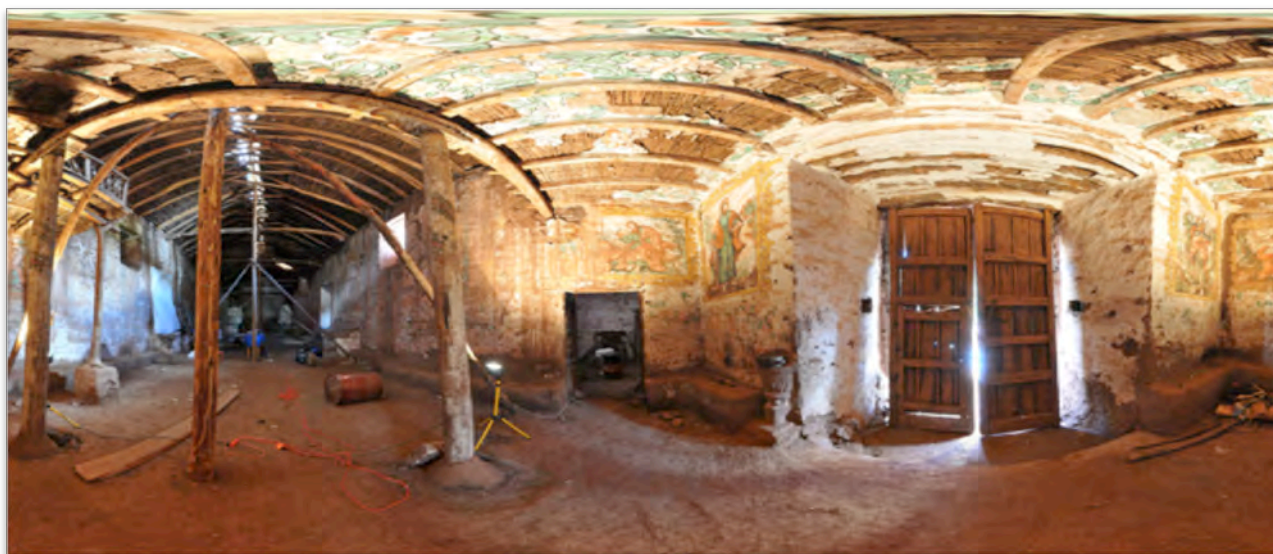
Figure 1. Panoramic spherical image of the interior of Kuño Tambo church, Peru

A set of several full spherical panoramic photographs were prepared from specified locations throughout interior and exterior of the church as reference to the photogrammetric processing and preparation of ortho-photographs for referential purposes (Figure 1).

Using the software PTGui, the resulting panoramas were prepared by stitching 8 overlapping images for a complete coverage of 360 degrees of the captured scene (6 horizontal and two bottom and top views). The images were taken using a Nikon D300 DSLR camera (12.3 megapixel DX format CMOS sensor) equipped with a fisheye Nikkor lens of 10.5 mm that covers a Field of View of around 180° diagonal. To prevent major effect of parallax a Nodal Ninja 3 panoramic adapter was used.

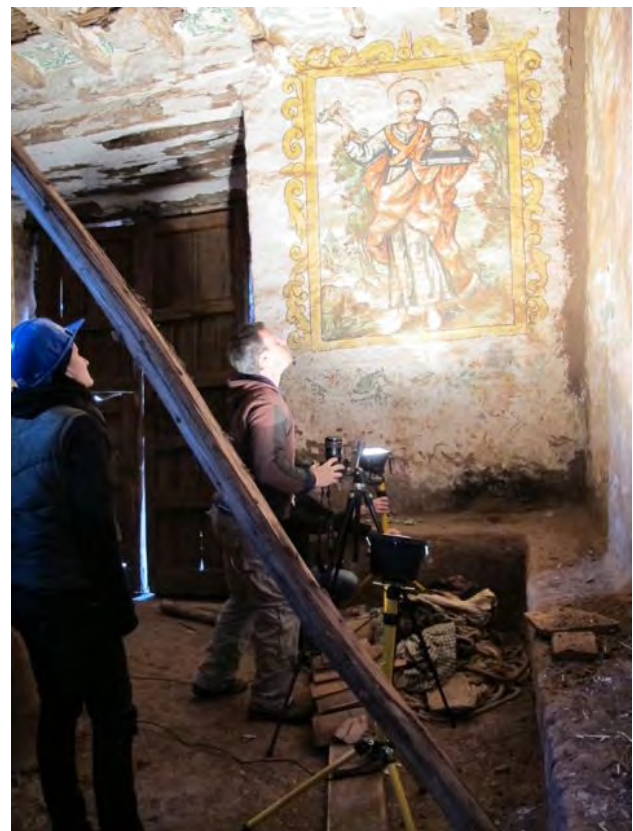
Figure 2. taking photograph using artificial lighting.

During the recording process three stages of work were conducted: given the poor illumination conditions inside the church, the first stage of documentation involved experimenting with the use of artificial lighting for capturing photographs aimed at generating smooth photogrammetric processing and an accurate digital model (Figure 2).

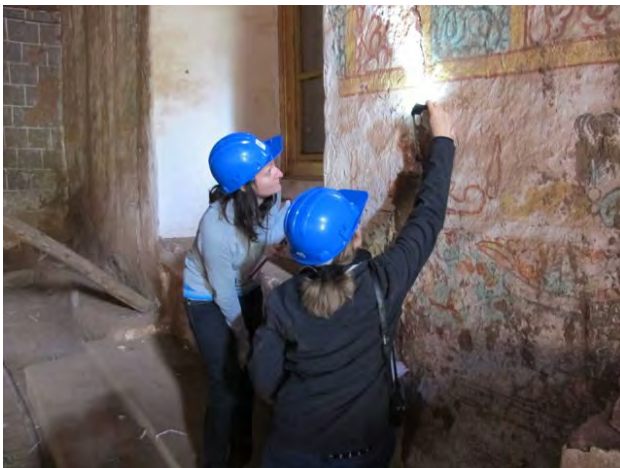
Figure 3. Identification of conditions using visual inspection

During the fieldwork, condition record photography was taken from selected areas identified by wall painting specialist (Figure 3). These photographs were used for the preparation of a weathering atlas of decay patterns present on the wall painting surfaces, such as cracks, spalling, detachment, etc.

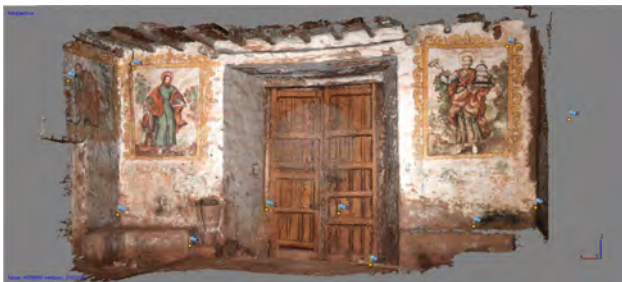
Figure 5. Final photogrammetric model of the east entrance with scaled survey points picked (blue flags) and texture applied

Once each section of the church was modelled using the photographs in Photoscan, the resulting mesh was cleaned up in Geomagic. Geomagic is a software owned by 3DSystems (Geomagic). We used the Studio version of the software which contains many useful mesh altering tools including: hole fixing, mesh slicing and edge repairs. Any gaps or holes in the mesh were filled or corrected to ensure that the texture had a complete surface on which to project (Figure 5).

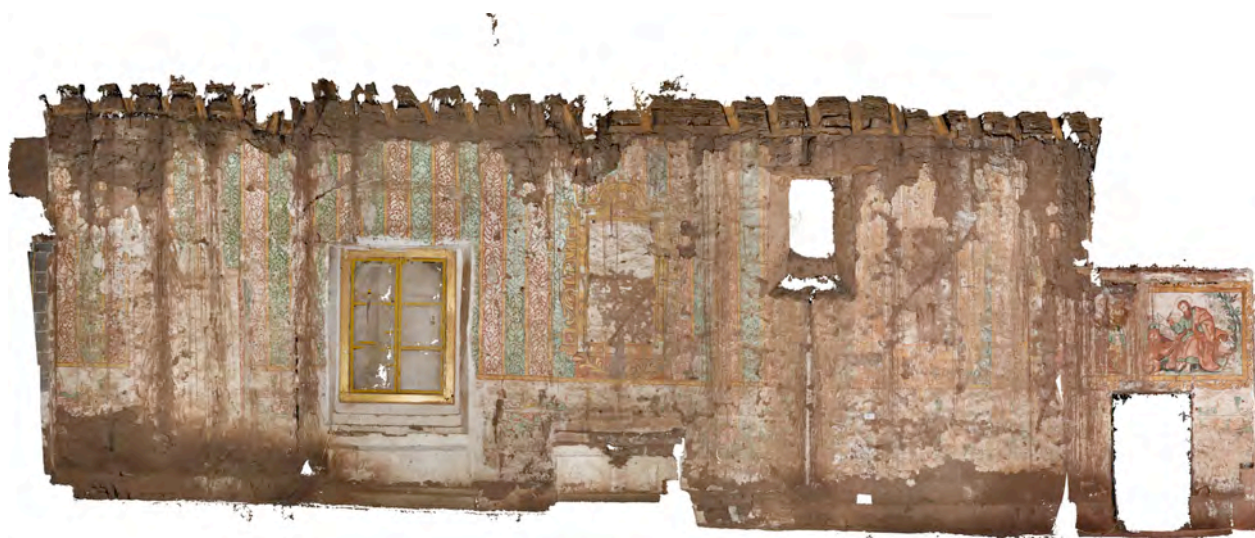
Figure 6. South façade, orthographic elevation of frescos generated from a photogrammetric model

The final ortho-image (Figure 6) can then be printed from a standard sheet in AutoCAD with the glossary and a titleblock containing relevant project information.
