Cox, A., Herbert, S., Villain-Chastre, J.-P. et al. (2 more authors) (2019) The effect of machining and induced surface deformation on the fatigue performance of a high strength metastable  $\beta$  titanium alloy. *International Journal of Fatigue*, 124. pp. 26-33. ISSN 0142-1123

The effect of machining and induced surface deformation on the fatigue performance of a high strength metastable  $\beta$  titanium alloy

# The effect of machining and induced surface deformation on the fatigue performance of a high strength metastable $\beta$ titanium alloy

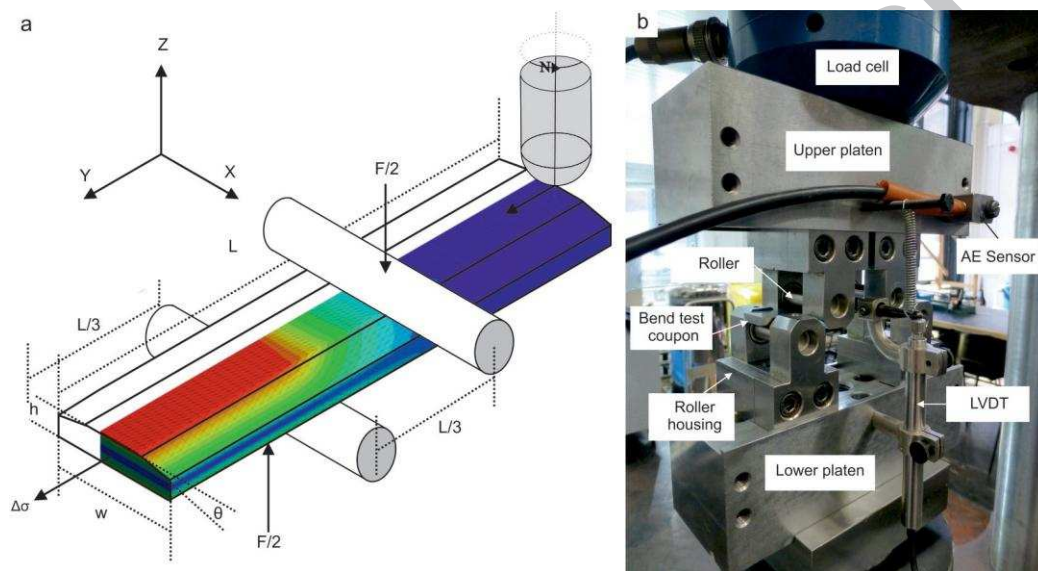
Figure 2: (a.) A cross-sectional schematic representation of the four point bend fatigue test assembly, coupon geometry and superimposed FEA stress distribution with respect to milling and microstructural directions and (b.) an annotated photograph of the four point bend fatigue test rig assembly at the University of Sheffield.

Fatigue tests were conducted at room temperature in air using a Nene 12 kN servo-hydraulic testing machine operated via a Moog SmarTEST One controller. All tests were conducted to failure within the low cycle fatigue (LCF) range under controlled load at high elastic stresses to induce local plasticity under a sinusoidal application at a frequency of 5 Hz. A stress ratio of  $R=0.1$  with the  $\sigma_{max} = 1050$  MPa was maintained throughout the fatigue test. A custom four point bend fatigue test design was applied for this study, as shown in Fig.2b, in which the load was distributed through two upper static and two lower dynamic rollers each secured within needle roller bearings set in high strength steel housings and bases. This test allowed for a large region of maximum applied tensile stress on the upper face as illustrated

by the stress contour map exported for Ansys FE analysis (Fig. 2a). Fatigue coupons were extracted from the source material via wire-EDM along the Y direction with respect to Fig.1a. The low cycle fatigue regimen employed in this study is comparable with regards to stress application and stress ratio to that found in industrial applications. Due to the none conventional nature of this testing design it was important to maintain comparable parameters throughout the study. Due to the none conventional nature of this fatigue testing design, the loading regime employed is based upon those used in industry for material and component characterisation. Due to the costly nature of the coupon fabrication and fatigue testing, a small number of machining conditions were investigated. Those chosen were based on the achievable processing window within industrial machining centres. Machining was performed on a Starrag STC 1250 5 axis machining centre producing coupons to the required geometry of 3.6, 19 and 120 mm in height (h), width (w) and length (2L) respectively Fig.2a . The chamfer angle ( $\theta$ ) of 100-produces an upper face of 10 mm in width. This upper face, milled with machining conditions used by Safran Landing Systems using Kennametal solid carbide 6 flute ball nose end milling tools. A high lead angle ( $\Psi_r$ ) was used in order to engage the maximum effective cutting diameter ( $\Phi_{eff}$ ) and thus optimum MRR and tool life. Hocut 795B coolant was delivered via flood and through tool holder supply at 100 bar and 70 l/min throughout milling. In order to study the effect of increased MRR, two machining conditions were used at cutting speeds ( $V_c$ ) and feed per tooth ( $f_z$ ), as described in Table 1. Prior to the fatigue testing a substantial array of machining conditions were investigated with regards to the impact on machinability and tool wear [34]. A limited number of parameters were used in this study and represent those offering a substantial step change with regards to material removal rate from those typically employed in industry for this application. To replicate finish machining practises constant radial and axial depths of cut were maintained.
