Hoopng as an Ancient Remedy for Conservation of Large Masonry Domes / Ottoni, Federica; Blasi, Carlo. - In: INTERNATIONAL JOURNAL OF ARCHITECTURAL HERITAGE. - ISSN 1558-3058. - 10(2016), pp. 164-181. [10.1080/15583058.2015.1113335]

Hooping as an Ancient Remedy for Conservation of Large Masonry Domes

Federica Ottoni and Carlo Blasi

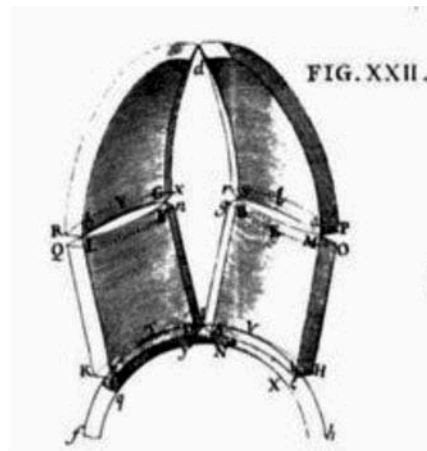
Figure 1. The horizontal thrust of the dome: its “trap” (Poleni 1748). © [rightsholder]. Reproduced by permission of [rightsholder]. Permission to reuse must be obtained from the rightsholder.

Over time, vertical fractures have appeared in nearly all the masonry domes, highlighting their fundamental mechanical principle (the "arch") as well as their typical mechanism of instability (Figure 1), their "trap": The droop of the top of the structure under its own weight and the horizontal thrust at its base. The fractures can vary for amplitude and position; regardless, the "trap" is created and the dome has been transformed from a compact and solid body to a sequence of arches with variable sections, mutually contrasting through the compressed parallels.

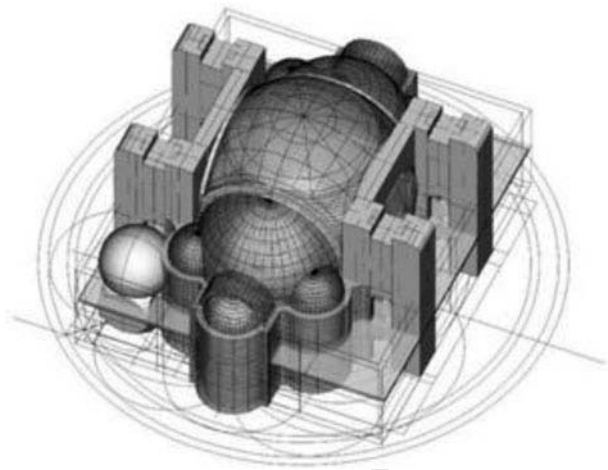
Figure 3. The perfect geometry of Hagia Sophia and its different systems of thrust restraint: The two semi-domes in longitudinal direction, and the two great pillars in the transversal one (Blasi and Bianchini 2001). © [rightsholder]. Reproduced by permission of [rightsholder]. Permission to reuse must be obtained from the rightsholder.

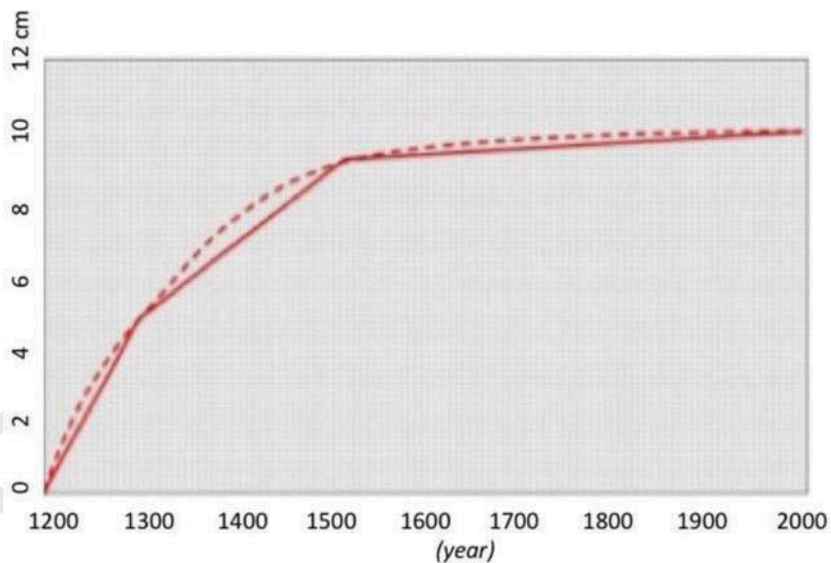
Figure 7. Graph of the hypothesized evolution of the main cracks on sides 1, 3, 5 of the dome, starting from its construction (at the end of XII century): The increasing trend has clearly decreased after the insertion of the two hoopings systems.

system—which has been found and measured—all around the dome at the level of the second cornice³ (Figure 6). This hooping system proved to be a decisive and non-invasive restoration for the Florentine Baptistery since the structural disorders have substantially stopped or at least were reduced to very small cracks after this intervention, thus demonstrating its efficacy on the stability of the dome (Figure 7).

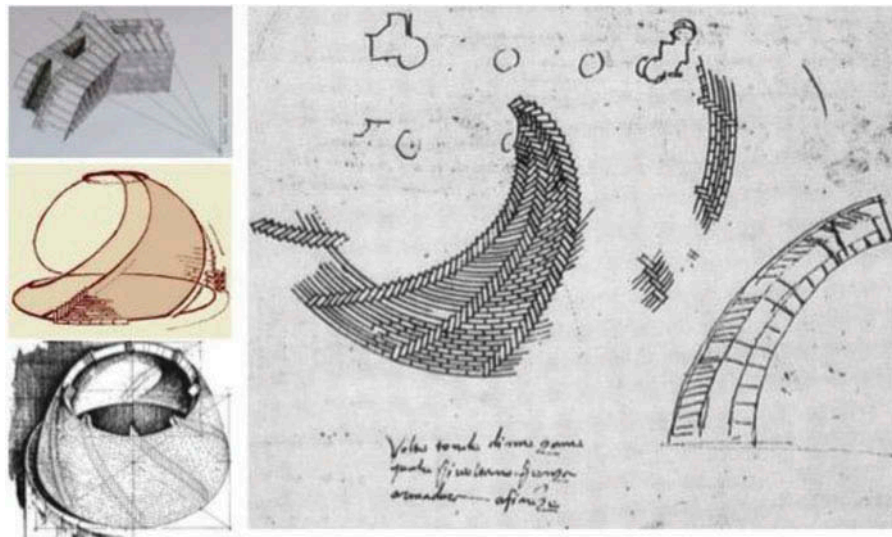
Figure 8. On the right, the Drawing of a “spinapesce” dome (XVI century) by Antonio da Sangallo il Vecchio; on the same “trick” applied by Brunelleschi in Santa Maria del Fiore dome: courses of bricks interrupted at regular intervals (about 1.20 m) from vertical bricks, radially oriented, with the function not only of containing the courses of bricks and of building the dome without centinas, but also of creating a dome of radial propellers in the thickness of the walls. The spirals actually follow, with the normal to the joints of mortar, the isostatic lines inside the shell (which are always tangent to the principal directions of stresses).

225 are well known. Despite some irregularities (Giorgi and
Matracchi 2008), they have assured masonry resistance
and homogeneity for centuries, transforming the octa-
gonal dome into a rotational one (Blasi and Ottoni
2012) (Figure 8).

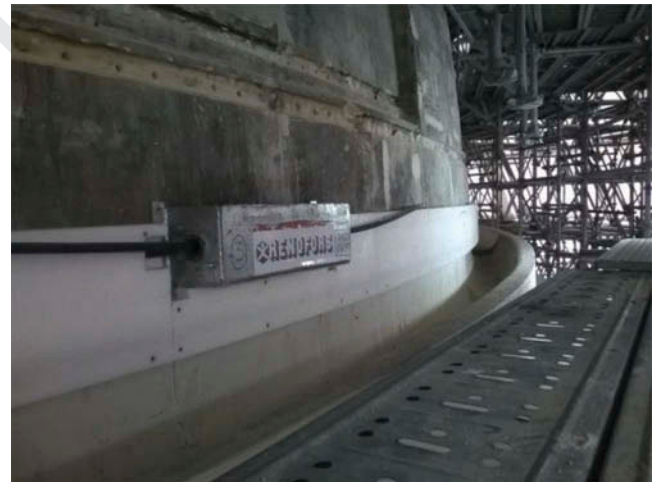
Figure 16. The new iron hoopings, realized by two pre-tensioned high resistance cables, recently added around the French Pantheon dome.

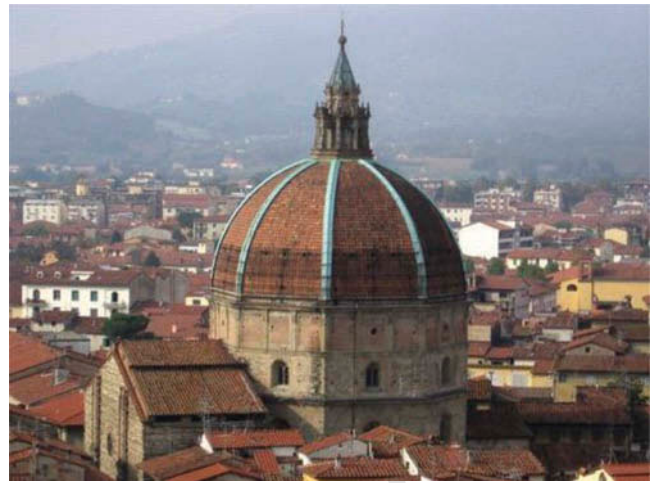
Figure 17. The dome of Madonna dell’Umiltà in Pistoia and its outer iron chains, clearly visible.

fact, this masonry structure was so weak that, in differ-
 ent periods and with different techniques, several hoop-
 ing systems have been inserted on it (Figure 17).

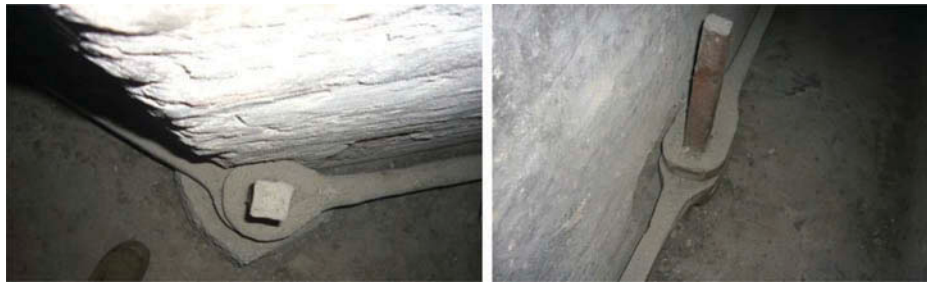
Figure 22. Pictures of the first iron chains inserted by Vasari, in 1570, in the corridor between the two shells.

Today, eight tie rods are present on this dome, seven of which—with the exception of the first one inserted by Vasari in the corridor between the two shells (Figure 22)—are well visible at the extrados of the outer shell (Figure 23). This fact makes unique the dome of Madonna dell’Umiltà which is actually the only one in which we have ancient tie-rods free to vibrate. 505 510

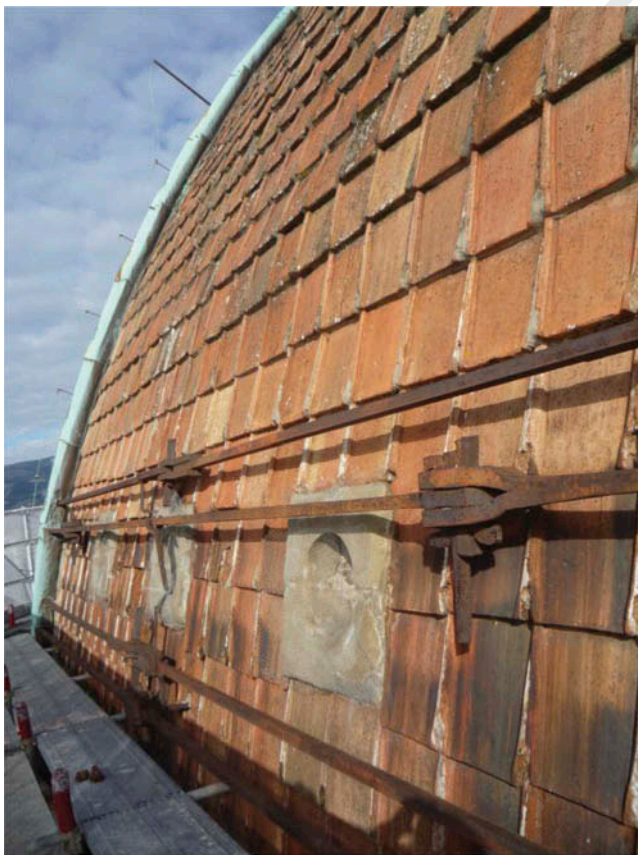
Figure 23. Picture of the iron chains at the extrados of the dome, which are free from rib to rib.

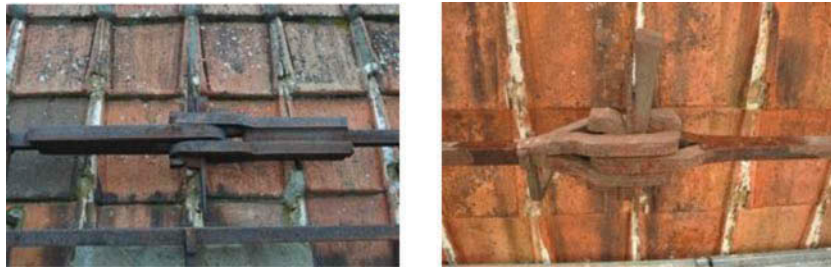
Figure 24. Two different junction systems present on the dome, belonging to the two different period: (a) 1570 and (b) 1620.

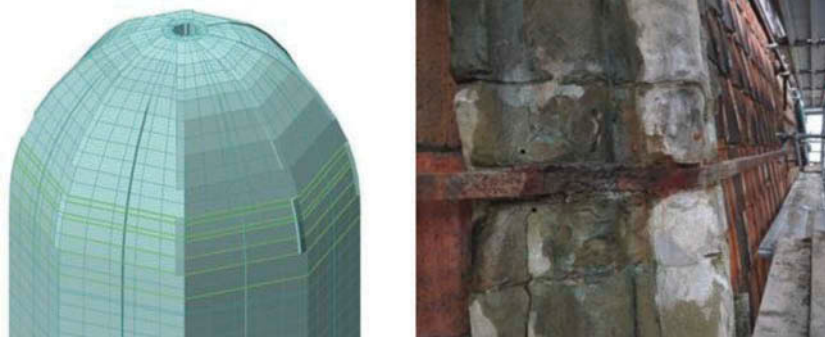
Figure 25. On the left, the linear elastic model: (a) the real nodes at the 8 vertices of the dome.

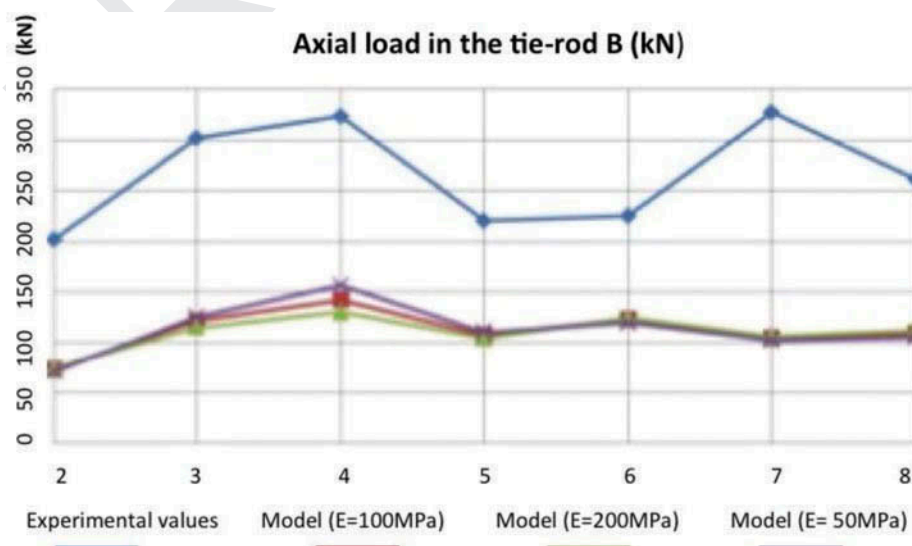
**Figure 26.** Axial load (KN) in tie-rod B: measured (in blue) and calculated (for each step of simulation).

In order to obtain the same values of traction strain measured in the tie-rods with the performed model, the deformability parameter of masonry would have been settled around **500 MPa**, then three times lower than the one proposed by the Italian law. Indeed, the higher
