# Real-time evacuation and Failure mechanism of an oversize soil landslide on 19th July in Yanyuan County, Sichuan Province, China

**Abstract** At around 5:40 am on the 19th July, 2018, an oversize soil landslide (the Boli landslide) occurred on the right bank of Taozi Gully, a branch of Jiami River in Taozi Town, Sichuan Province, China. The landslide destroyed 186 houses and about 300 acres of farmland of Boli Village. Real time evacuation was successfully implemented avoiding the casualties from 65 families (281 people) due to the effective warning. Based on visual interpretation of the multi-temporal remote sensing images, field investigation, analysis of the landslide soils and related model, this study tries to reveal the typical characteristics, the cause and failure mechanism of such an oversize soil landslide. A response mode based on the community warning system has been proposed that is simple, effective and scalable in response to such latent disasters in the mountains from this successful real-time evacuation. And more importantly, we look forward to expanding such successful experiences and effective risk mitigation system in order to improve the disaster prevention

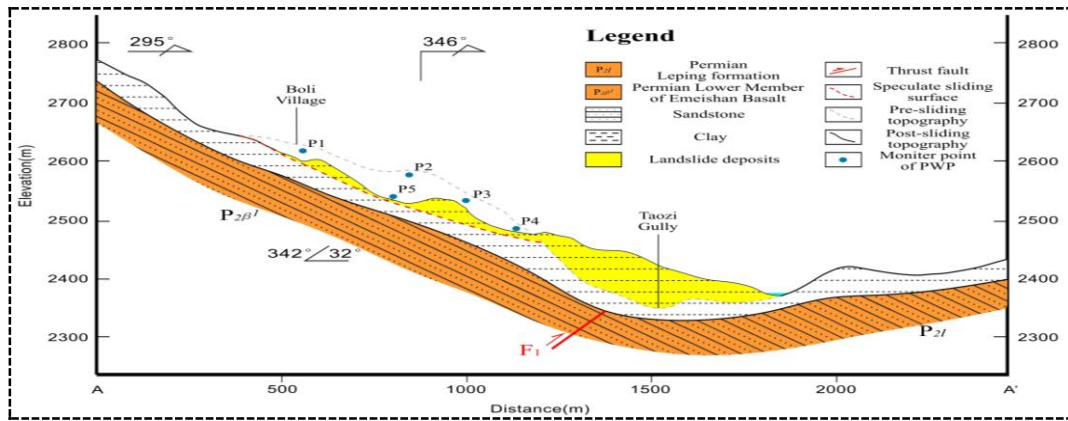
**Fig.4** The geological longitudinal profile of the Boli landslide

edge is partially exposed, and the occurrence is  $342/32^\circ$  as a gentle and consequent slope (Fig.4). The upper plane configuration is also in a tongue shape, with the elevation of 2700 m at the back stage and 2530 m at the front stage, leaving a difference height of 138m (Fig.3 d). The upper part of the landslide is approximately 1200 m long in the north-west direction and 300-400 m wide in the west-east direction. The main sliding direction of the upper part is  $345^\circ$ , with  $33 \times 10^4 \text{m}^2$  in area and  $1,000 \times 10^4 \text{m}^3$  in volume. The slope of the landslide area is between  $25 \sim 30^\circ$ , which is relatively gentle except the escarpment.

one is located at the junction of the upper and lower soil layers (Fig. 4). The simulation results are shown in Figure 9 below.

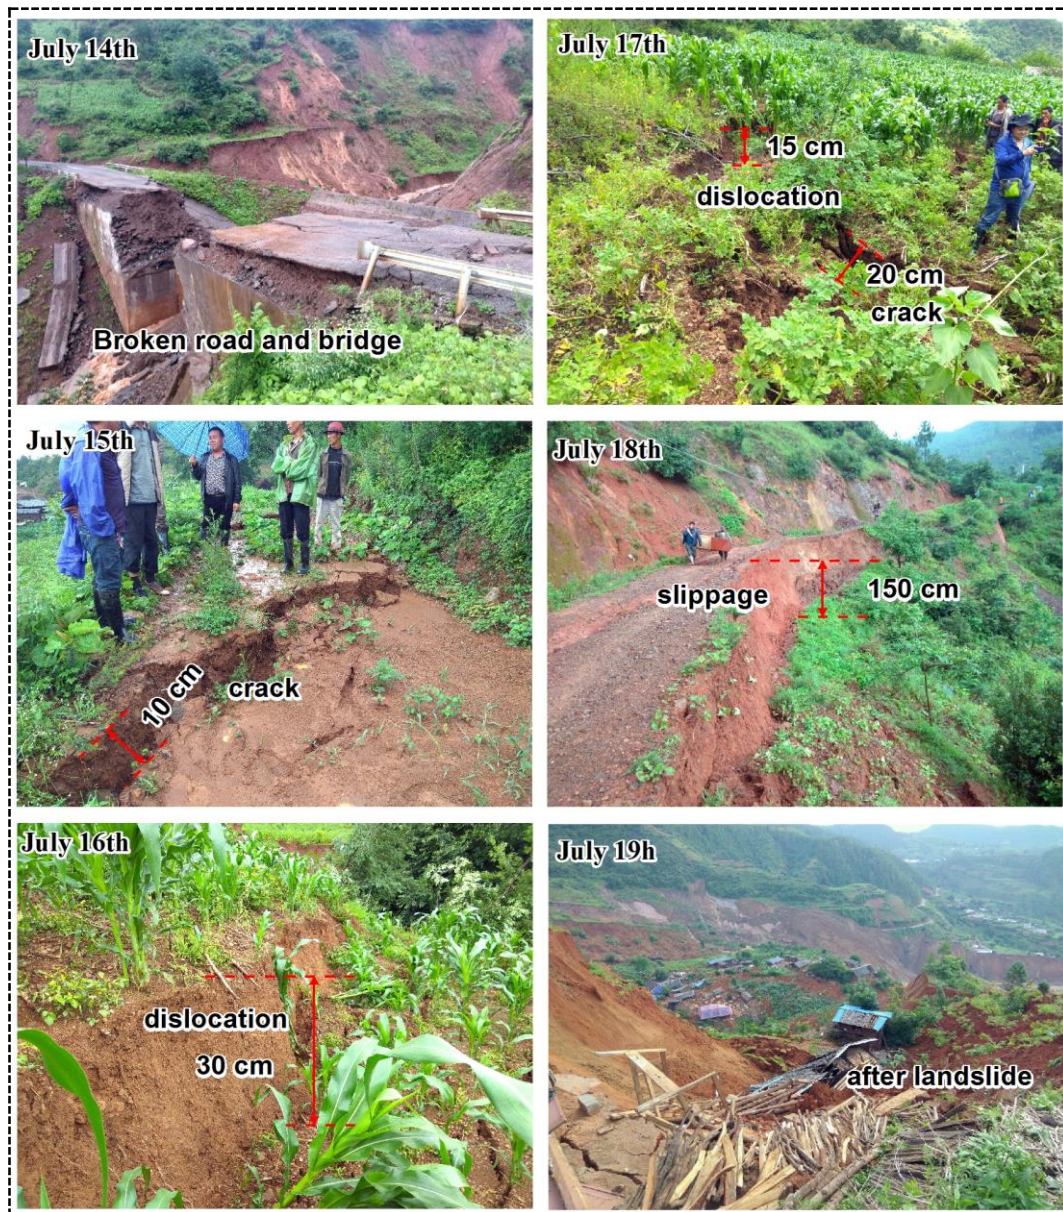
Fig.5 Deformation characteristics of the Boli landslide from July 14th to 19th

The Boli landslide is formed in two stages of creep deformation and sliding under the excitation of precipitation. The creep deformation stage occurred from July 14th to 18th (Fig.5). On the 14th, the road and bridge were broken and damaged in Boli Village. On the 15th, some cracks occurred in the front of the landslide, with the crack width ranging from 5 to 10 cm. On the 16th, obvious dislocation occurred in the middle and front of the landslide, and the maximum height difference of dislocation is 30 cm. On the 17th, dislocation and crack occurred in the trailing edge of the landslide, the maximum height difference of dislocation is about 15 cm, and the maximum width of crack is 20 cm. On the 18th, a large area of slippage occurred in the trailing edge of the landslide with the maximum height difference of 150 cm, and the channel water in the middle part of the slope appeared to be interrupted, with groundwater overflow occurring in the front part of the sloping body. Under the action of antecedent-precipitation and runoff yield under excess infiltration, landslides occurred at around 5:40 am on the 19th and formed a disaster (Fig.5). The sliding phase lasted for about tens of seconds. After the landslide occurred, the slip mass was deposited in the Taozi Gully with a length of about 1000 m. The rear part of the piled body formed a dammed water body with a length of 200 m, a width of 70 m and a volume of about 30,000 m<sup>3</sup>. The average gradient of the dammed ditch was 115%. At present, the water body has flowed over the dammed embankment, forming a closure gap.
