Article title: FRP Seismic Strengthening of Concrete Structures

FRP SEISMIC STRENGTHENING OF CONCRETE STRUCTURES

M. A. Ciupala* and K. Pilakoutas**

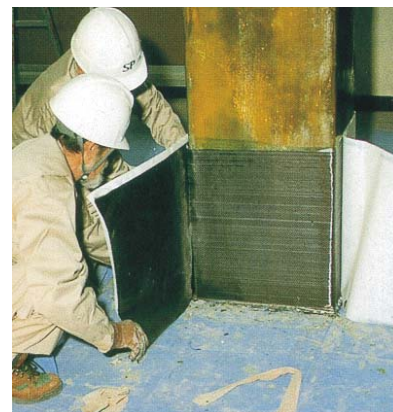
Fig. 1 FRP confinement of concrete columns

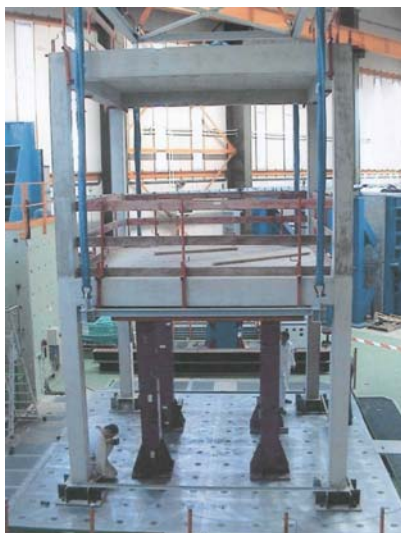
Initially, the bare frame (Fig. 2) was subjected to white-noise test, with frequencies varying between 0.5-50 Hz and a low acceleration level (max. 0.05g) in order to measure the natural frequencies of vibration.

Fig. 2 Bare frame

The bare frame was afterwards damaged, being subjected to five uni-directional seismic tests with the maximum accelerations 0.05g, 0.10g, 0.2g, 0.3g and 0.4g. The natural frequencies of vibration of the frame were measured after each seismic test. The first two natural frequencies of vibration of the undamaged and damaged bare frame are presented in Table 1.

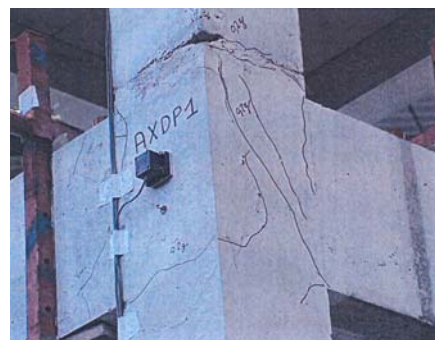
No damage was observed after the first two seismic tests. First damage occurred during the 0.2g seismic test. Diagonal cracks appeared at the joints of the 1st floor (Fig.3) and horizontal cracks formed under the joints of the 2nd floor. Some new horizontal cracks appeared above the joints of the 1st floor and in the columns during the 0.3g seismic test. During the last seismic test (0.4g), new cracks developed along the height of columns and spalling of concrete was noticed at the base of one column.

Fig. 3 Joint damage

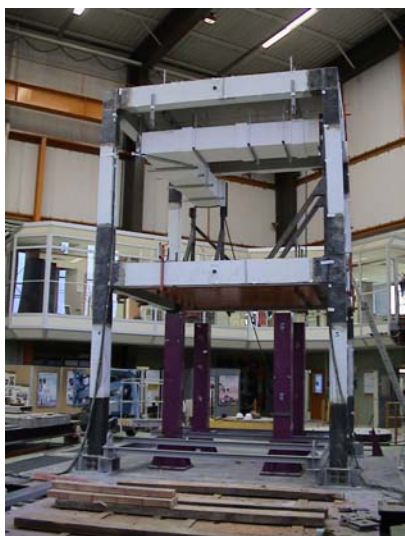
Since the most damaged areas were the joints and the end of the columns, the FRP confinement was applied at these locations (Fig.4). Very little amount of FRP reinforcement was applied at the end of the beams since the aim of the strengthening was to transfer the plastic hinges (zones with concentrated damage) from columns onto beams. In the columns and beams, the FRP material was applied with the fibers in the warp direction parallel to the axis of the members, while at the joints, the FRP confinement was applied at 45⁰ to follow the shear (diagonal) cracks.

Fig. 4 FRP strengthened frame
