Water attenuation performance of experimental green roofs at Ruislip Gardens London Underground Depot

Authors: Connop, S. Clough, J., Carneiro, M.A., and Borland, T.

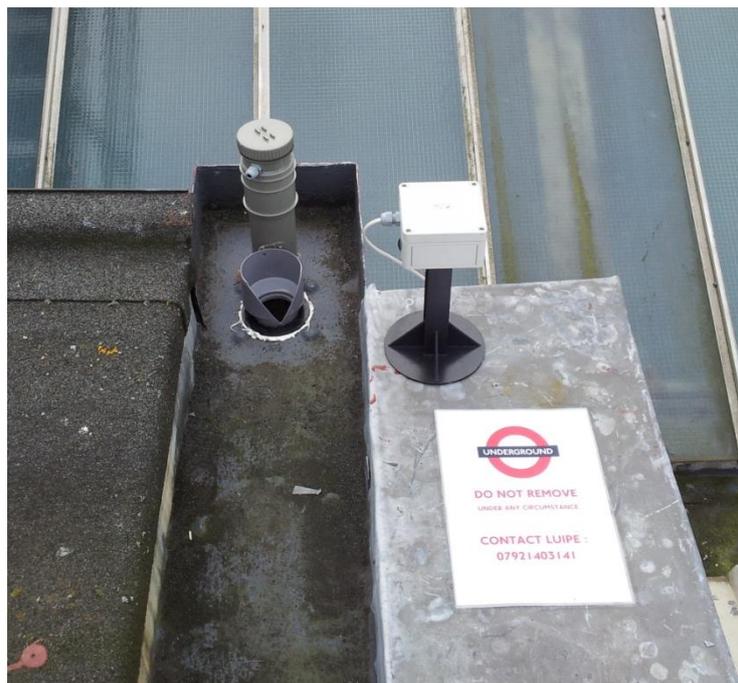
Figure 2. V-notch capacitance sensor monitoring device.

To meet the project specifications, prototype V-notch capacitance sensor monitoring devices were developed and installed in the down pipes of each green and control roofs respectively (Figure 2). The v-notch systems limited the rate of flow from the roofs gutter system. The gauges were calibrated so that they could detect changes in height of the water in the gutter systems and this could be converted to a relative flow rate of rain water leaving each roof.

During field testing on this project the prototype gauges suffered from several issues that it was not possible to detect nor predict from the short-term lab-based trials that were carried out with the gauges prior to the initiation of the experiment. This included issues related to the solar power supply and long term pooling of rain water caused by the large atypical gutter network on the depot roof. These issues meant that data loss on the project was not
