Water attenuation performance of the Museum of London green roof

Authors: Connop, S., Clough, J., Borland, T. and Newport, D.

Published by the University of East London

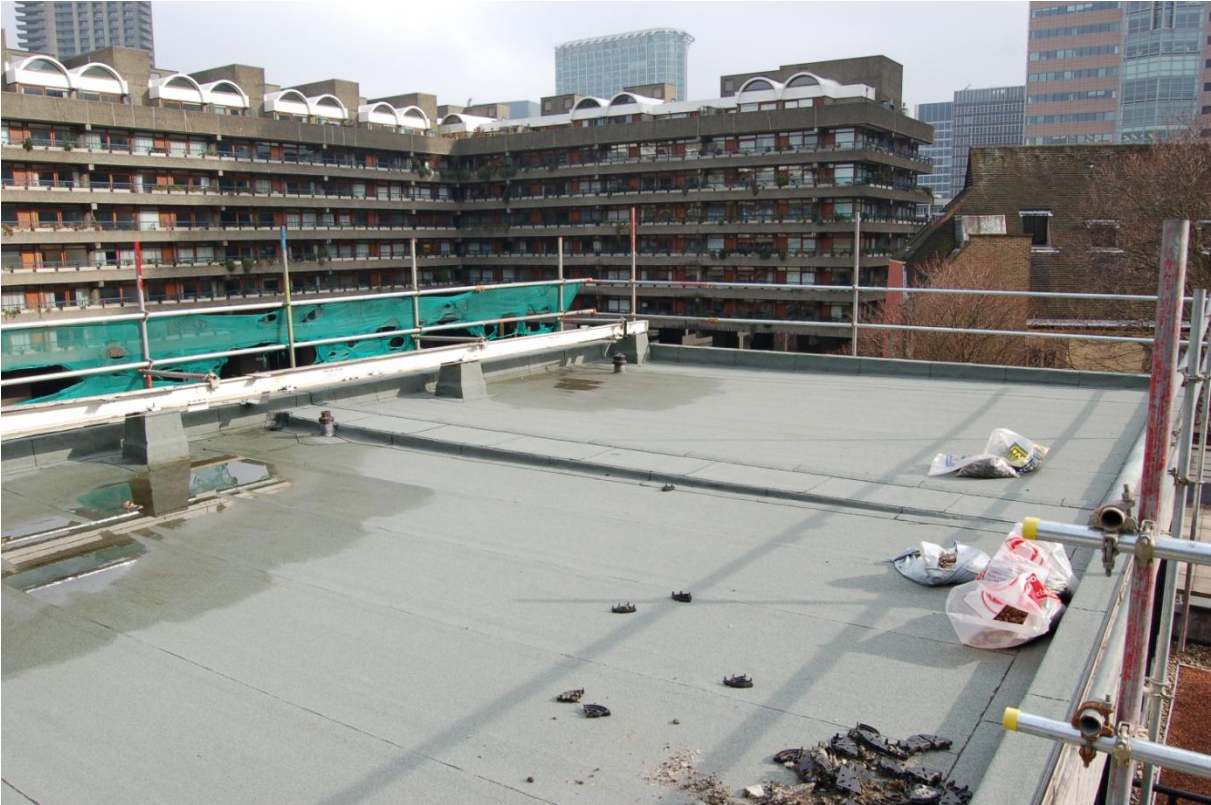
Figure 2. Area of the Museum of London roof to be greened.

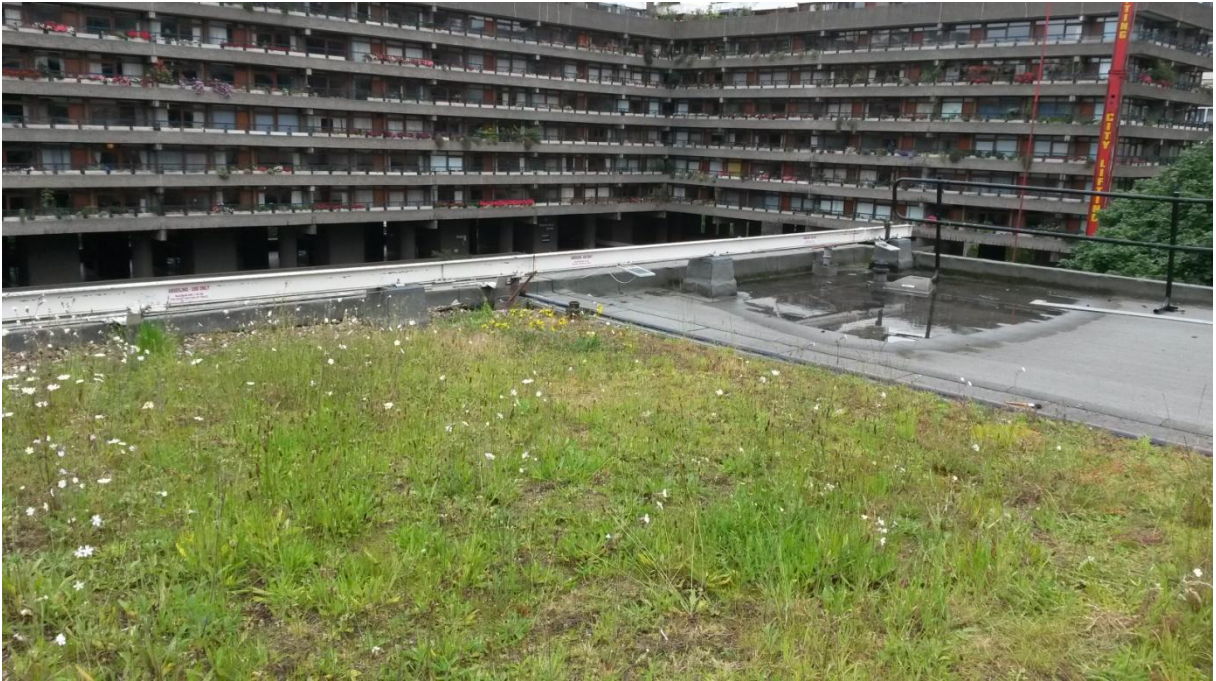
Figure 3. Installed green roof on the northwest corner of the Museum of London roof.

The green roof was installed in 2011 and allowed to establish before monitoring began in 2014. Figure 3 shows an image of the green roof at the time the monitoring was initiated. The green roof area (including a gravel margin) was 64.22 m². The control roof area was 42.18 m².

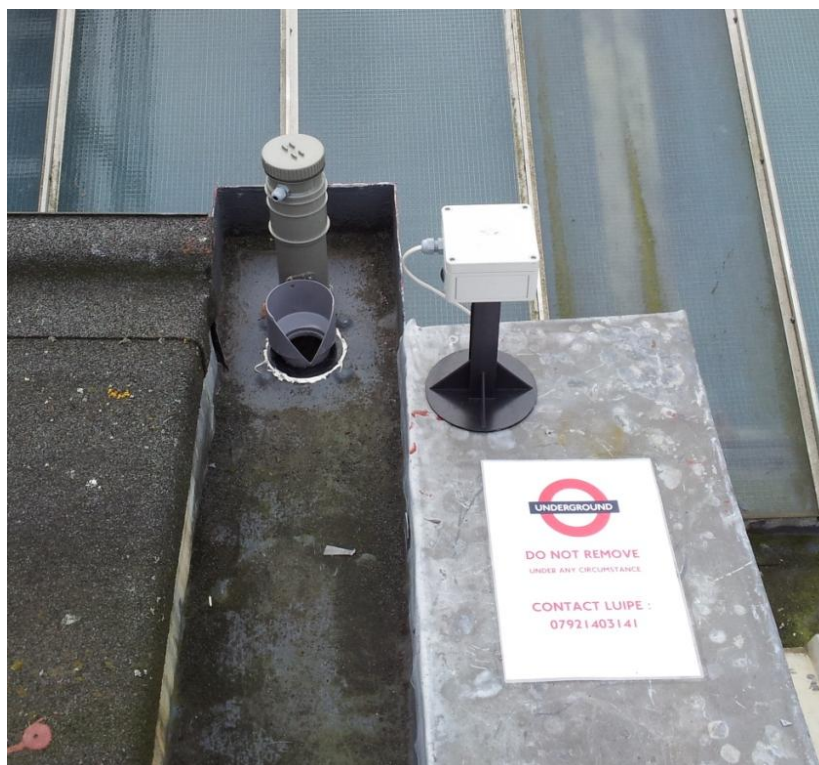
Figure 5. V-notch capacitance sensor monitoring device in-situ on the London Underground depot at Ruislip, London.

To meet the project specifications, prototype V-notch capacitance sensor monitoring devices were developed, tested and calibrated in the laboratory and then installed in the opening of downpipes of each green and control roof respectively (Figure 5). The v-notch systems limited the rate of flow from the roof gutter systems. The gauges were calibrated so that they could detect changes in the height of the water in the gutter systems and this could be converted to a flow rate of rain water leaving each roof.

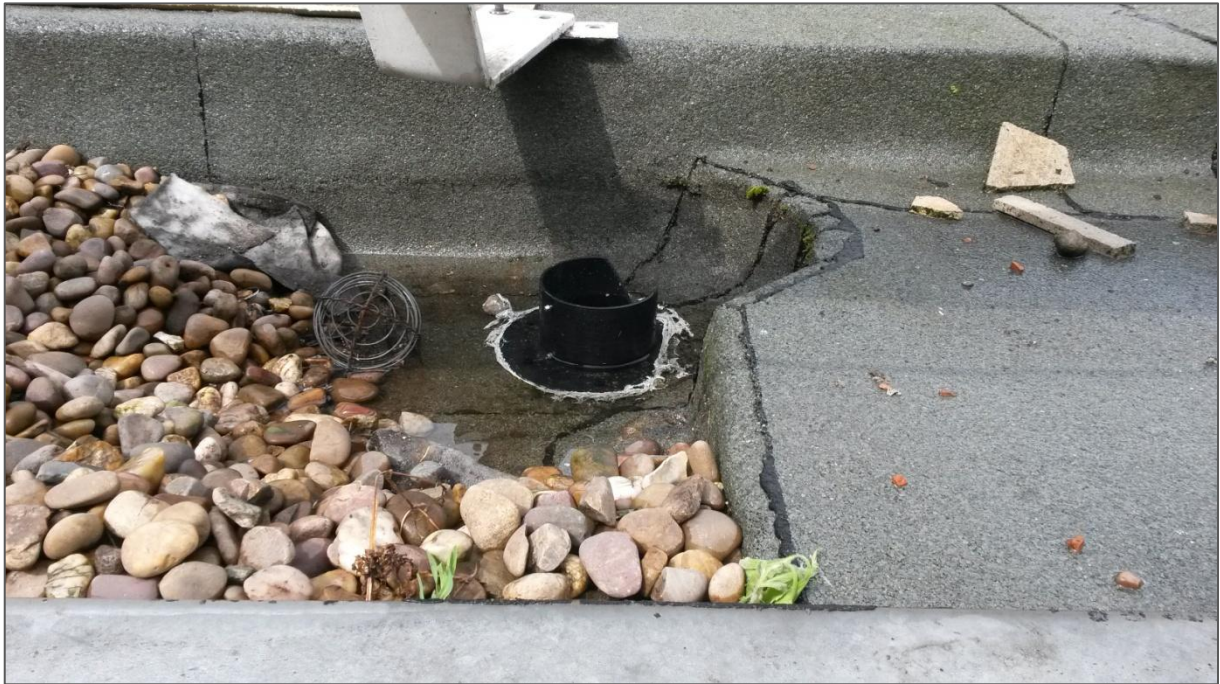
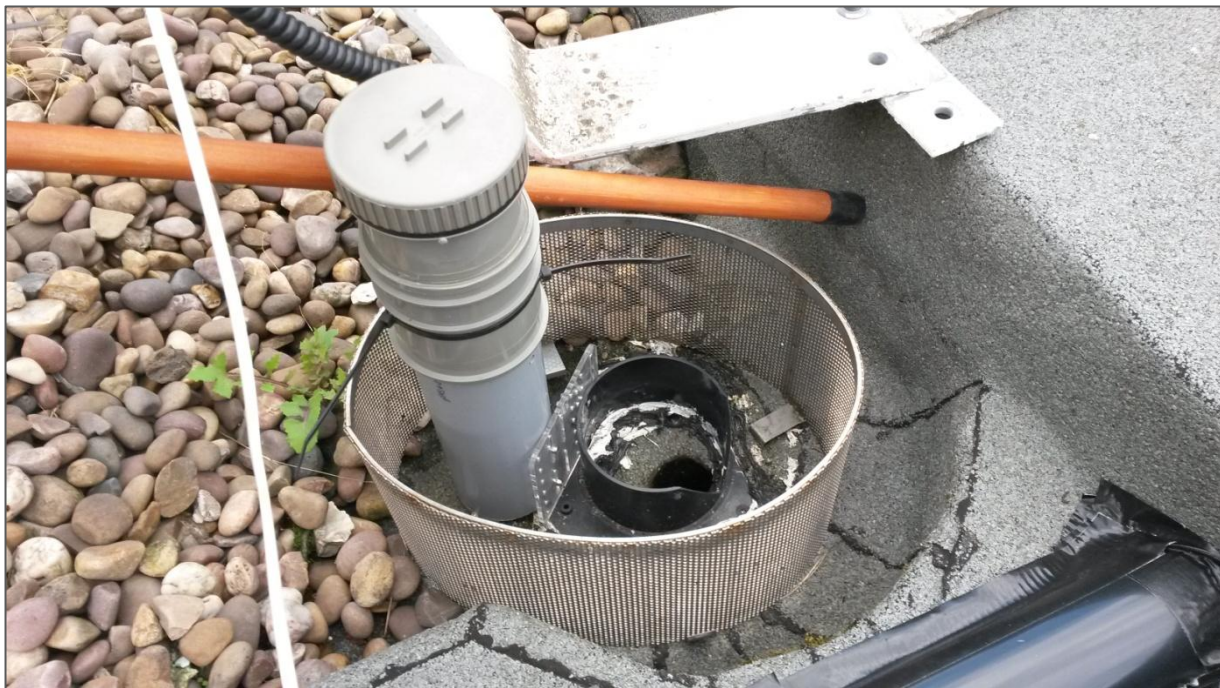
Figure 6. V-notch capacitance sensor monitoring device. (Top) V-notch installation; (Bottom) Capacitance sensor stilling tube attached to v-notch.

Two V-notch capacitance sensors were installed at the opening of the downpipes of the green and control roofs on the Museum roof in May 2014 (Figure 6). In addition to the two v-notch rainfall runoff gauges, barriers were installed across the divided sections of the roof to ensure that the only rainfall runoff being measured came from the hydrological catchments of the green and grey roof areas (Figure 7).

In addition to this issue related to low flow rates, prolonged pooling of water around the base of the gauges caused additional unforeseen problems. Whilst this was not a significant problem for the green roof gauge due to the small area of pooled water between the green roof and the outlet (see Figure 6), the control roof area pooled a substantial area of water prior to it reaching the outlet point (presumably due to sagging of the roof materials over time (see Figure 3). Raising the height of the outlet using the v-notch exacerbated this effect and it meant that the gauge sat in pooled water for long periods. This affected both the pattern of runoff from the roof and also led to unexpected changes in the baseline level readings (i.e. 0 mL/m² flow rate) for the gauges. Nevertheless, the gauges were designed to capture raw capacitance sensor data in addition to processed calibrated data. This meant that it was possible to post-process raw data to ascertain baseline levels (zero flow rate levels) by careful analysis of the raw data recorded by each gauge to identify the baseline at the time of pooling. Whilst this added an additional level of complication preventing the precise measurement of overall volumes at very low flow rates, it would not be expected to substantially affect the results of the gauges during peak flow events when the gauges were operating nearer to their maxima.

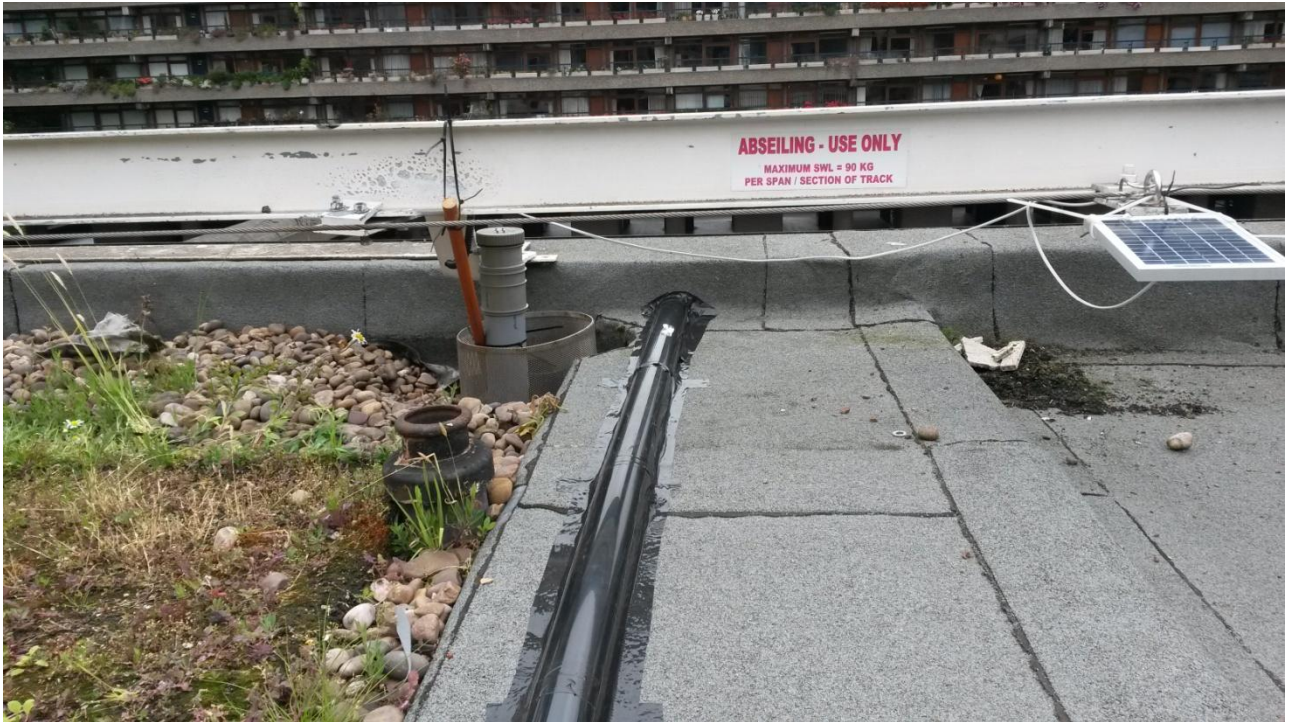
Figure 7. Barrier dividing the green roof catchment from the control roof catchment.

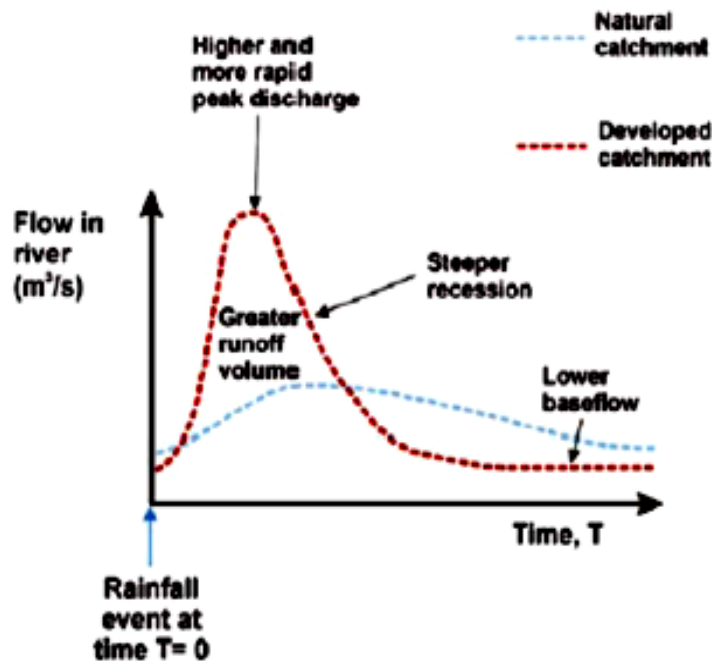
Figure 9. Natural and developed catchment hydrograph. Hydrograph demonstrating the differences in peak flow, run off rates and run off volumes between developed catchments (with large areas of hard surfaces) and natural catchments (green infrastructure) (Woods Ballard et al 2007).

In developed catchments typical of urbanized areas, swathes of hard impermeable surfaces cause large volumes of rainwater to rapidly transfer into storm drain systems following major rain events. This can lead to surface water flooding. Such incidences are becoming increasingly common in large cities where intense rain events can cause significant social and economic disruption. This can be exacerbated further during spells of very hot dry weather when ground level green infrastructure can become extremely dry and compacted and thus perform hydrologically like hard surfaces rather than soft catchments (Figure 9). Climate change predictions indicate that such weather patterns will become more frequent in future and the impacts of these will be severe. Such impacts were reported in Central London during the green roof monitoring period including periods of very heavy rain on the 28th July 2014 (ITV 2014), with 43 mm of rain falling in a two hour period, and the 10th

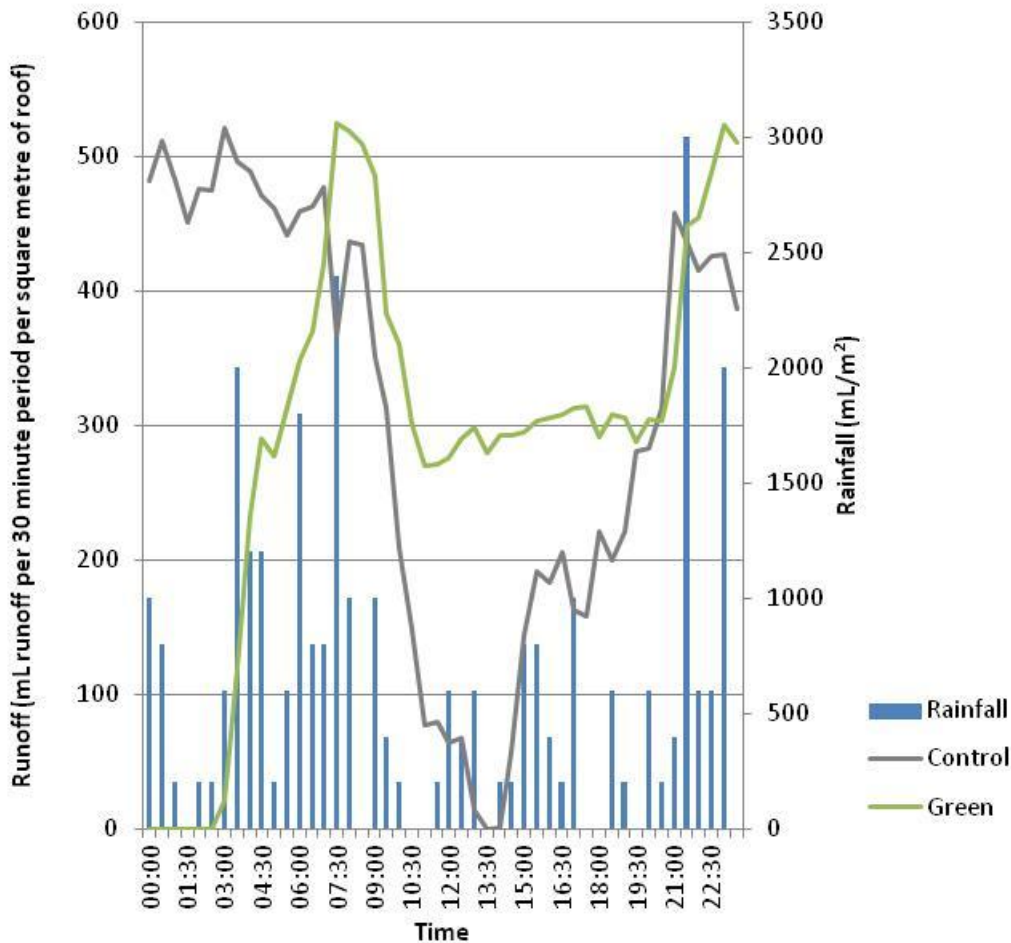
Figure 16. Rainfall and rainfall runoff patterns from green and control roofs at the Museum of London, 13th October 2014. The first axis represents the runoff from the control and green roof areas in terms of mL of rainfall per square metre of roof area summed for every 30 minute period (this includes the gravel margin around the green roof). The second axis represents the size of the rain event recorded by the weather station (in mL/m²) summed for every 30 minute period. The two axis have been normalized for purpose of display. Where data is listed as N/A this means that gauge was not working or there was a 100% reduction in flow rate so no delay could be calculated. All gauges were operating.

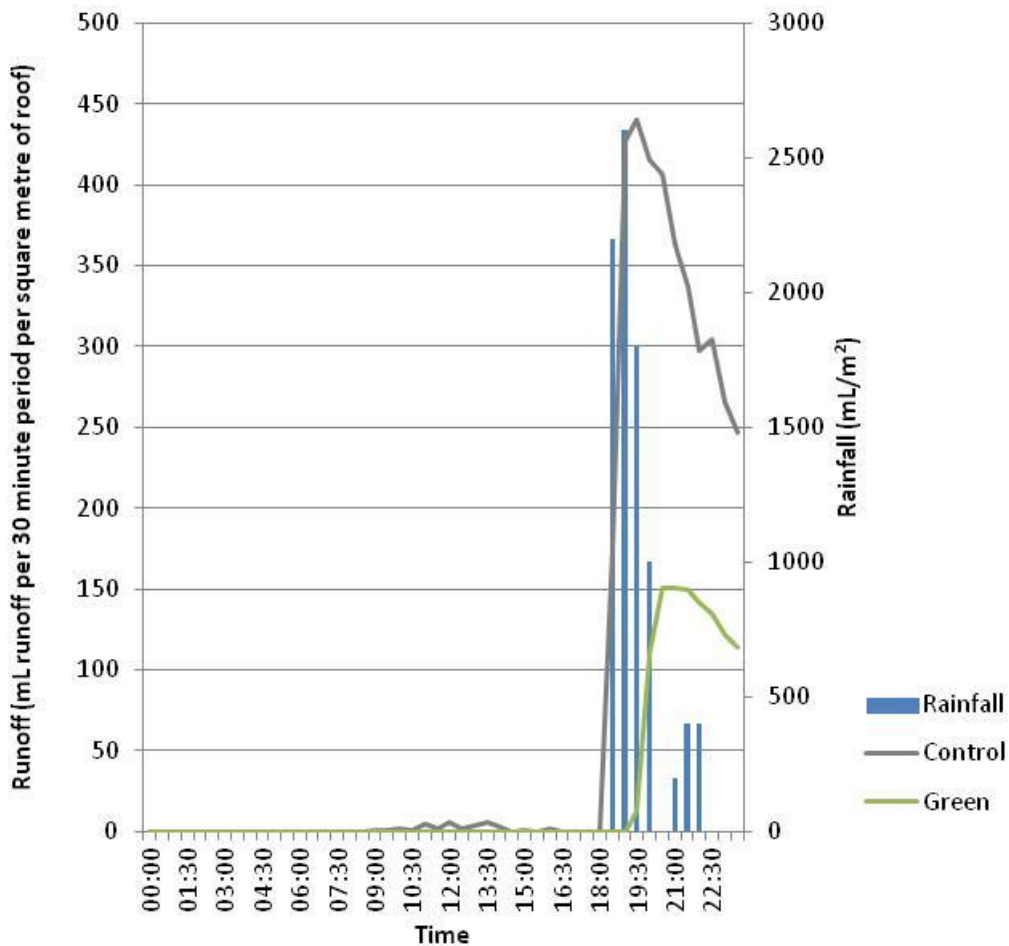
Figure 18. Rainfall and rainfall runoff patterns from green and control roofs at the Museum of London, 8th November 2014. The first axis represents the runoff from the control and green roof areas in terms of mL of rainfall per square metre of roof area summed for every 30 minute period (this includes the gravel margin around the green roof). The second axis represents the size of the rain event recorded by the weather station (in mL/m²) summed for every 30 minute period. The two axis have been normalized for purpose of display. Where data is listed as N/A this means that gauge was not working or there was a 100% reduction in flow rate so no delay could be calculated. All gauges were operating.

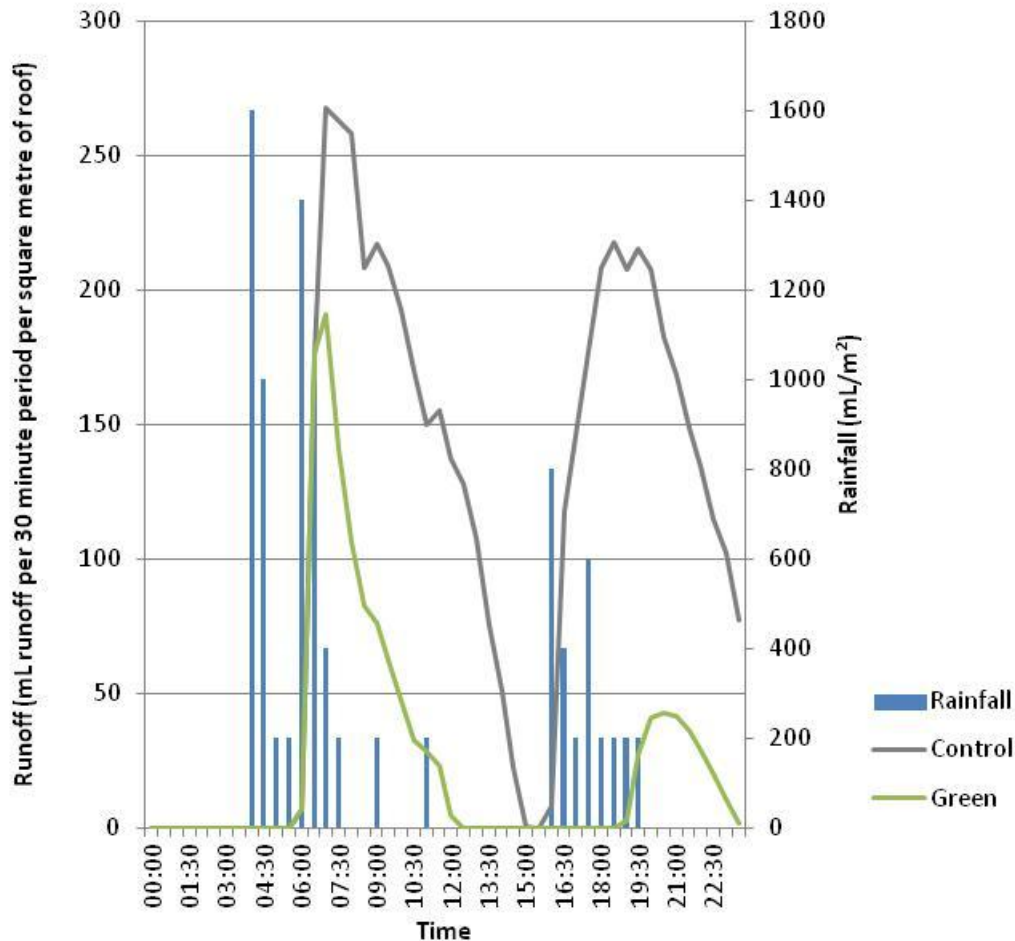
Figure 21. Rainfall and rainfall runoff patterns from green and control roofs at the Museum of London, 26th May 2014. The first axis represents the runoff from the control and green roof areas in terms of mL of rainfall per square metre of roof area summed for every 30 minute period (this includes the gravel margin around the green roof). The second axis represents the size of the rain event recorded by the weather station (in mL/m²) summed for every 30 minute period. The two axis have been normalized for purpose of display. Where data is listed as N/A this means that gauge was not working or there was a 100% reduction in flow rate so no delay could be calculated. All gauges were operating.

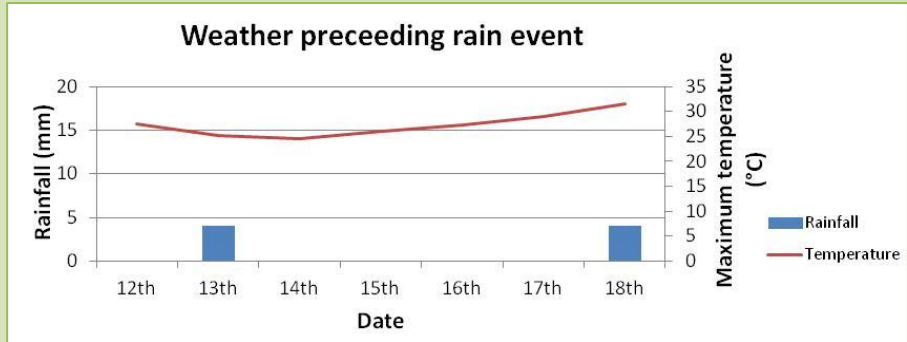
Rain intensity: 72.4 mm/hr

Max temp: 31.6 °C

Percentage peak flow rate reduction:

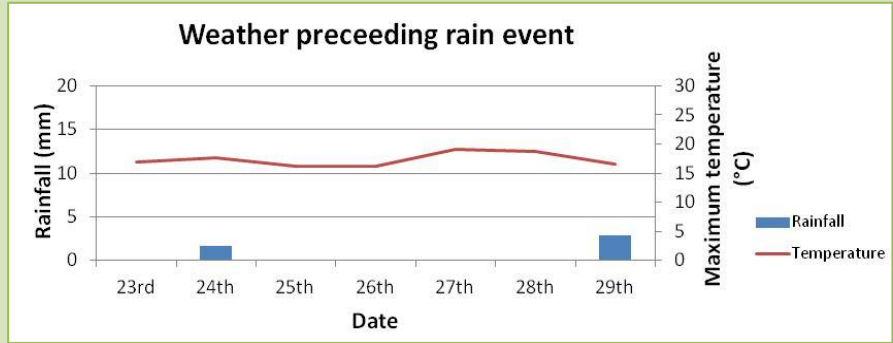
Rain intensity: 4.4 mm/hr

Max temp: 16.6 °C

Percentage peak flow rate reduction:
