Alternate Reinforcement for Structural Concrete

Barrett Lowe

Cal Poly San Luis Obispo
San Luis Obispo, California

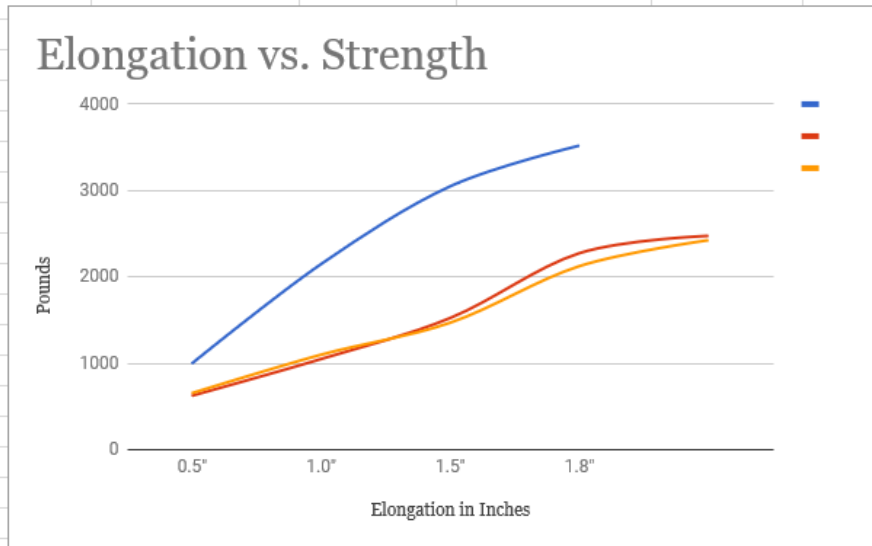
Material Strength / Elongation Graph					
Speed of Test Machine		ASTM Standards <0.1"/second			
Pine Wood		PVC Ext.		PVC Int.	
Elongation	Pounds	Elongation	Pounds	Elongation	Pounds
0.5"	1000	0.5"	625	0.5"	655
1.0"	2150	1.0"	1050	1.0"	1100
1.5"	3050	1.5"	1525	1.5"	1470
BROKE @ 1.8"	3520	2.0"	2275	2.0"	2125
XXX		BROKE @ 2.36"	2475	BROKE @ 2.41"	2425
XXX		XXX		XXX

The graph of the curves above display the materials strength vs the extension of the material tested. For testing we, myself and Cal Poly lab technician Vince Pauschek, utilized a Riehle FS-300 Testing Machine. Visible in the picture below, the materials were loaded into the machine and slowly pulled apart until complete failure occurred. In reference to the graph, *Elongation* refers the extension of the material, while *Pounds* refers to the force at each distance interval. To keep measurements consistent, intervals of half an inch were used.

After analyzing the data taken it is clear the tensile strength of wood is significantly higher than PVC, as to be expected. Additionally, the data above displays the energy stored in each material prior to failure. The amount of energy stored in the wood per 0.5" was noticeably higher in all cases. This wasn't taken into account during the hypothesis stage, but definitely should be taken into account for future reinforcement testing to evaluate areas that this reinforcement could be used, especially in high seismically active zones.

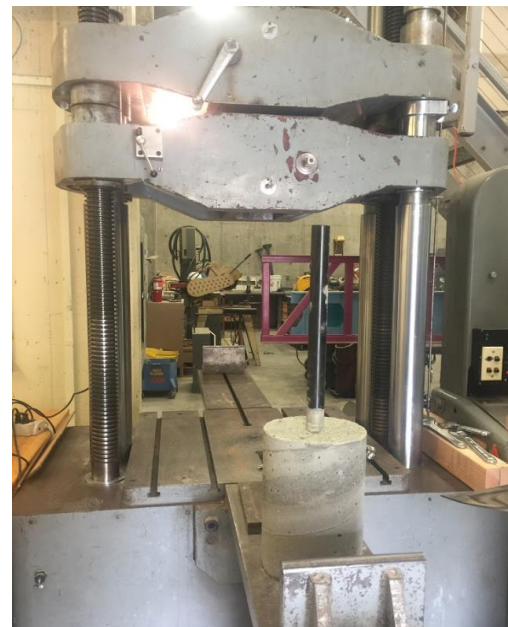
Pine Wood failure point and embedment construction

Lastly, revealed during testing, it was proven that all the materials tested were too weak in tension. In all cases the embedment shapes of each reinforcement method remained completely intact and unmoved. On the other hand, in all cases the materials broke before embedment could even be tested.
