Erosion Resistance of Tungsten-Carbide Coatings for Steel Pipes in Fluid Catalytic Cracking Units

MATERIALS
ENGINEERING
California Polytechnic State University

June 11th, 2019

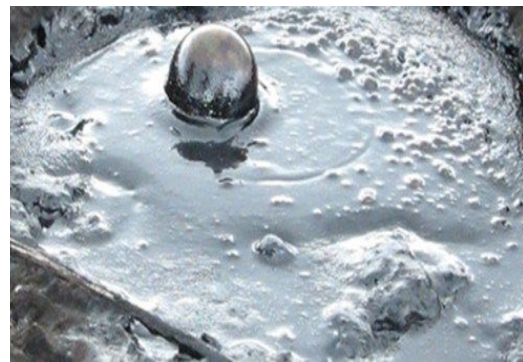
Figure 1: Physical characteristics of raw petroleum oil.

Petroleum is a key substance that propels modern society. It provides fuel and energy for transportation, and is also used in polymers, paints, fertilizer, and medicine. The composition of petroleum varies depending on deposit location, but the percentage of chemical elements changes over fairly narrow limits (Ancheyta 2011). Carbon and hydrogen account for a majority of the composition (Table I). Sulfur, nitrogen, oxygen, and metals are present in relatively low quantities. Crude oil (petroleum) resides deep underground where residue of plants and animals have been heated up and pressurized over millions of years. Crude oil is a blackish viscous liquid and gives off a sulfur odor (Figure 1) (AAPG).

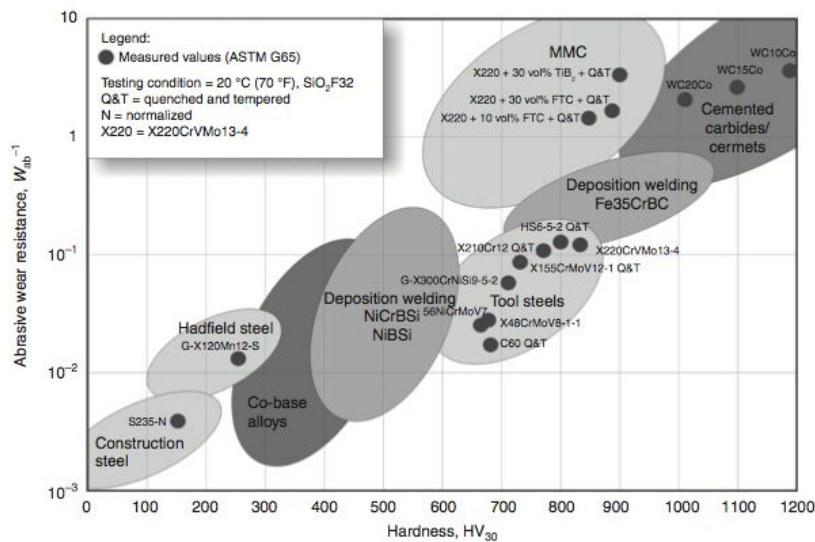
Figure 4: Relationship between three-body abrasion wear resistance and Vickers hardness of various materials designed for erosion resistance.

Abrasive wear occurs when the abrading material contacts a surface of lower hardness. This results in scratching, indentation, fracture, and volume loss of the eroding material. It can, therefore, be beneficial to increase the hardness of surfaces at risk of erosion. Some high hardness coatings include hard alloys, which contain large amounts of hard phases that form during solidification, and metal-matrix composites (MMC), which consist of a metal (usually cobalt, nickel, or iron) matrix dispersed with hard ceramic particles (Theisen 2017). Plotting hardness against abrasive wear resistance, measured using ASTM standards, it is apparent that there is a positive correlation (Figure 4).

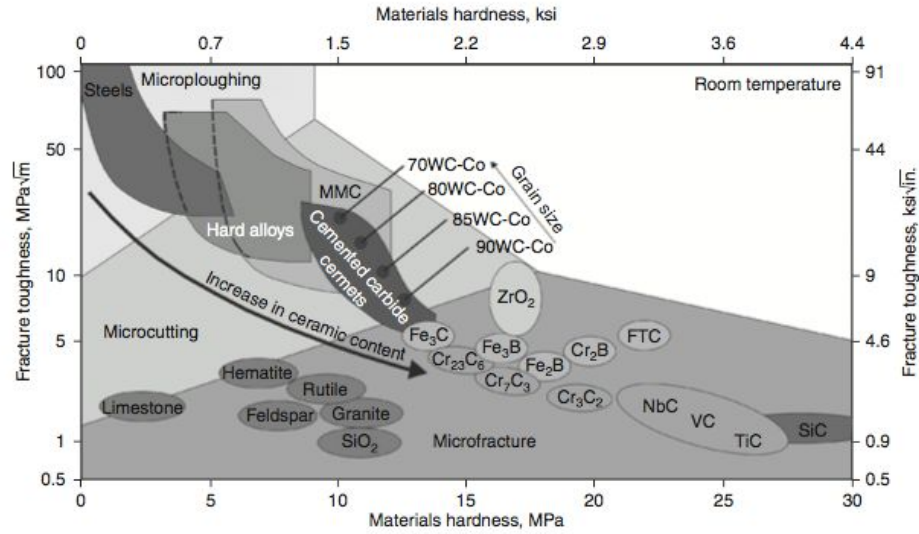
Figure 5: Wear micromechanisms of various materials with different hardness and fracture toughness values.

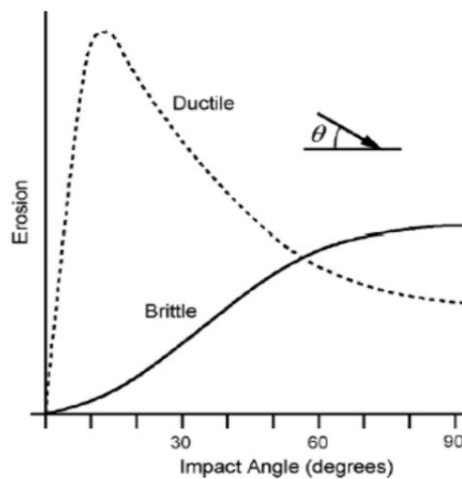
Figure 6: Plot of trends in severity of erosion for ductile and brittle materials based on the angle of impingement of erosive media (Lee 2013).

Initially, the erosion rates calculated from our test data were surprising, as we expected the WC claddings to have a lower erosion rate than bare A36 steel. After reviewing literature, we can begin to speculate the cause of these results. Due to their brittle nature, the Conforma Clad coatings experienced higher amounts of mass loss at higher angles, due to fracture mechanisms. Conversely, the more ductile A36 steel was less susceptible to mass loss at oblique impingement angles. This can be seen graphically from Figure 6 in section 3.2.

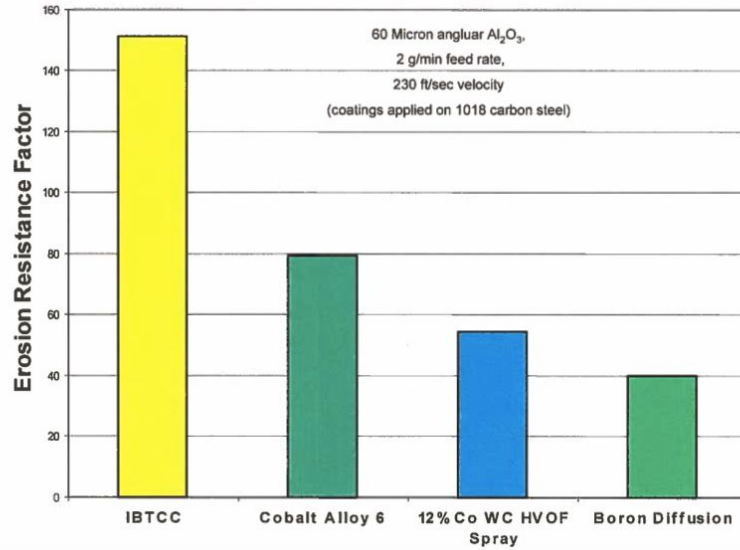
Figure 10: Solid particle erosion data from the Exxon Mobil pumping service wear case study investigating protective coatings for extreme erosive conditions showing impressive results for infiltration brazed tungsten-carbide cladding or Conforma Clad.

Further industry data comparing ASTM G76 solid particle erosion of Conforma Clad and other coatings indicate the potential for WC claddings to outperform Stellite under harsh erosive conditions (Figure 10) (Wiltz 2011).

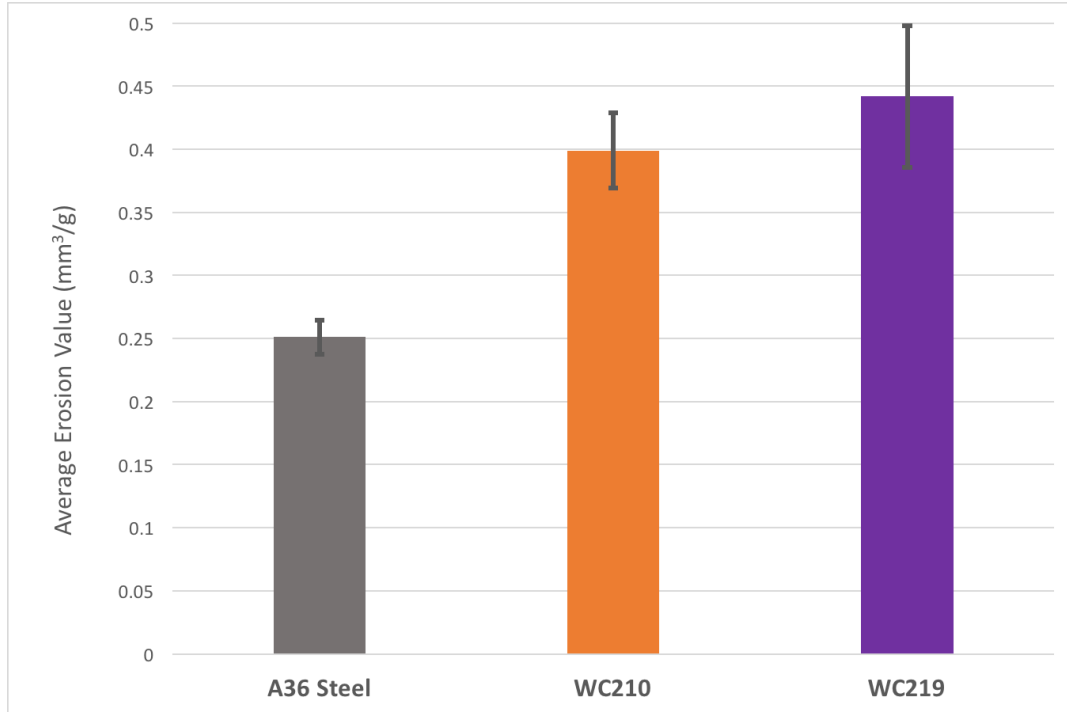
Figure 16: Visual representation of average erosion values for A36 steel, WC219, and WC210 at a mass flow rate of 1.2 g/s and 90° impingement angle.

The average erosion rate of the A36 steel coupons was 2.3433 mg/s, which was 58% less than both WC219 and WC210. Both Conforma Clad coatings displayed similar average erosion rates of 5.677 and 5.5482 mg/s respectively. Taking into consideration the density of the eroding material as well as the mass flow rate, average erosion rates were converted to average erosion values (Figure 16). The erosion value is a measure of volume loss of material per gram of abrasive. A36 steel yielded an average erosion value of 0.251 mm³/g, while WC219 and WC210 had similar values of 0.428 & 0.398 mm³/g respectively. The average erosion values reinforced the trends seen in the average erosion rate data (Table VI).

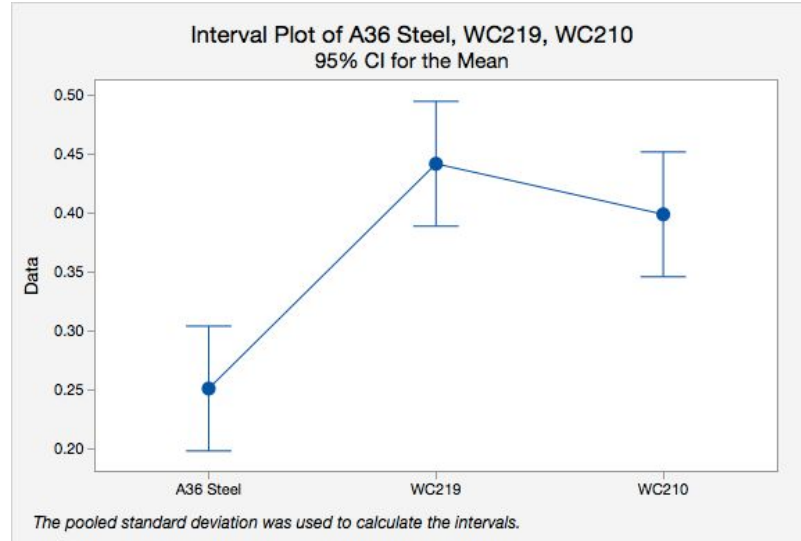
Figure 17: One-way ANOVA statistics of mean erosion values for A36 steel, WC219, and WC210 at 90° impingement.

One-way ANOVA testing was conducted to compare the mean erosion values for A36 steel, WC219, and WC210. Hardide data was not included due to the rapid breakthrough of the coating leading to invalid results. The resulting P-value of 0.0019 indicated that at least one of the means was different than the others. A pooled standard deviation interval plot showed that the mean erosion value for A36 steel was different from the values for both claddings, which were not different from each other, with 95% confidence (Figure 17).

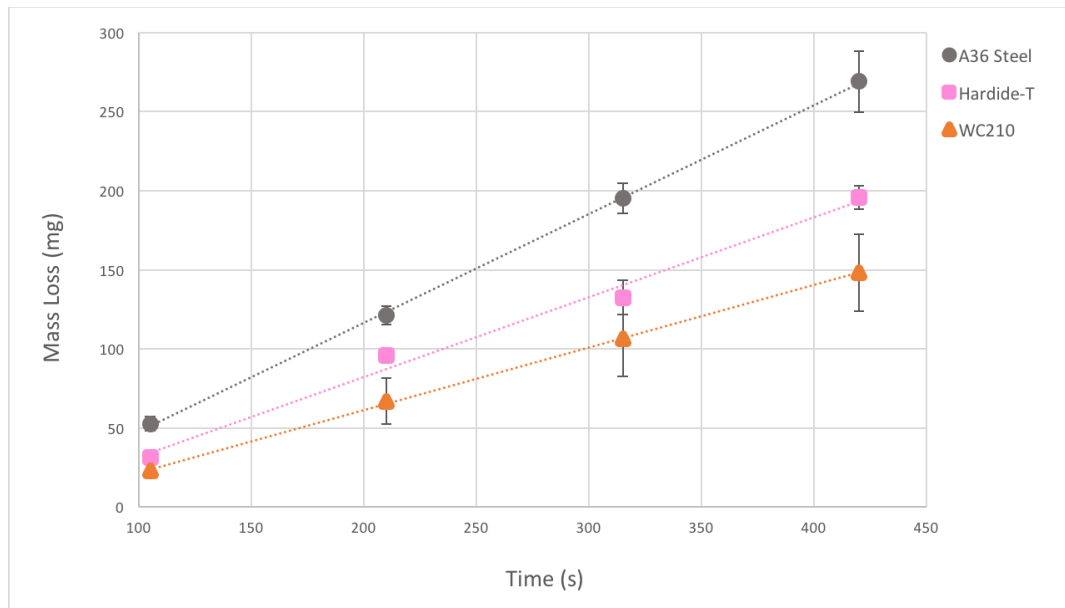
Figure 23: Erosion plot of A36 steel, Hardide-T, and WC210 eroded at 25°.

After 90° erosion testing, it was determined that the angle was too severe for the WC-W coatings, so the impingement angle was reduced to about 25° to understand how all testing materials would withstand a lesser angle of impact as well as to obtain usable data for Hardide-T. At a lower impingement angle, the A36 bare steel eroded at the highest rate, while the Hardide-T and WC210 eroded at lower rates (Figure 23). WC219 was not re-tested due to its similarity to WC210. The resulting average erosion rates fortified that ductile materials experience a higher mass loss, while brittle materials experience a relatively lower mass loss at lower angles.

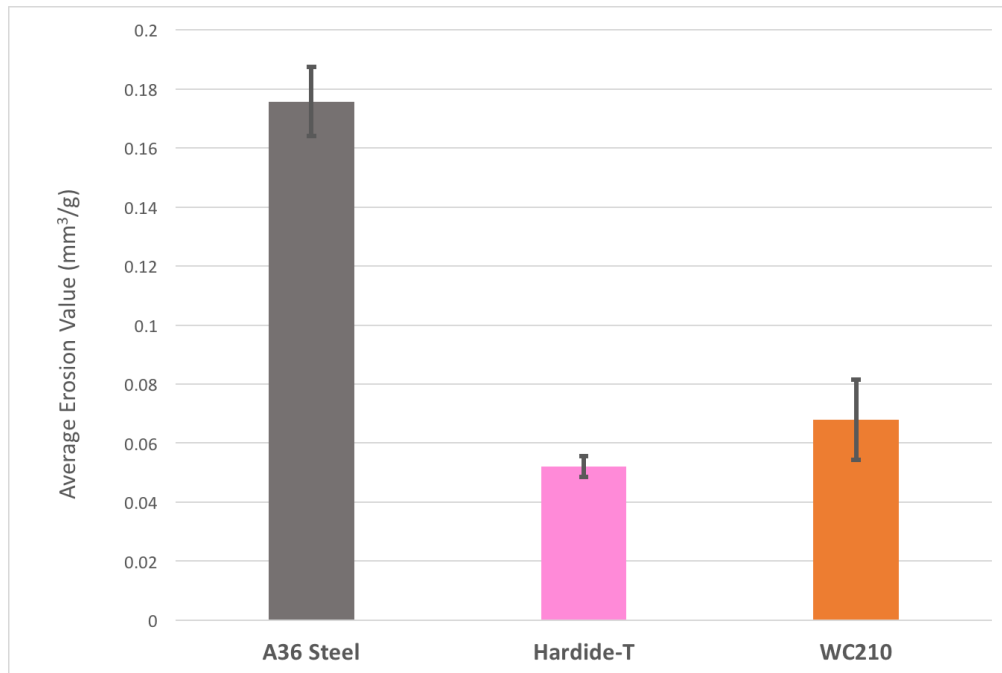
Figure 24: Visual representation of average erosion values for A36 steel, Hardide-T, and WC210 at a mass flow rate of 0.5 g/s and 25° impingement angle.

Conversion of average erosion rates to average erosion values changed the ranking of Hardide-T to appear to erode slightly less than WC210 due to the high density of Hardide-T with a value of 19 g/cm³ compared to WC210 with a density of 11.6 g/cm³. A36 steel still appeared to clearly have the highest

erosion value (Figure 24). Standard deviation and R^2 values for the average erosion rates and the standard deviation values for the average erosion values again indicated testing repeatability (Table VIII).

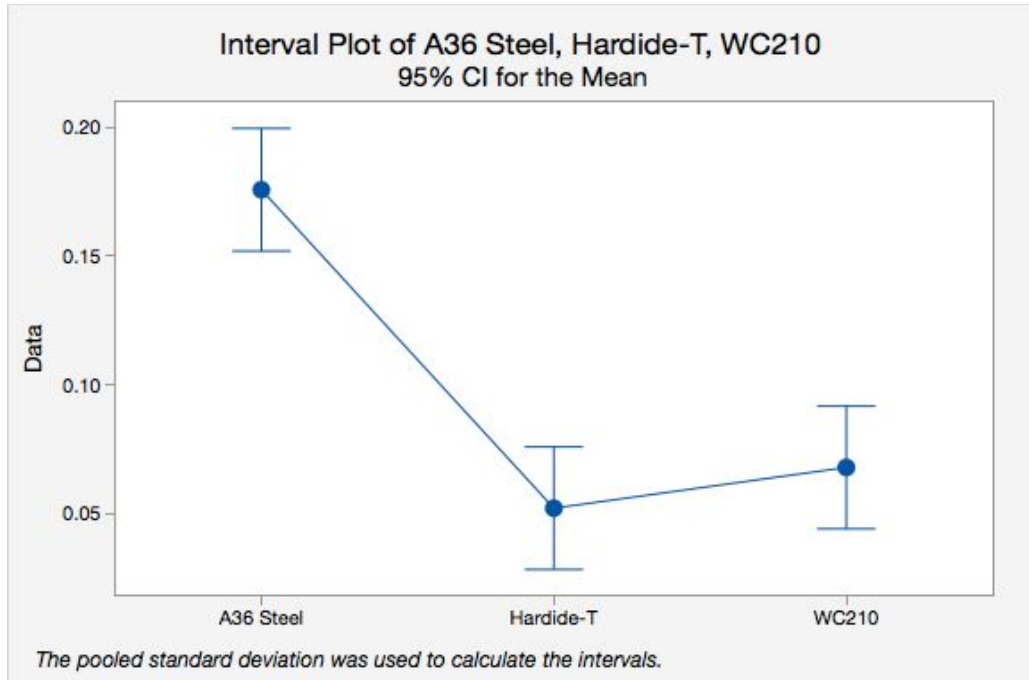
Figure 25: One-way ANOVA results for mean erosion values of A36 steel, Hardide-T, and WC210 at 25° impingement.

One-way ANOVA statistics were calculated using the mean erosion values for A36 steel, Hardide-T, and WC210. The resulting P-value of 0.0025 indicated that at least one of the means was different than the others. Using pooled standard deviation (Figure 25), it was determined that A36 steel had a higher average erosion value than Hardide-T and WC210, which did not have means values different from each other, with 95% confidence.
