Authenticity of the Light Environment of the Pennsylvania Academy of the Fine Arts

A THESIS

Historic Preservation

MASTER OF SCIENCE IN HISTORIC PRESERVATION

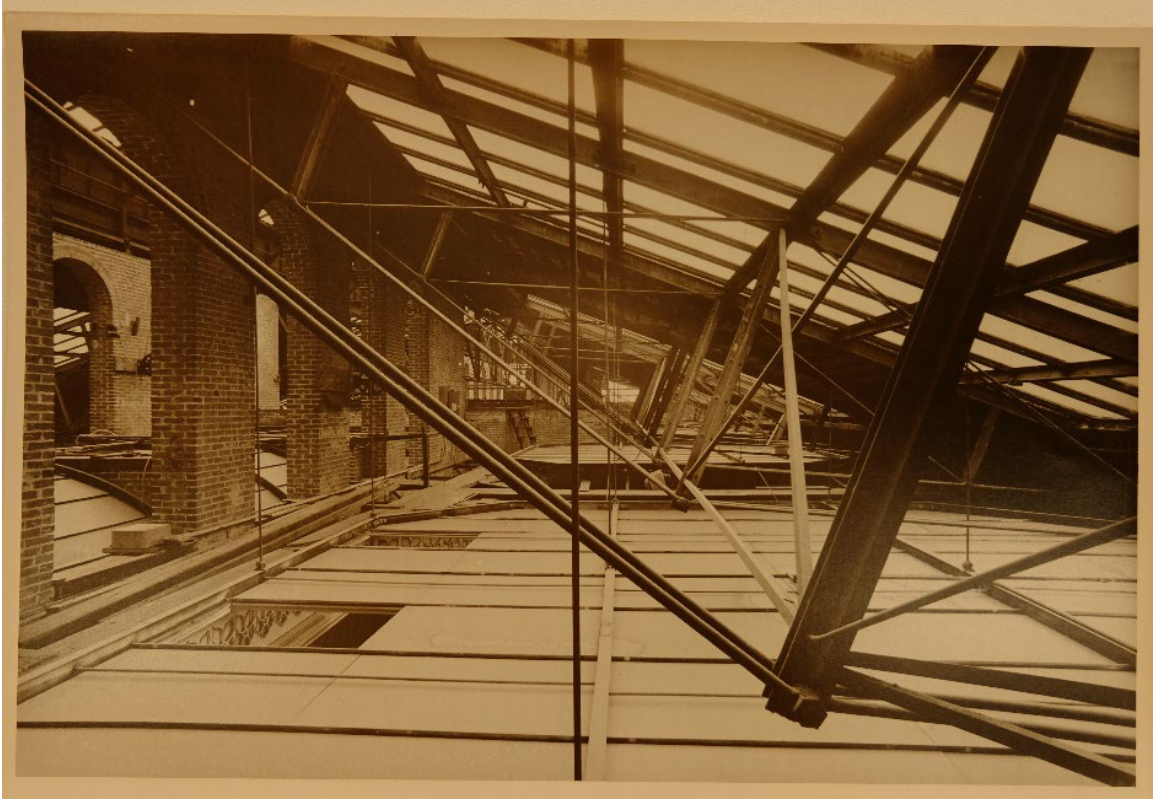
Figure 16 Detail of the skylight structure (North side of the museum) (Harris Davis Photography 1973)

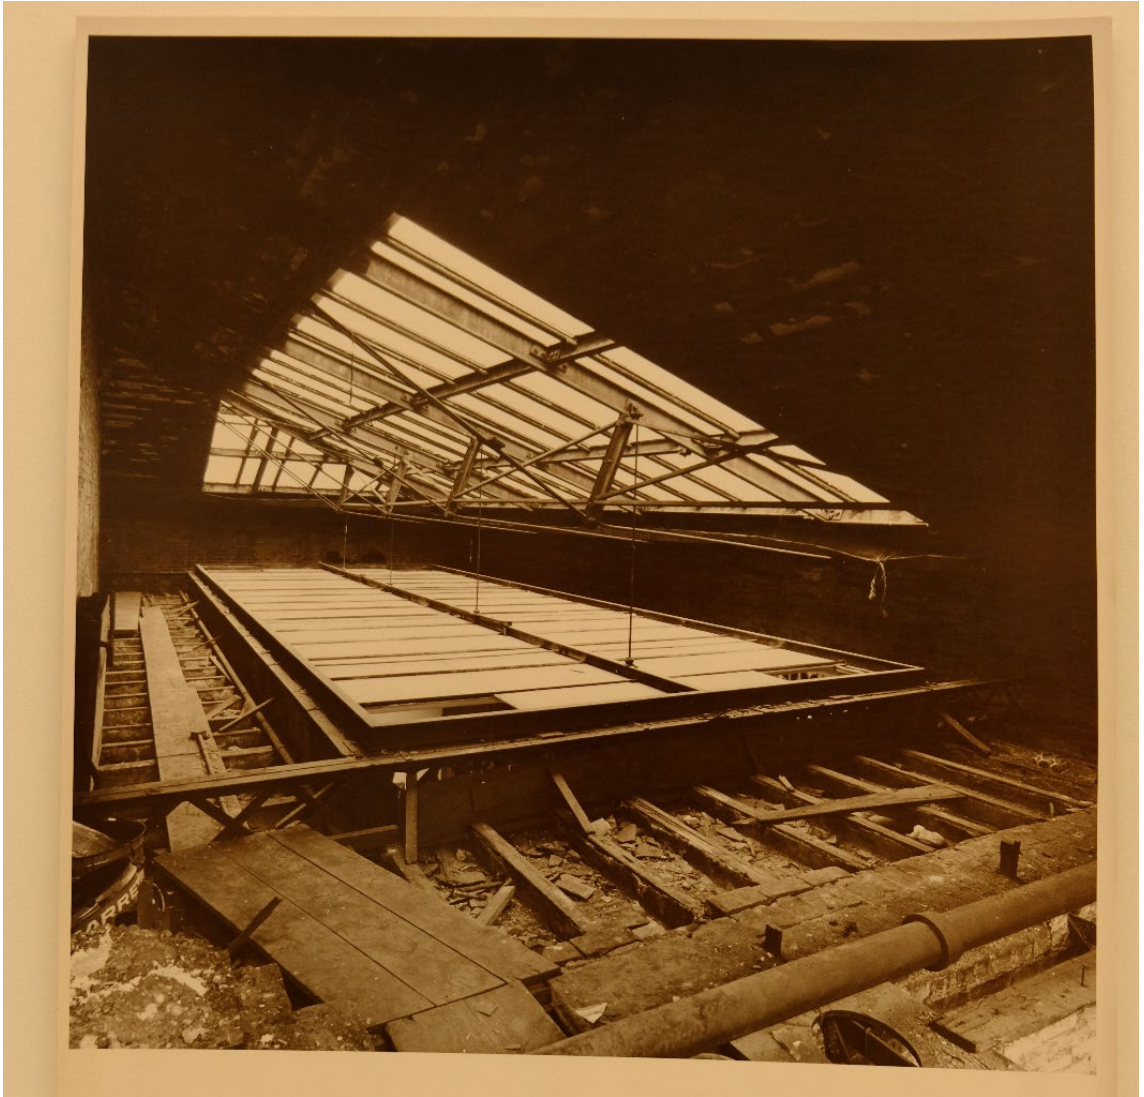
Figure 17 Detail of the skylight structure (North side of the museum) (Harris Davis Photography 1973)

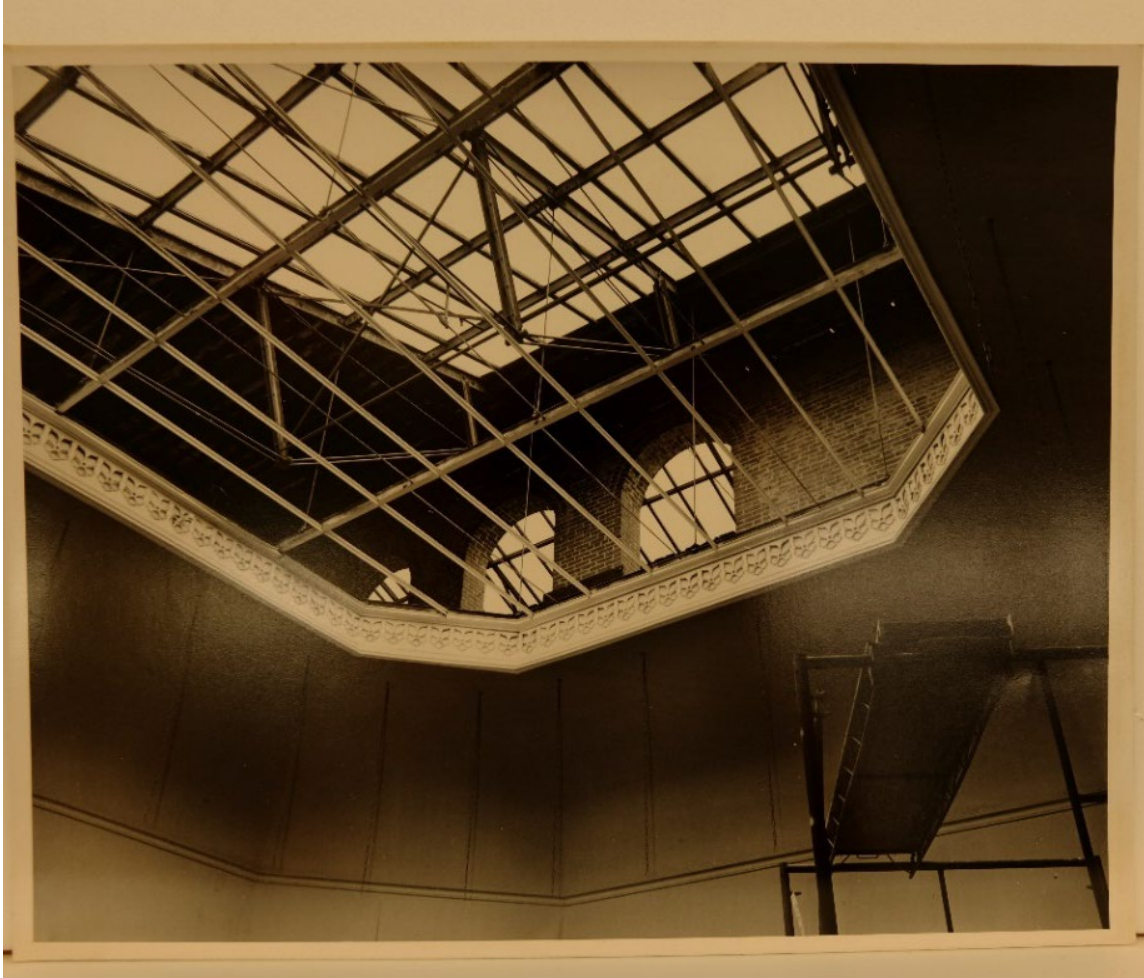
Figure 18 Detail of the skylight structure (view of skylight frame from the gallery)
(Harris Davis Photography 1973)

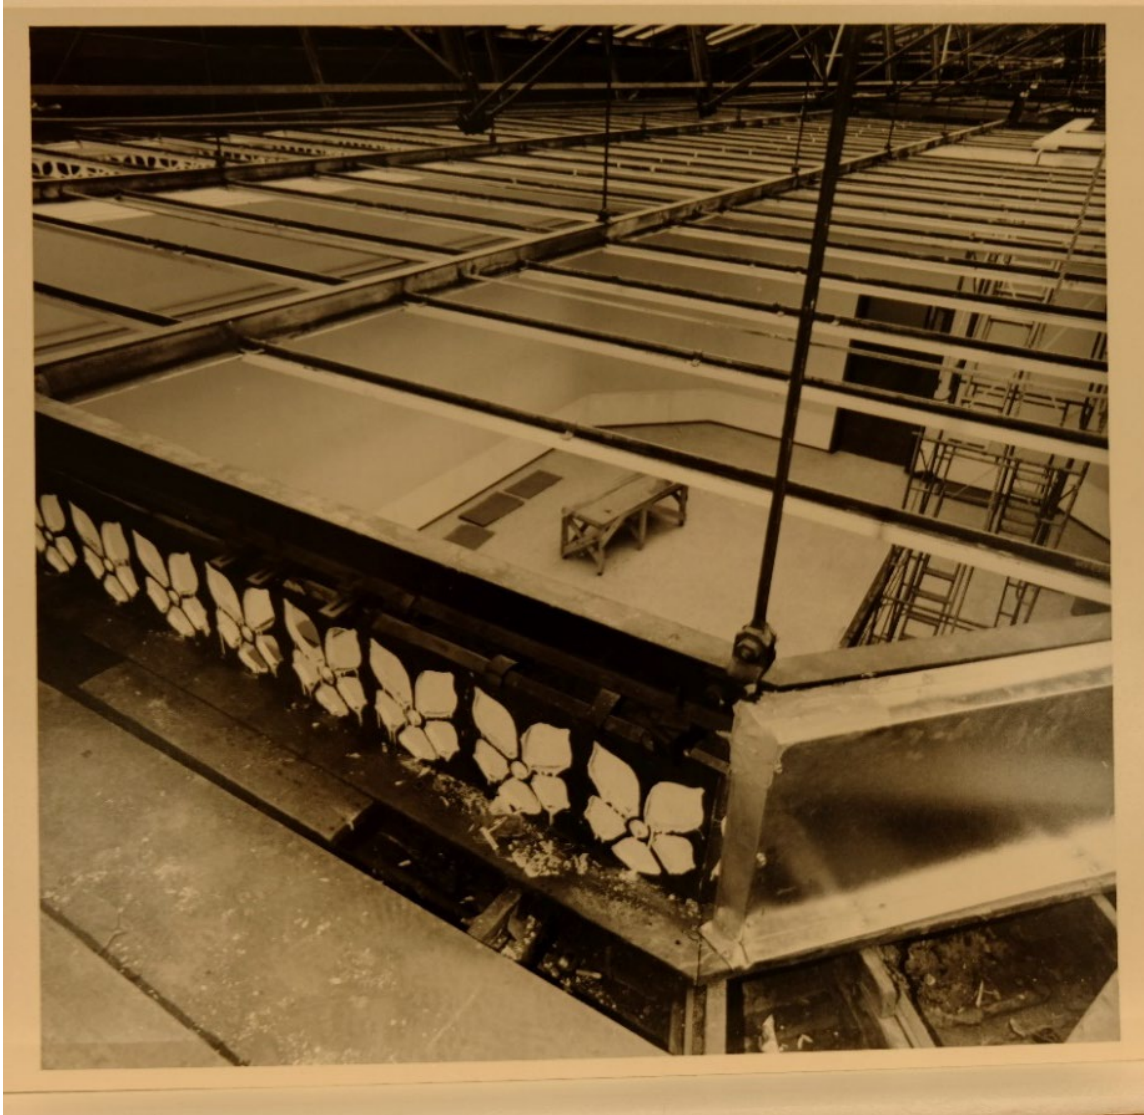
Figure 19 Detail of the skylight structure above the gallery space (Harris Davis Photography 1973)

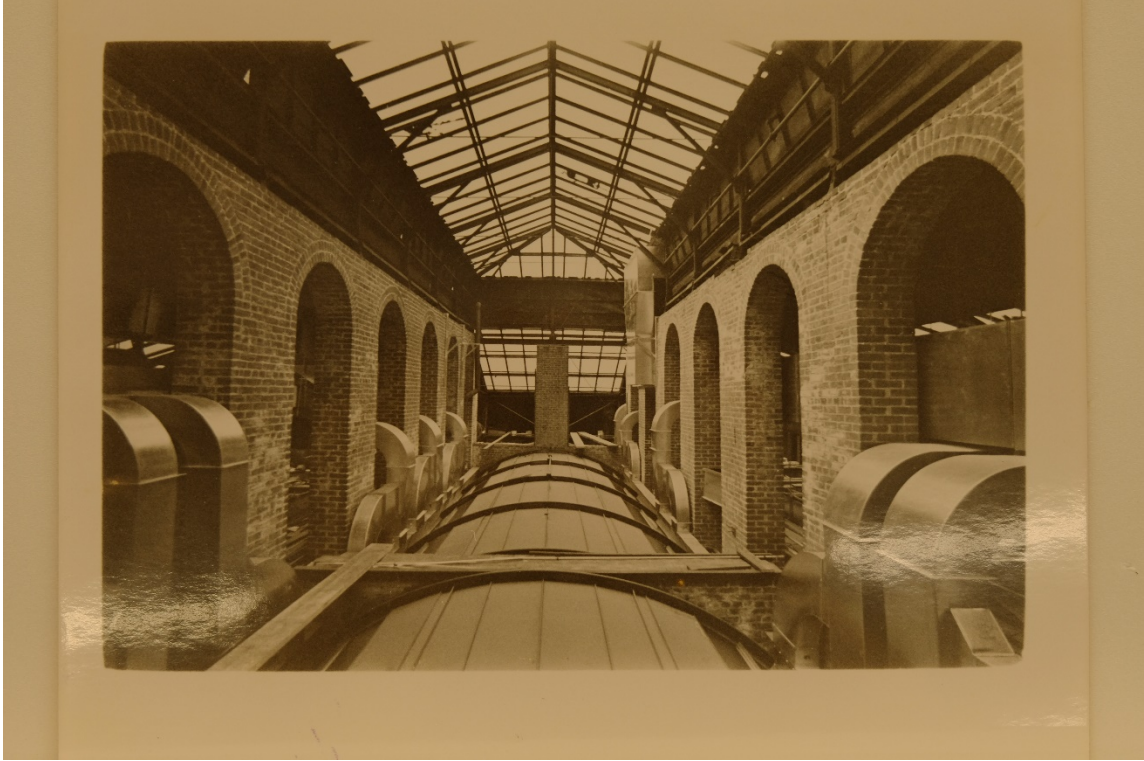
Figure 202 Detail of the skylight structure above the central hallway (Harris Davis Photography 1973)

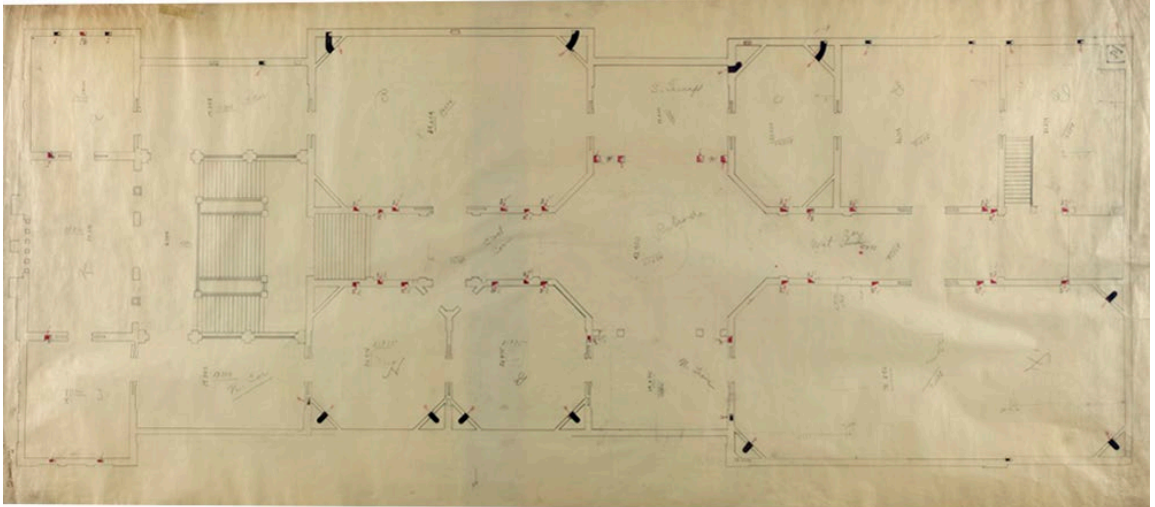
Figure 28 Historic Plan Drawing (PAFA Archive)

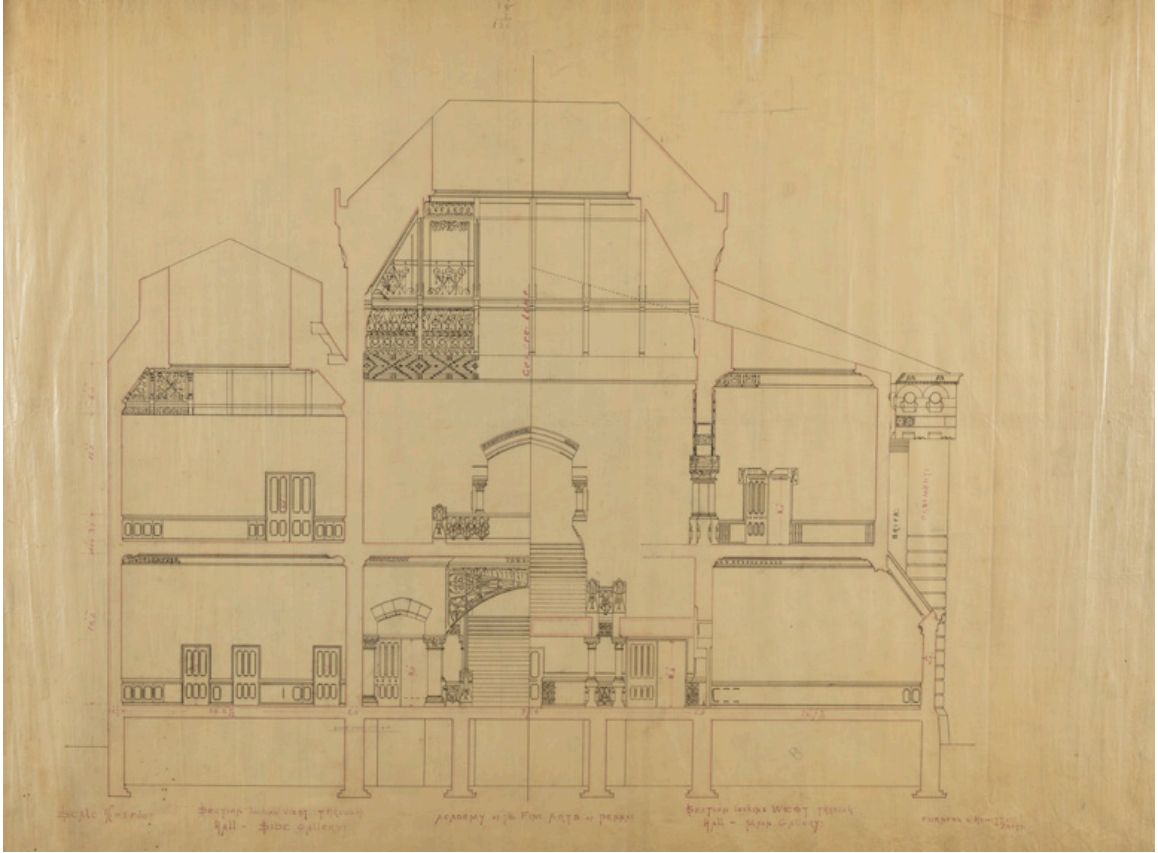
Figure 29 Historic N-S Section Drawing (PAFA Archive)

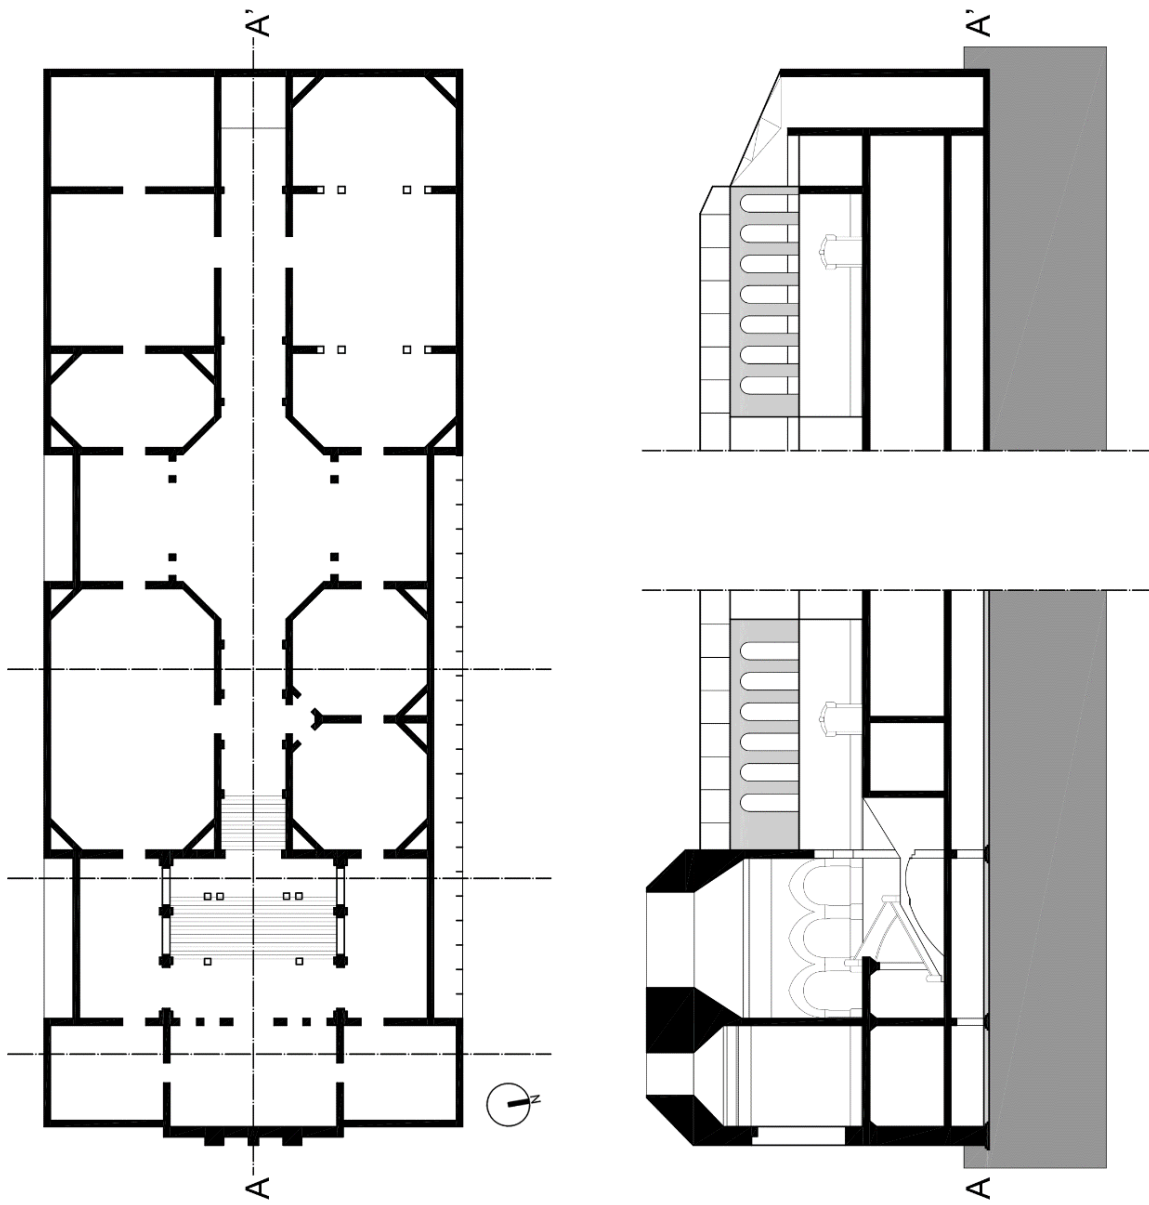
Figure 30 W-E Section (Pae,2019)

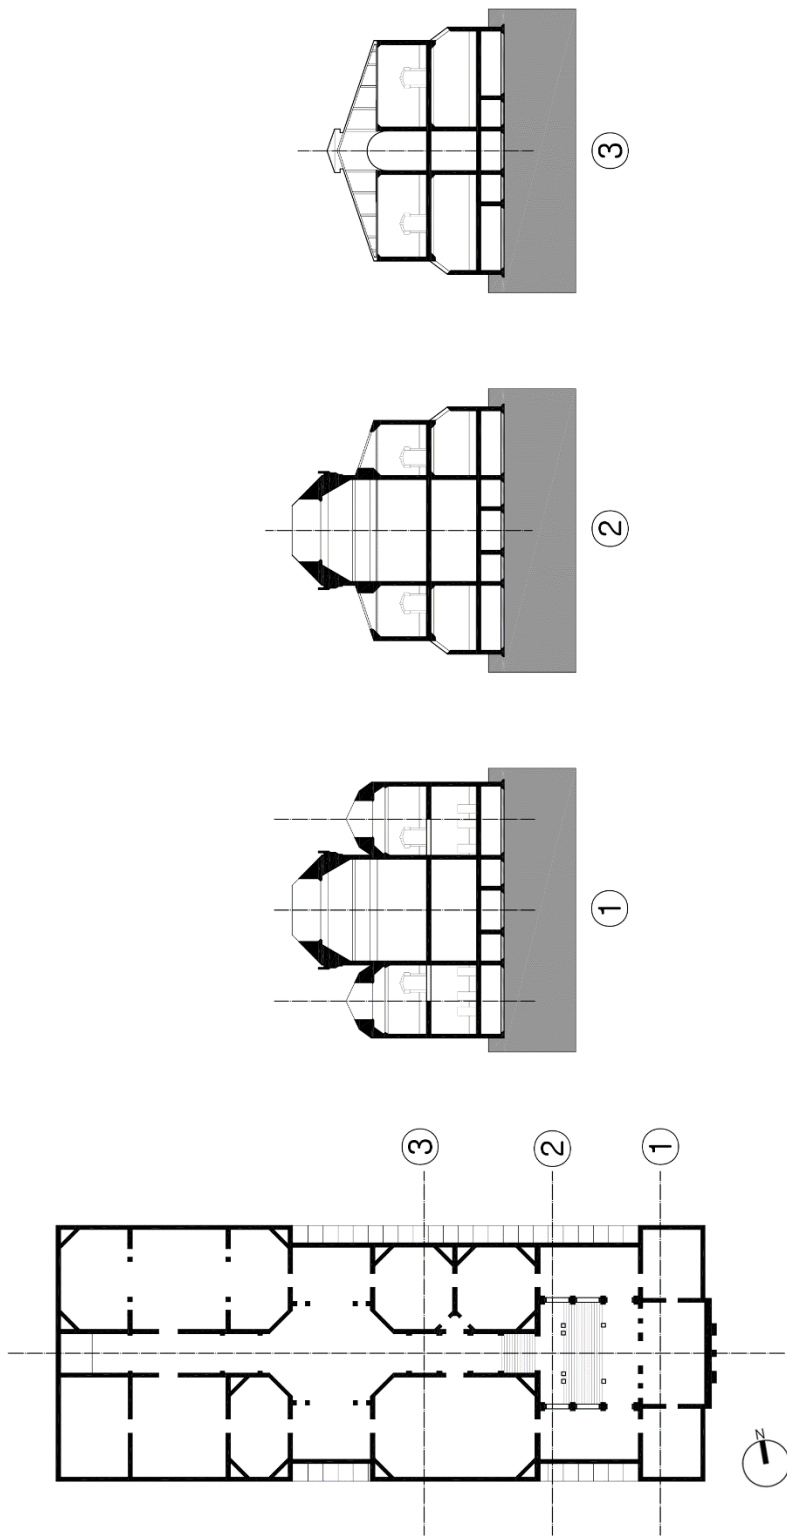
Figure 31 N-S Sections (Pae, 2019)

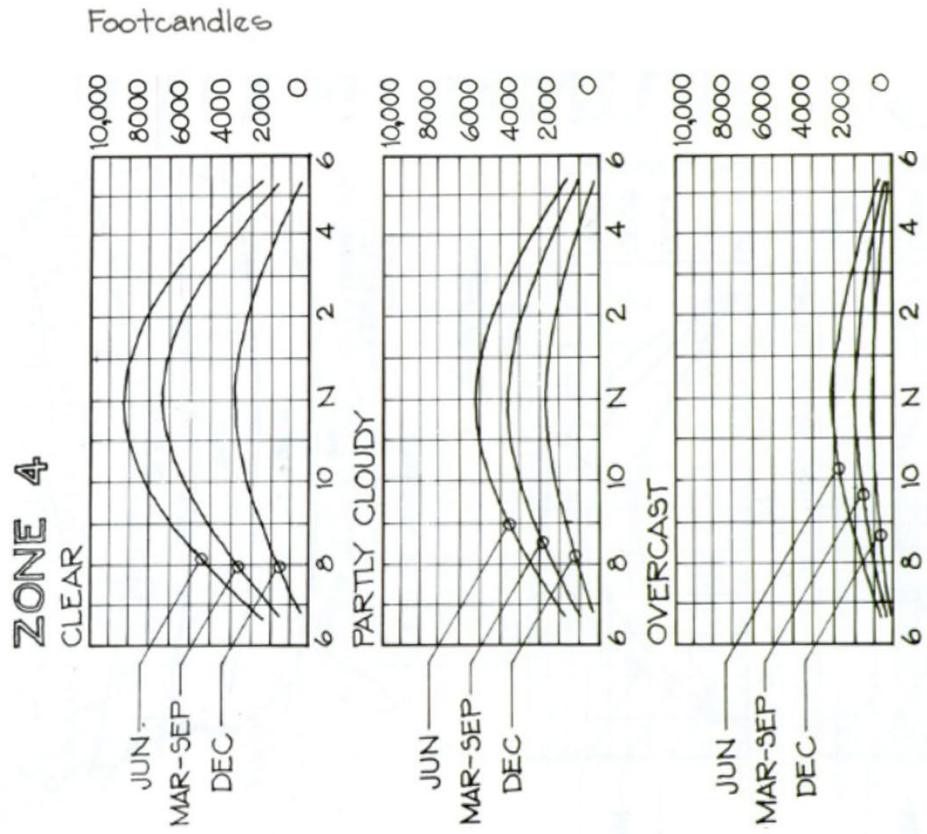
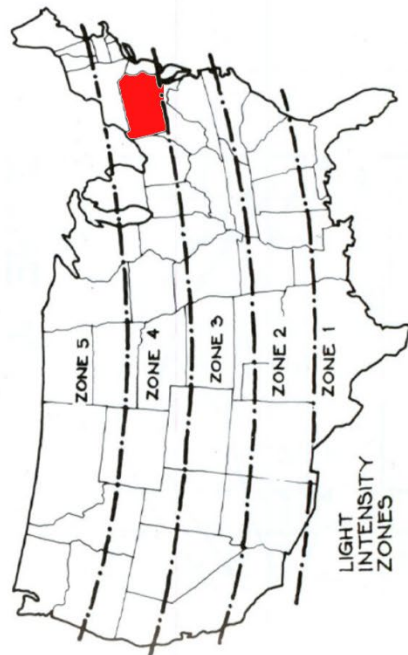
Figure 33 Light Intensity Zones in US & Yearly Light Intensity in Philadelphia (Architect's Handbook of Energy Practice- Daylighting)

As the climate difference occurs by the location, daylight is affected by geographical location. Philadelphia is within ASHRAE Zone 4A,³⁴ which is a mixed-humid climate zone. Figure 33 is about light intensity zones in US with the yearly light intensity in Philadelphia. Within the ASHRAE Zone 4A, the light intensity is described divided into three time points: June, March to September, and December. Sun path changes by location and season. The changes in the angle of the sun also affects the intensity of illuminance and daylight exposure time hours, creating a wide range of brightness and color palette of daylight. These wide spectrums of daylight had a great impact on the galleries of PAFA, giving viewers a new sense of space, depending on the time and weather of visit.

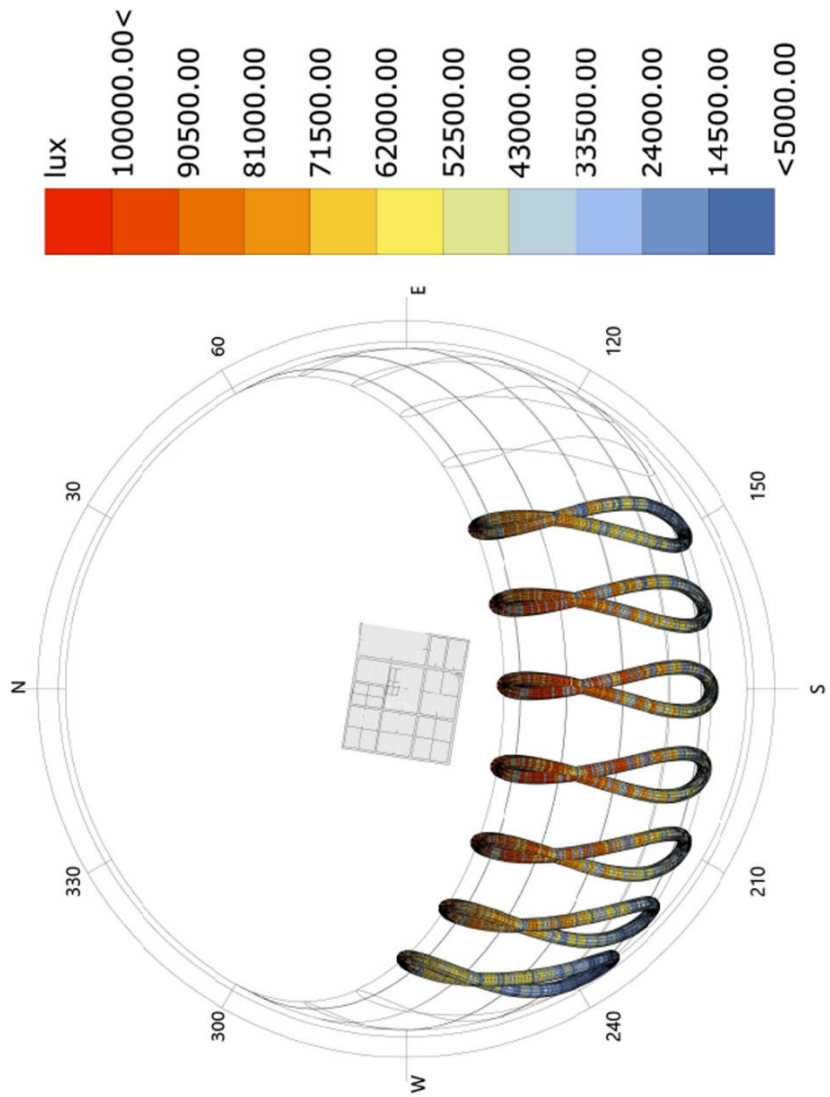
Figure 34 Sun path and Global Illuminance in Philadelphia (Yearly) (Pae, 2019)

Figure 34-36 shows the sun path and global illuminance in Philadelphia: during the whole year, during the winter season (December to February), and during the summer season (May to August) consecutively. Comparing the data, the less intense sunlight and an acute-angled sun path to the south side is observed in winter, which also results in shorter daylight exposure time. On the other hand, severe sunlight exceeding 100,000 lux is shown in the summertime with the steeper angle of sun path from the ground resulting in longer daylight exposure time. The sun angle from the ground is particularly important in the current condition as the research area is potentially shaded by taller structures. This angle determines whether the surface of the area will be exposed to the daylight, and this angle is observed in the simulation of PAFA.

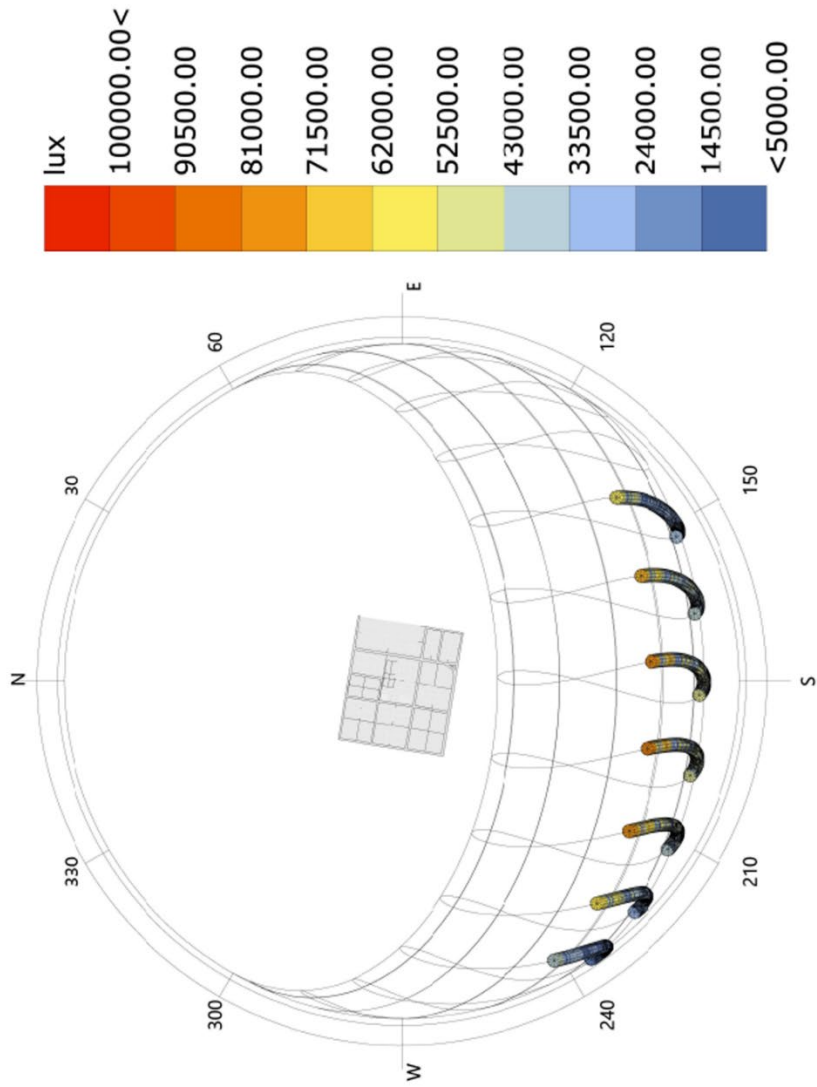
Figure 35 Sun path and Global Illuminance in Philadelphia (Dec to Feb) (Pae, 2019)

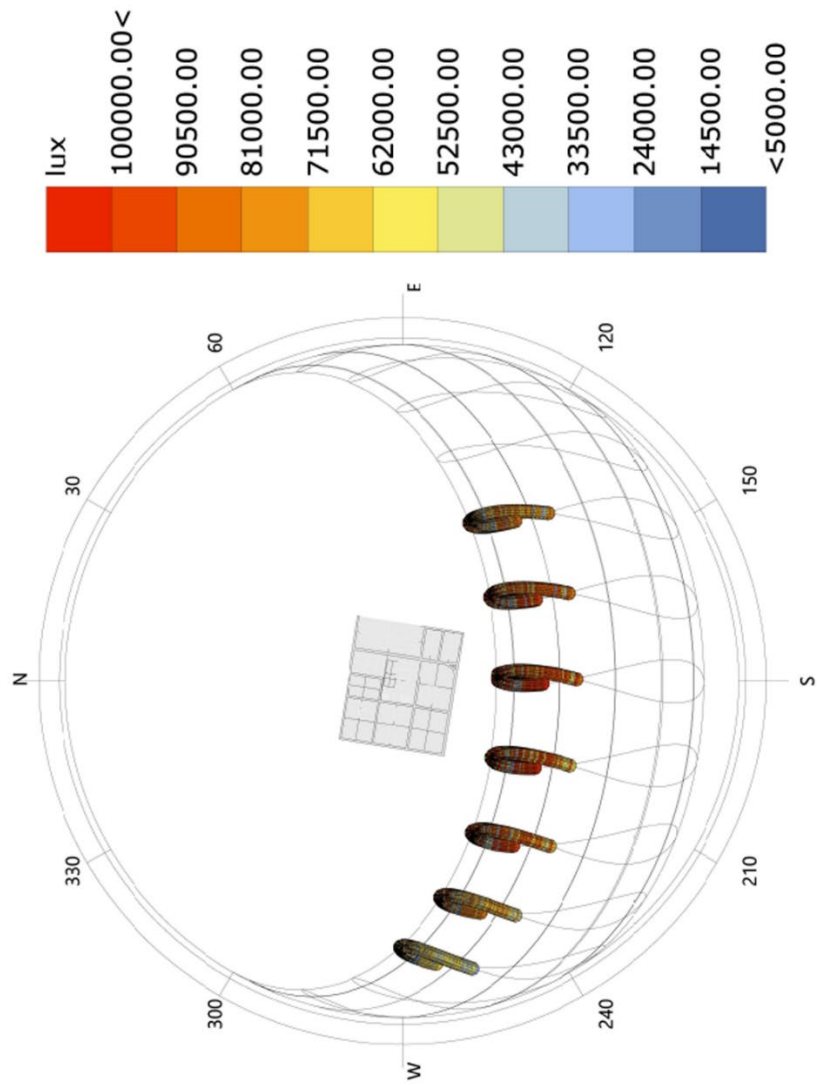
Figure 36 Sun path and Global Illuminance in Philadelphia (May to Aug) (Pae, 2019)

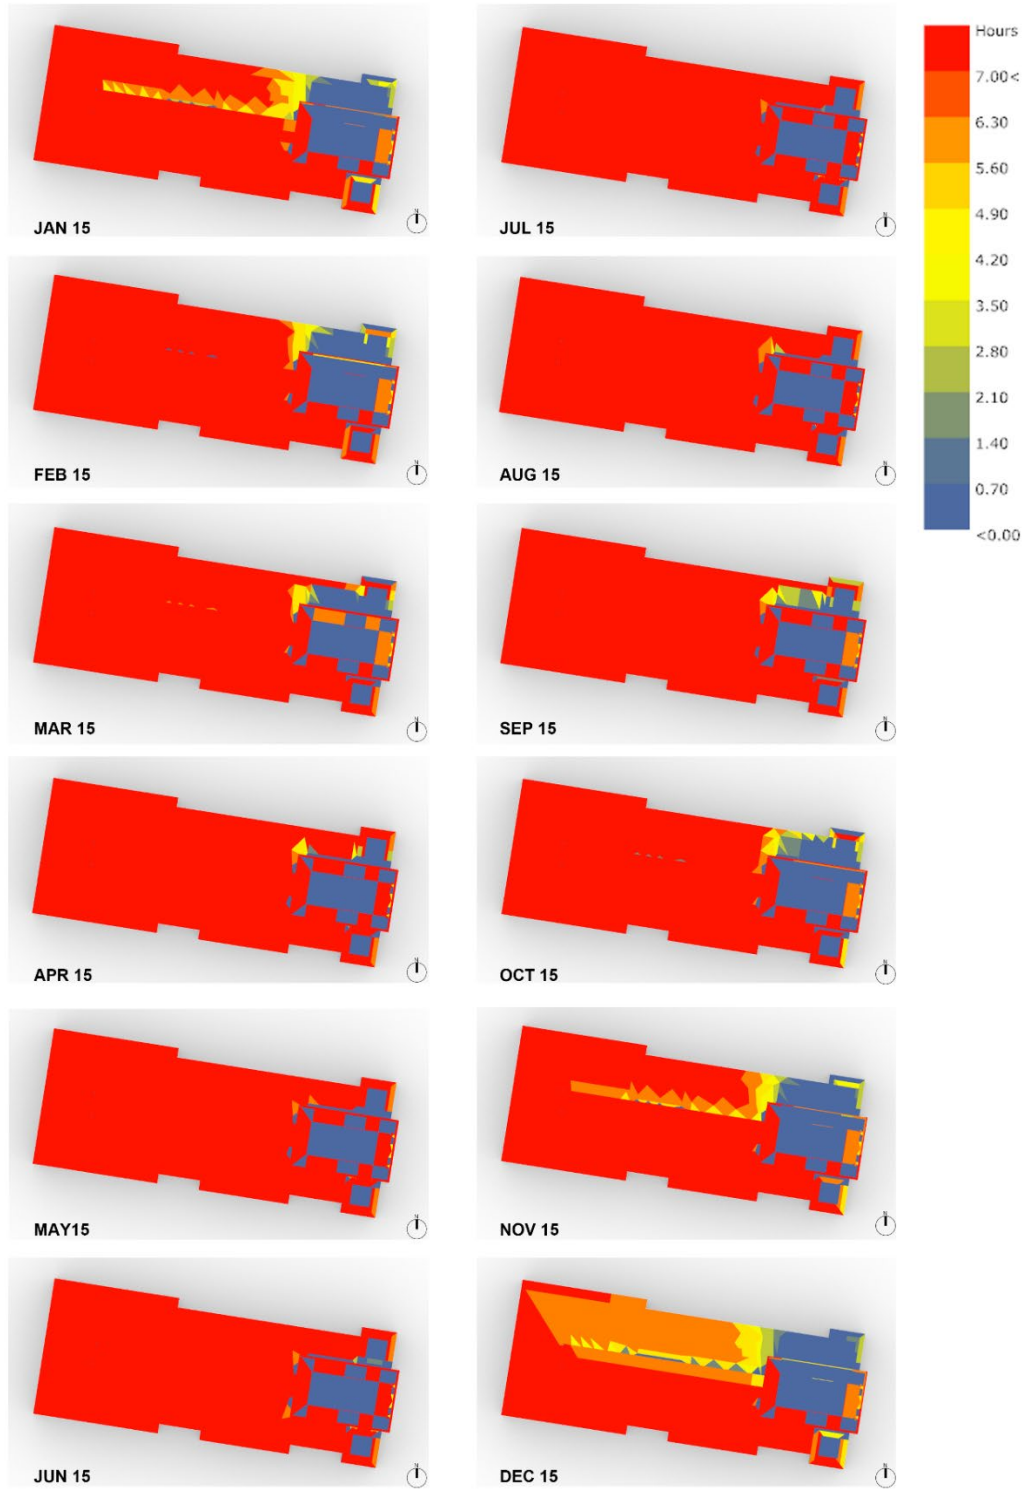
Sunlight Hours Analysis (10AM-5PM) in 1876

Figure 40 Sunlight Hours Analysis in 1876 (Pae, 2019)

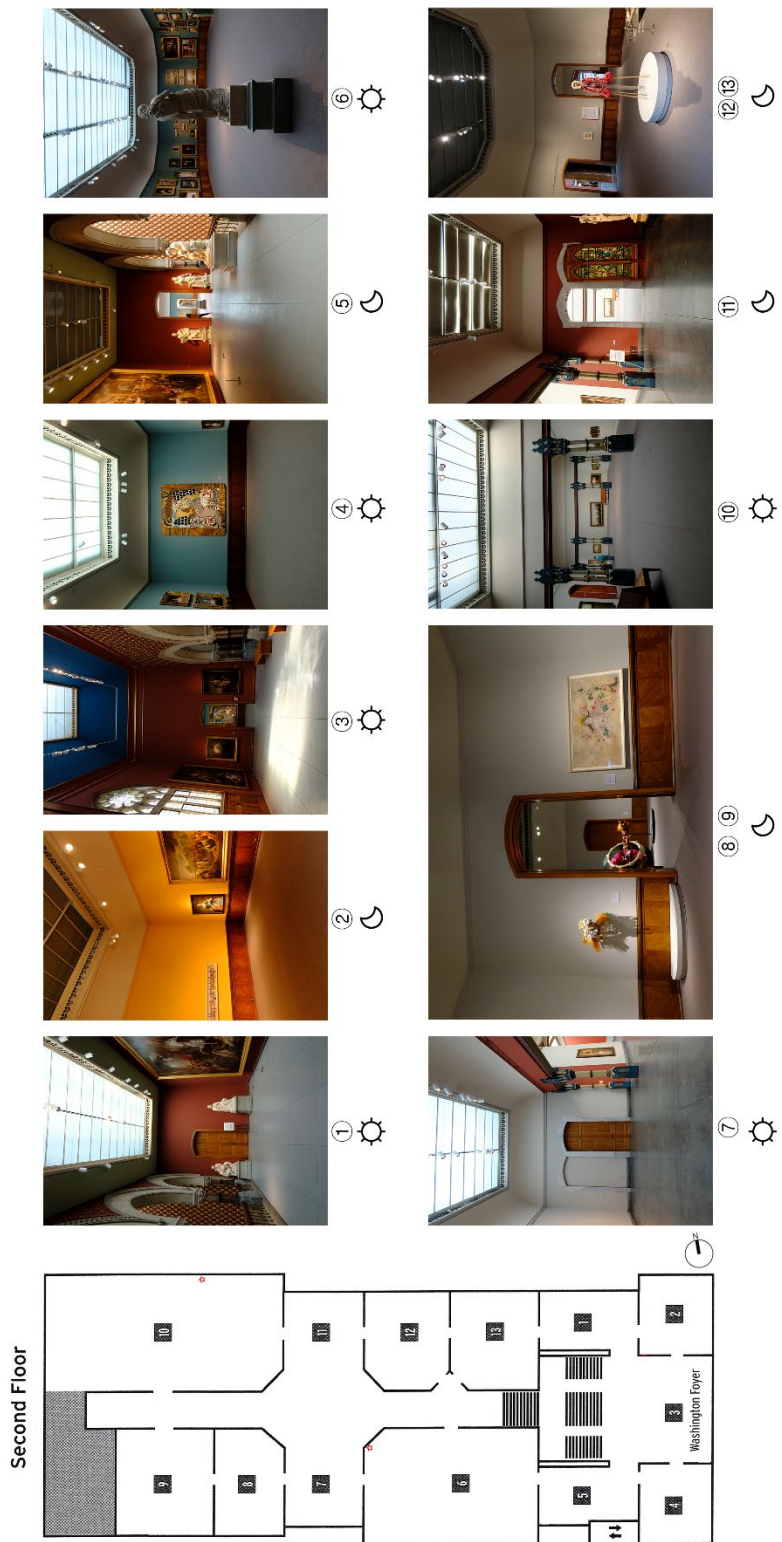
Figure 43 Shutters on the skylights on each gallery (Pae, 2019)

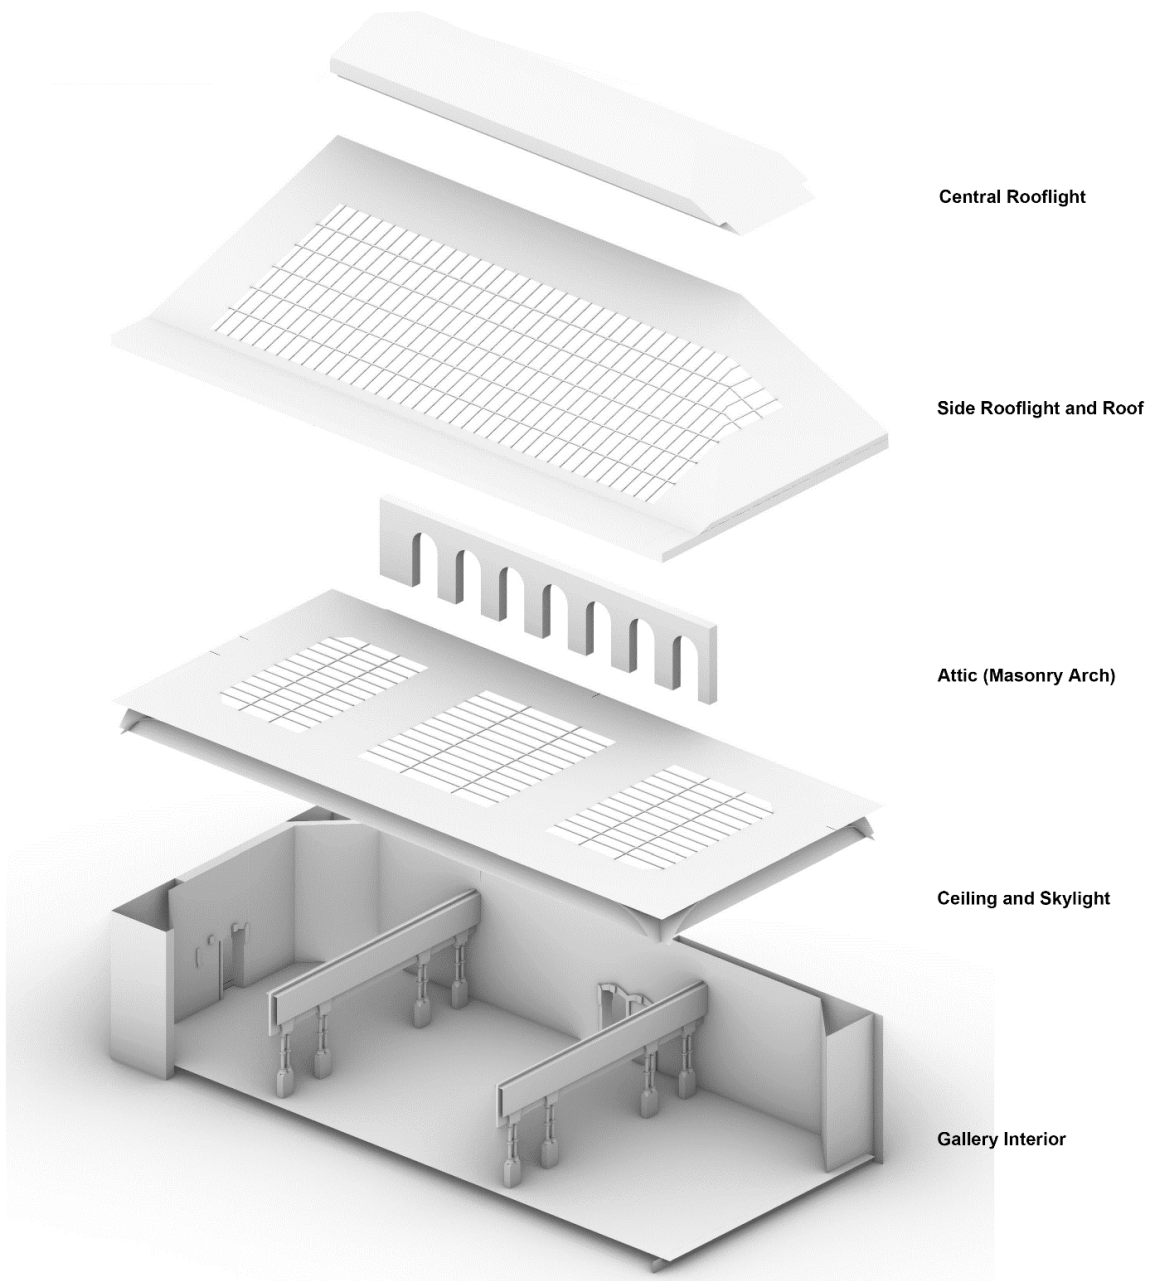
Figure 45 Structure diagram of the gallery (Pae, 2019)

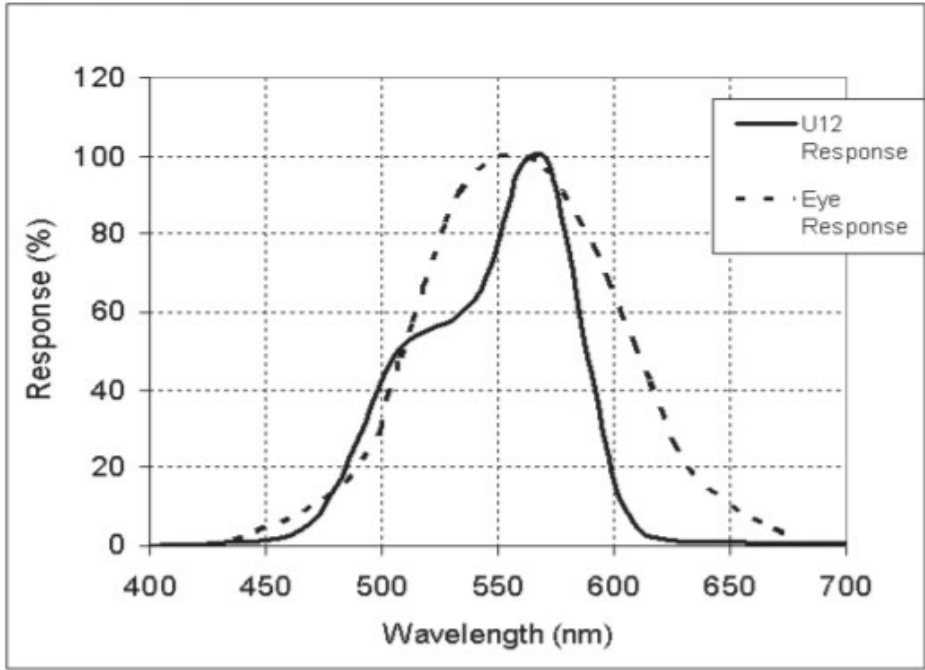
Figure 49 Response ratio of the light meter by the wavelength (HOBO U12 Manual)

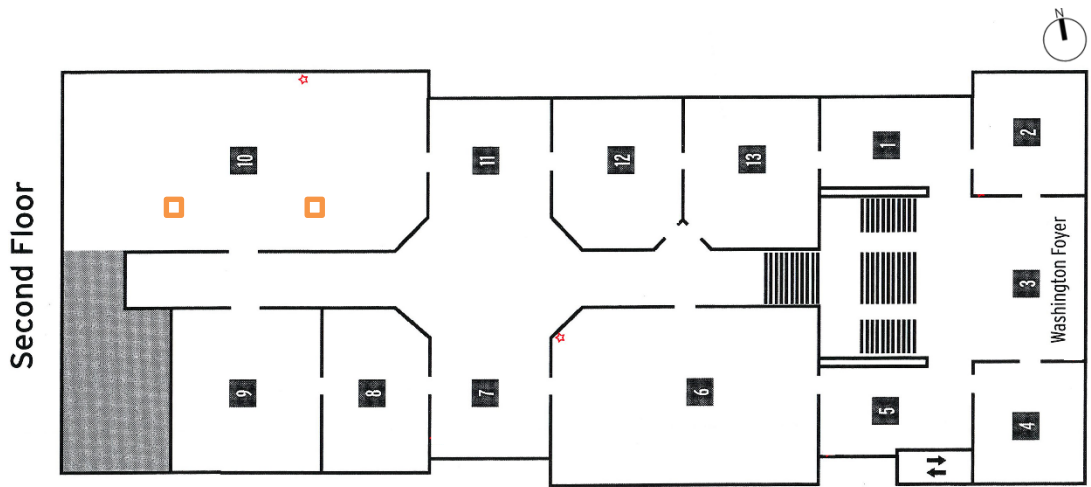
Figure 50 Installed location of the light loggers at gallery 10 (Pae, 2019)

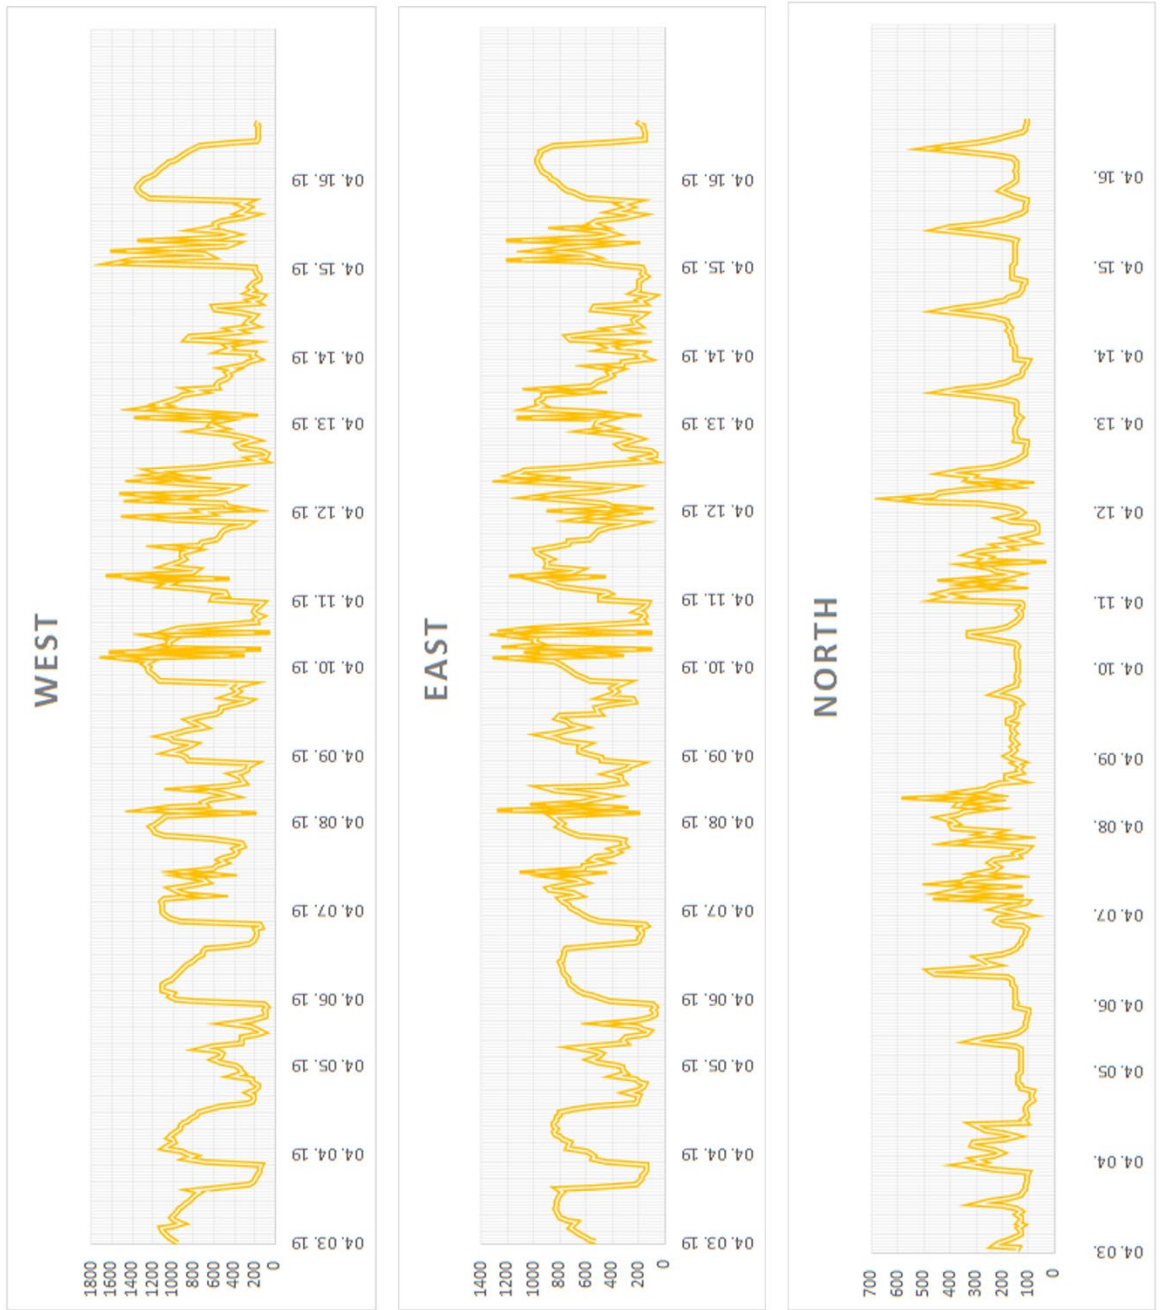
Figure 52 Illuminance data graph from Apr 3rd to Apr16th (Pae, 2019)

While contacting the PAFA, I have found that the museum had collected various data, including light intensity of the gallery. I have obtained the yearly data of illuminance on the gallery 6 and 10; from January 1st, 2016 to December 31st, 2016, from the Conservation Office in Pennsylvania Academy of the Fine Arts. The data were utilized as a worthy supplement to on-site research and was helpful in comparing with simulation results, as well as with my own light meter results. Therefore, to make the corresponding data, the same kind of light meter was used for my own on-site illuminance research.

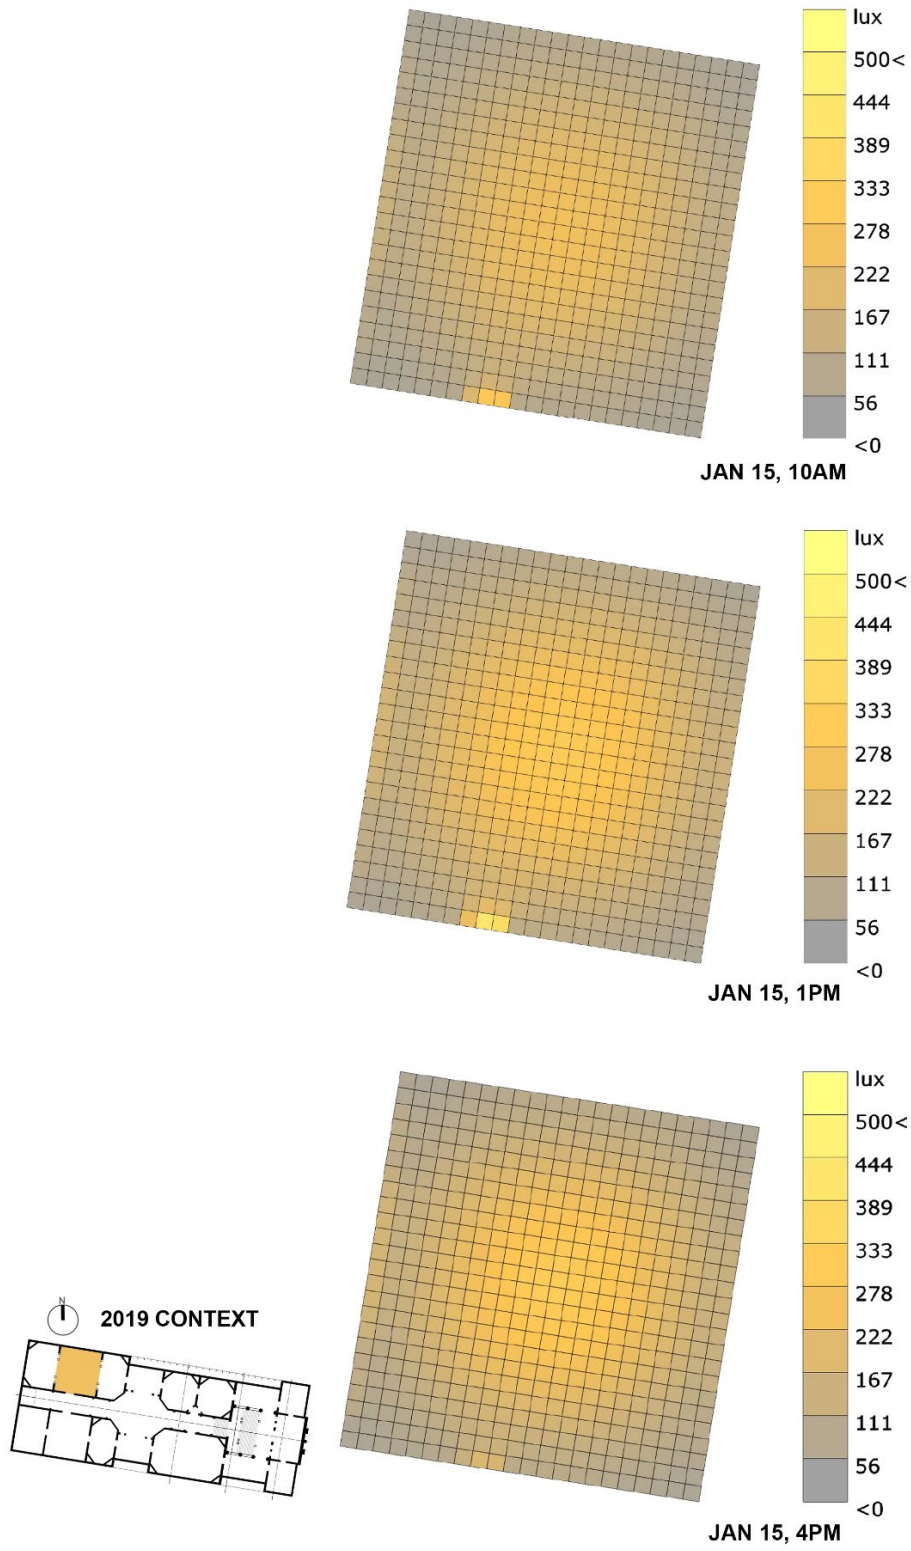
Figure 54 Current illuminance simulation results on Jan 15th (Pae, 2019)

environment has changed significantly throughout the day. The most intense daylight is observed at 10 AM, with the value exceeding 2000 lux. The illuminance gets dimmer as time goes by. In July, the daylight environment is strongest within a year. At 1 PM, the brightest part reaches over 5000 lux, which is also seen at the 1876 context with same day and time. This means that the changes in the surrounding areas have not influenced the daylight illuminance for this date and time. In October, the amount of illuminance is similar with the result in January.
