Authenticity of the Light Environment of the Pennsylvania Academy of the Fine Arts

A THESIS

Historic Preservation

MASTER OF SCIENCE IN HISTORIC PRESERVATION

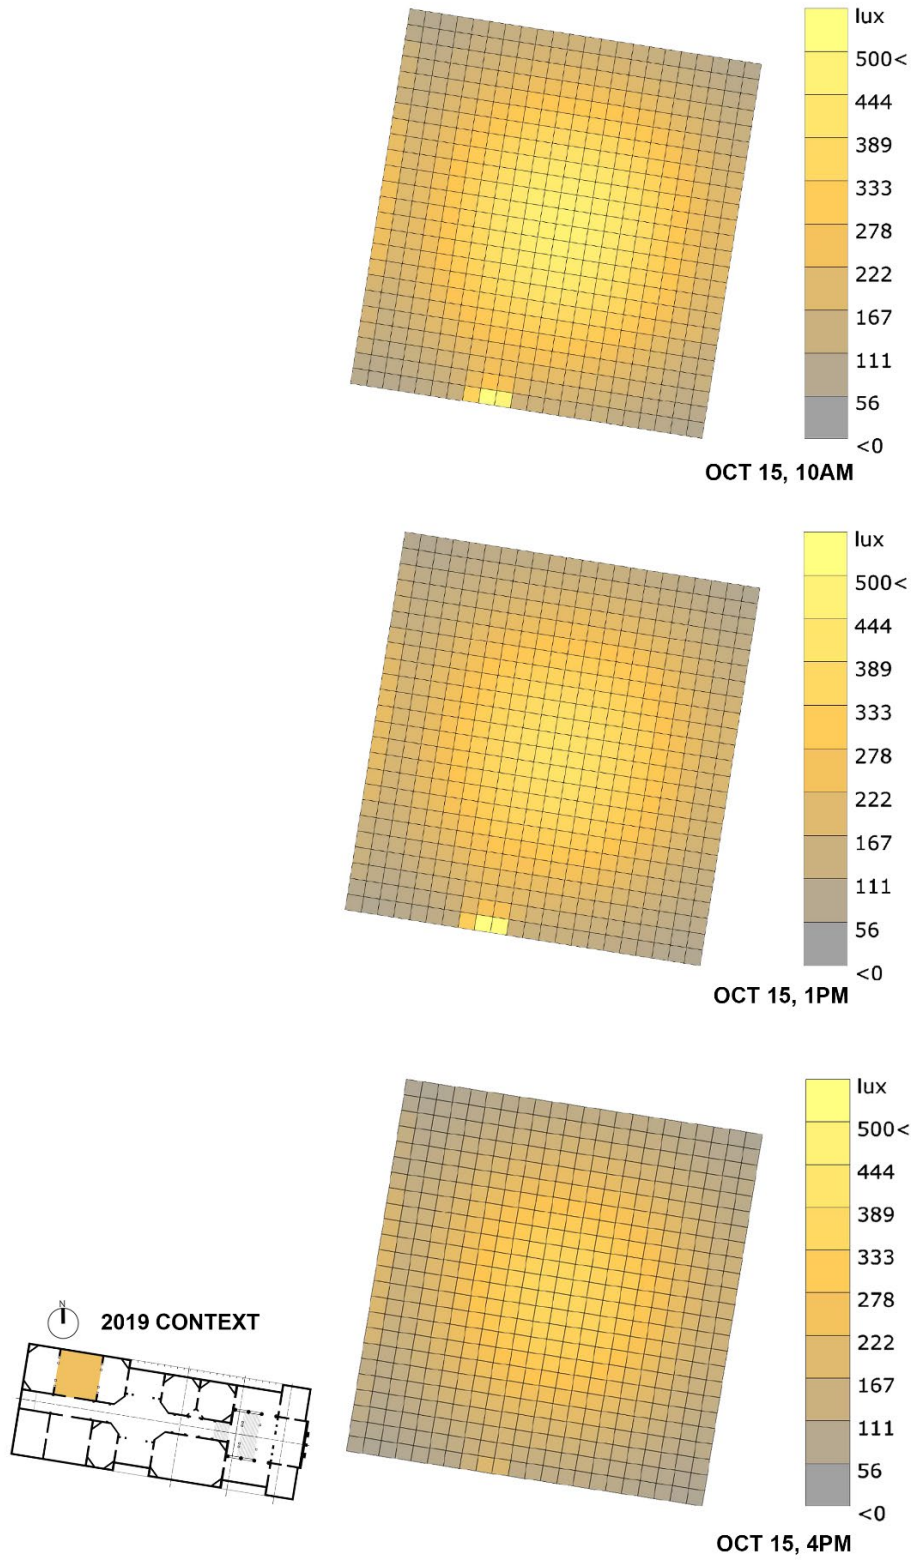
Figure 57 Current illuminance simulation results on Oct 15th (Pae, 2019)

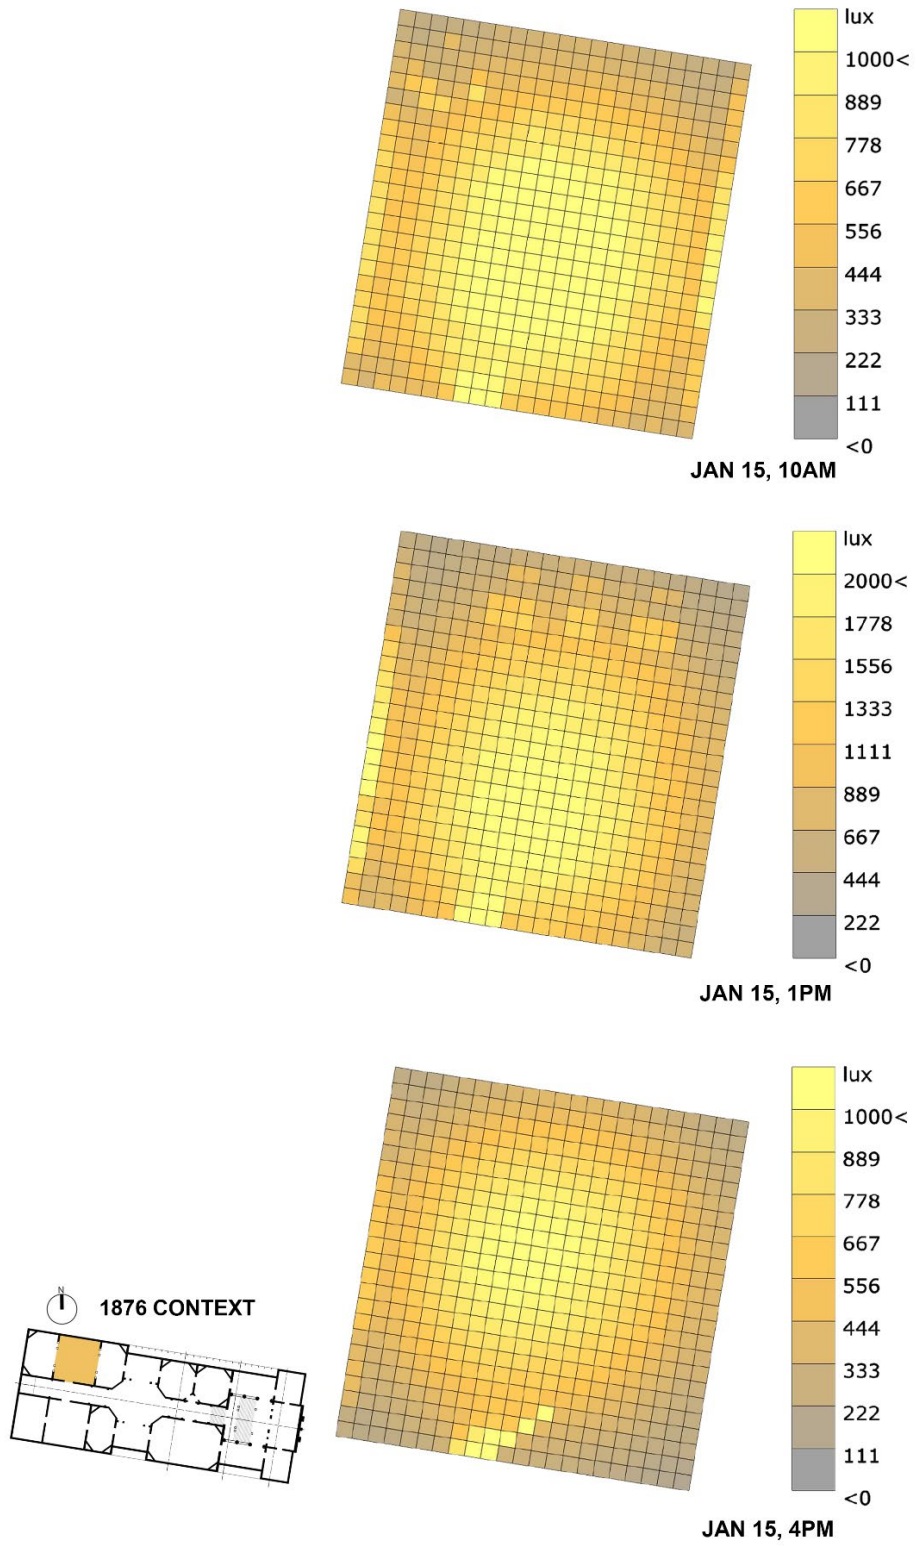
Figure 58 Historic illuminance simulation results on Jan 15th (Pae, 2019)

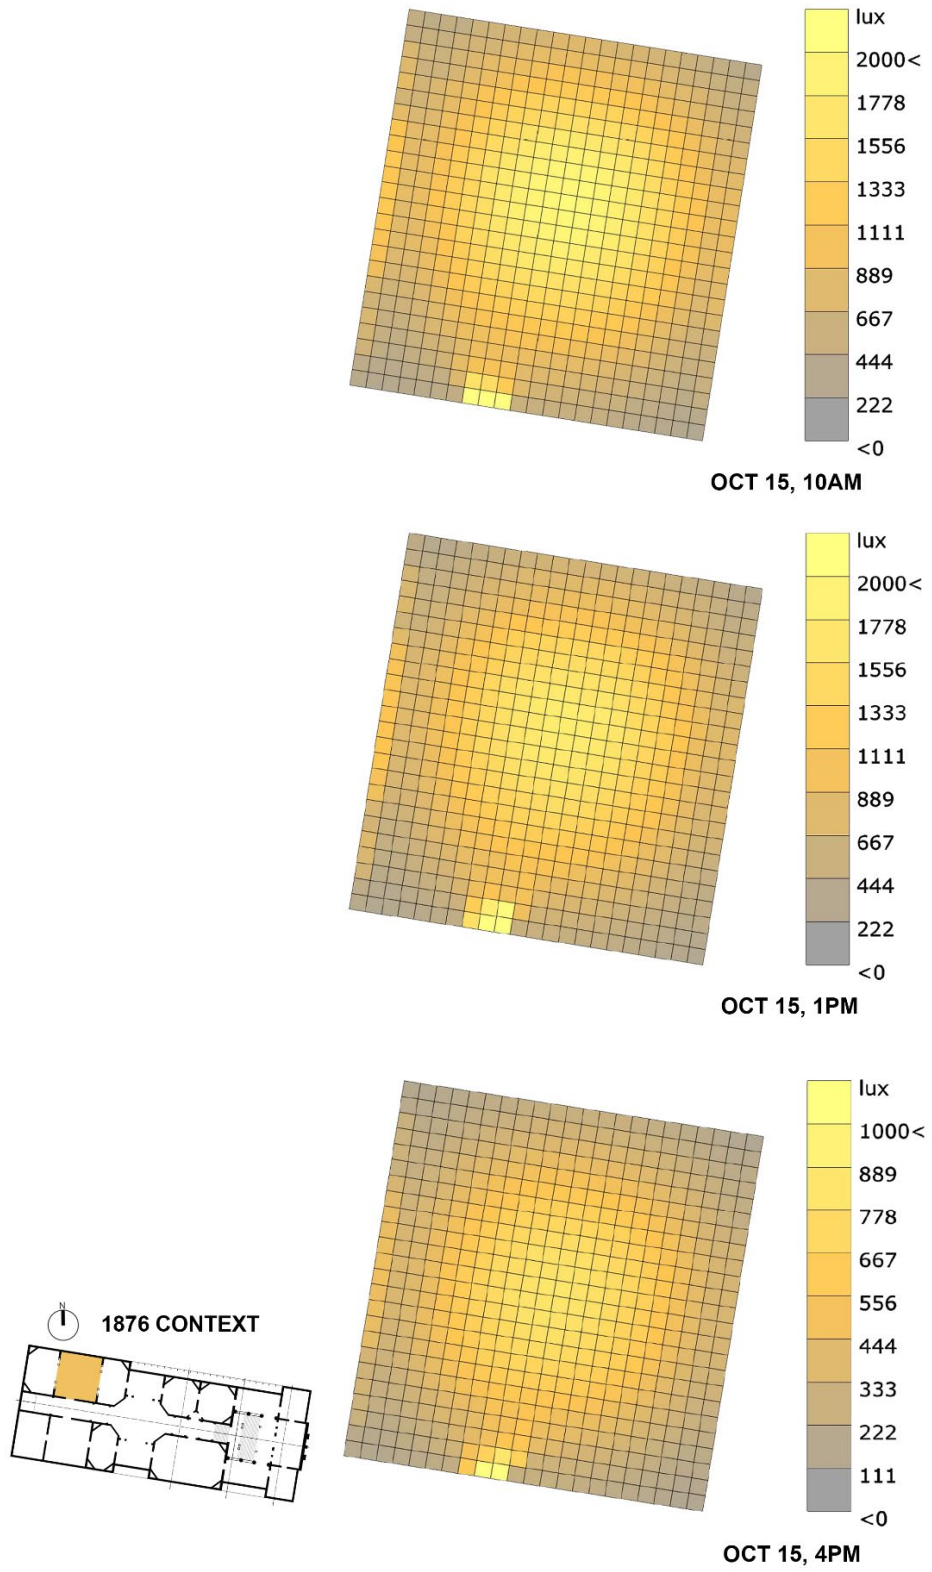
Figure 61 Historic illuminance simulation results on Oct 15th (Pae, 2019)
