# Multiplane/3D transesophageal echocardiography monitoring to improve the safety and outcome of complex transvenous lead extractions

Both transesophageal echocardiography (TEE) and intracardiac echocardiography have been used to assist transvenous lead extractions. The clinical utility of continuous echocardiographic monitoring during the procedure is still debated, with different reports supporting opposite findings. In cases where the procedure is expected to be difficult, we propose adding a continuous TEE monitoring using a static 3D/multiplane probe in mid-esophageal position, with digital remote manipulation of the field of view. This approach may improve the chances of a successful extraction, increase safety, or even guide the entire intervention. We present here a short case series where continuous monitoring by TEE played an important role.

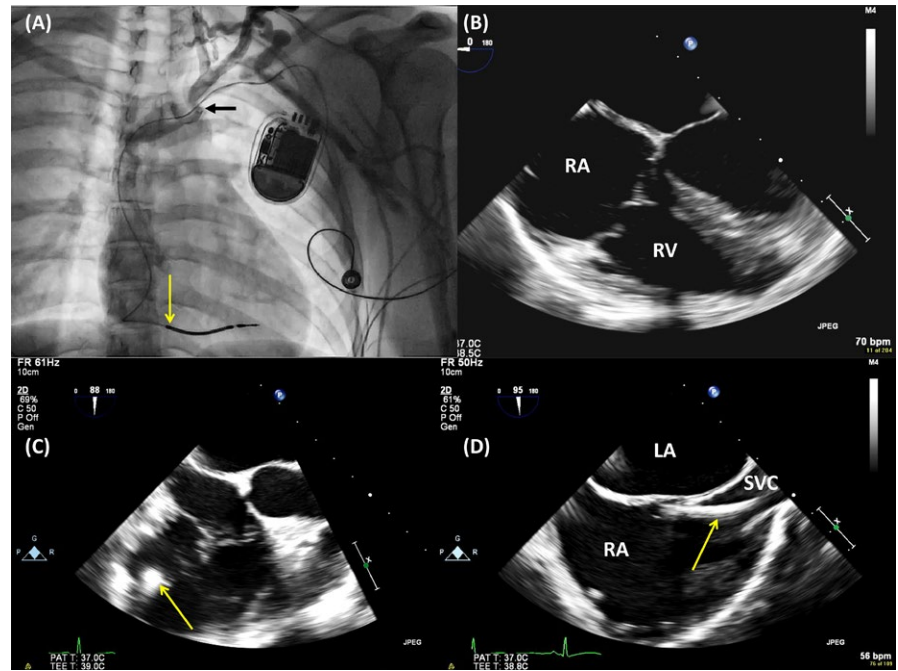
**FIGURE 1** A, Left arm phlebography. The subclavian vein stops abruptly (dark arrow), with collateral filling visible above; the right ventricular lead is indicated with a yellow arrow. B, In 2D transesophageal 4-chamber view, the lead was difficult to image being situated very posteriorly; C, in short axis of the tricuspid valve, the lead becomes visible; D, bicaval view, demonstrating the relation between the lead and the superior vena cava

of electrical noise resulting in aborted shocks and needed to be replaced. On left arm phlebography, a total occlusion of the left subclavian vein in its mid-portion was noted, probably in relation to the presence of the lead. Venous return from the left arm followed a collateral supraclavicular system to join the more proximal left subclavian (Figure 1). Because of the venous occlusion, endovascular adhesions were suspected along the lead and we decided to perform the intervention under TEE monitoring. The shock lead was difficult to visualize with 2D echocardiography because of its position in the posteroseptal commissure. Switching to 3D imaging allowed clear visualization of the lead course, from the terminal part of the superior vena cava (SVC), through the tricuspid valve, and up to the right ventricular (RV) apex (Figure 2, Movie S1). No venous or valvular adhesions were noted. Because of a very narrow subclavian passage, but without any venous adhesions, the lead was extracted via

felt while pulling on the lead, a free-floating lead is very likely. In the presence of occlusion in the innominate vein (case 1), this maneuver is not useful. In this case, TEE was useful to demonstrate the absence of vascular and valvular adhesions from the level of the SVC to RV. Snaring the lead was deemed the most logical option in this case.

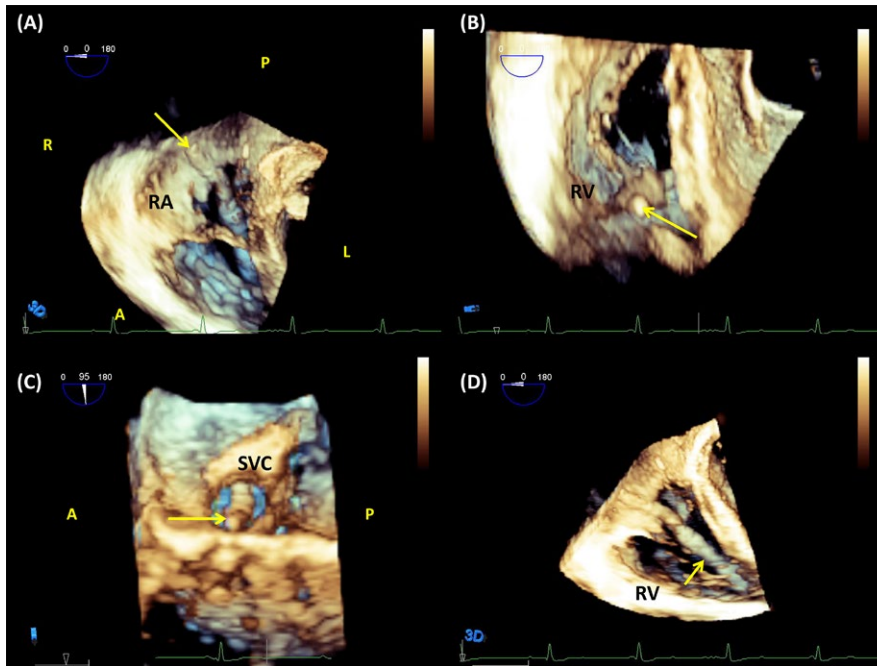
**FIGURE 2** A, On tridimensional echocardiography, the lead was easily identifiable in the posterior commissure of the tricuspid valve from the right atrial aspect of the valve; B, the lead is free from adherences to the valve, coursing further to the apex of the right ventricle (RV). C, Transversal view of the superior vena cava demonstrated a lead (arrow) moving freely from the venous walls; D, RV segment of the lead, visible up to the apex

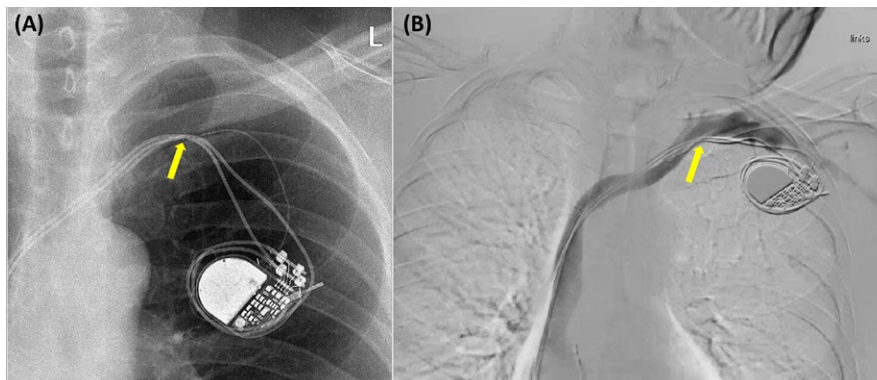
**FIGURE 3** A, crushed leads (arrow) in the subclavian passage, visible on focused X-ray. Note the presence of three leads (two active leads and one old inactive right ventricular lead); B, left arm phlebography confirming the crush

A 69-year-old man with sick sinus syndrome had a dual-chamber pacemaker implanted in 2010. Shortly after implantation, both leads became dysfunctional. During the first extraction, both leads were replaced but only the atrial lead could be removed. The old RV lead was abandoned. In 2017, the new leads also became dysfunctional. The chest X-ray and left arm phlebography showed signs of subclavian crush syndrome (Figure 3). The presence of three relatively old leads was considered to complicate the extraction procedure, which was then performed under continuous TEE monitoring (Figure 4). The locking stylet could not be inserted in the leads (probably due to the subclavian crush); thus, a femoral approach with a snare tool (Needle's-Eye Snare, Cook Medical) was chosen. The atrial lead was extracted with ease as well as the most recent implanted RV lead. During careful but progressive pulling of the abandoned RV lead, we saw near inversion of the RV cavity with TEE (Figure 4). In this short period, the blood pressure dropped but quickly recovered after the lead detached and the RV re-expanded (Movie S2). The patient was re-implanted with a new dual-chamber pacemaker (Figure 5). No complication was noted, and the patient was quickly discharged.

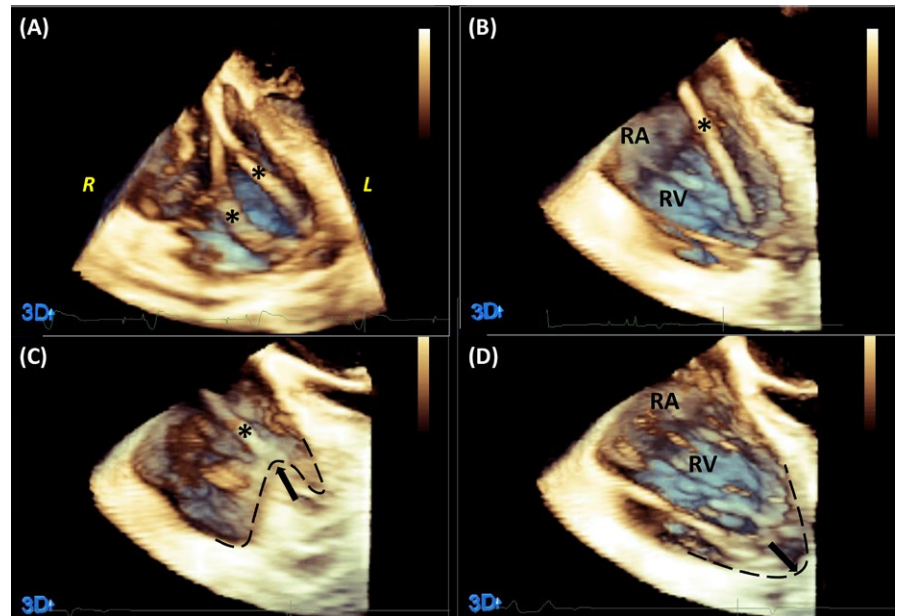
**FIGURE 4** 3D echocardiography focused on the right ventricle (RV) and right atrium during the ventricular lead extraction. A, Start of the procedure, with the two RV leads in situ (asterisk). B, The first lead was easily extracted; C, near inversion of the RV cavity (arrow, dashed contour) during pulling of the last lead; D, RV cavity re-expanded after the lead detached (arrow, dashed contour)

Transesophageal echocardiography is also useful for rapidly identifying or excluding cardiovascular causes of hemodynamic instability during a TLE procedure.<sup>3,5,10</sup> It is especially useful for monitoring pericardial effusion. Another important cause of hemodynamic instability is impairment of venous return during controlled pulling on the leads as demonstrated by case 2. RA or RV retraction limits venous return and lowers LV filling causing hypotension. Hemodynamic stability is acquired by releasing pulling pressure or successful extraction.

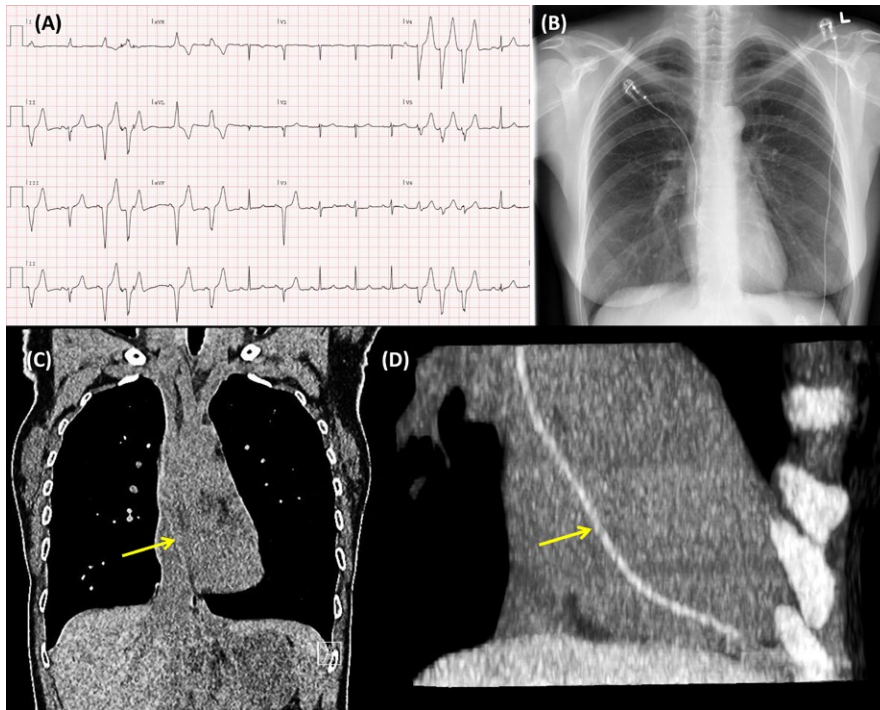
**FIGURE 6** A, ECG sinus rhythm with frequent multifocal premature ventricular complexes; B, normal thorax X-ray, no lead fragment could be seen; C, CT scan frontal plane, focused on the caval veins: A linear structure (arrow) could be noticed in the proximal superior vena cava. D, CT focused oblique view of the right atrium and right ventricular, demonstrating the linear structure (arrow) coursing to the apex of the right ventricle

full-system dual-chamber pacemaker extraction. No pacemaker was re-implanted due to the absence of pacing in the previous 5 years. Her ECG at presentation showed sinus rhythm with frequent multifocal premature ventricular complexes and short runs of ventricular tachycardia. Her chest X-ray was normal and did not demonstrate a complication of the recent lead extraction. On transthoracic echocardiography, a very weak linear echo was visible (Movie S3) in the right atrium (RA). A thoracic CT scan was performed, and a linear structure could be noticed coursing from the proximal SVC to the RV apex (Figure 6). The most probable diagnosis was a retained fragment of the silicone insulation of the previous extracted RV lead. After discussing the case in a heart team, it was decided to try a TEE-guided percutaneous removal. Surgical removal remained as an escape option. The retained silicone sheath could not be visualized with high-intensity fluoroscopy; thus, the extraction was guided by TEE. By 3D and multiplane imaging, the silicone insulation sheath was visible from the terminal part of the superior vena cava (Movie S4), coursing through the RA, the tricuspid valve, and ending in the RV apex, "trapped" into the complex trabeculae but without being firmly attached (Figure 7). The upper end of the fragment was found floating freely in the last 4 centimeters of the superior vena cava, clearly visible on multiplane and 3D TEE (Figure 8, Movie S4). A snare tool (Needle's-Eye Snare, Cook Medical) was guided into the RA using fluoroscopy. Thereafter, guiding was performed using multiplane/3D echocardiography alone, from a modified bicaval view. The snare tool was advanced into the SVC, and the retained silicone sheath was snared and removed (Figure 8, Movie S5). Extraction was complete, confirmed by visual inspection of the insulation fragment and TEE. The patient had no recurrence of ventricular arrhythmia, despite discontinuation of antiarrhythmic drugs. She was quickly discharged to outpatient follow-up.

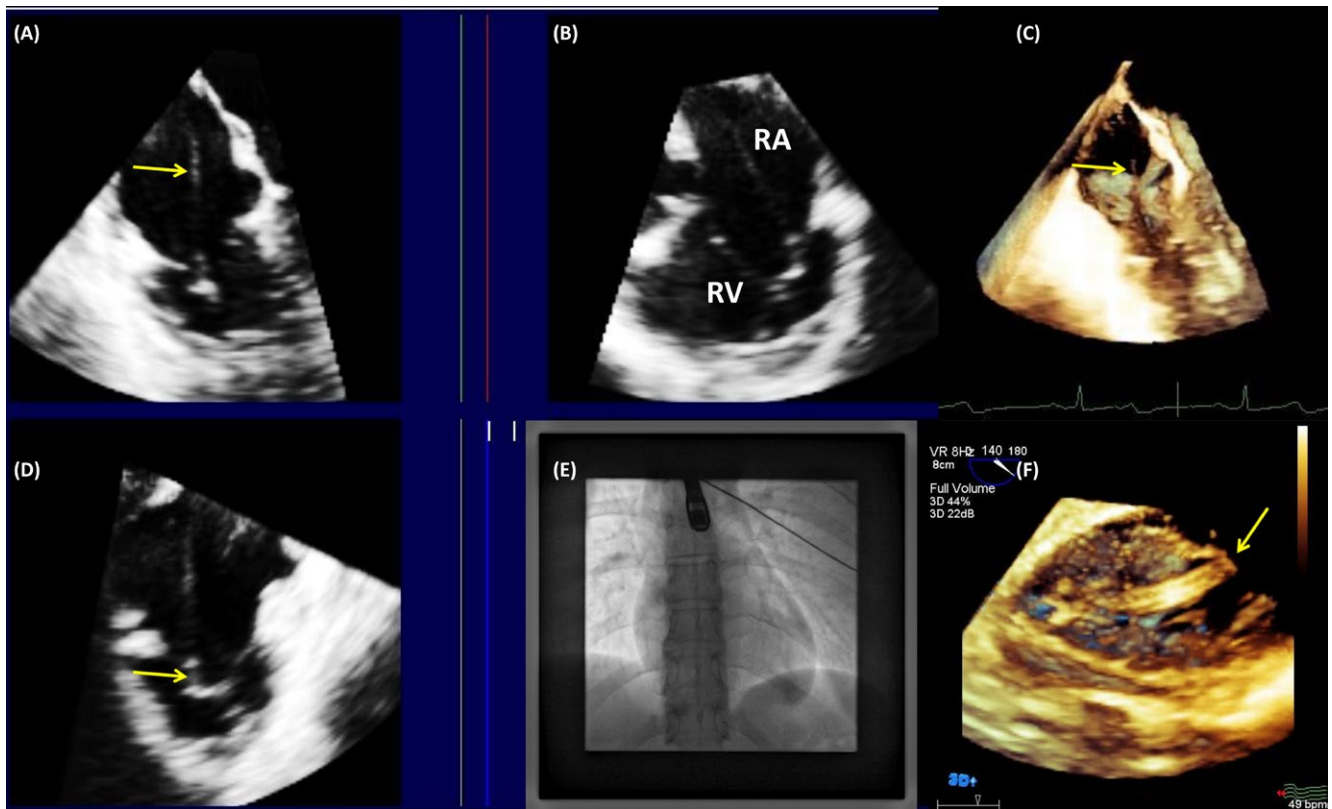
**FIGURE 7** 3D and multiplane sections of the right cavities demonstrating the presence of the radiotransparent insulation sheath. A, B, D, triplane sections of right atrium (RA) and right ventricular (RV). The silicone insulation sheath is coursing through the right atrium, the tricuspid valve, and ending in the right ventricular apex (F, arrow); C, 3D view of RA and RV in mid-esophageal position, the insulation sheath is also visible as a relatively weak but clear linear echo (arrow); E, with high-resolution angiography, the sheath could not be seen

fracture due to mechanical stress during extraction and become obvious on fluoroscopy checkup. Cases have been described of remaining fragments of the silicone protective tube around the lead. These can easily be missed by fluoroscopy if no metallic fragment is retained.<sup>12,13</sup> Echocardiography however is an ideal imaging tool in this clinical scenario, given the relatively high contrast between intracavitary blood and any type of solid foreign body. This is illustrated by our Patient 3 in whom, although a multimodality approach was needed for the diagnosis, TEE was the only intraprocedural imaging tool allowing successful guidance of the TLE procedure.
