10th IMC
10th International Masonry Conference
G. Milani, A. Taliercio and S. Garrity (eds.)
Milan, Italy, July 9-11, 2018

DYNAMIC MONITORING OF ANCIENT MASONRY TOWERS: ENVIRONMENTAL EFFECTS ON NATURAL FREQUENCIES

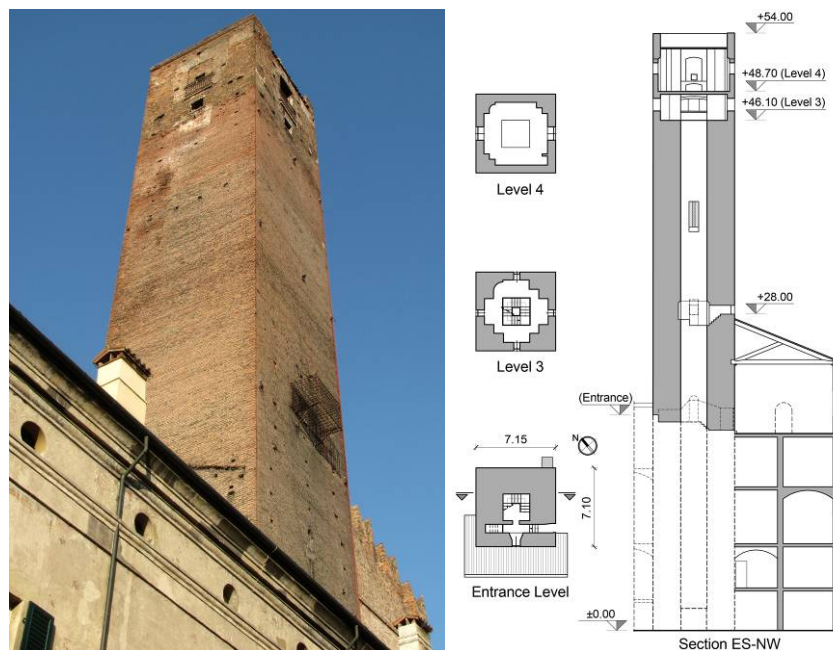
Figure 1: View of the *Gabbia* tower in Mantua, Italy and sections of the tower (dimensions in m).

The *Gabbia* tower [5-6] (Fig. 1), with its 54.0 m height, is the tallest tower in Mantua. The tower was built in 1227 for defensive purposes by the Bonacolsi family, governing Mantua in the 13th century. The structure is built in solid brick masonry and the load-bearing walls are about 2.4 m thick, except in the upper levels, where the walls thickness decreases to about 0.7 m. As shown in Fig. 1, the tower is nowadays part of an important palace, whose load-bearing walls seem to be not effectively connected to the tower; nevertheless, the several vaults and floors of the palace are directly supported by the tower. While the main part of the building – below the height of about 46.0 m from the ground level – does not exhibit any evident structural damage (with the materials being only affected by superficial decay), the upper part of the tower is in a poor state of preservation. In more details, at a distance of about 8.0 m from the top, the brick surface workmanship changes and the masonry quality significantly decreases (as it was confirmed by pulse sonic tests); furthermore, the presence of several structural discontinuities and the lack of mechanical connection between subsequent additions determined concerns on the seismic behavior of the upper part of the tower.

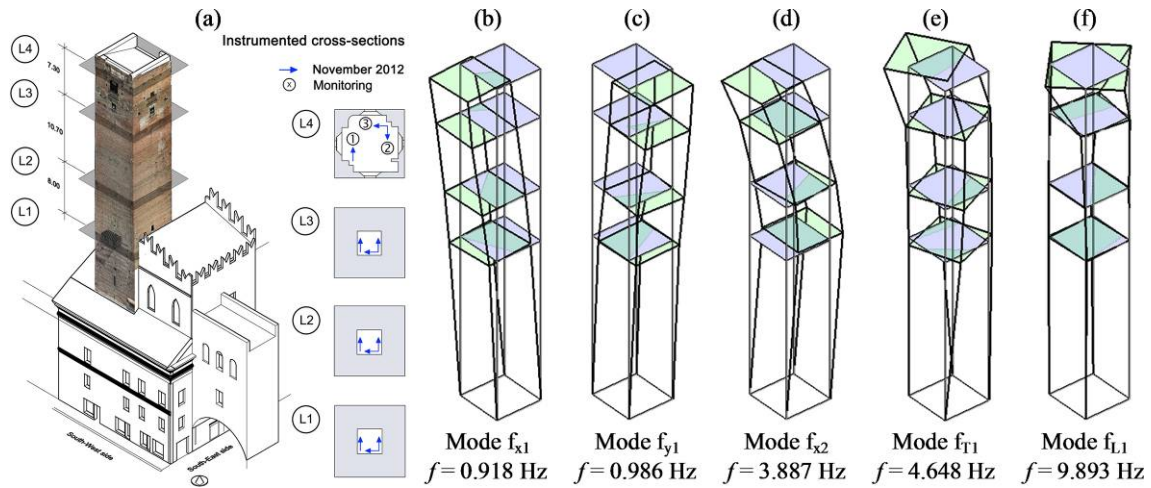
Figure 2: (a) Instrumented cross-sections and layout of the accelerometers during the preliminary tests (November 2012) and the continuous dynamic monitoring; (b)-(f) Identified modes of vibration.

After preliminary ambient vibration tests (November 2012, Fig. 2), a simple dynamic monitoring system was installed in the tower on December 17th, 2012 (and removed at the beginning of July 2015). The sensing devices consisted of: (i) three piezoelectric accelerometers (WR model 731A, 10 V/g sensitivity and ± 0.50 g peak), mounted on the cross-section at the crowning level of the tower (Fig. 2a), and (ii) one temperature sensor, installed on the S-W front and measuring the outdoor wall temperature.

Five vibration modes were identified in the preliminary ambient vibration tests and the corresponding natural frequencies were successfully tracked during the monitoring period. As shown in Fig. 2, the identified modes correspond to three bending modes (Figs. 2b-d), one torsion mode (Fig. 2e) and one local mode involving the upper part of the structure (Fig. 2f).

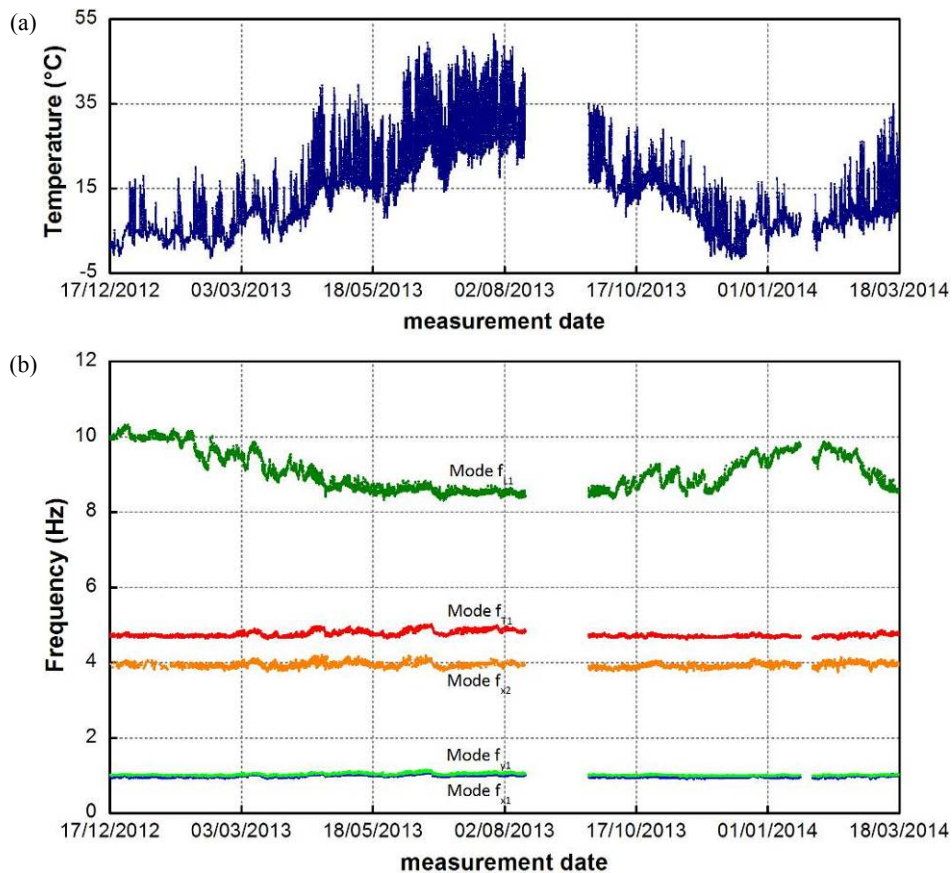
Figure 3: Time evolution (from 17/12/2012 to 17/03/2014) of: (a) the temperature measured on the S-W front of the tower; (b) the automatically identified natural frequencies.

Figure 3 reports the time evolution of the outdoor temperature (S-W front, Fig. 3a) and of the automatically identified modal frequencies (Fig. 3b) for a period of about 15 months, from 17/12/2012 to 17/03/2014.

The temperature tracking reveals large fluctuations, between -2°C and $+45^\circ\text{C}$, with significant daily variations on sunny days. A closer inspection of Fig. 3b highlights that the natural frequencies of global modes (f_{x1} , f_{y1} , f_{x2} and f_{T1} , Fig. 2) vary accordingly with the outdoor temperature. This correlation can be better investigated by plotting each modal frequency with respect to the recorded temperature. Figs. 4a-c show the results obtained for modes f_{x1} , f_{y1} and f_{T1} along with the best fit lines and the coefficient of determination R^2 : the three plots refer to the time period from 17/12/2012 to 20/06/2013 and confirm that the frequency of global

In order to complete the discussion of the results of the *Gabbia* tower's monitoring with the local mode f_{L1} , Fig. 3b shows that frequency evolution of f_{L1} looks very different from the others and is characterized by significant frequency variations (approximately in the range 10.33-8.33 Hz); similarly, Table 1 confirms that high values of the standard deviation are especially observed for this mode. The observed behavior suggests the progress of a possible damage mechanism, conceivably related to the thrust exerted by the inclined wooden roof with increased temperature, and confirms the poor structural condition and the high vulnerability of the upper part of the tower. This conclusion seems to be confirmed by the frequency loss of the local mode detected after one year of monitoring (and after the earthquake), with the natural frequency being unable to reach the maximum values identified one year before in a similar temperature conditions (Fig. 3b).

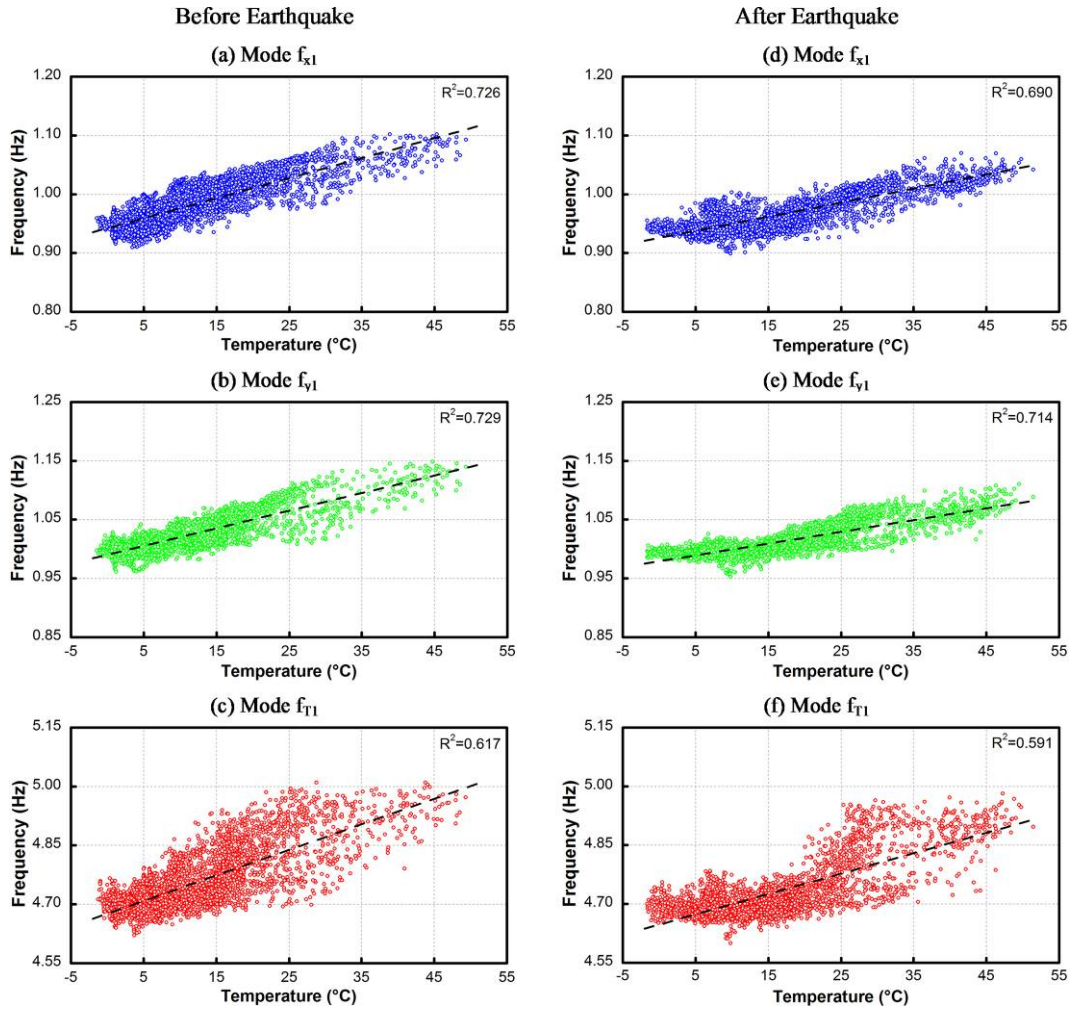
Figure 4: Natural frequency of modes f_{x1} , f_{y1} and f_{T1} plotted versus the outdoor temperature: (a)-(c) from 17/12/2012 to 20/06/2013; (d)-(f) after 21/06/2013.

modes tends to increase with increased temperature. This behavior, observed in all studies of masonry towers [3-10, 12] can be explained by the closure of superficial cracks, minor masonry discontinuities or mortar gaps induced by the thermal expansion of materials.

The frequency-temperature relationships obtained after the Garfagnana earthquake (21/06/2013) are shown in Figs. 4d-f. The comparison with the results referred to the first six months of monitoring (Figs. 4a-c) reveals significant differences: the frequency dependence on temperature still remains roughly linear but the regression lines of all modes exhibit remarkable variations after the earthquake, with the temperature range being almost unchanged. This trend is also confirmed by the general decrease of the statistics of the natural frequencies (mean value, standard deviation, extreme values) summarized in Table 1 and highlights the occurrence of abnormal structural changes.

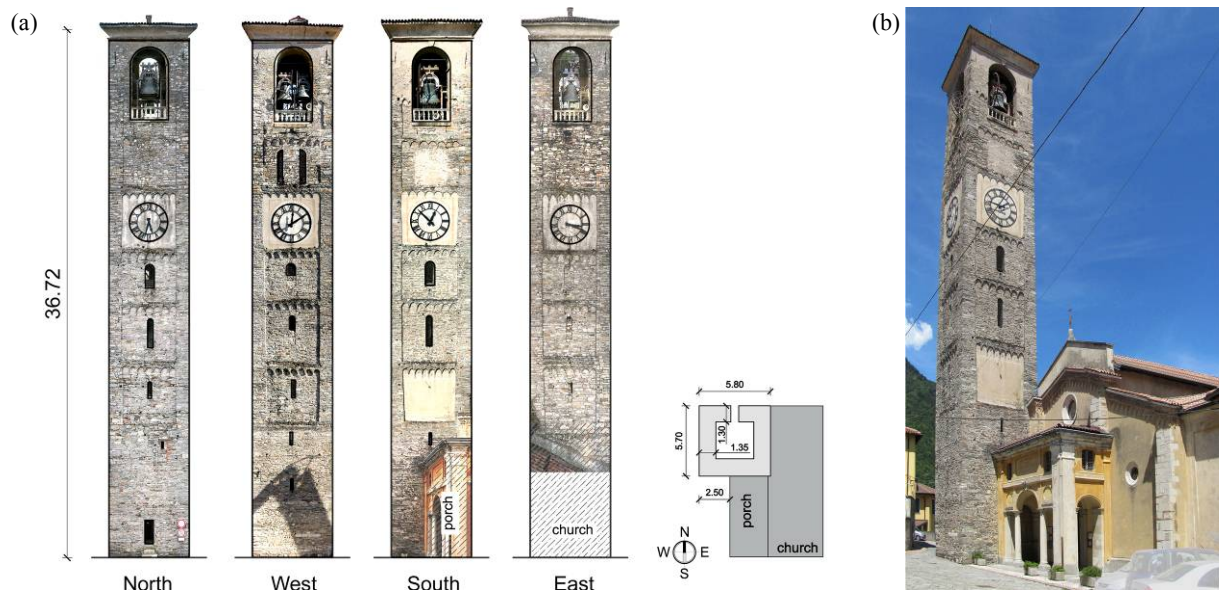
Figure 5: (a) Fronts and cross-section (dimensions in m) of the *San Vittore* bell-tower; (b) View of the bell-tower.

The *San Vittore* bell tower [4-5, 8, 17] is located in the small town of Arcisate (northern Italy) and is connected to the neighboring church *Chiesa Collegiata di San Vittore* (11th century) on the east side and partly on the south side (Fig. 5). The tower, built in stonework masonry, is about 37.0 m high and has a square plan (5.8 m \times 5.8 m); the thickness of the

load-bearing walls progressively decreases from 135 cm at the ground level to 65 cm at the top.

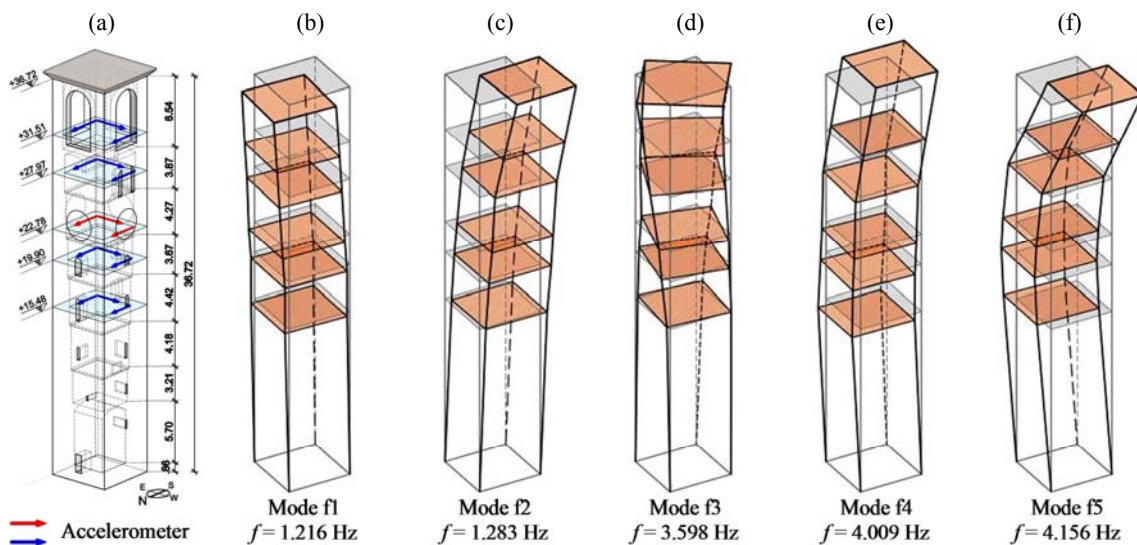
Figure 6: (a) Instrumented cross-sections and layout of accelerometers during the dynamic tests (blue and red arrows) and the continuous monitoring (red arrows); (b) Vibration modes identified from ambient responses.

Two AVTs were conducted on June 2007 and June 2008. In both tests, the response of the tower was measured in 15 selected points (Fig. 6a) and datasets of 3600 s were collected adopting a sampling frequency of 200 Hz. Five vibration modes were identified in the frequency range 0-6 Hz (Fig. 6b-f). As expected, the identified modes can be classified as bending and torsion: dominant bending modes were identified at 1.22 (f₁, Fig. 6b), 1.28 (f₂, Fig. 6c), 4.01 (f₄, Fig. 6e) and 4.16 Hz (f₅, Fig. 6f) while only one torsion mode (f₃, Fig. 6d) was identified at 3.60 Hz. It is worth noting that the dominant bending modes of the tower (Figs. 6b-c and 6e-f) involve flexure practically along the diagonals.

In June 2009, a continuous dynamic monitoring system was installed in the bell tower, with the sensing devices consisting of 3 uni-axial Dytran 3191A1 piezoelectric accelerometers (10 V/g sensitivity and ± 0.50 g peak). Logistical motivations and the results of the preliminary AVT allowed to identify the level at 22.78 m (Fig. 6a) as the one to be instrumented in order to detect all the previously observed modes.

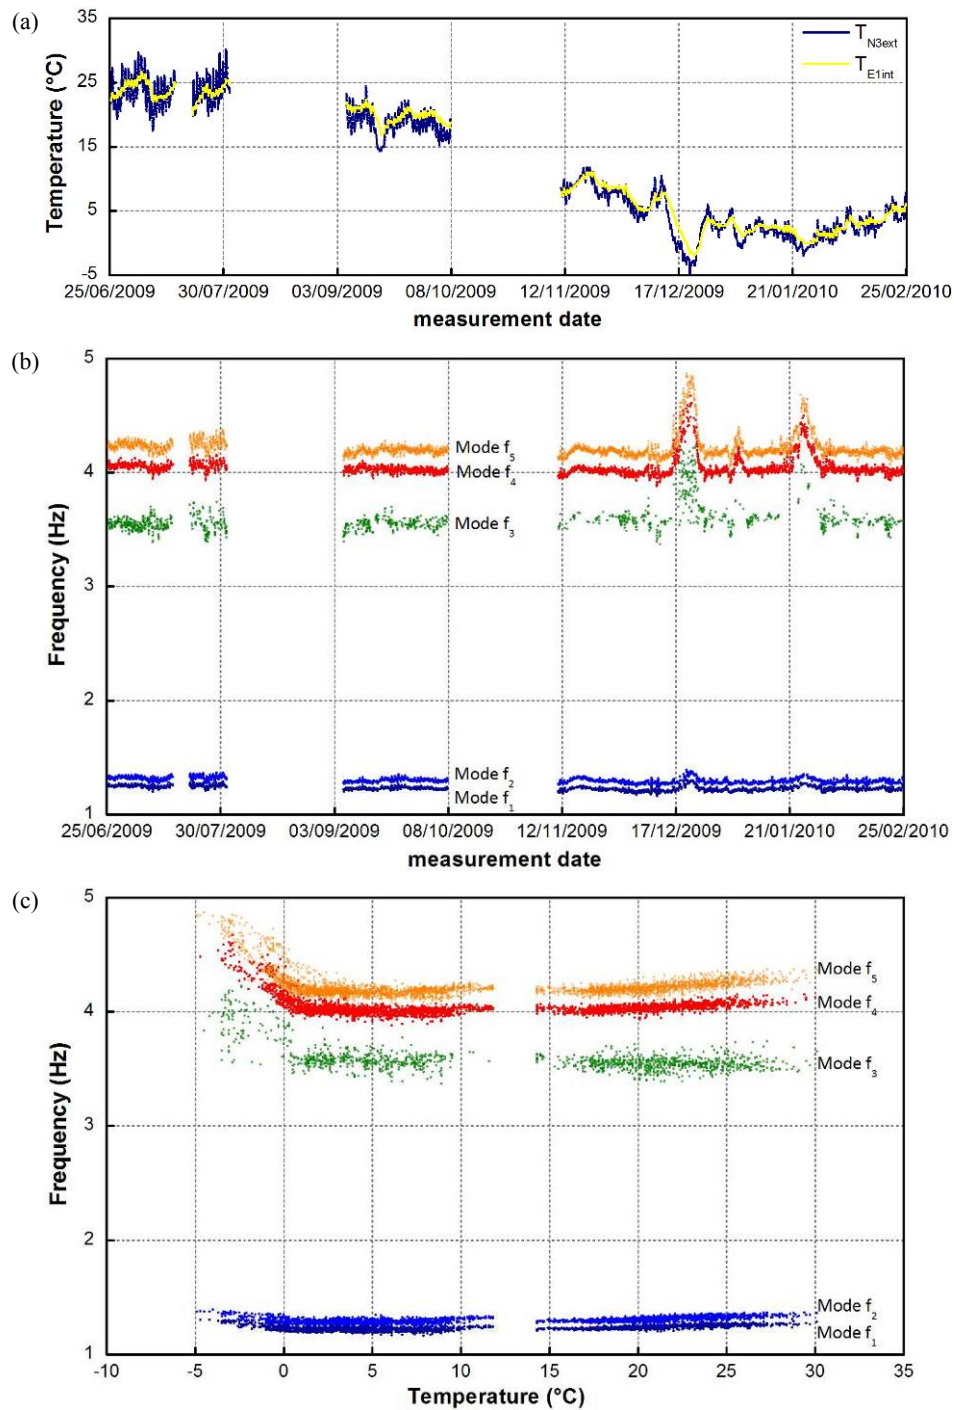
Figure 7: Time evolution (from 25/06/2009 to 24/02/2010) of the temperatures T_{N3ext} and T_{E1int} ; (b) Time evolution (from 25/06/2009 to 24/02/2010) of the automatically identified natural frequencies; (c) Natural frequencies plotted with respect to the outdoor temperature (from 25/06/2009 and 24/02/2010).

Figure 7 shows the time evolution of temperatures (Fig. 7a) and natural frequencies (Fig. 7b) as well as the correlation between modal frequencies and the outdoor temperature $T_{N3\text{ext}}$ (Fig. 7c). The statistics (mean value, standard deviation, minimum and maximum value) of the natural frequencies identified during the monitoring are reported in Table 2.

The inspection of Figs. 7a-c allows the following comments:

1. The bending modes are more frequently identified than the torsion mode, probably as a consequence of the low level of ambient excitation characterizing the tower;
2. Similarly to the global modes of the *Gabbia* tower, the modal frequencies follow almost linearly the daily temperature variation, as their value increases with the increased temperature;

3. Corresponding to below zero temperatures, the natural frequencies rapidly and significantly increase with decreased temperature. This behavior, also observed in [7], is conceivably related to the freezing of the structural system (including its foundation) and to the presence of ice, which fills and closes the cracks, causing a temporary stiffening of the structure.

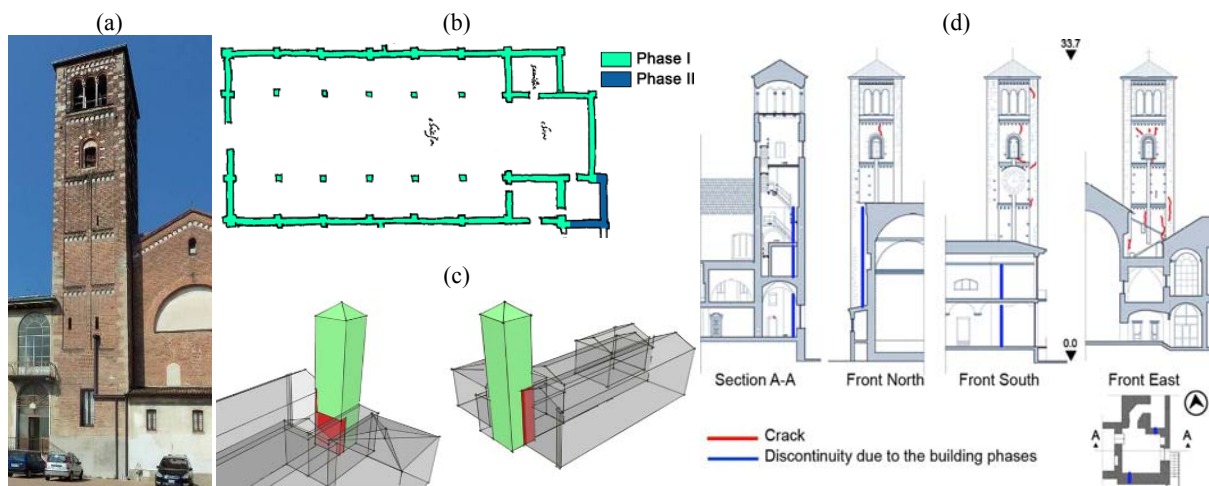
Figure 8: (a) View of the *Santa Maria del Carrobiolo* bell-tower (Monza, Italy); (b) Building phases in a plan dating back to 1572; (c) Schematic representation of the interaction between the bell-tower and the church apse; (d) Section and fronts of the bell-tower.

Historical documents testify that the construction of the church and monastery dates to the 13th century, whereas the bell-tower was completed in 1339 (Fig. 8b). The sequence of the construction stages has been confirmed by visual inspection of the masonry discontinuities: (a) the North and West sides of the tower are directly supported by the load-bearing walls of the apse and the right aisle of the church; (b) the Southern and Eastern load-bearing walls of the tower are continuous from the ground to the roof but do not exhibit any mechanical connections with the walls of the church (Figs. 8c and 8d). Moreover, several cracks cut the entire wall thickness, mainly at the level below the belfry (Fig. 8d), and a metallic tie-rod opposes to the opening of a deep crack on the Western wall of the bell-tower.

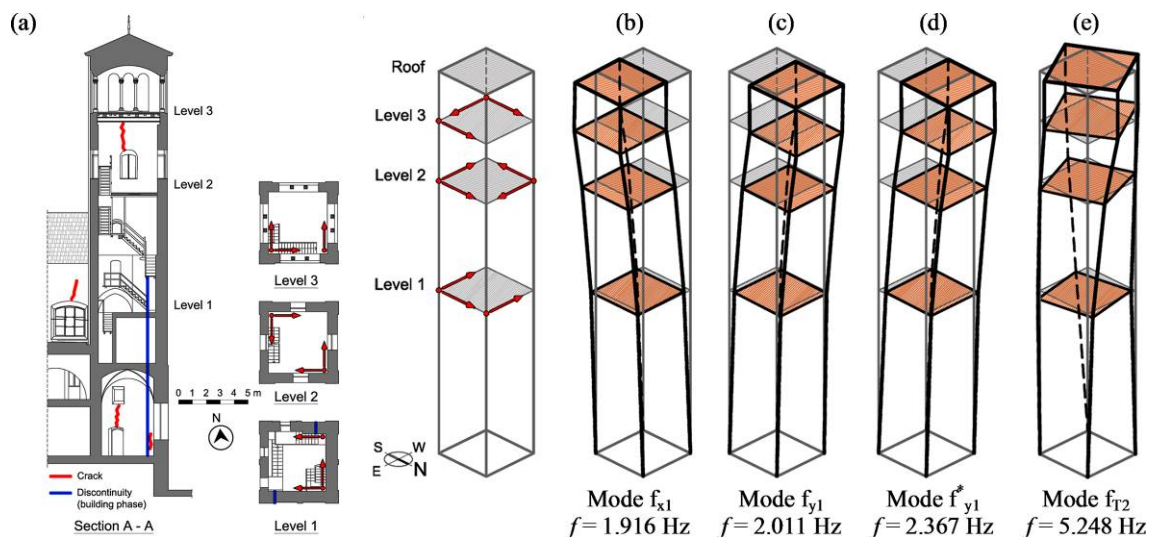
Figure 9: (a) Schematic of accelerometers layout and (b)-(e) selected vibration modes identified from ambient vibration tests.

AVTs were carried out on 23 September 2015 [10] and mainly aimed at evaluating the baseline dynamic characteristics of the tower before the installation of a continuous dynamic monitoring system in the building. Selected mode shapes identified by applying the SSI-Cov method are presented in Fig. 9 and reveal very peculiar dynamic characteristics of the tower, that are conceivably related to the structural arrangement and construction sequence of the building. In more details, closely spaced modes with similar mode shapes were clearly identified, so that the sequence of identified modes turns out to be very different from the expected regular series of two bending modes (one for each principal plane of the structure) and one torsion mode (see e.g., the *San Vittore* bell-tower). As shown in Fig. 9, the identified sequence of vibration modes (Fig. 9) includes: (a) the fundamental mode ($f_{x1} = 1.92$ Hz, Fig. 9b), involving dominant bending in the E-W direction; (b) two bending modes in the N-S direction, that are characterized by closely spaced natural frequencies ($f_{y1} = 2.01$ Hz and $f_{y1}^* = 2.37$ Hz) and very similar mode shapes (Figs. 9c and 9d).

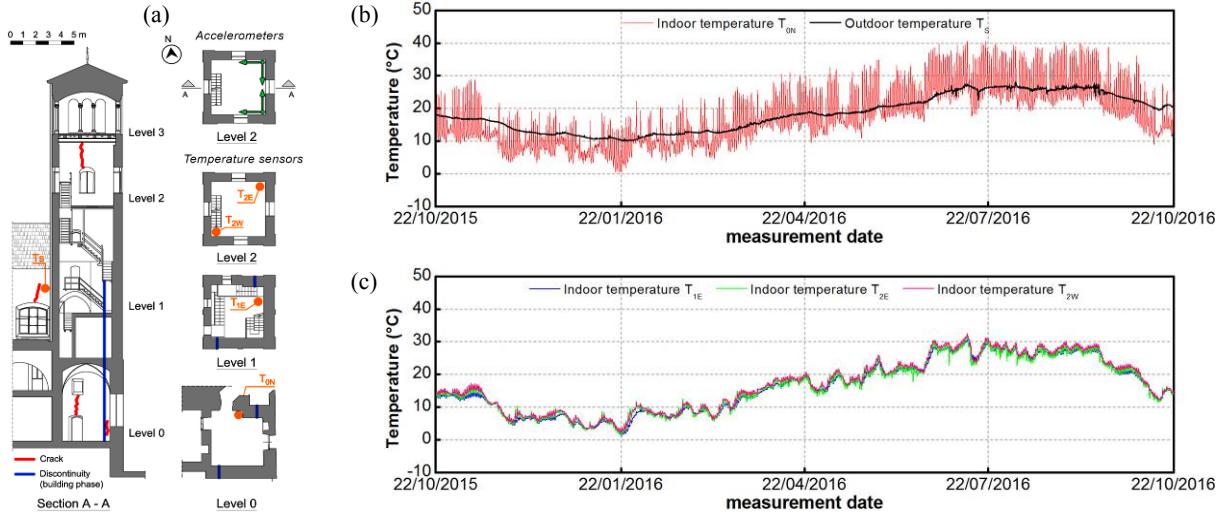
Figure 10: (a) Accelerometers and temperature sensors installed in the tower; (b) Variation in time of the measured temperatures T_{0N} and T_S ; (c) Variation in time of the measured temperatures T_{1E} , T_{2E} and T_{2W} .

The continuous dynamic monitoring system (Fig. 10a) installed in the tower since 22 October 2015 includes 4 MEMS accelerometers (Kistler model 8330A3, 1.2 V/g sensitivity, ± 3.00 g peak acceleration, 1.3 μg resolution and 0.4 $\mu\text{g}/\sqrt{\text{Hz}}$ r.m.s. noise density), one Ethernet carrier with NI 9234 data acquisition module and one local PC for the management of the continuous acquisition and the data storage. In addition, 5 temperature sensors – denoted as T_{0N} , T_{1E} , T_{2E} , T_{2W} and T_S in Fig. 10a – were available, and measured both the indoor temperature at different levels of the tower and the outdoor temperature on the South side of the structure; hence, a relatively dense representation of the temperature conditions of the tower is achieved.

Figures 10b-c show the hourly averaged value of the measured temperatures in the monitoring period from 22 October 2015 to 21 October 2016. Table 3 summarizes the correlation

coefficients between the environmental data during the same period. Figures 10b-c and Table 3 indicate that a large degree of correlation exists between all temperature data, with the measurements T_{1E} , T_{2E} , and T_{2W} being almost perfectly correlated and characterized by correlation coefficients very close to unity.

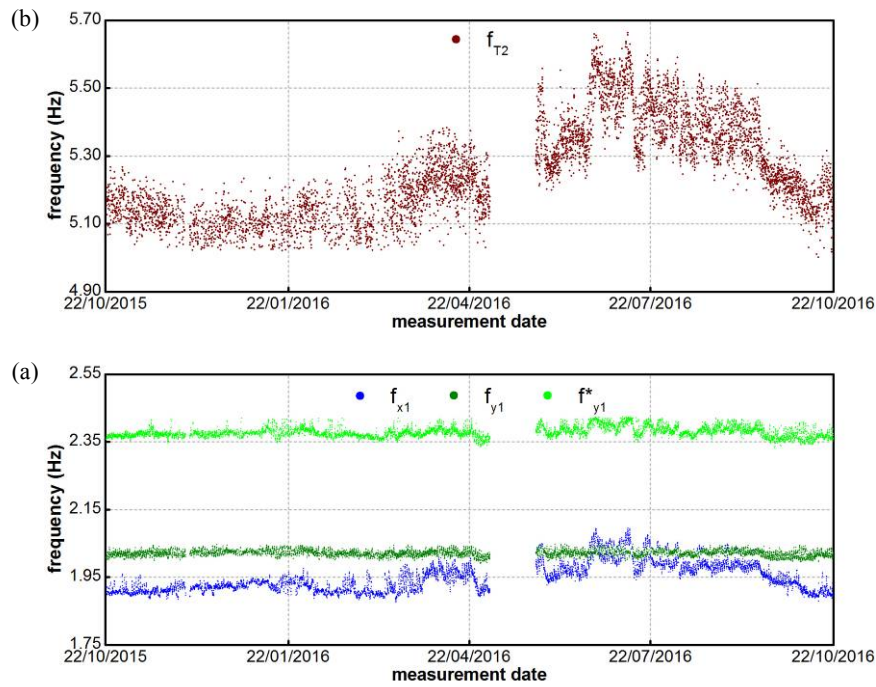
Figure 11: Time evolution of the automatically identified natural frequencies along the first year of monitoring (from 22/10/2015 to 21/10/2016): (a) modes f_{x1} , f_{y1} and f_{y1}^* ; (b) mode f_{T2} .

The modal identification was performed applying a fully automated OMA procedure [14] to time windows of 3000 s (which were obtained from each 1-hour recorded dataset after detection and removal of the time series corresponding to the swinging of bells). Figure 11 presents the evolution of the identified modal frequencies in the first year of continuous dynamic monitoring (i.e., from 22/10/2015 to 21/10/2016), whereas the relevant statistics are summarized in Table 4 through the mean value (f_{ave}), the standard deviation (σ_f), and the extreme values (f_{min} , f_{max}) of each natural frequency. The results summarized in Fig. 11 and Table 4 allow the following comments:

1. Notwithstanding the low level of the ambient excitation, 4 normal modes were identified with high occurrence and accuracy;
2. The natural frequency of modes f_{x1} and f_{T2} exhibits significant increase in Spring and Summer period. This trend suggests that these modal frequencies are strongly affected by the temperature and – similarly to *Gabbia* tower and *San Vittore* bell-tower – increase with increased temperature;
3. On the contrary, the natural frequency of modes f_{y1} and f_{y1}^* exhibits very limited variation, with the standard deviation being equal to 0.009 and 0.015 Hz, respectively. For those

modes, the frequency trend increase with increased temperature is conceivably balanced by the loss of tension in the metallic tie-rod placed on the West side and connecting the North and South load-bearing walls of the tower;

4. As shown in Fig. 11a, the natural frequencies of the two lower modes f_{x1} and f_{y1} exhibit crossing in Summer months. To the best of the authors' knowledge, this behavior has not been observed before on masonry towers and conceivably depends on the different effect exerted by the temperature on the natural frequencies of the two modes. Furthermore, the mode shape of both modes f_{x1} and f_{y1} tends to hybridize when crossing occurs: in other words, the two modes tend to involve biaxial bending in both the main E-W and N-S directions when the natural frequencies become very close to each other. It is further noticed that this hybridization, suggesting the occurrence of something similar to mode veering (see e.g. [18]), is more significantly detected for mode f_{y1} .

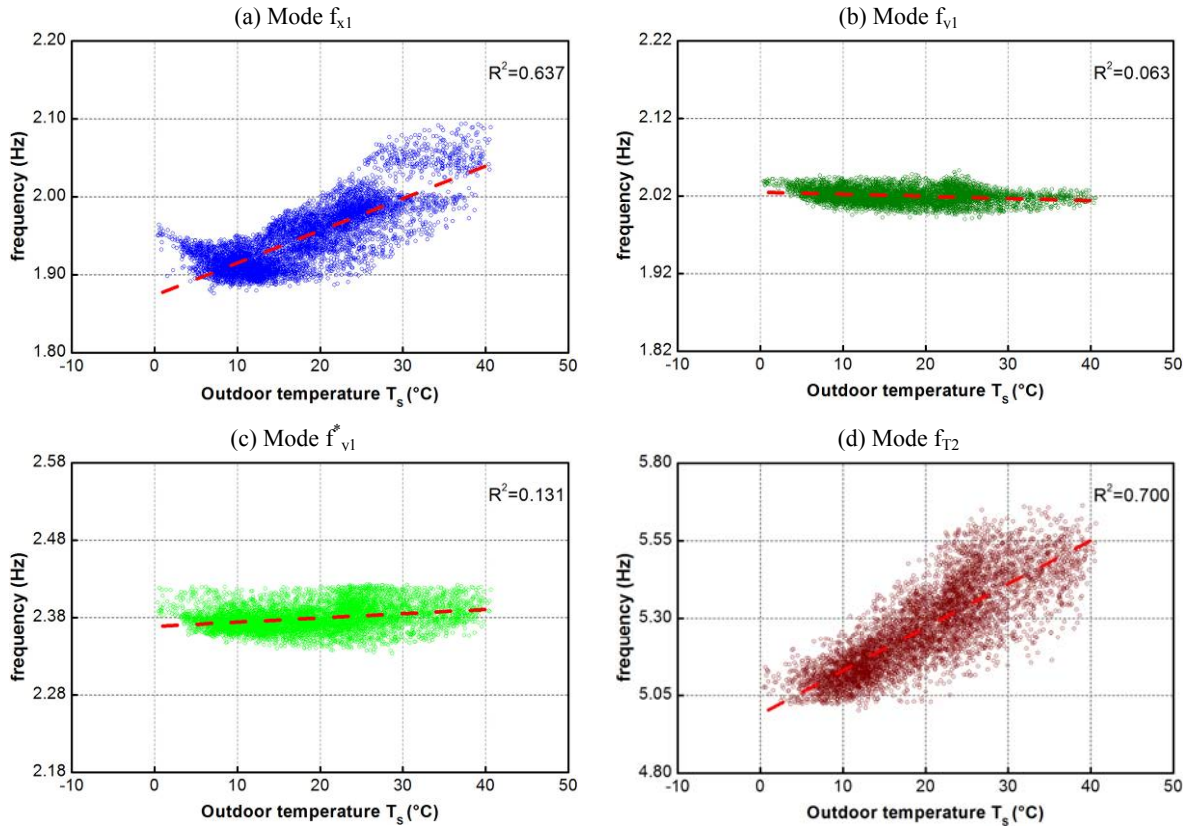
Figure 12: Correlation between outdoor temperature T_s and natural frequencies.

The identified natural frequencies have been plotted versus the outdoor temperature T_S in Fig. 12, along with the best fit line and the coefficient of determination R^2 . Figures 12a and 12d refer to modes f_{x1} and f_{T2} and confirm that the frequency of those modes increases with increased temperature, with slight non linearity being observed in the low temperature range

($T_s < 10^\circ\text{C}$). Figures 12b and 12c refer to closely spaced and similar modes f_{y1} and f_{y1}^* and confirm the very low effect of the changing environment on the frequency of these modes. It is further noticed that ongoing numerical investigation seems to indicate that the PCA-based regression turned out to be an effective tool to mitigate the environmental effects on automatically identified frequencies, in spite of the relatively small number of monitored frequencies.
