Investigating Erosion and Ecological Impacts to an Urban Coldwater Stream Using Multiple Techniques

INVESTIGATING EROSION AND ECOLOGICAL IMPACTS TO AN URBAN
COLDWATER STREAM USING MULTIPLE TECHNIQUES

Daniel Thomas Latimer Myers

Master of Science in Biology

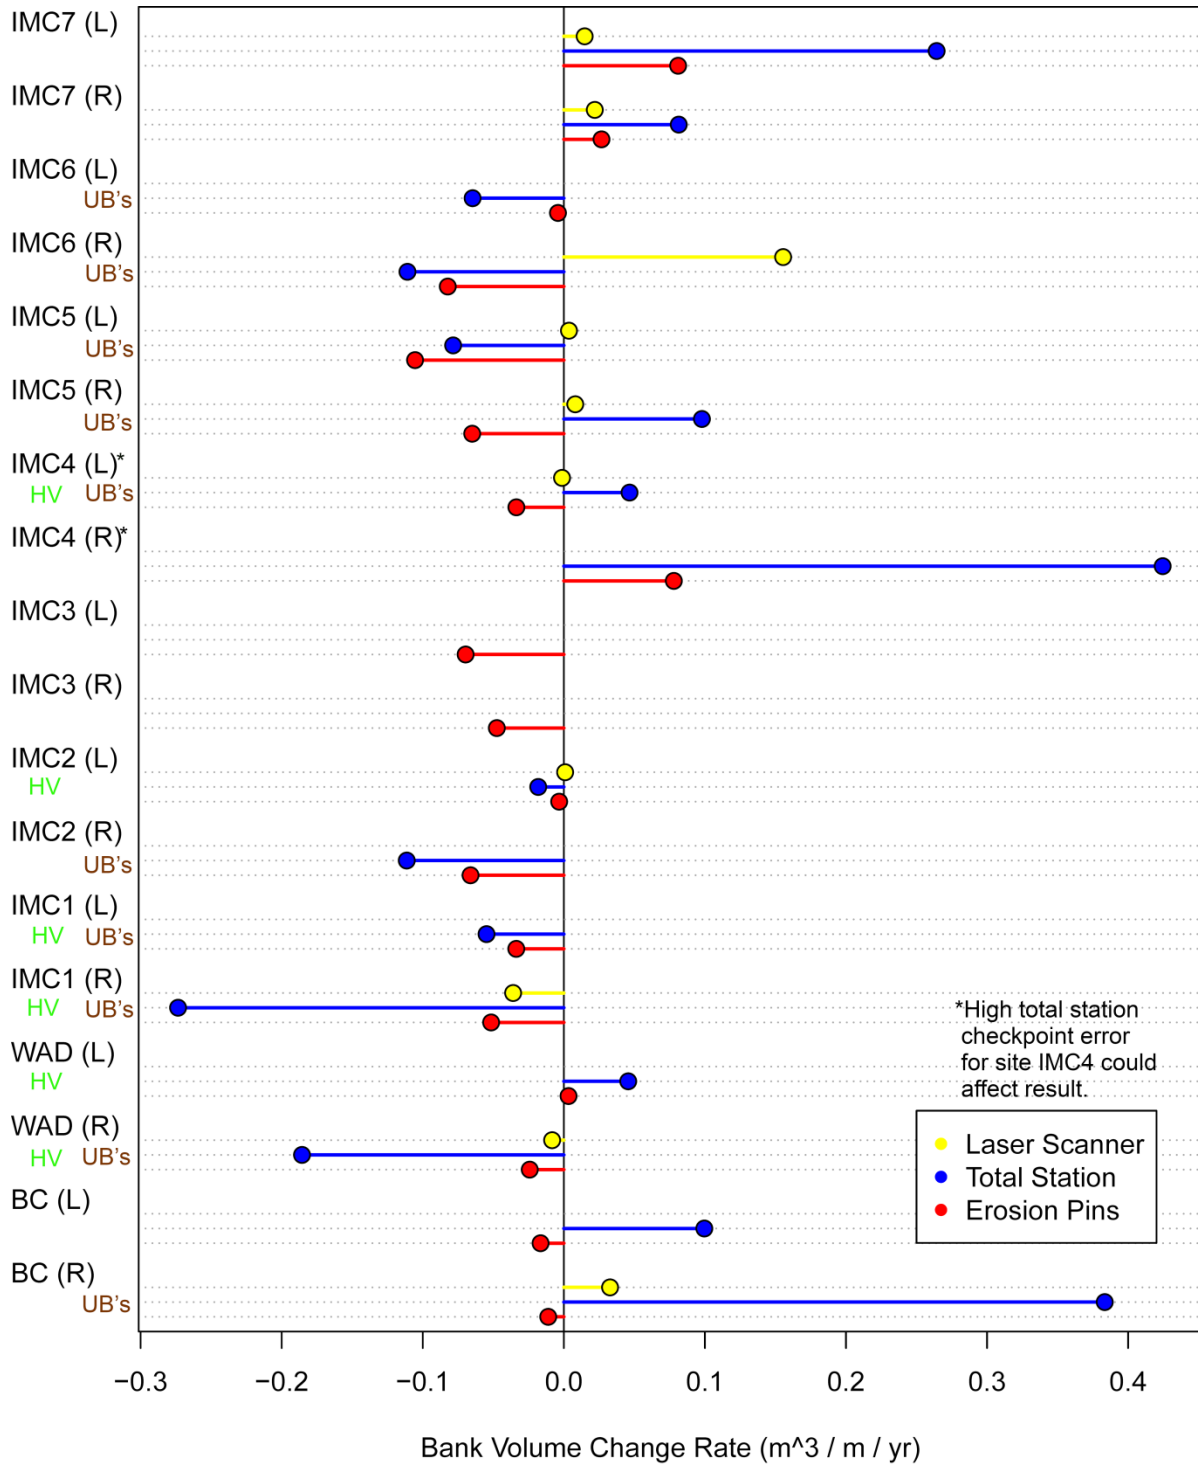
Figure 4.4. Comparison of results from techniques used to measure streambank erosion in the Indian Mill Creek watershed 2017-2018. Positive values indicate net deposition while negative values indicate net erosion being measured. Presence of heavy vegetation (HV) or undercut banks (UB's) is noted under site names.

The dot chart shows that study streambanks experienced net deposition (positive volume change), net erosion (negative), little change in bank volume (points near zero), or a mixture depending on the technique (Figure 4.4). Sites are labeled with name and left (L) or right (R) bank and are ordered from lowest reach (IMC7) to headwaters (IMC1), followed by the two tributary sites. The presence of heavy vegetation (HV) or undercut banks (UB's) is noted under the site name to visualize the effects of these conditions on estimates of bank volume change. The following analysis of the chart is split into lower watershed, upper watershed, and tributary sites. Percent differences between techniques were substantial, with an average difference of 650% between erosion pins and total station data, 596% between the laser scanner and erosion pins, and 1,275% between the laser scanner and total station (Table 4.2). Bank photos are presented for reference in Figure 4.3.
